APPENDIX F1
TANSLEY BRIDGE CONDITION SURVEY REPORT 2009

**Dundas Street (Reg. Rd. 5)
Class EA Study
Brant Street (Reg. Rd. 18)
to Proudfoot Trail**

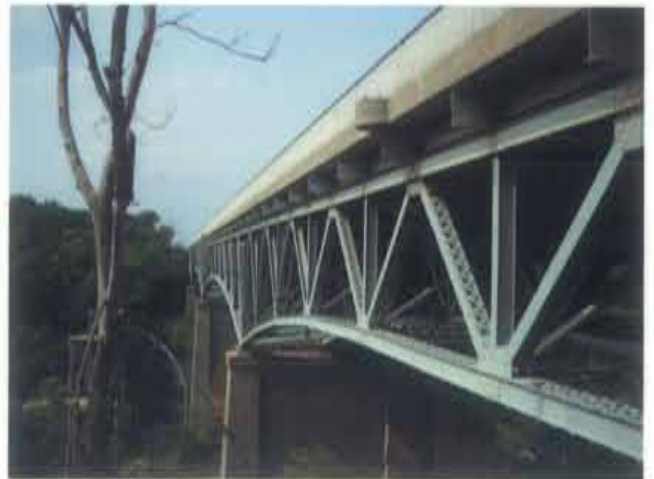
**Tansley Bridge
Dundas Street at Bronte Creek
Bridge No. 005109
MTO Site N0. 010-0111**

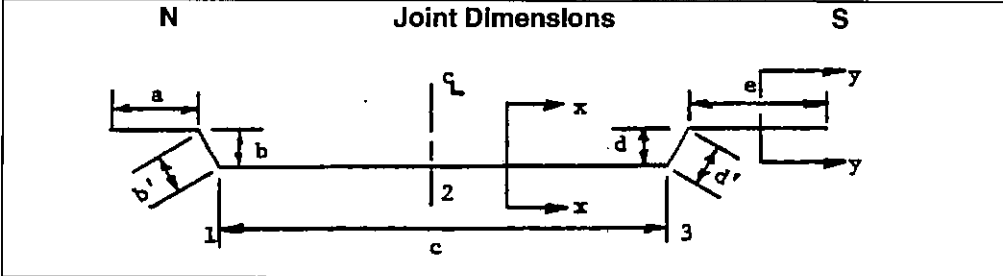
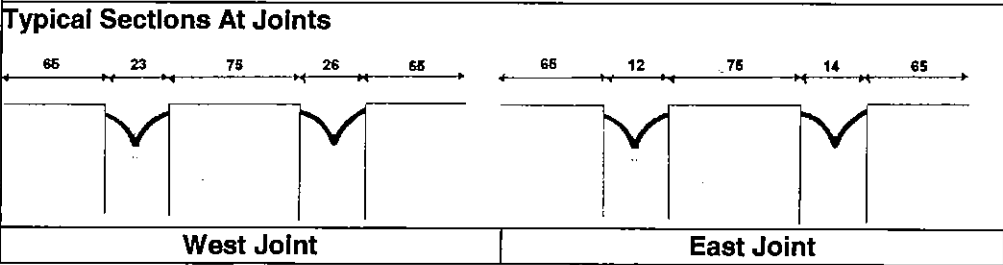
East Joint
 Debris accumulation
 Rubber seal popped out at north and south ends
 End dam has 30% area patched
 Seal broken between approach slab and ballast wall

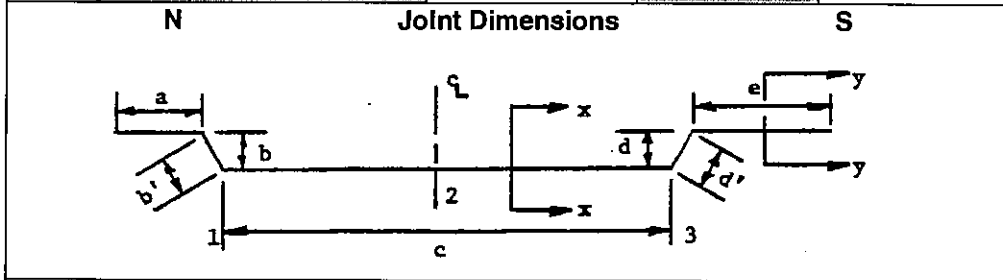
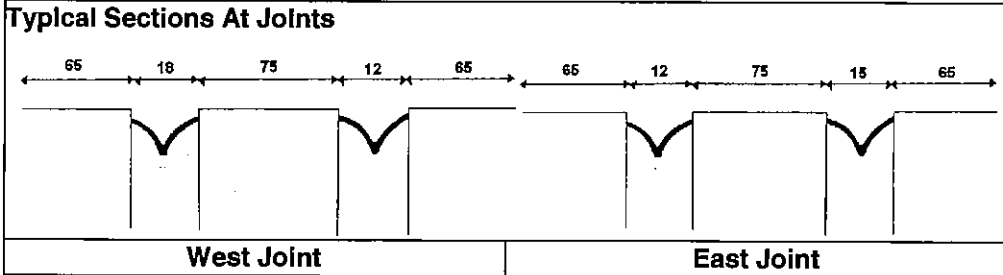
East Joint
Debris accumulation
Sealed crack and spalling along east side of concrete end dam
Large number of concrete patches on ballast wall and end dam (approximately 50% of area)

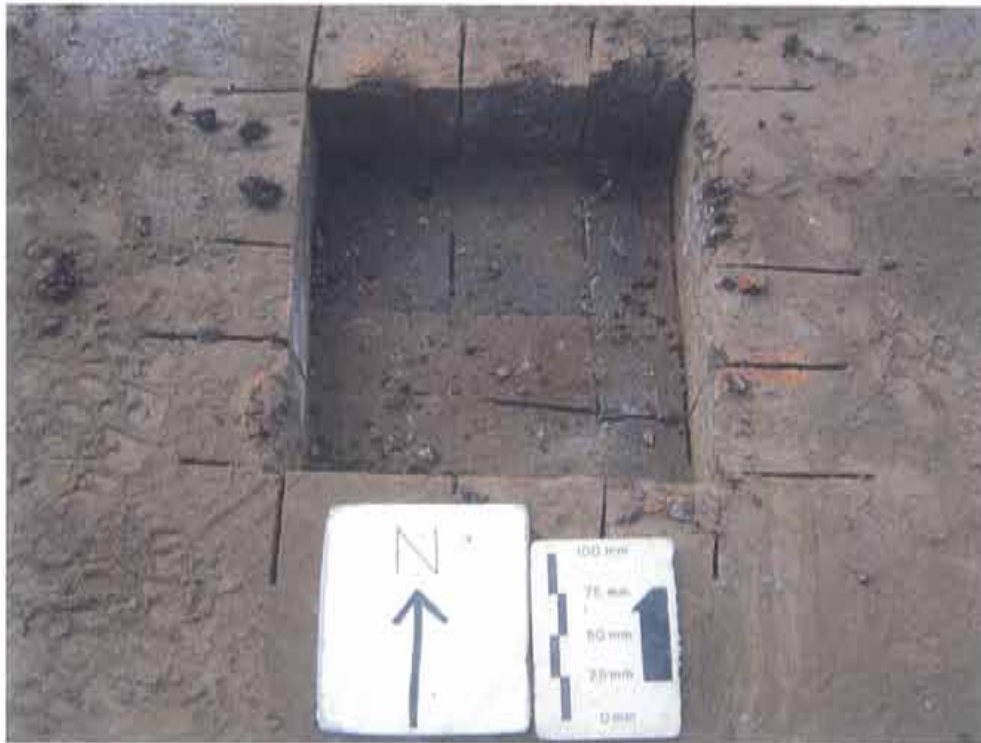
APPENDIX C
SAWN ASPHALT SAMPLE
PHOTOGRAPHS AND LOGS

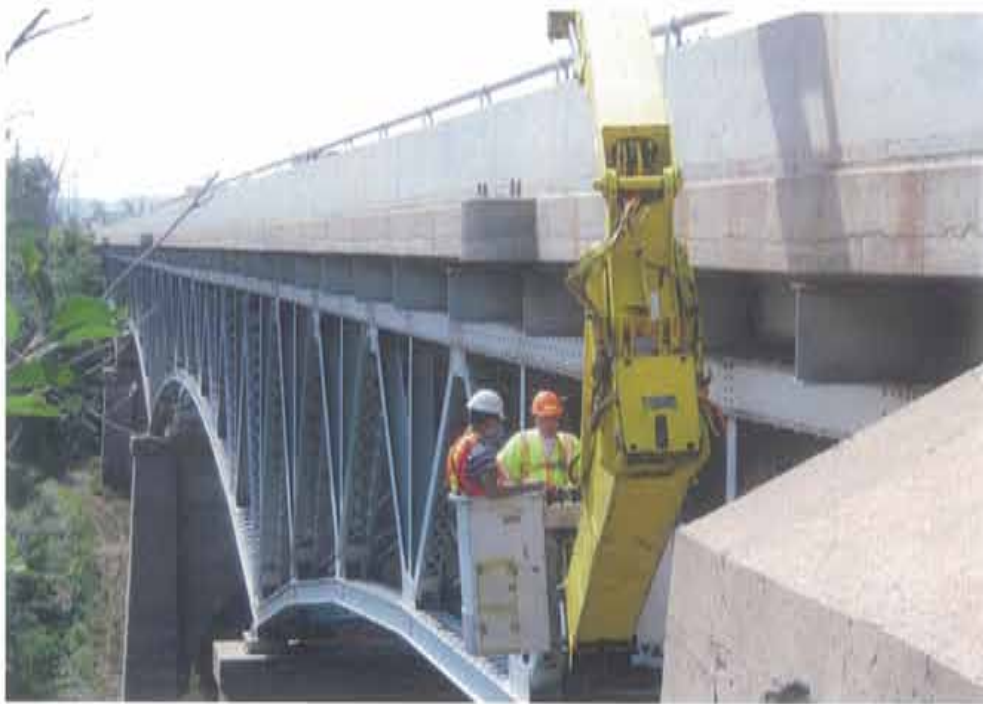
Photograph 1. South elevation of south structure

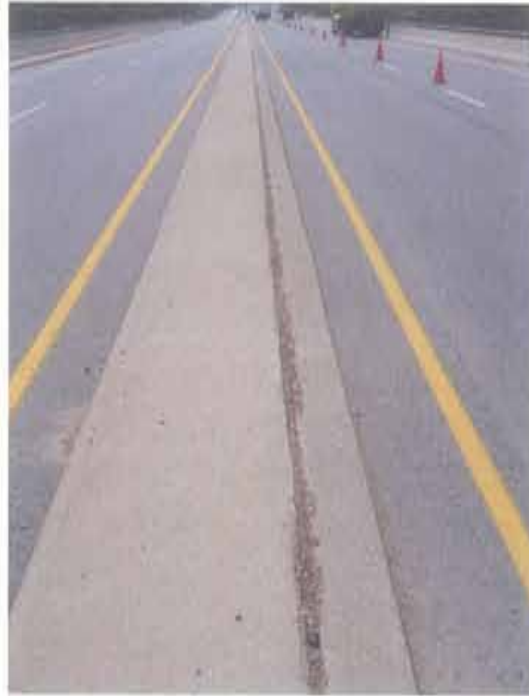
Photograph 9. Typical condition of centre longitudinal joint, looking west

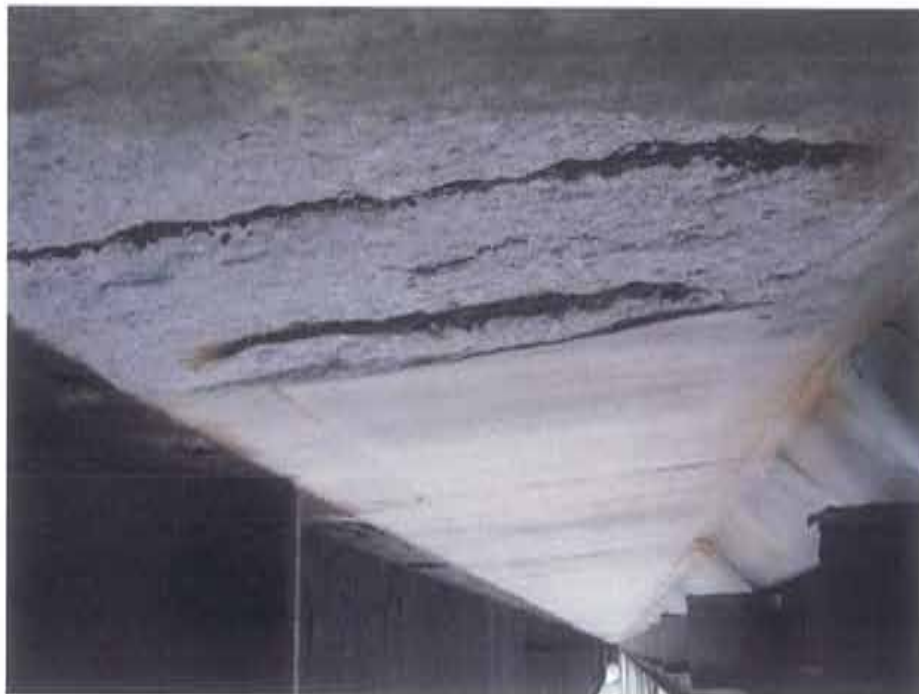
Photograph 10. Spalling in south deck cantilever of north bridge, looking east; note: photo shows the concrete deck cantilever at the centre median

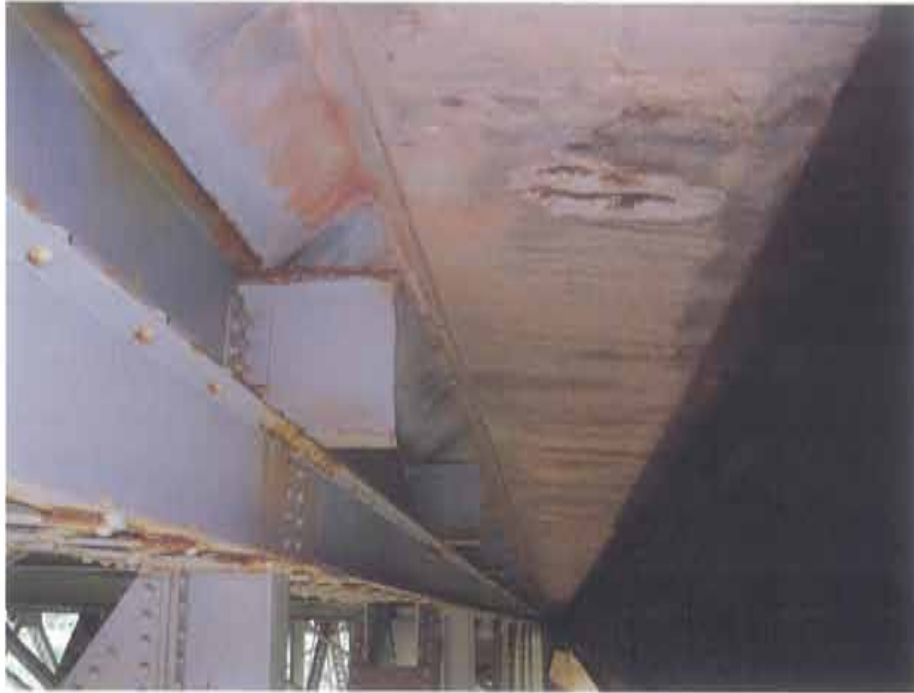
Photograph 11. Typical deterioration of deck cantilever at the centre median, looking west; note: spalling, rust staining, wet staining and transverse cracking

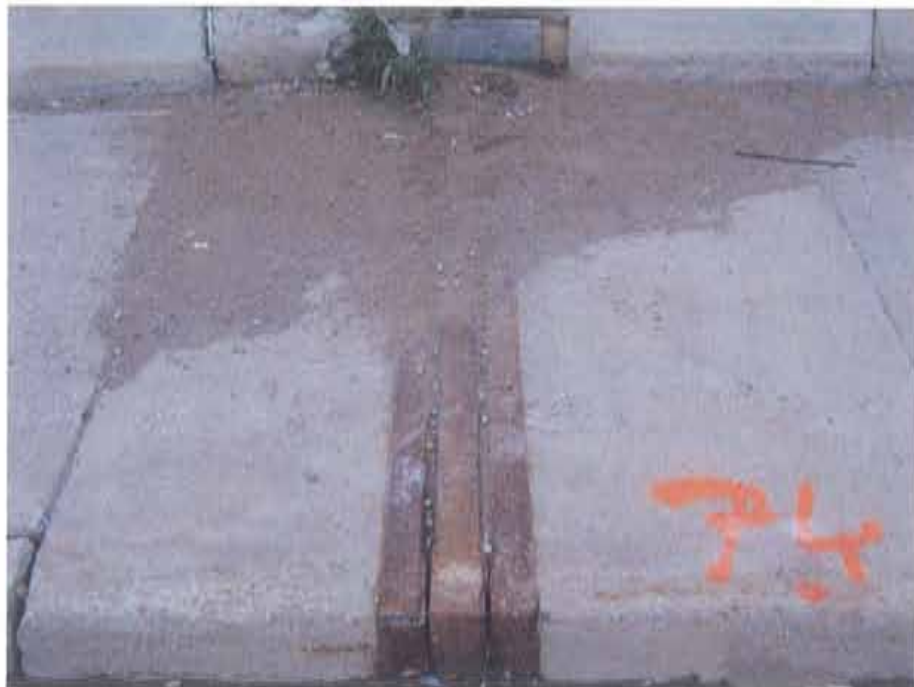
Photograph 12. Debris build-up in the east sidewalk joint of the south bridge; note: the large accumulation of debris build-up at this location may indicate the approach sidewalk has settled

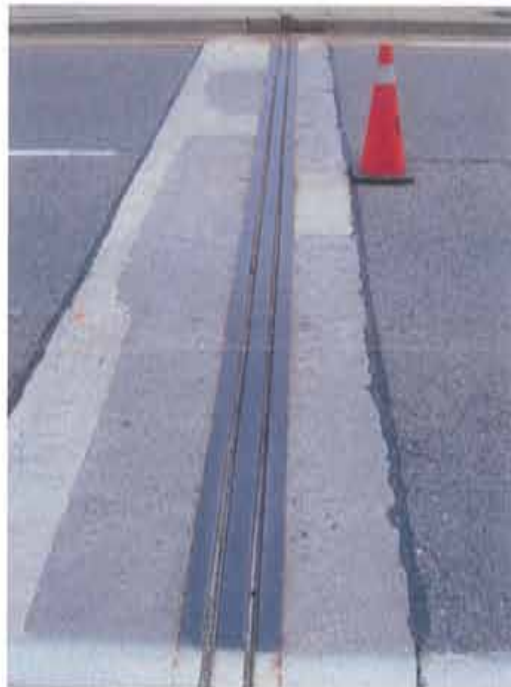
Photograph 14. Typical condition of concrete patching in concrete end dams and ballast wall (completed during the 2004 rehabilitation work)

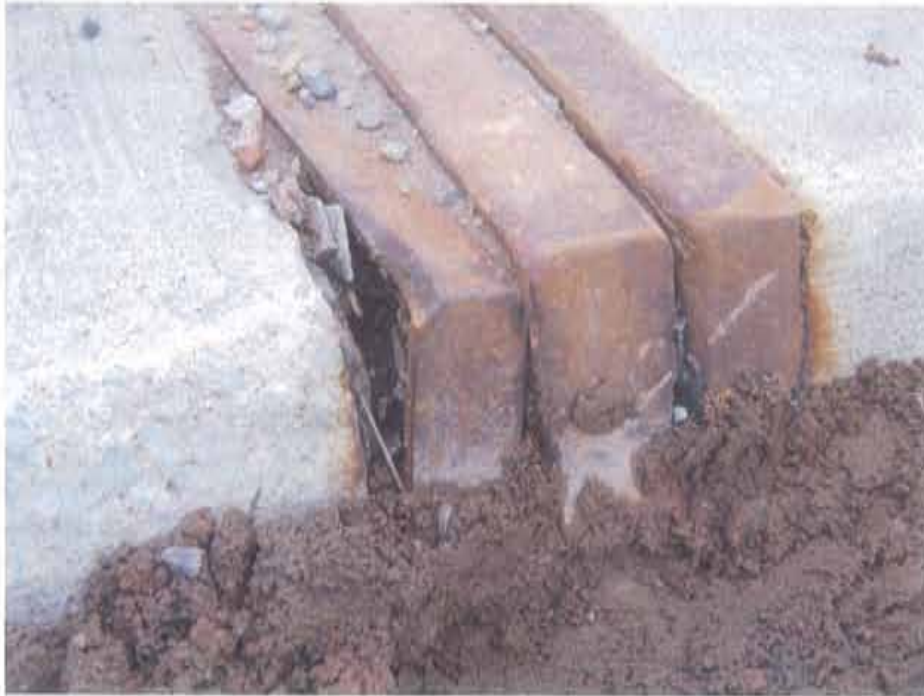
Photograph 15. Distortion of west sidewalk joint, facing south-west; note: impact damage on steel angle

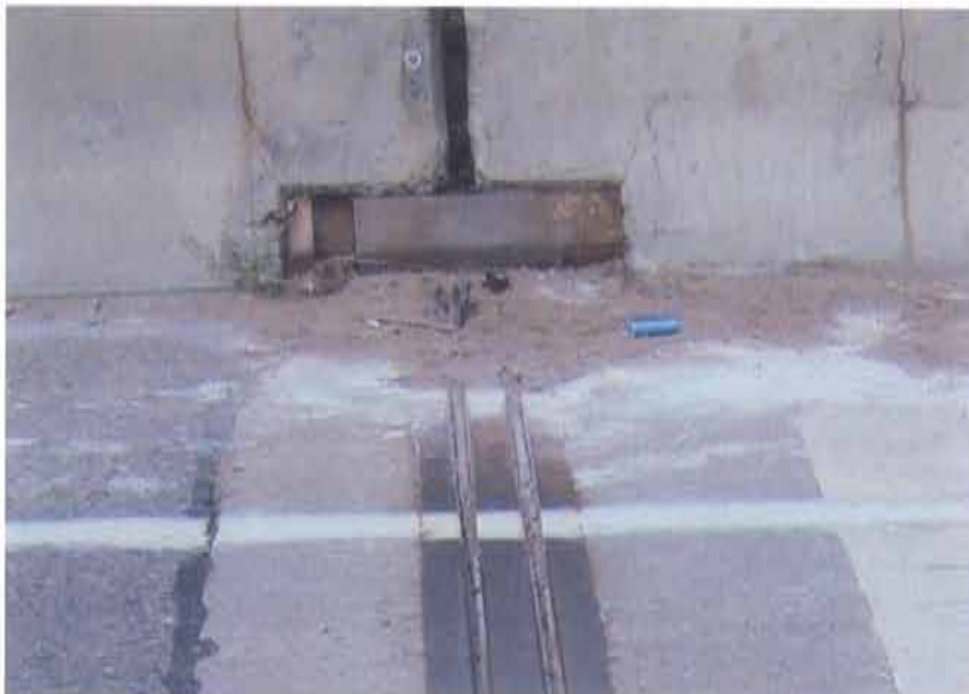
Photograph 16. Pop-out of joint seal at the west joint of the north structure, looking north; note: pop-out is typical of the ends of all the joints on the north structure

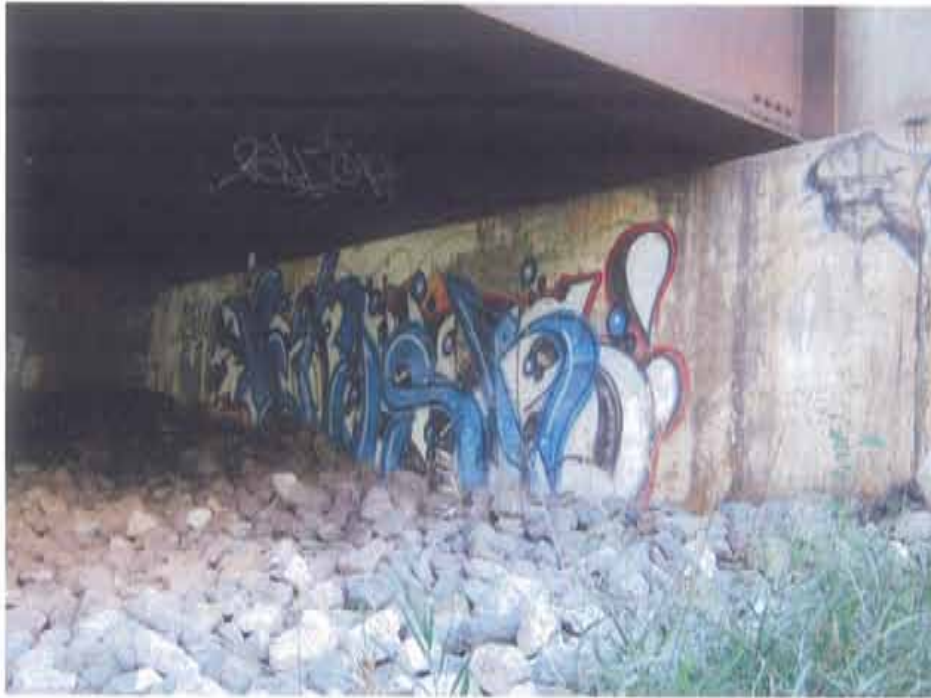
Photograph 17. Typical deterioration of abutment under north structure

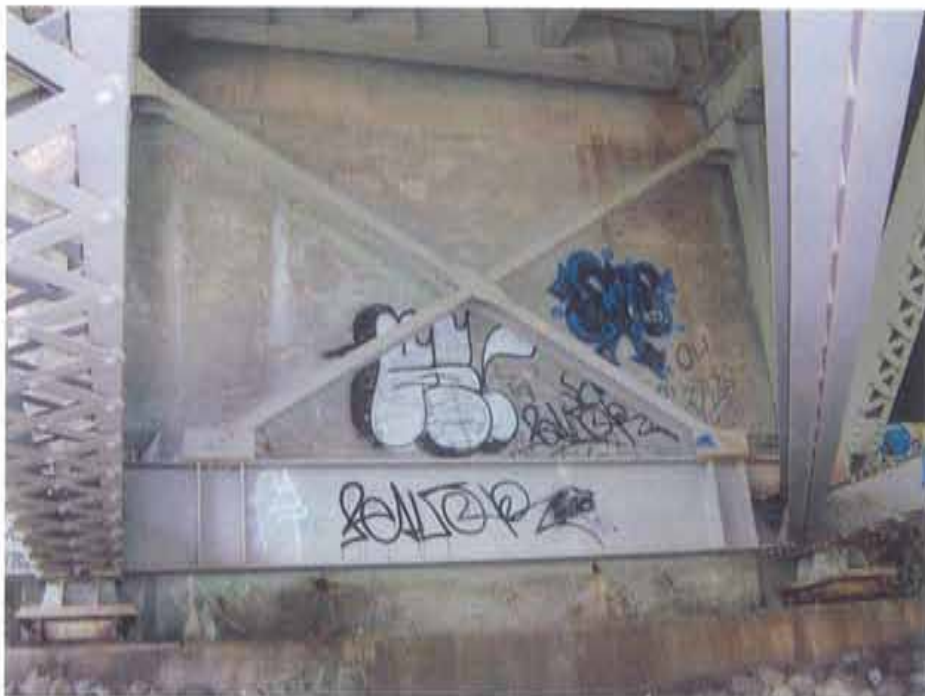
Photograph 18. Typical deterioration of abutment under south structure

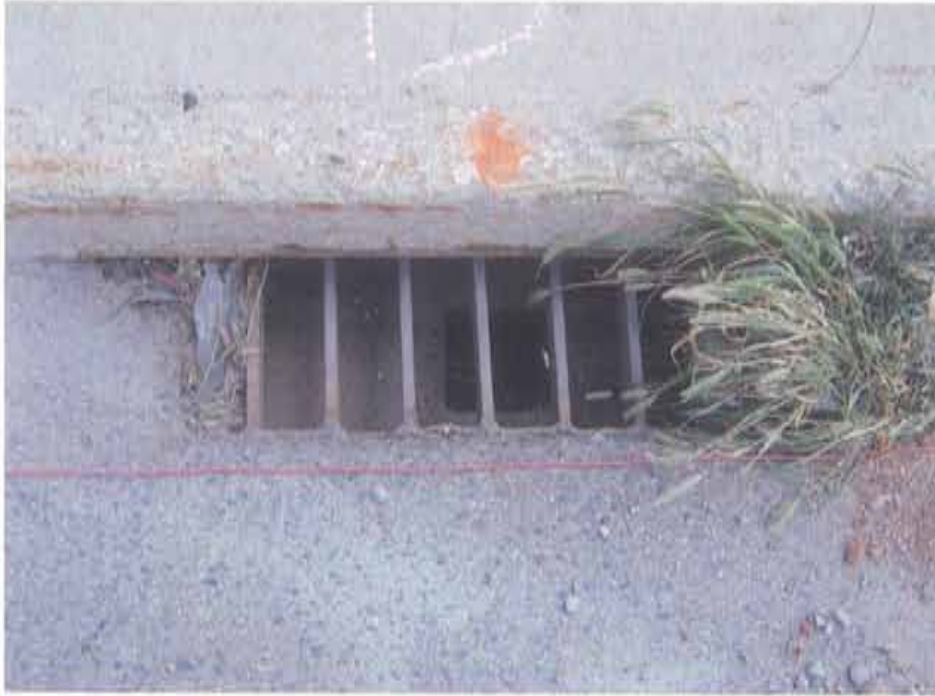
Photograph 19. Typical deck drain with vegetation growth

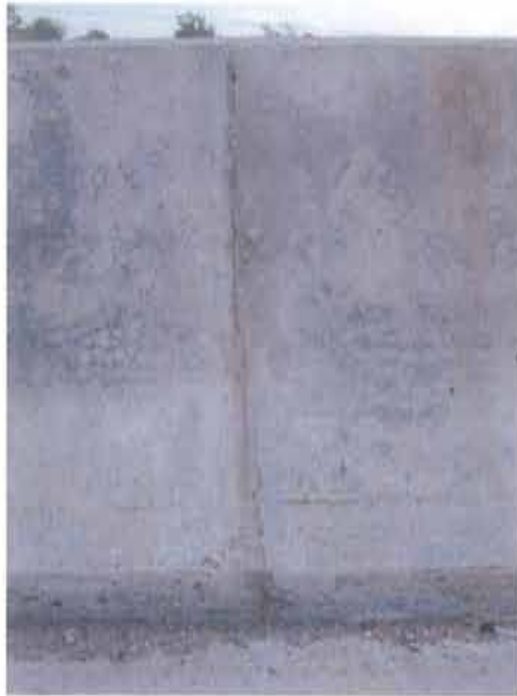
Photograph 21. Typical vertical cracking with staining on barrier wall

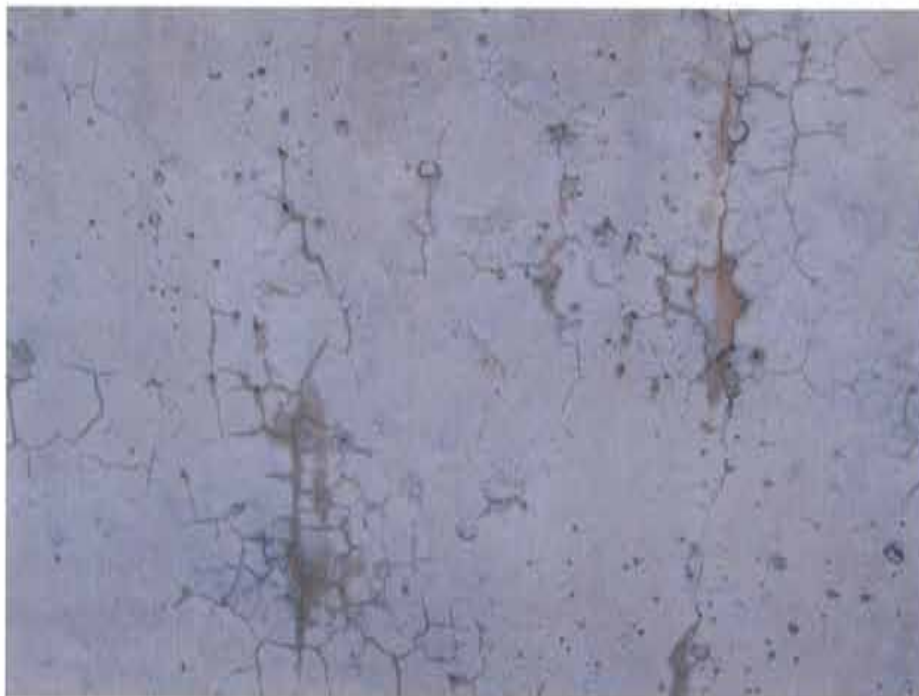
Photograph 22. Typical map cracking on barrier walls

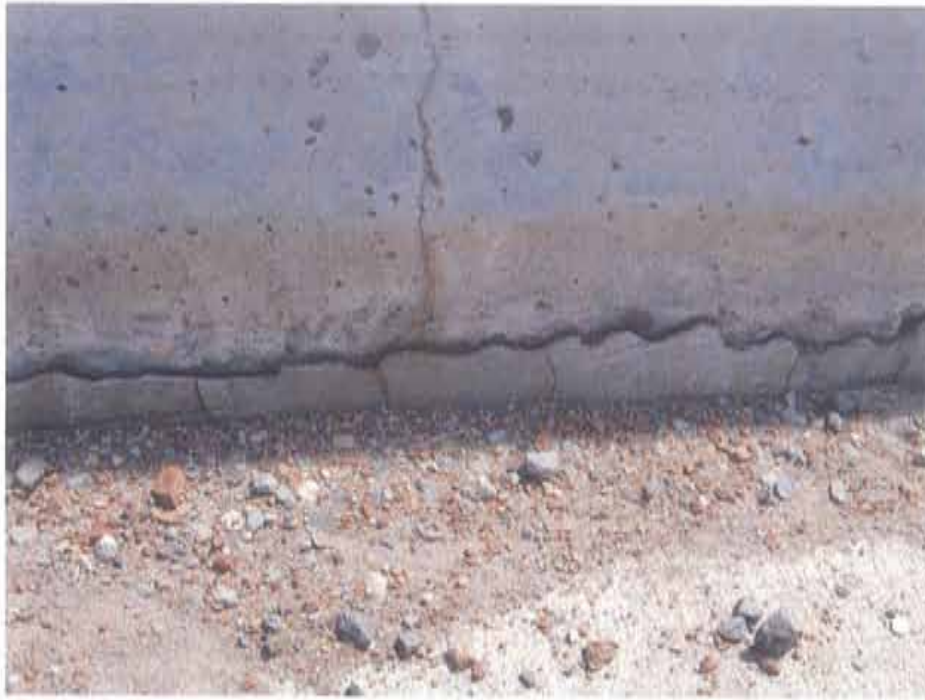
Photograph 23. Concrete disintegration at the base of the south barrier wall

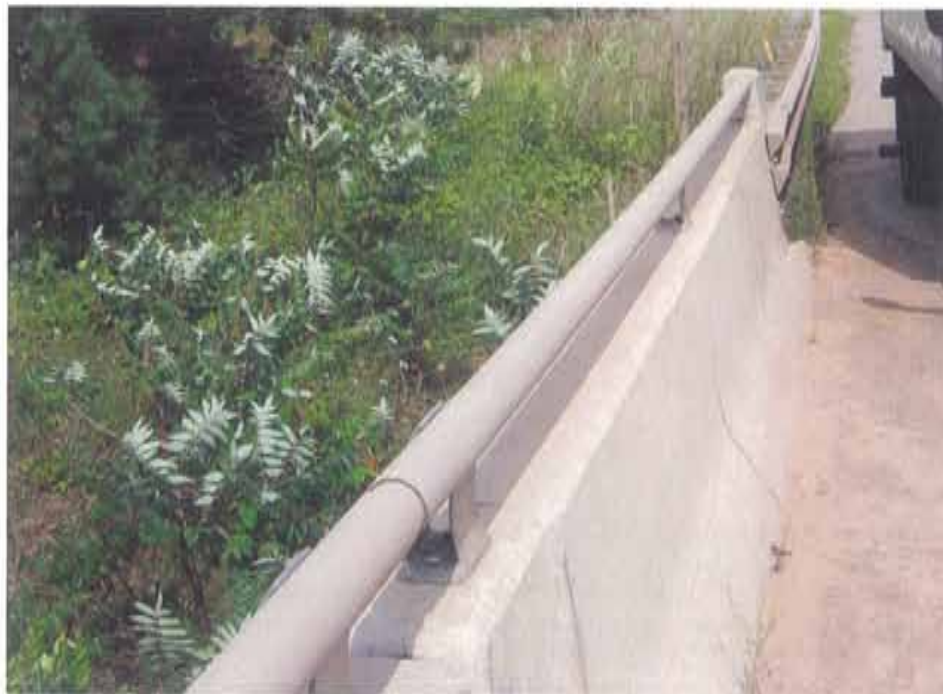
Photograph 24. Typical condition of railing; note: light surface corrosion

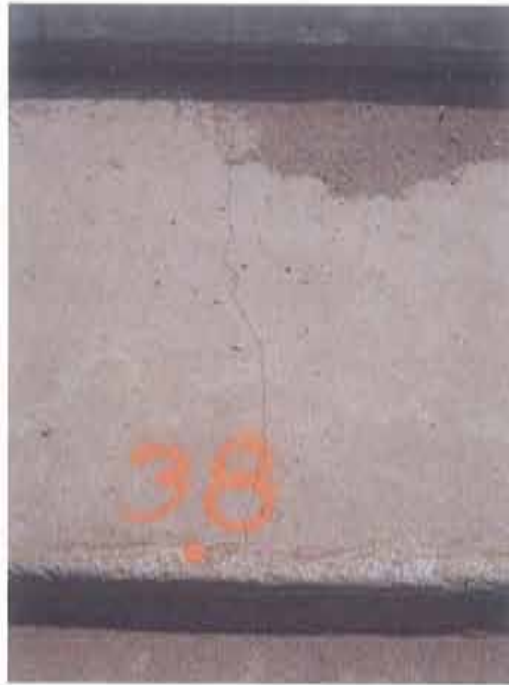
Photograph 25. Typical narrow to medium transverse cracking on sidewalk

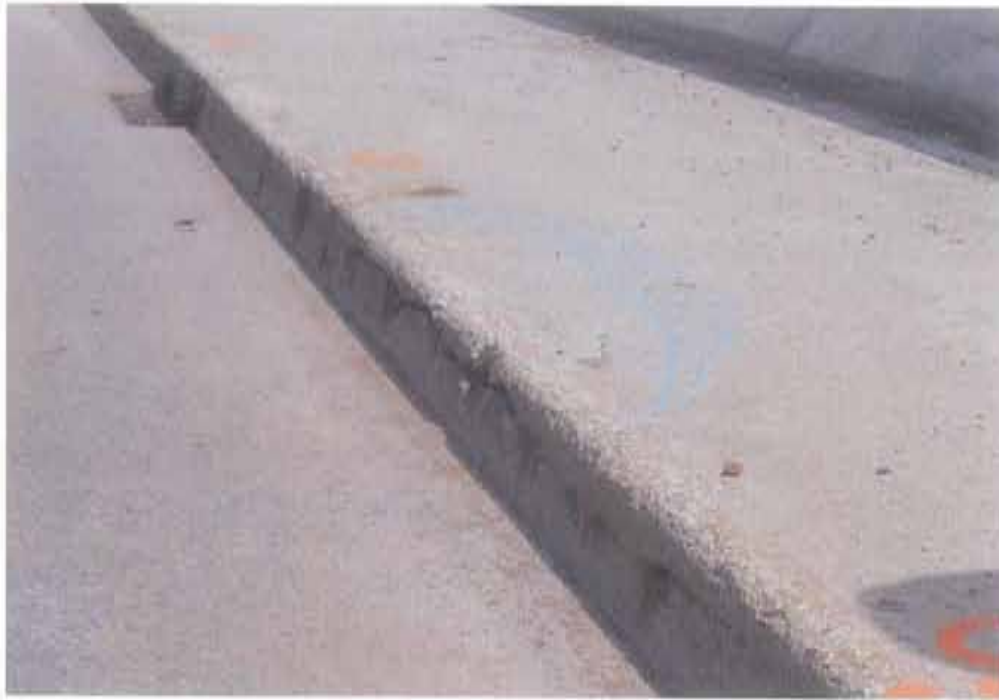
Photograph 27. Typical delamination in sidewalk

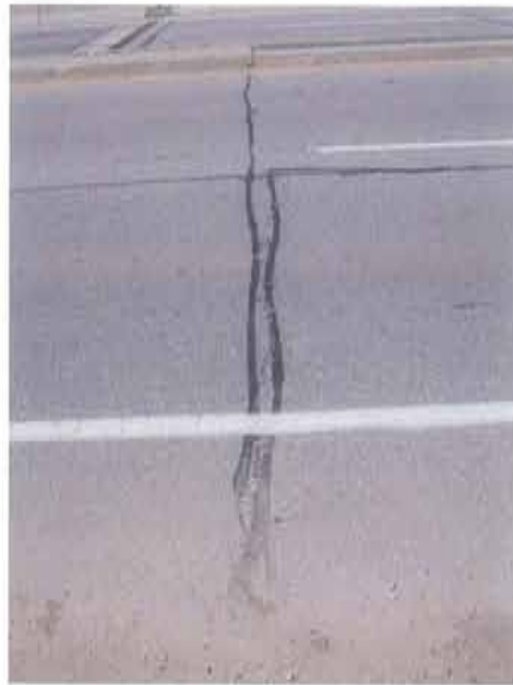
Photograph 29. Sealed transverse and longitudinal cracks at the east approach slabs (looking north)

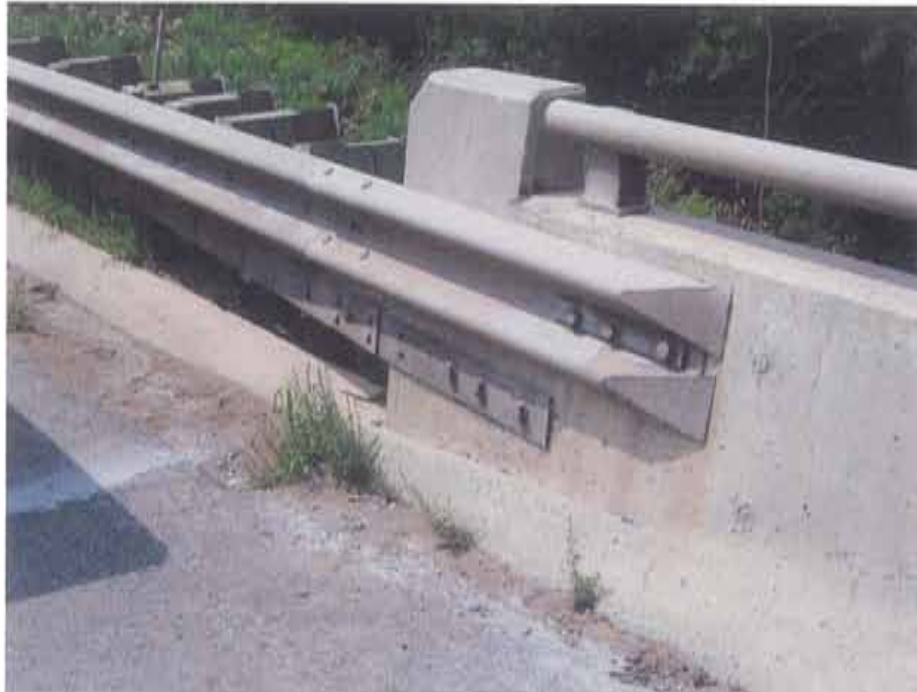
Photograph 30. Connection of steel beam guide rail to parapet wall at north west corner of bridge (typical)

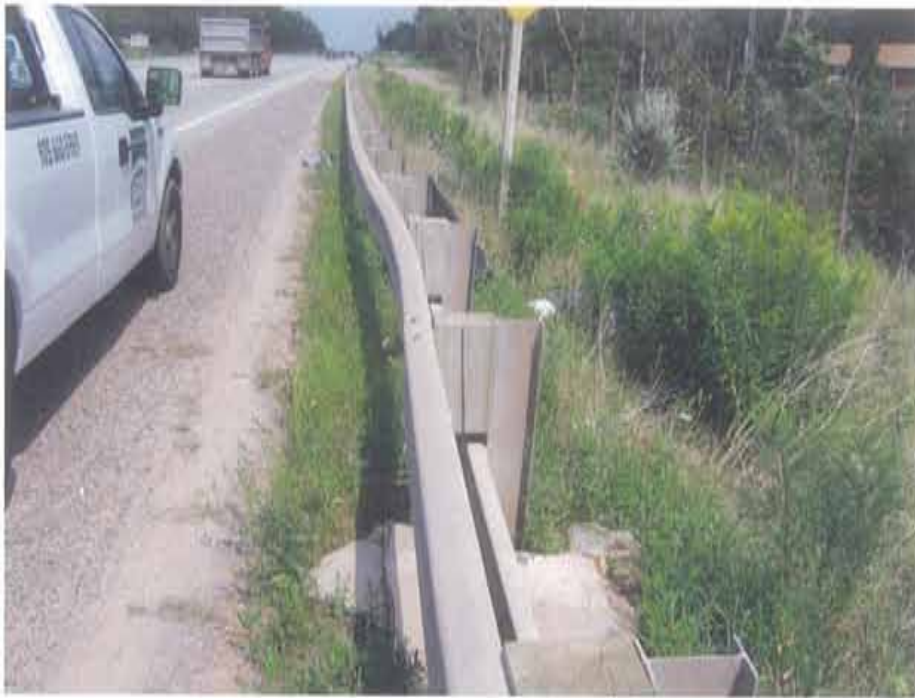
Photograph 31. Damage to south east steel beam guide rail

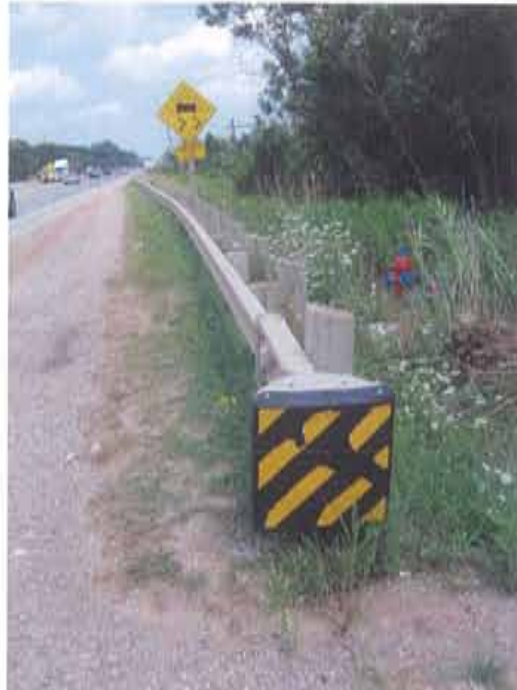
Photograph 32. Southwest steel beam guiderail with crash attenuator, looking east (typical); note: the fire hydrant

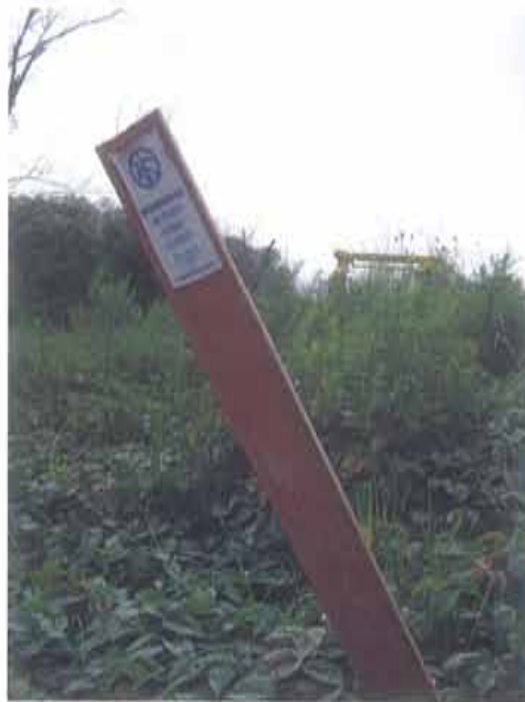
Photograph 33. Marker to southeast of bridge indicating presence of buried telephone cable. Telephone markings were also found at the southwest and northeast corners of the bridge.

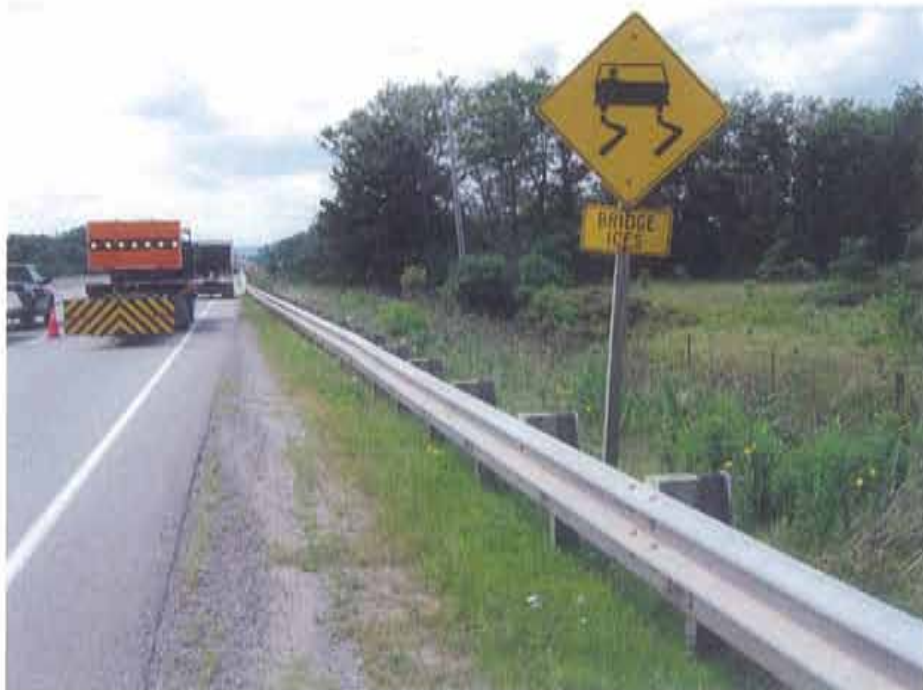
Photograph 34. "Bridge Ices" sign present along the southwest steel beam guide rail, looking east. A similar sign exists along the northeast steel beam guiderail.

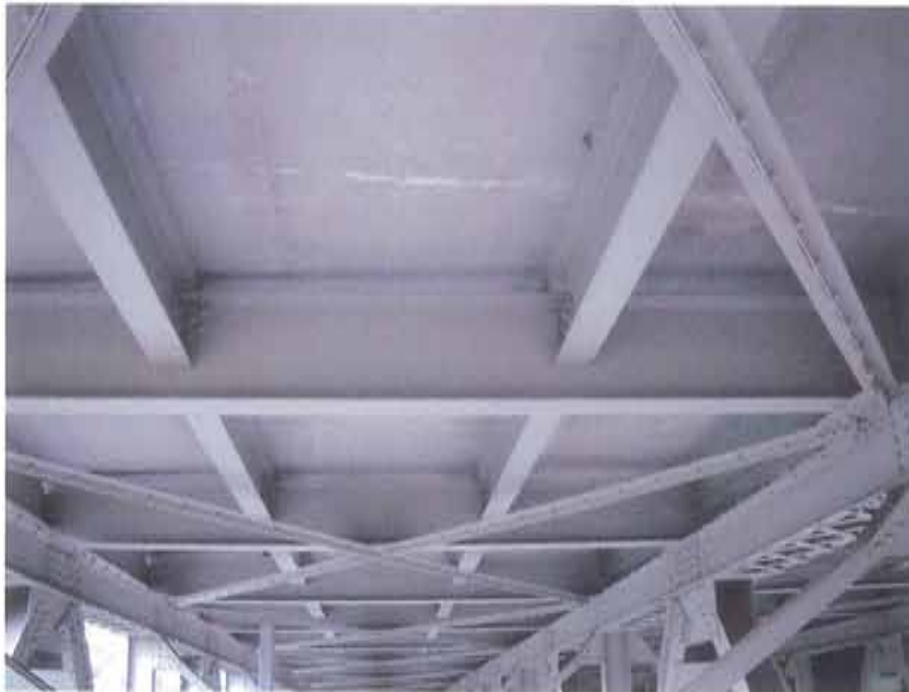
Photograph 41. Typical soffit condition of the south structure

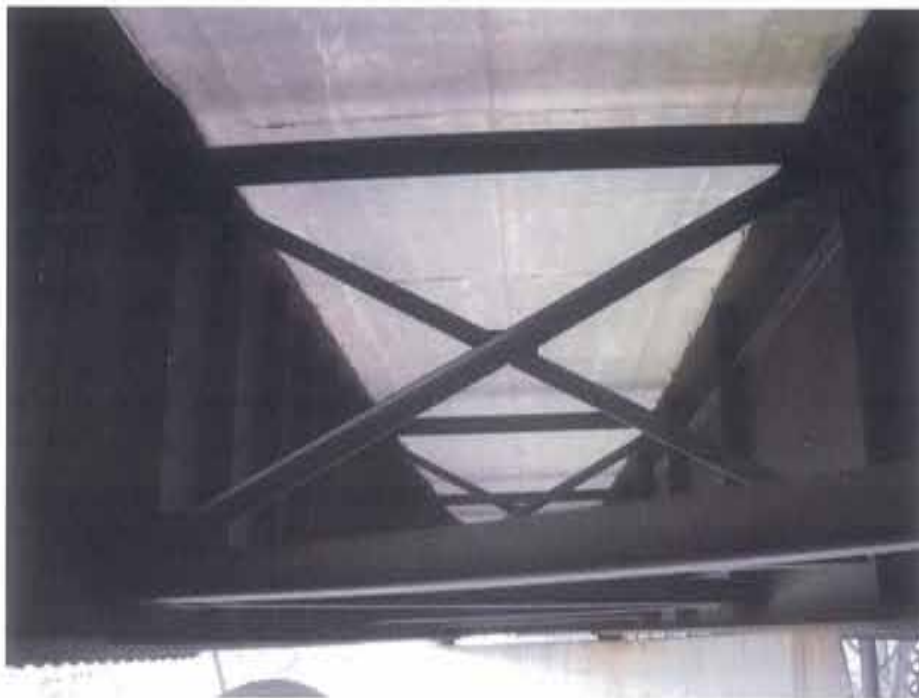
Photograph 42. Typical soffit condition of the north structure

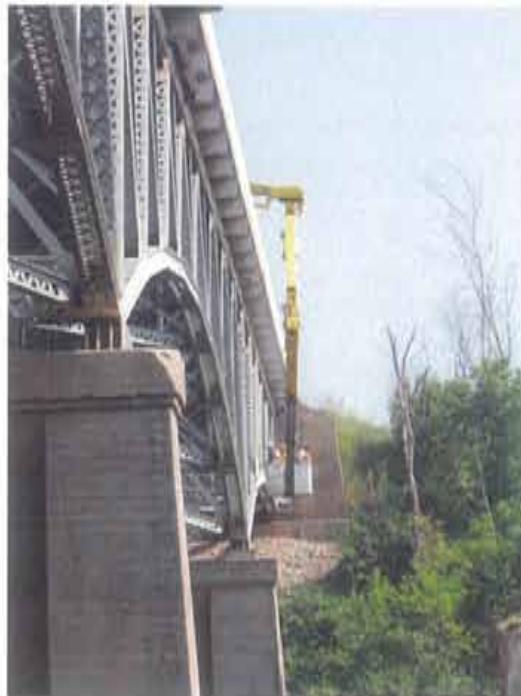
Photograph 43. MRC inspection crew inspecting truss 'T3' of the south structure

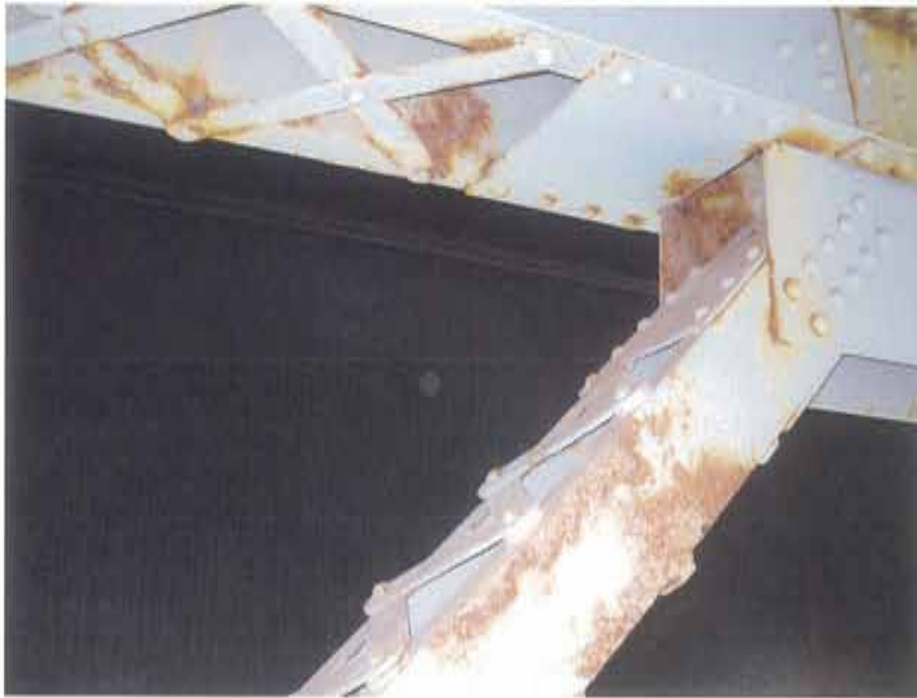
Photograph 45. Typical light corrosion noted on the upper chord member of truss T1

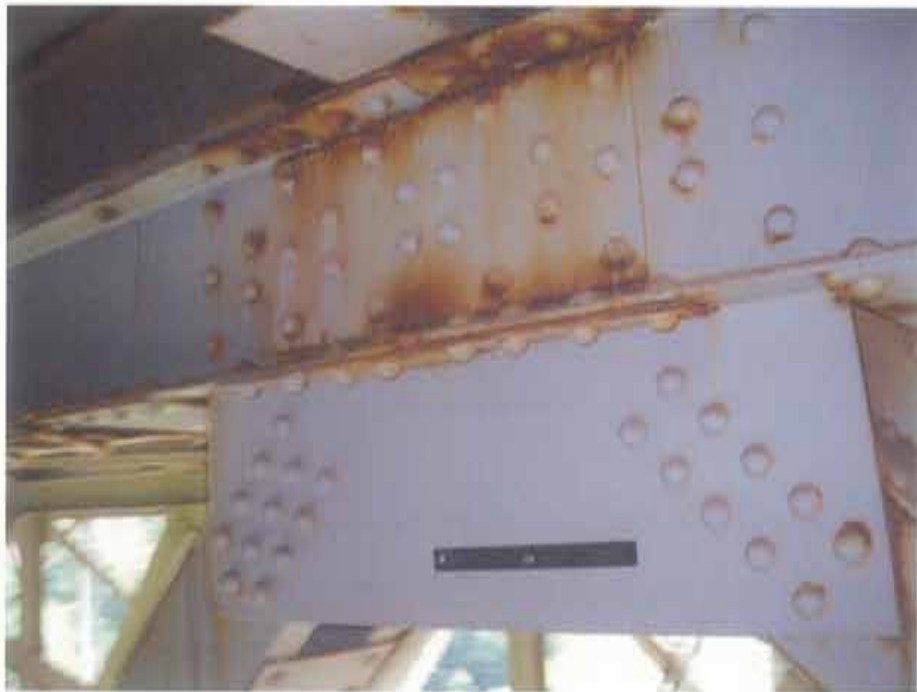
Photograph 46. Typical light corrosion noted on the upper chord member of truss T1

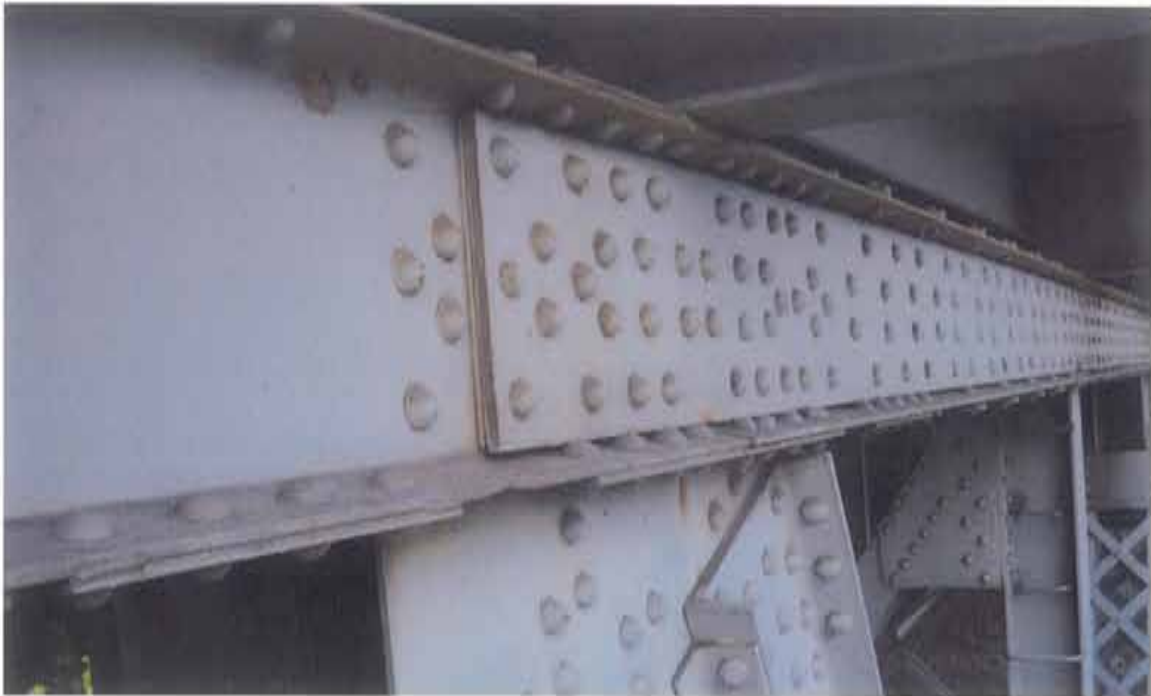
Photograph 47. Typical condition of the upper chord members of truss T3

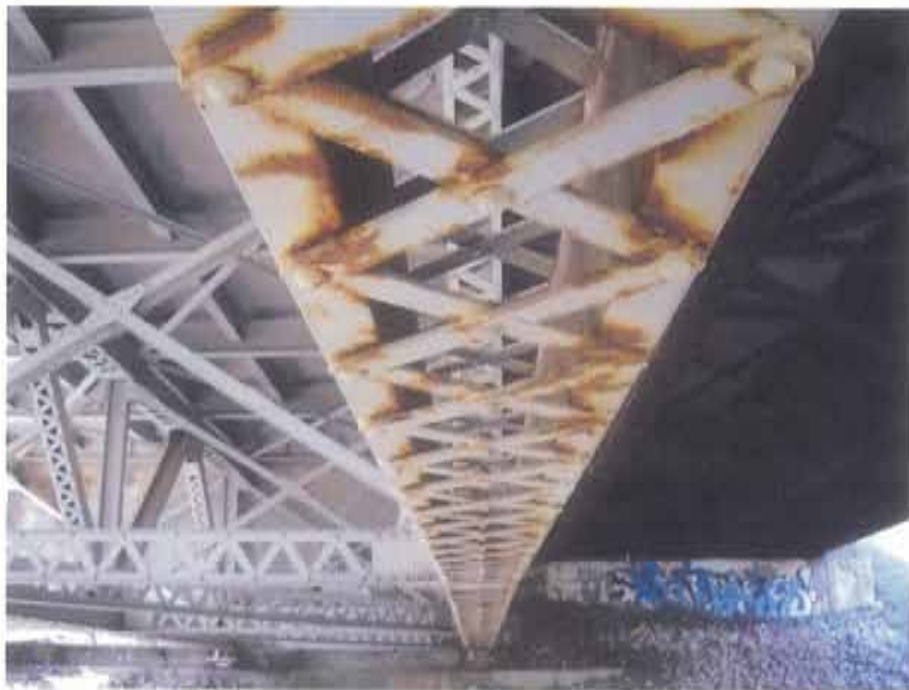
Photograph 48. Typical light corrosion noted on the lower chord members of truss T1

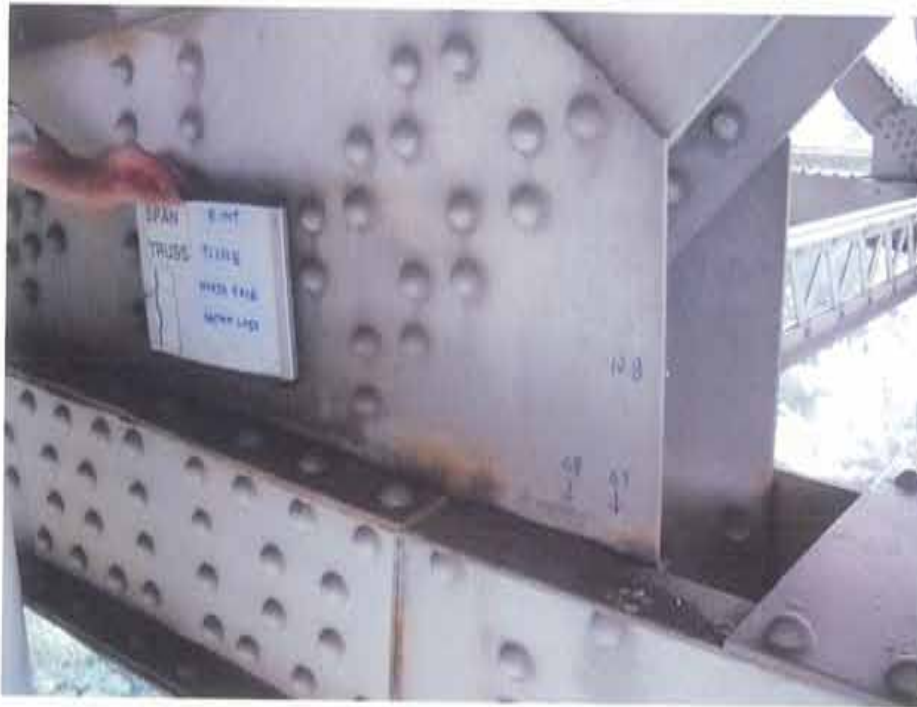
Photograph 49. Section loss in lower chord gusset plate at T1/L12E due to seam corrosion

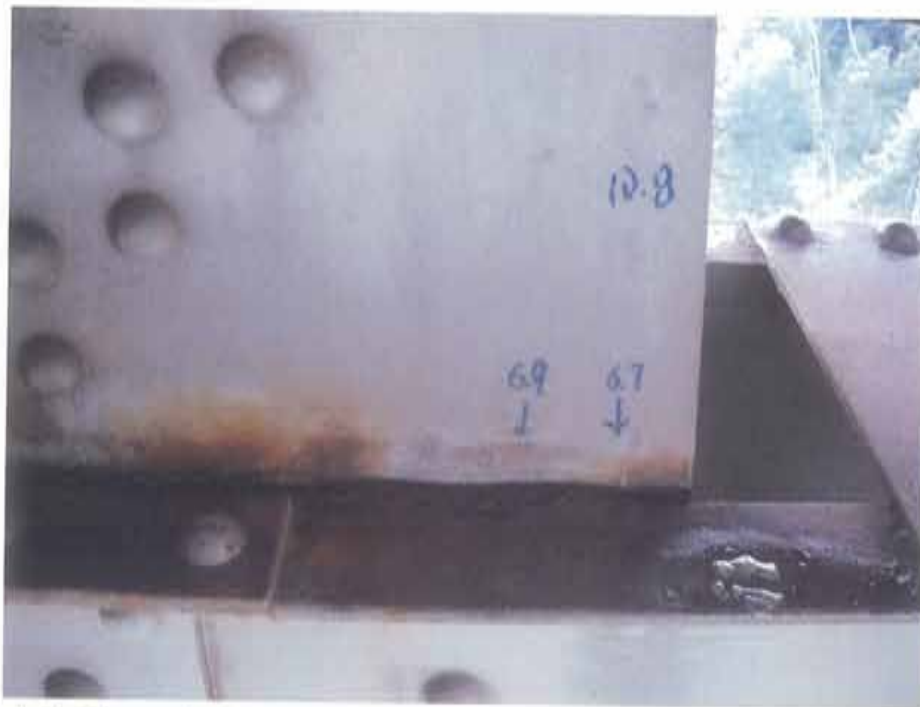
Photograph 50. Ultrasonic thickness measurements at T1/L12E (6.8 mm at section loss, 10.8 mm original thickness); see Photograph 49 for description

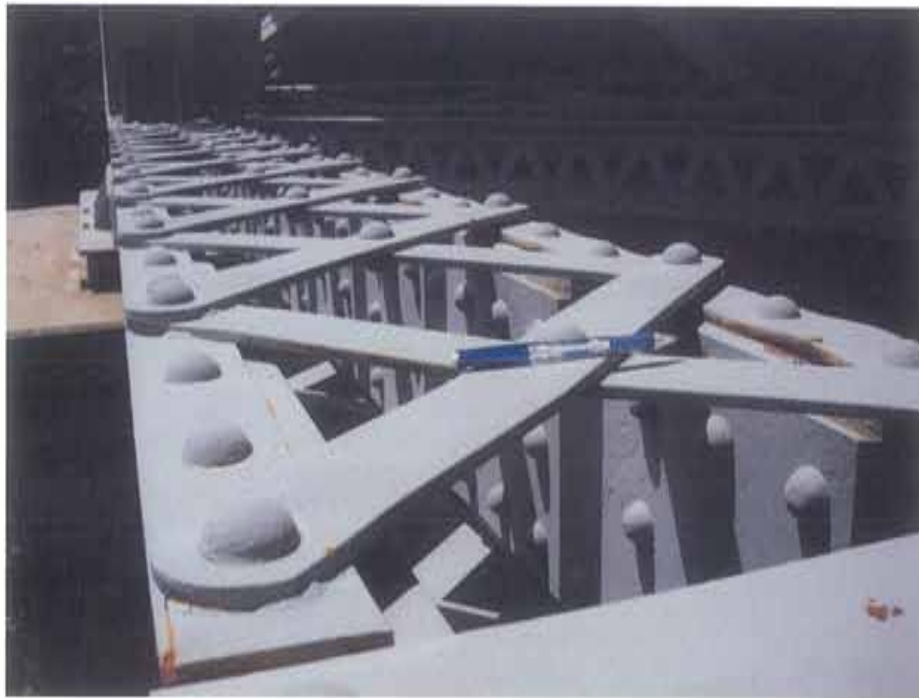
Photograph 51. Light seam corrosion noted in lower chord members of T3

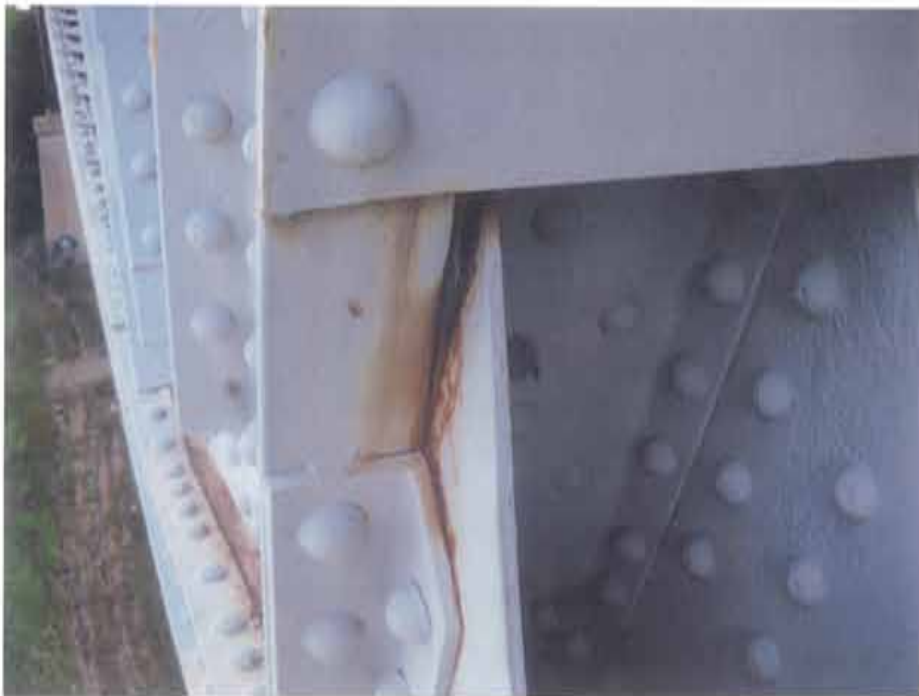
Photograph 52. Rust jacking noted in lower chord gusset plate
