APPENDIX F1
TANSLEY BRIDGE CONDITION SURVEY REPORT 2009

**Dundas Street (Reg. Rd. 5)
Class EA Study
Brant Street (Reg. Rd. 18)
to Proudfoot Trail**

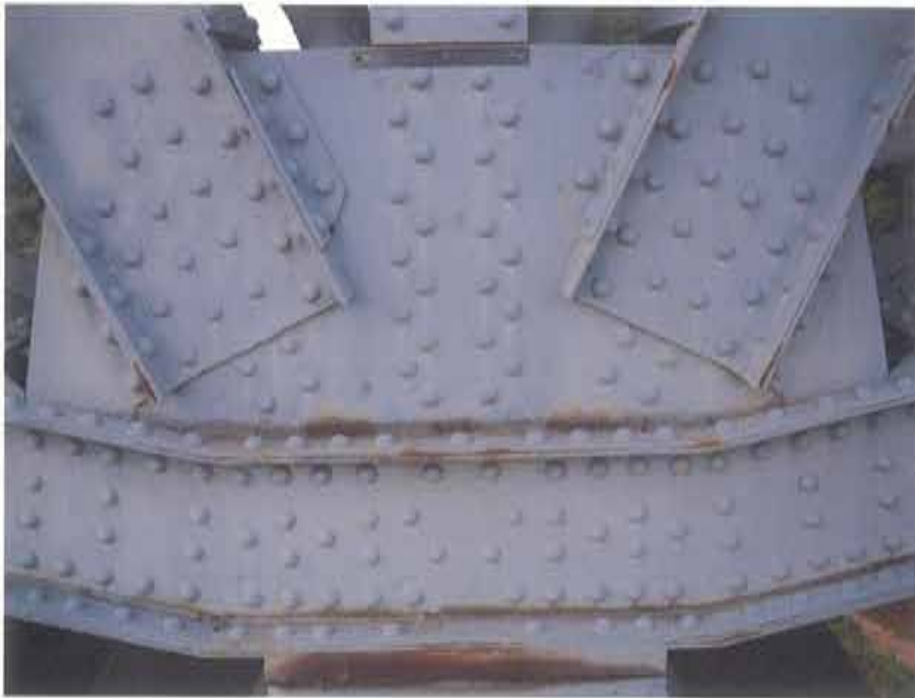
Photograph 53. Section loss due to previous and active corrosion, south gusset plate at T3/L28 shown; note: ultrasonic thickness measurements taken to determine section loss

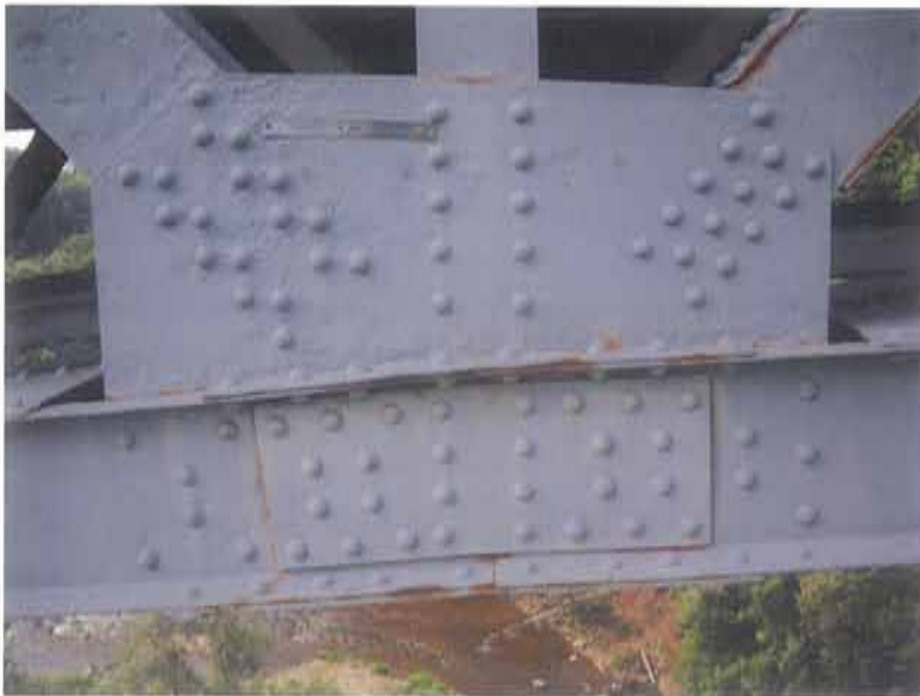
Photograph 54. Section loss due to previous and active corrosion, south gusset plate at T3/EL22 shown; note: ultrasonic thickness measurements taken to determine section loss

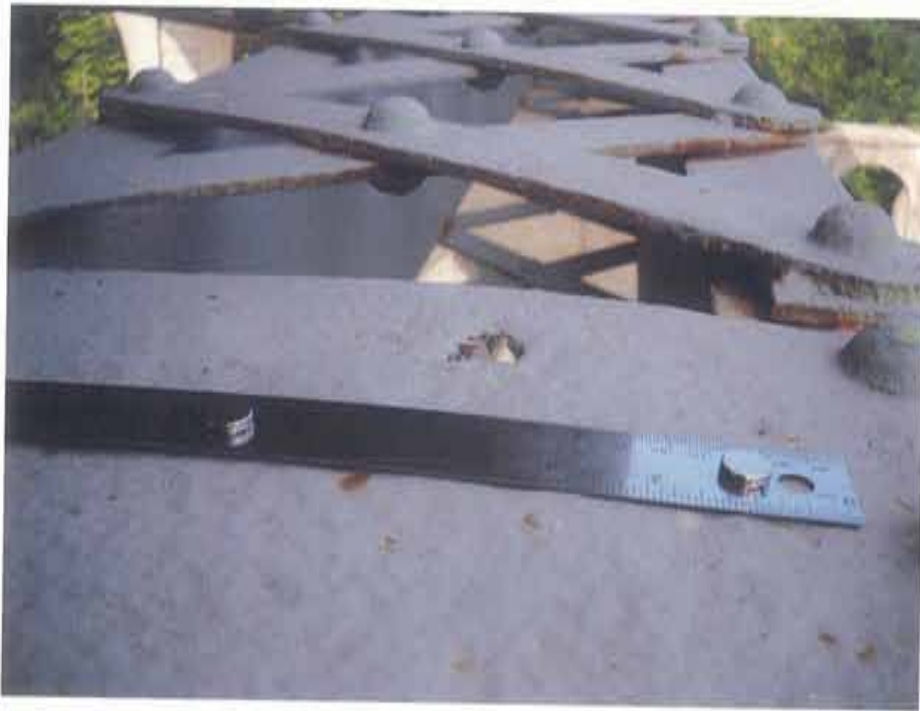
Photograph 55. Perforation in upper batten plate of T3/L22E-L20E (20 mm diameter)

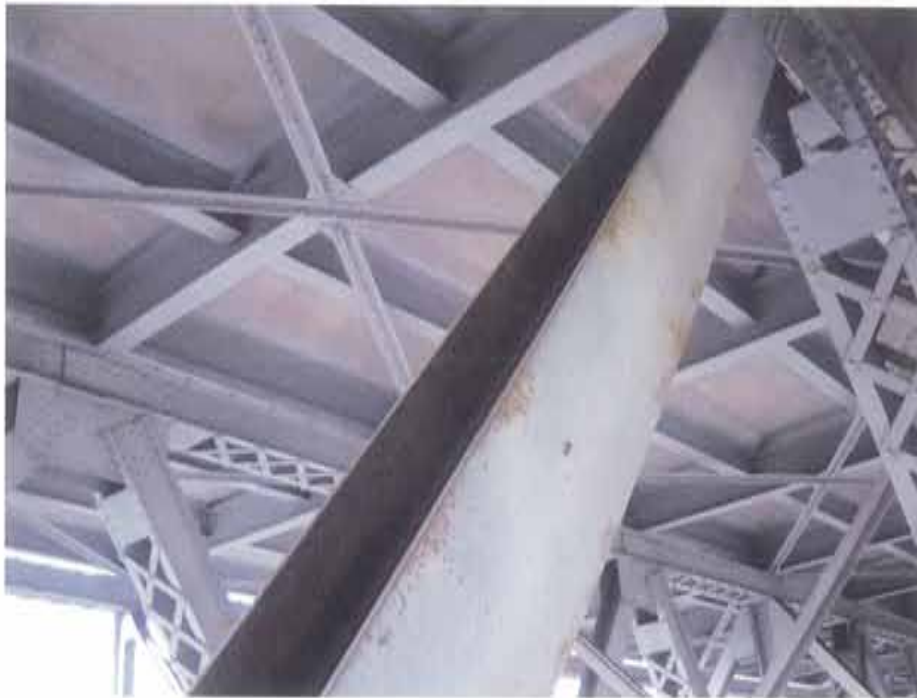
Photograph 61. Typical light corrosion noted in diagonal and vertical members of T1

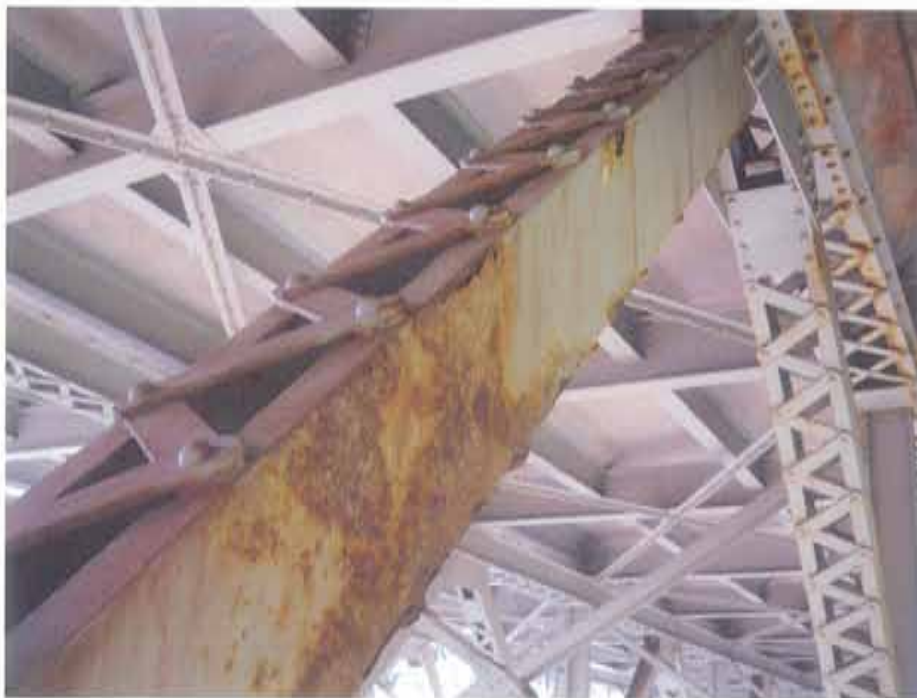
Photograph 62. Typical medium corrosion noted in diagonal and vertical members of T1

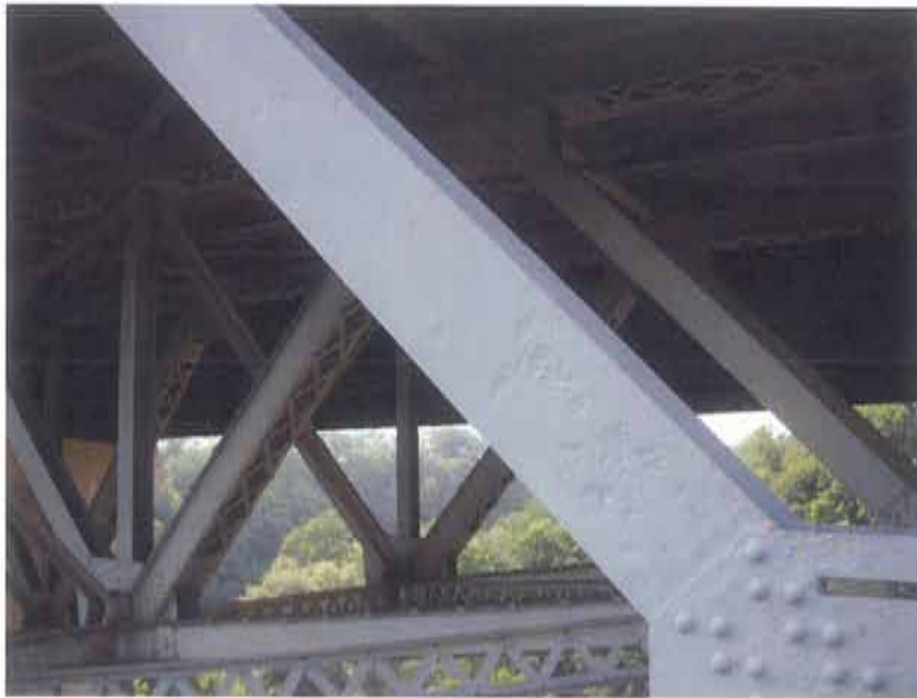
Photograph 63. Section loss due to previous corrosion in diagonal member T3/L22E-U23E

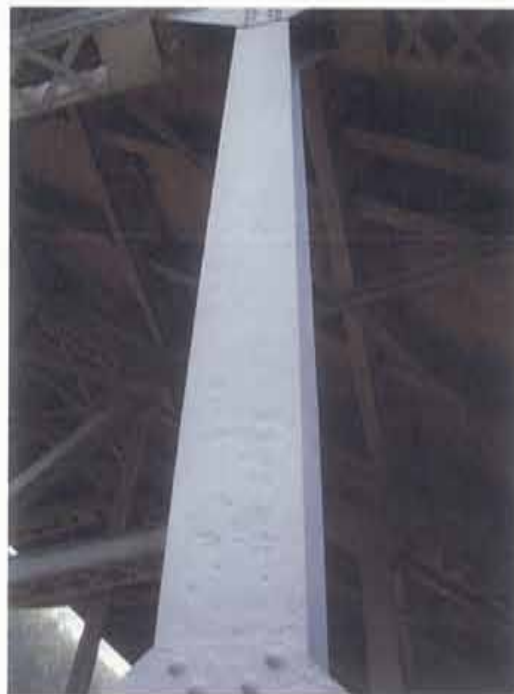
Photograph 64. Section loss due to previous corrosion in vertical member T3/L22E-U22E

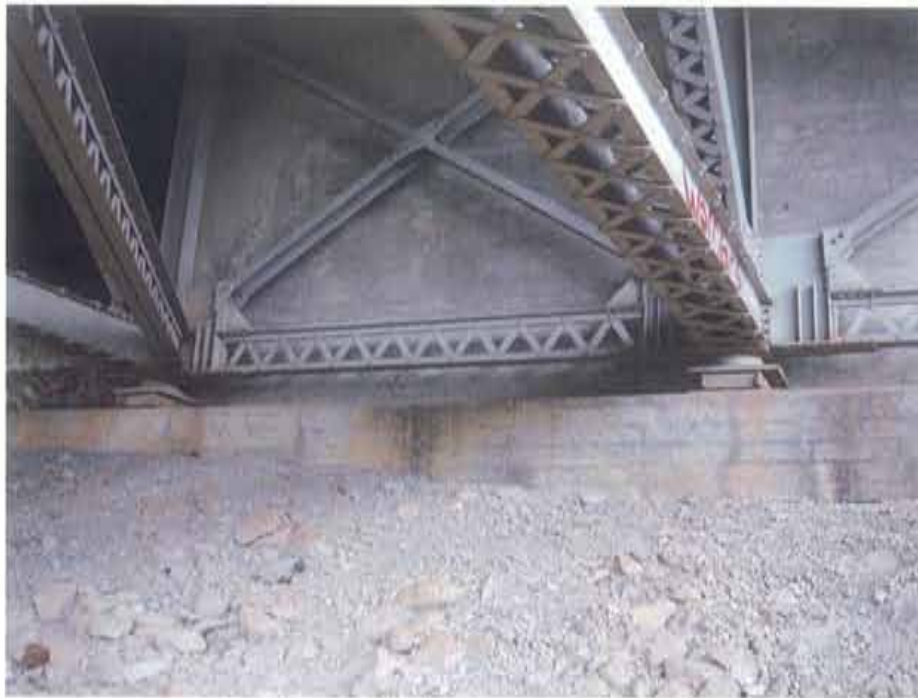
Photograph 65. East abutment of north structure (T1 and T2 shown)

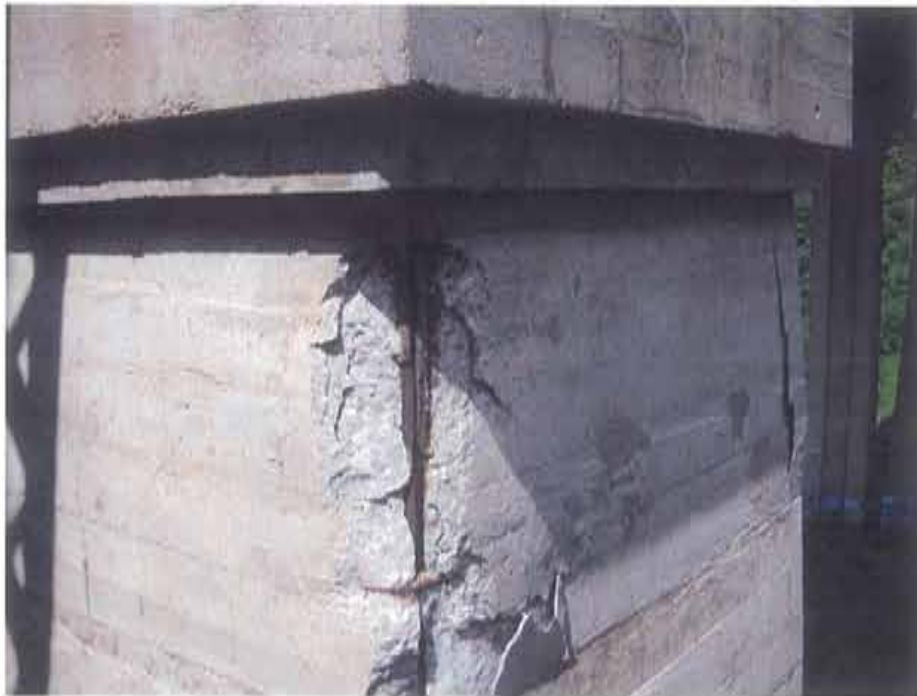
Photograph 67. Typical spalling and delaminations noted in the west pier of the south structure

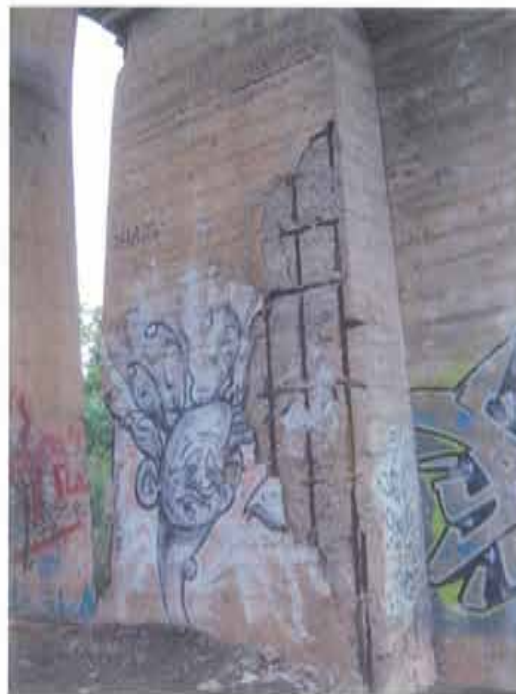
Photograph 68. Large concrete spalling in west face of west pier

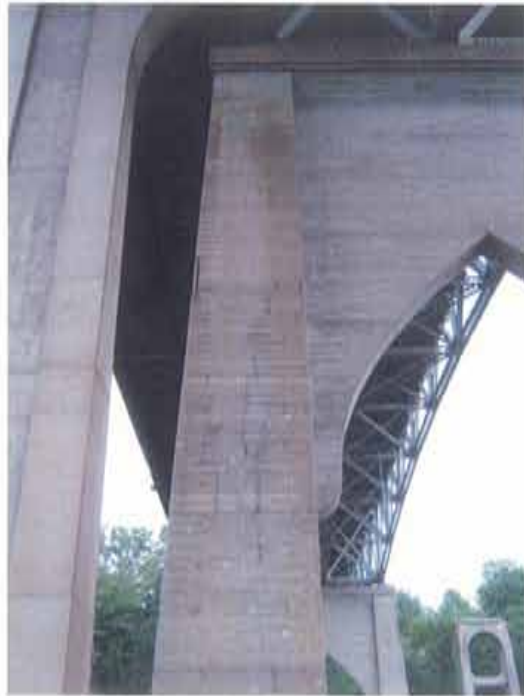
Photograph 69. Centre pier contained areas of vertical narrow concrete cracking

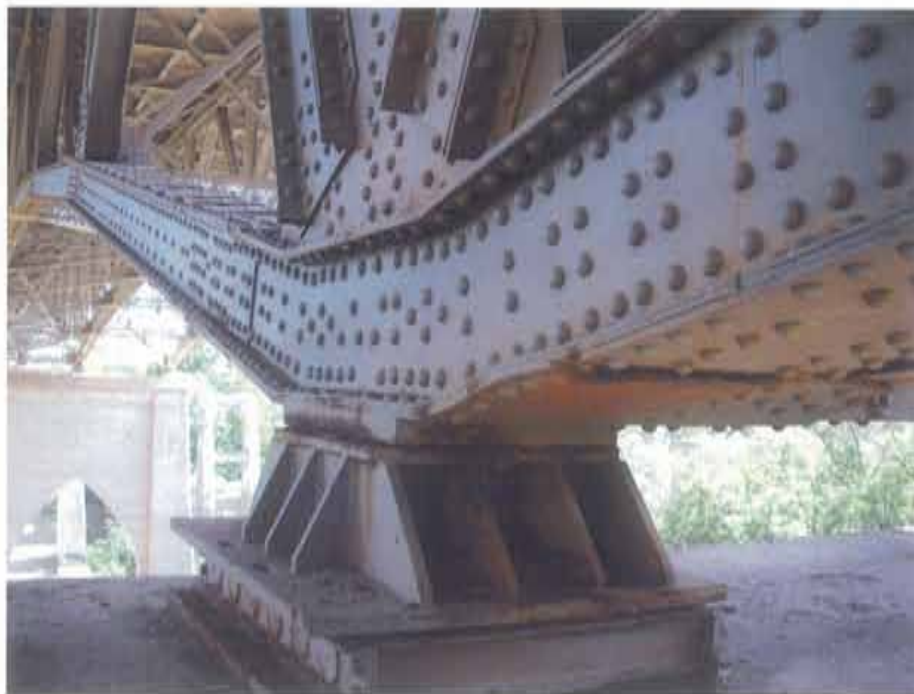
Photograph 70. Distortion in T1/L12W-T1/L10W about west pier bearings

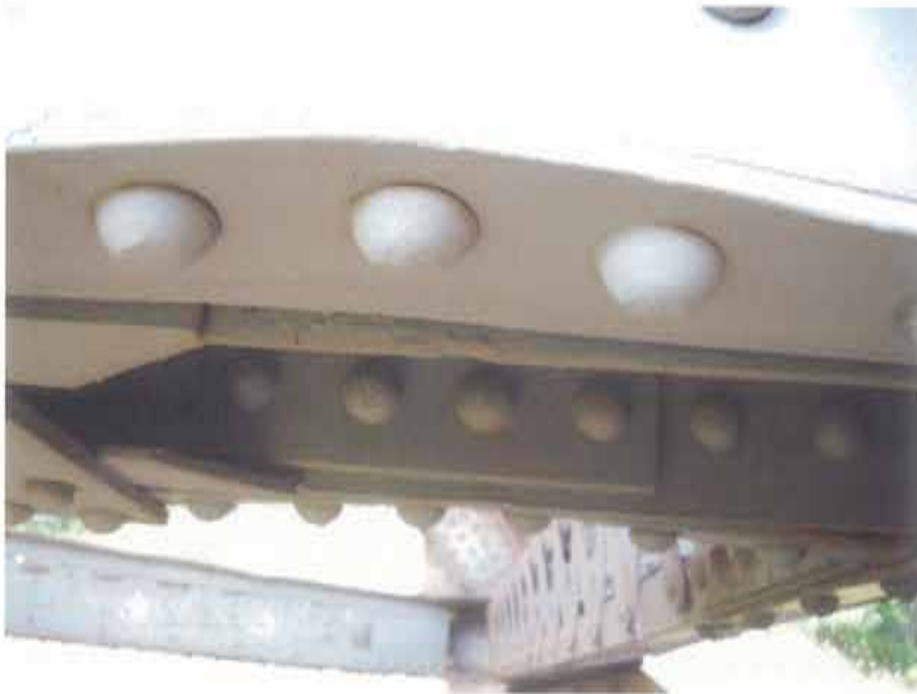
Photograph 72. Typical notch noted in distortions in lower chord flanges about west pier bearings

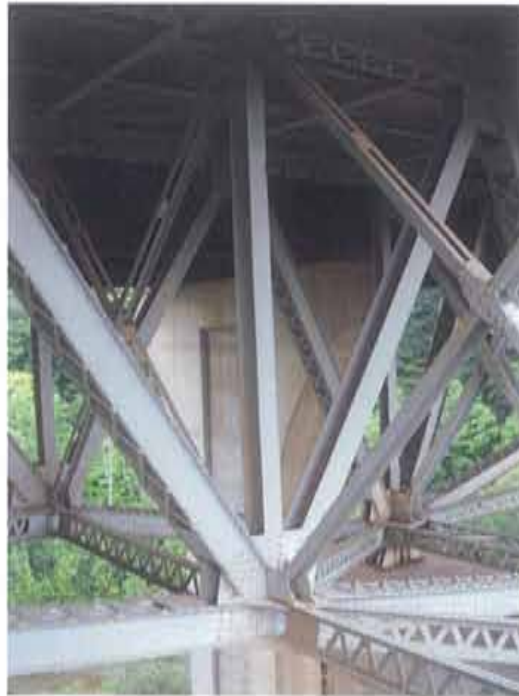
Photograph 73. Typical condition of T2 condition, T2/L26W shown

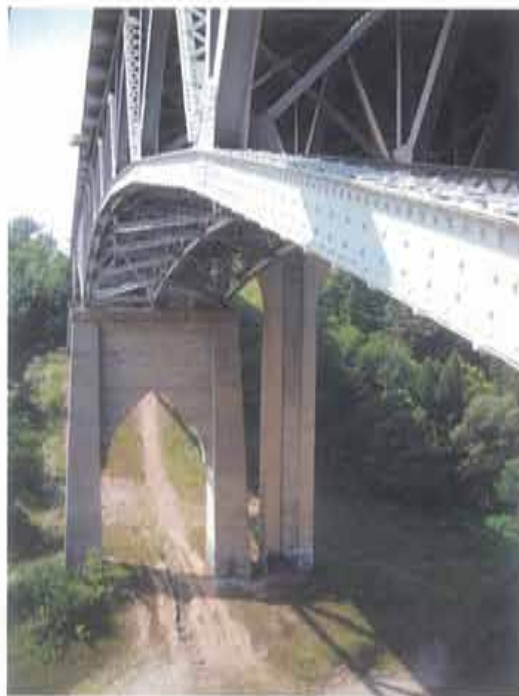
Photograph 74. Lower chord member of T3 in east interior span

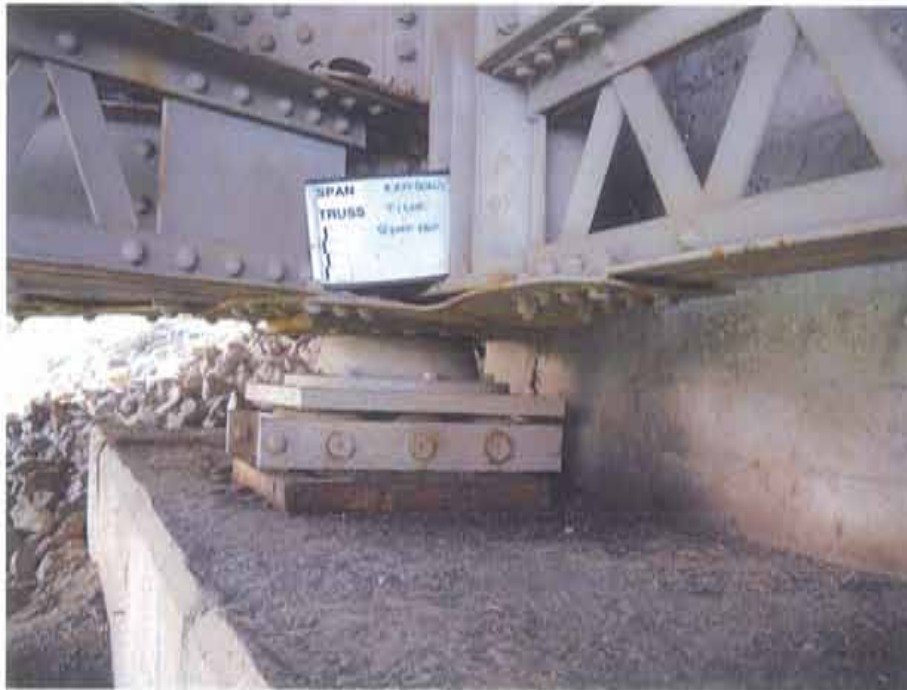
Photograph 75. Typical abutment bearing condition, T1/L0E shown at east abutment

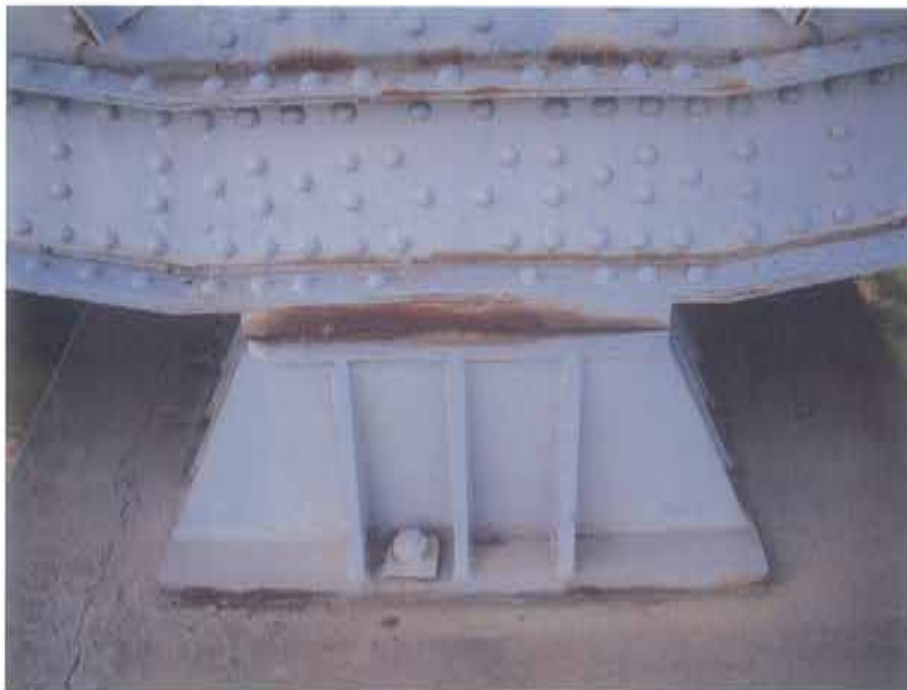
Photograph 76. Typical fixed pier bearing condition, T3/L28 shown at the centre pier

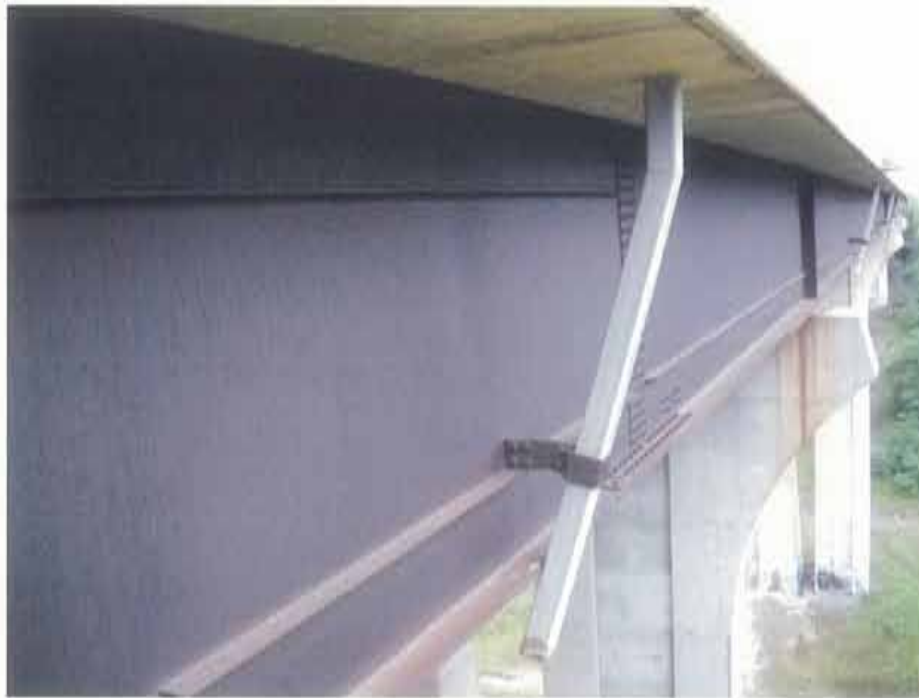
Photograph 77. Typical condition of G1, east exterior span shown

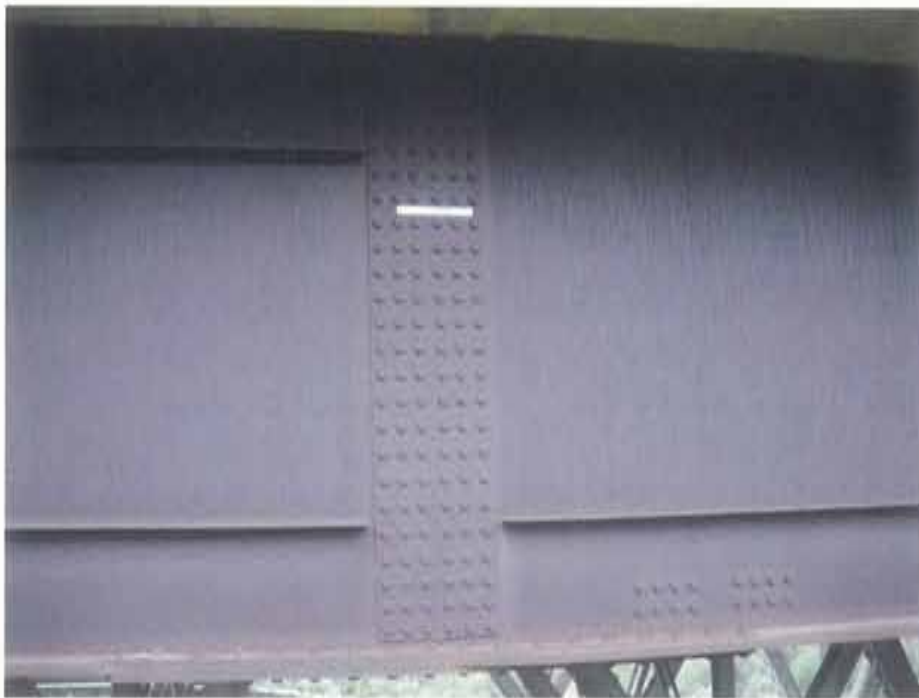
Photograph 78. Web splice plate, G1 shown

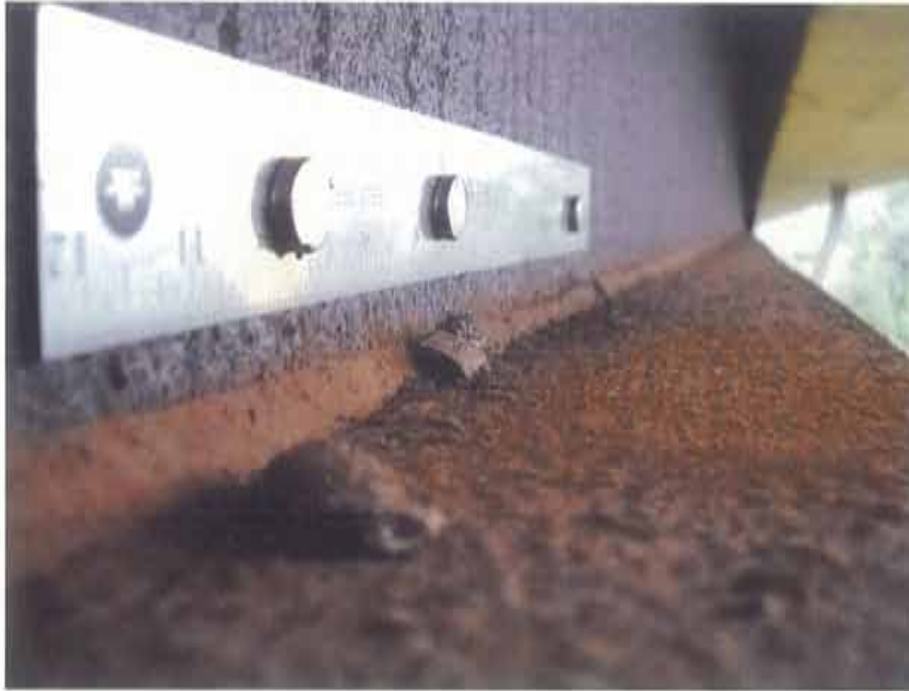
Photograph 81. Longitudinal web stiffener plate weld broken at several locations, G1 shown

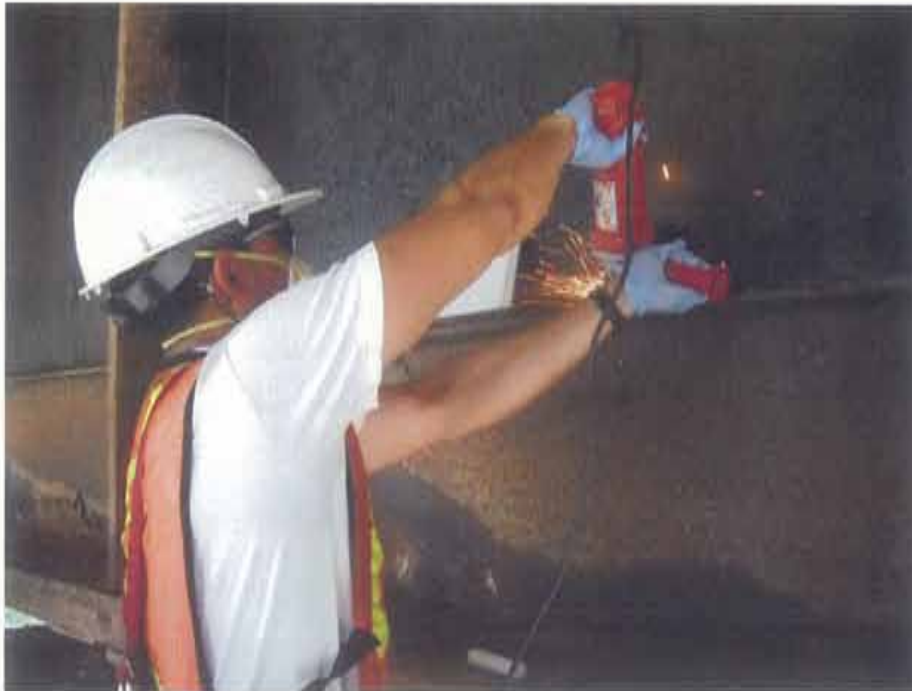
Photograph 82. Metal grinder used to clean surface prior to testing of section loss, G3 shown

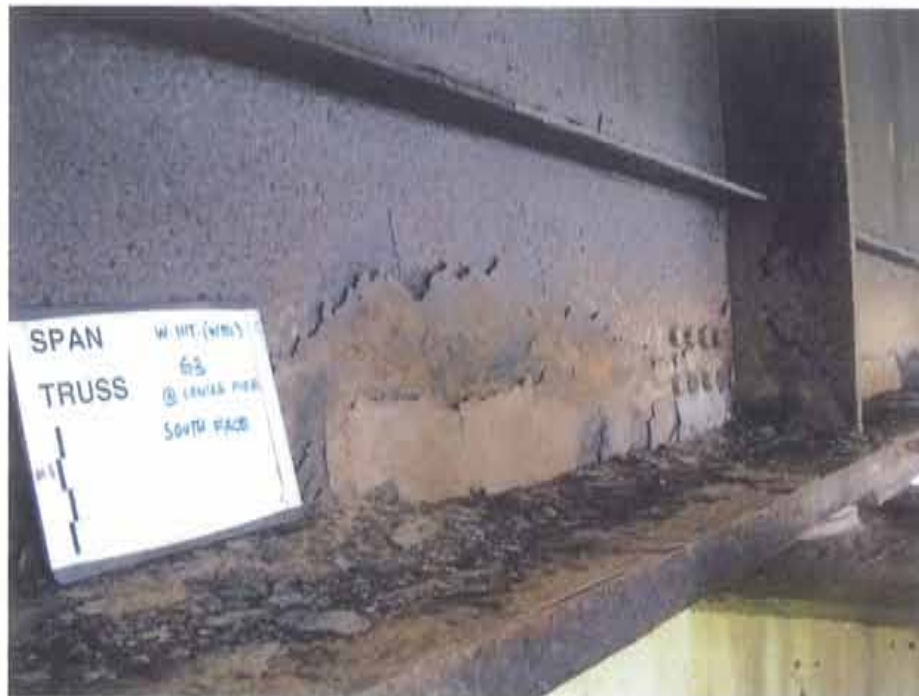
Photograph 83. Typical rust expansion noted in web plate of G3

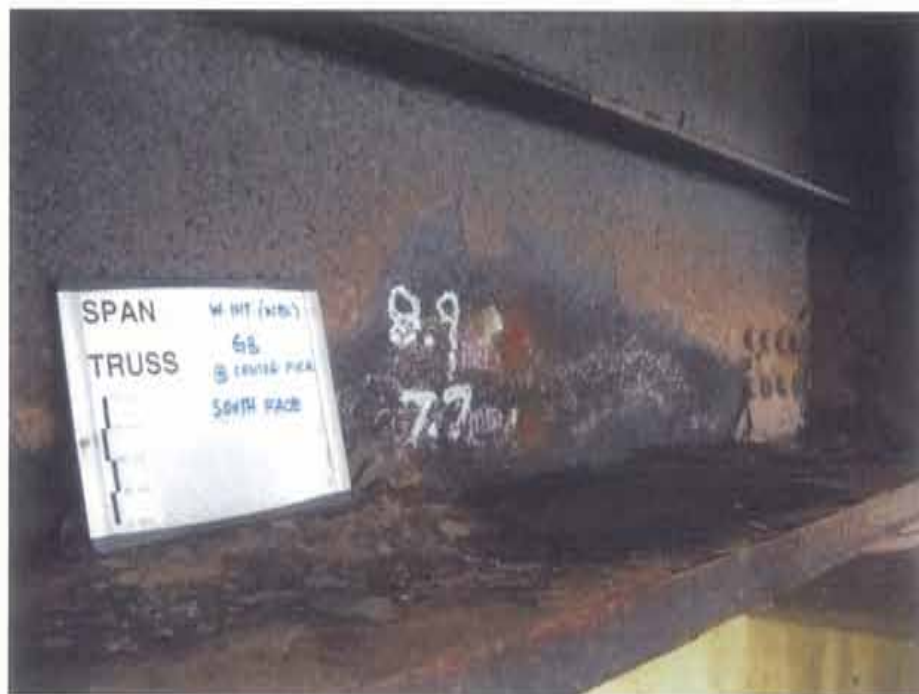
Photograph 84. Ultrasonic thickness measurements taken in areas of section loss; note: this photograph was taken in the same location as Photograph 83

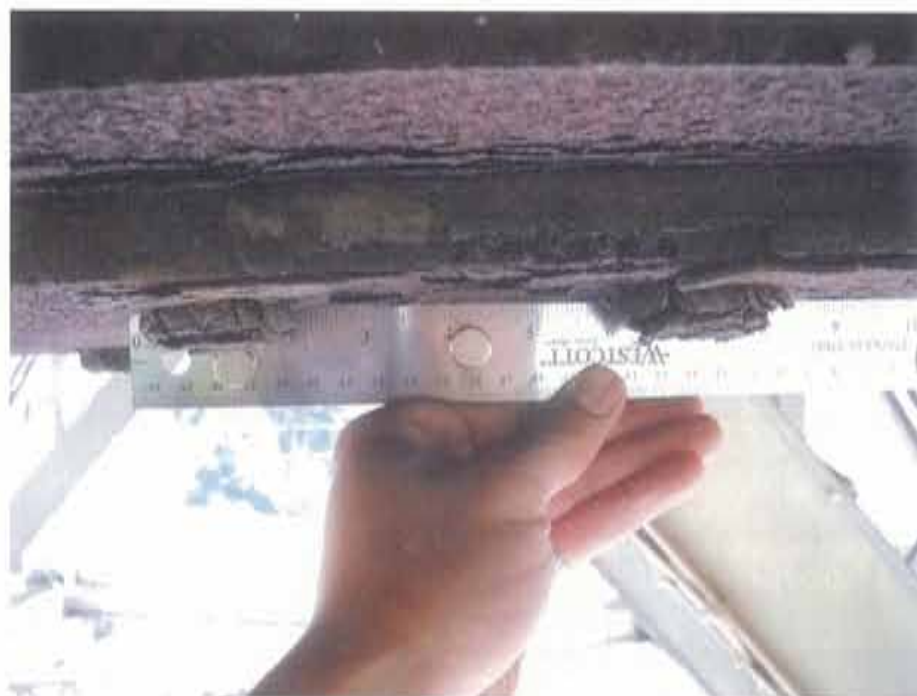
Photograph 88. Severe corrosion in splice bolted connection components of lower flange of G3

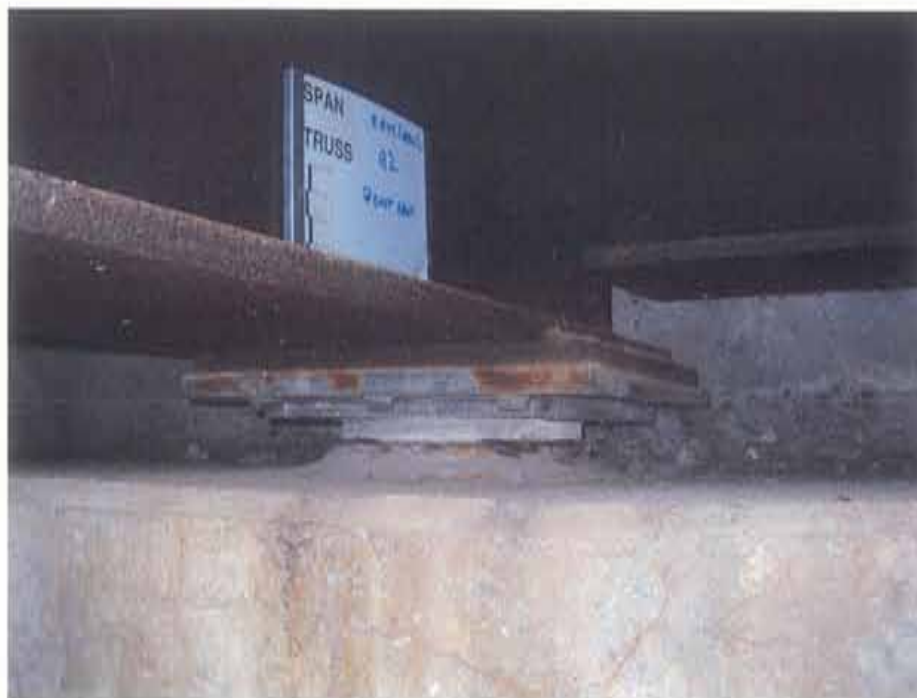
Photograph 89. Typical condition of bearings at east abutment, G2 shown

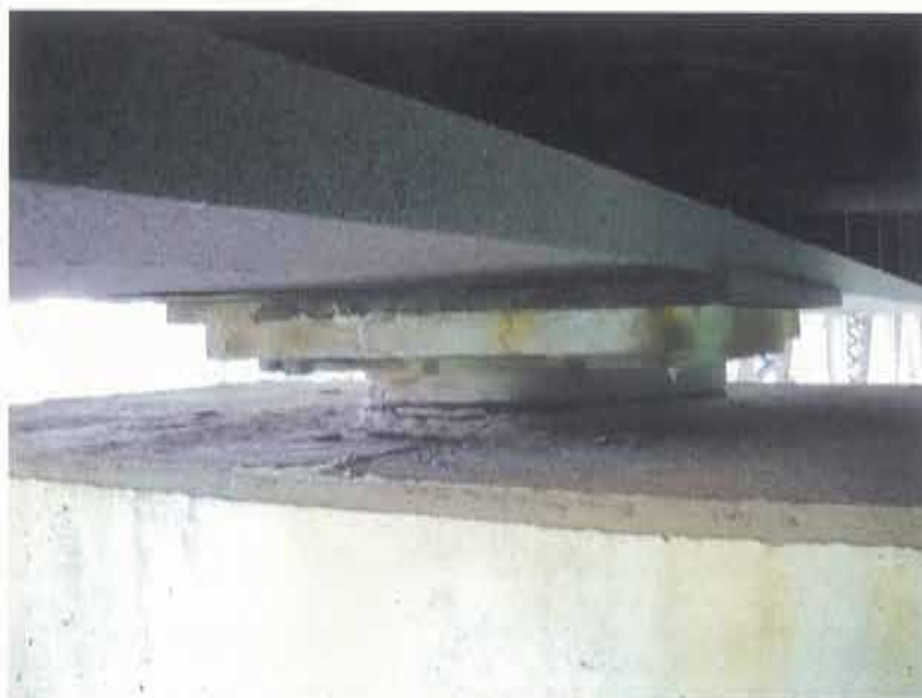
Photograph 90. Typical condition of bearings at east pier, G3 shown

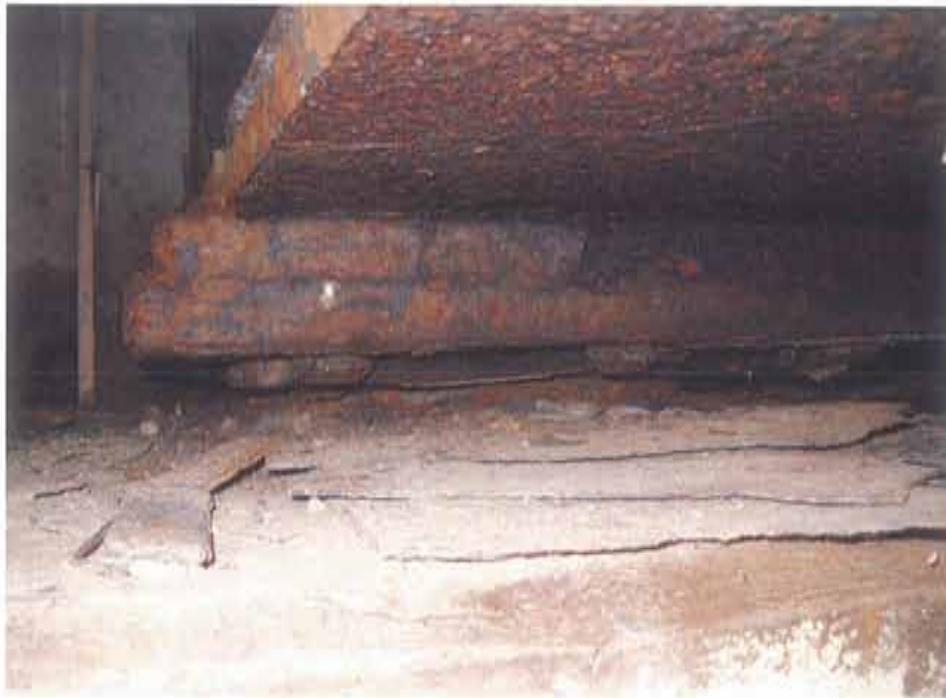
Photograph 91. Typical condition of bearings at west abutment, G3 shown

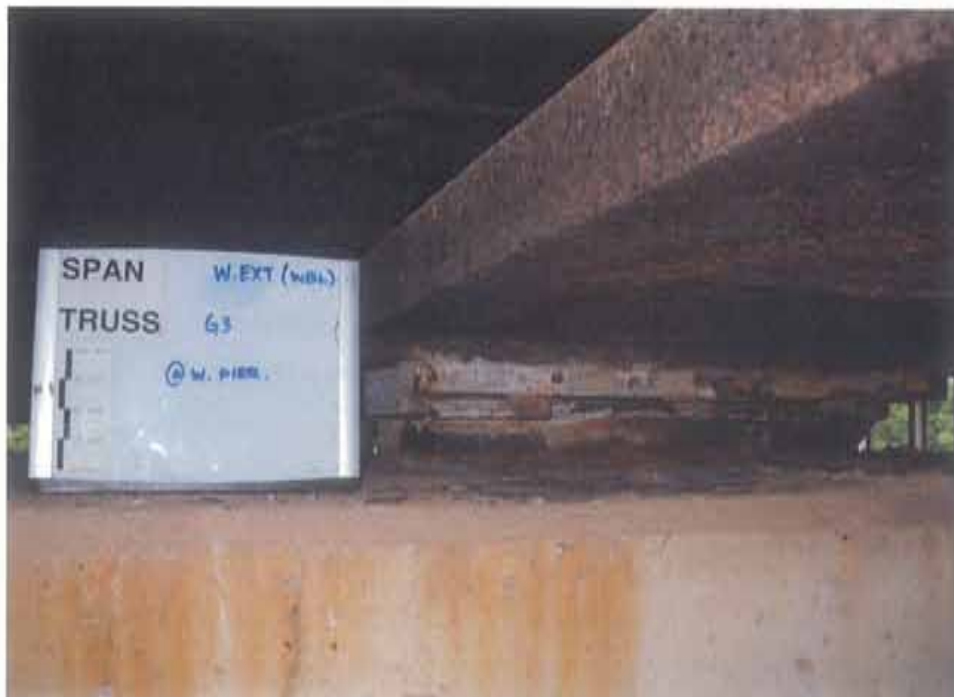
Photograph 92. Condition of bearing supporting G3 at the west pier

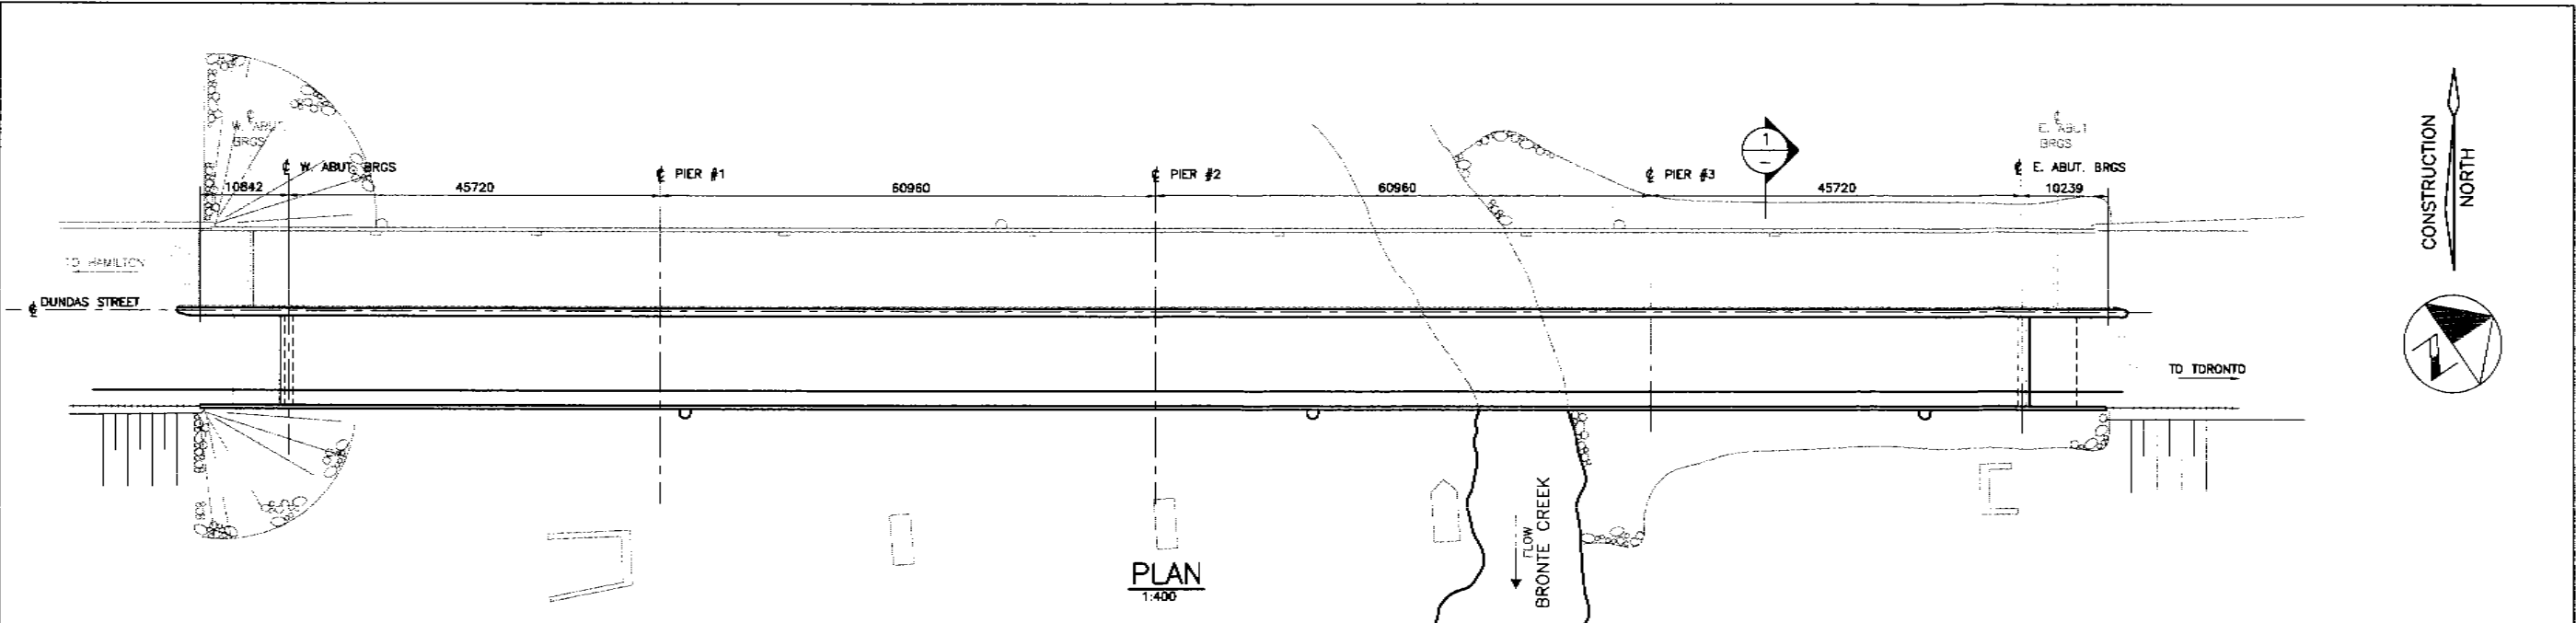
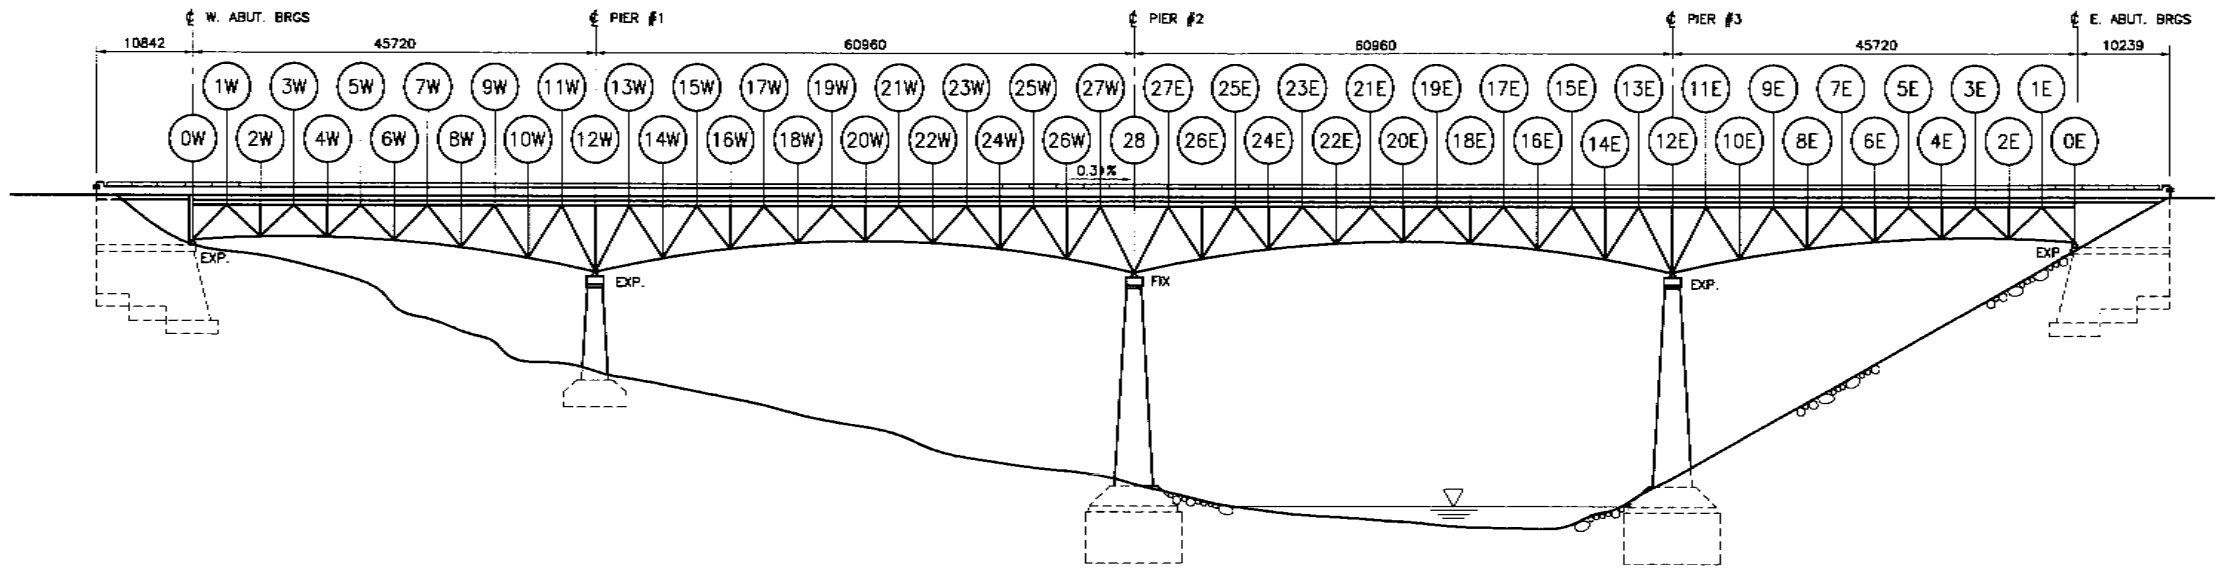
APPENDIX E
DECK CONDITION SURVEY DRAWINGS

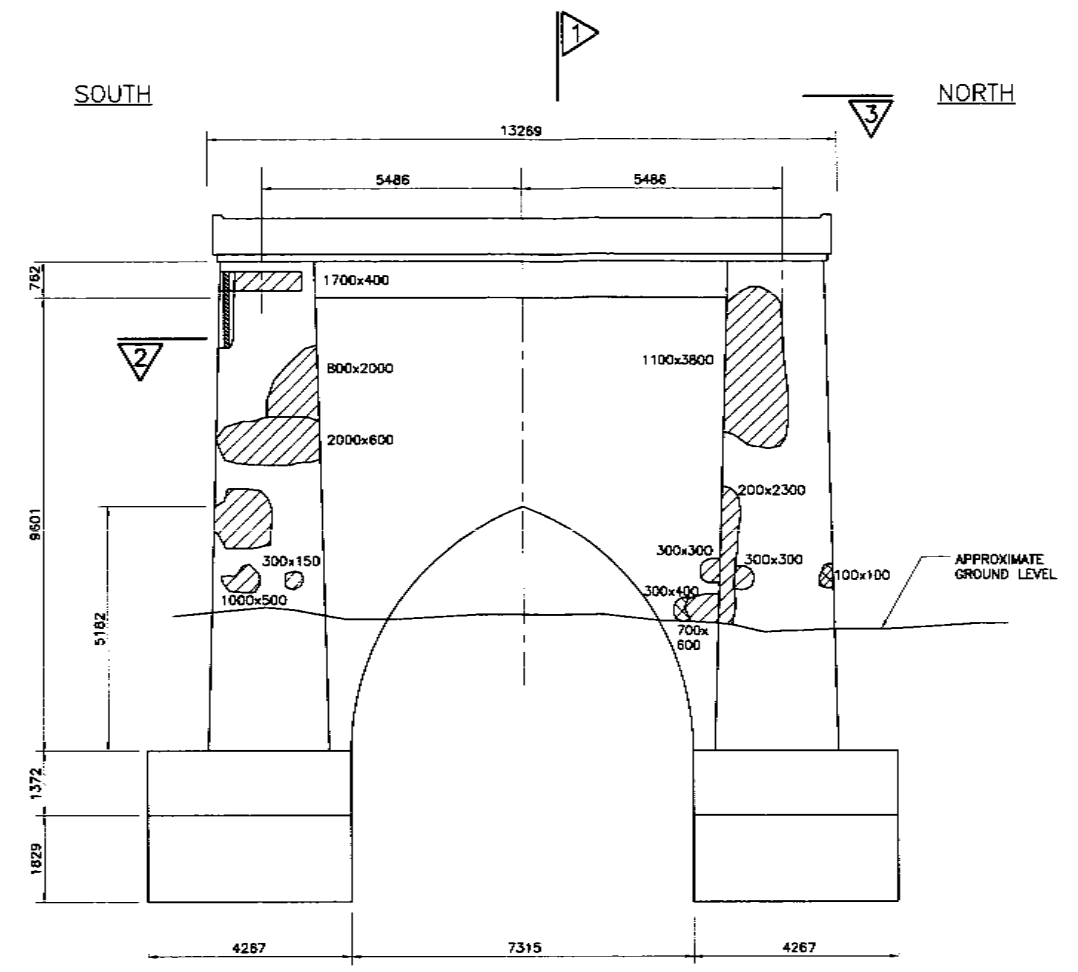
ELEVATION - PIER # 1 (EAST FACE)
1:75

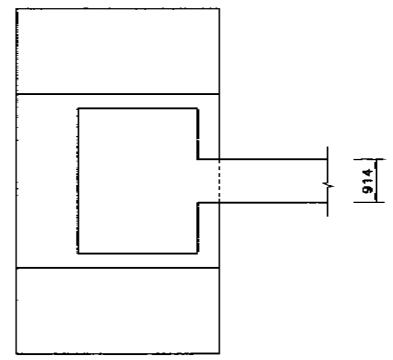
- LEGEND:**
- NARROW CRACK
 - MEDIUM CRACK
 - WIDE CRACK
 - STAINED CRACKS
 - DELAMINATIONS
 - SPALLS
 - EXPOSED REINFORCING STEEL
 - LIGHT SCALING
 - MEDIUM SCALING
 - SEVERE SCALING
 - VERY SEVERE SCALING
 - SURFACE RUST STAIN

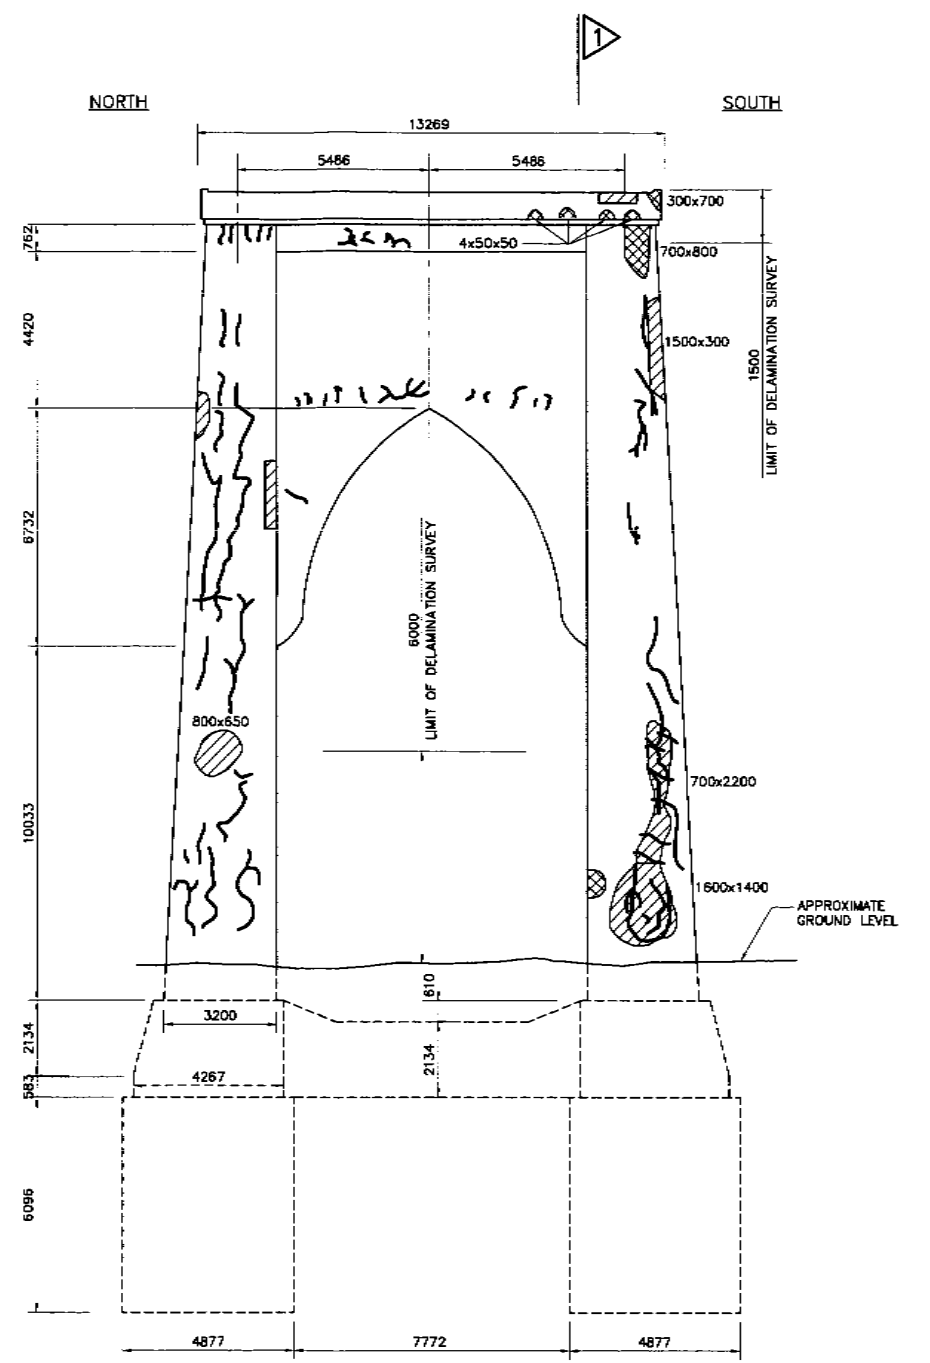
ELEVATION - PIER # 2 (WEST FACE)
1:100
