APPENDIX F1
TANSLEY BRIDGE CONDITION SURVEY REPORT 2009

**Dundas Street (Reg. Rd. 5)
Class EA Study
Brant Street (Reg. Rd. 18)
to Proudfoot Trail**

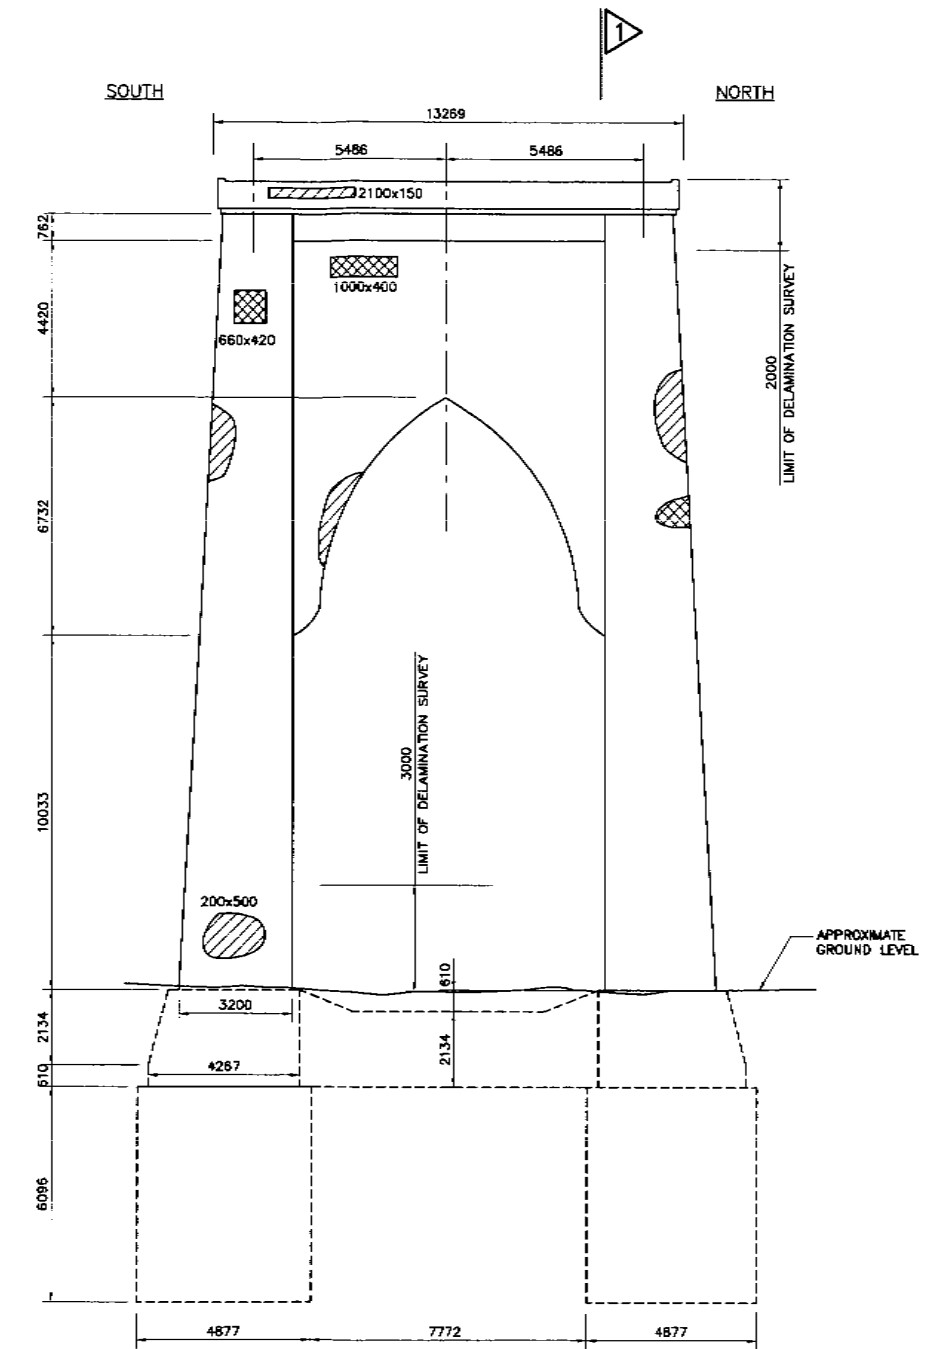
ELEVATION - PIER # 3 (EAST FACE)
1:100

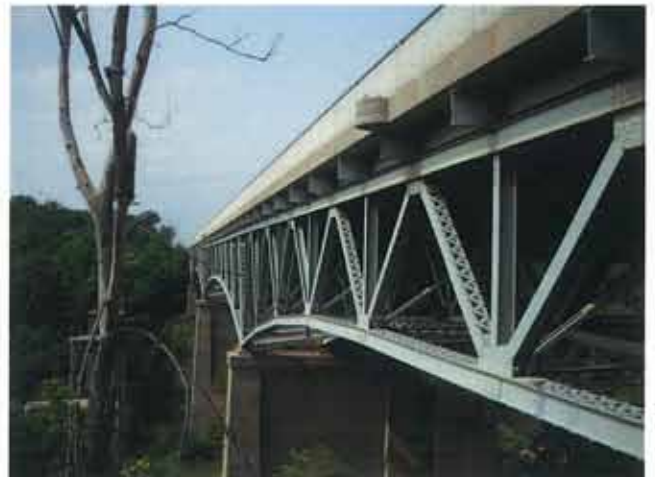
**Tansley Bridge
Dundas Street at Bronte Creek
Bridge No. 005109
MTO Site NO. 010-0111**
