**APPENDIX F2**  
**CNR OVERHEAD BRIDGE DECK CONDITION SURVEY REPORT 2009**

September 2009

## Dundas Street - CNR Overhead Structure Site Number 010-0175

### Bridge Deck Condition Survey Report

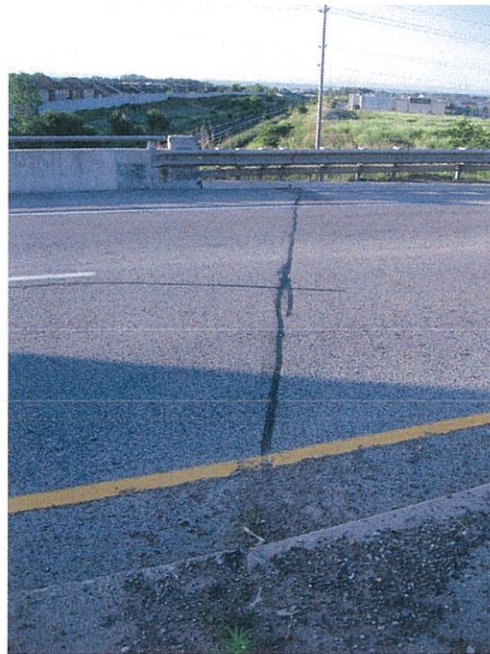
The asphalt wearing surface on the Dundas Street - CNR Bridge was partially replaced during the 2004 rehabilitation and appears to be in fair condition. There are several sealed and unsealed longitudinal and transverse cracks (see photograph 10). There are transverse sealed cracks spanning the width of the bridge at the edge of the east and west approach slabs. In total, approximately 60 m of longitudinal light and medium cracks were noted on the deck surface.

Photograph 10 – Transverse sealed crack at west approach (typical)

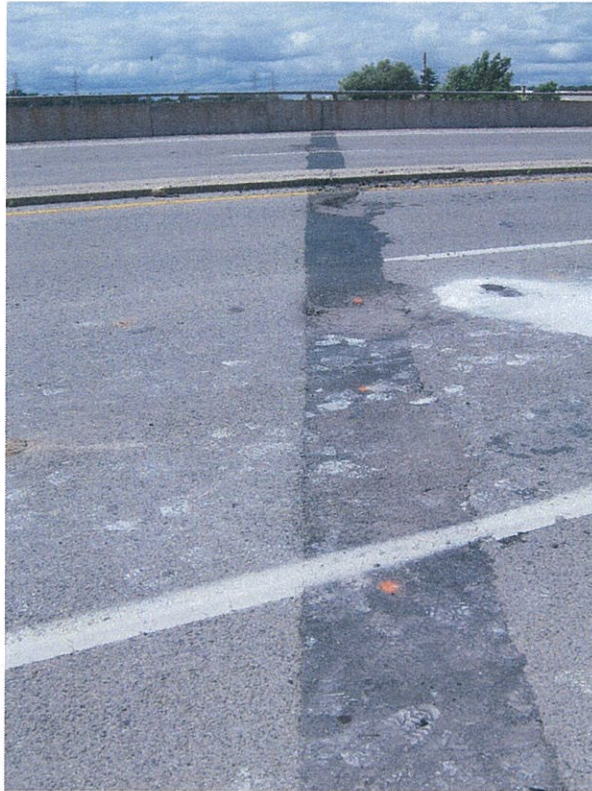
The wearing surface appears to be in fair condition based on visual inspection at core and sawn asphalt sample locations. Few areas of narrow and medium cracking in the asphalt were noted. However, the asphaltic plug seals appeared depressed below the deck wearing surface causing an uneven riding surface. In several areas, the asphaltic plug seals appeared to have been previously patched with cold mix asphalt. Some of these areas contained voids or missing material. This may contribute to the leaking joints by allowing water to penetrate the expansion joints.

Photograph 11 – Asphaltic plug seal applied over east pier expansion joint, looking north (typical); Note the patched areas and voids in the plug seal

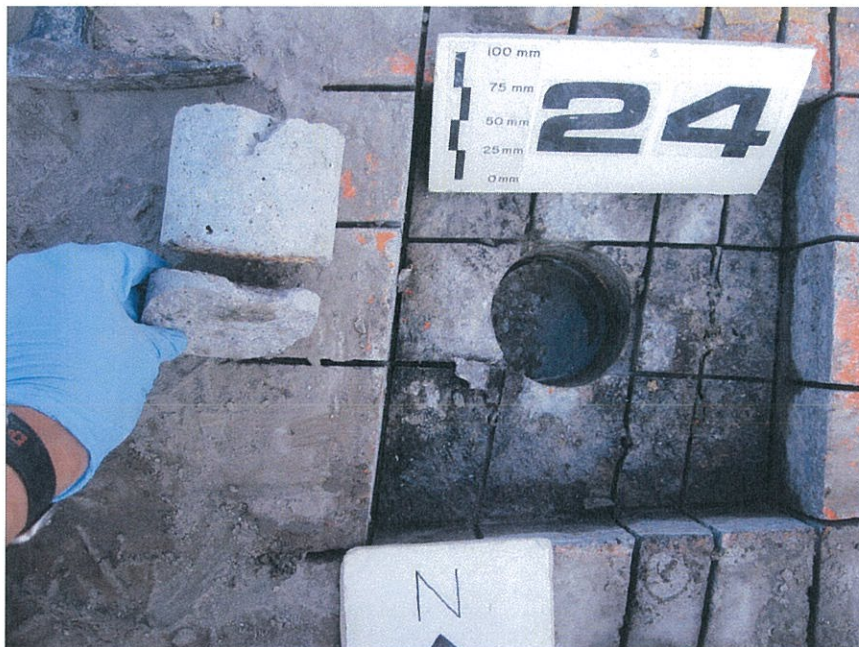
At three (3) of the five (5) sample locations, no defects or deterioration were noted in the concrete. At sawn sample S4, the concrete deck appeared to be in good condition (see photograph 12). However, a core taken at this location revealed a void within the concrete deck (see Section 2.2.2 for details). At sawn sample S5, scaling was noted on the concrete surface after the asphalt had been removed (see photograph 14).

Photograph 12 – Horizontal void found within the concrete deck at sawn asphalt sample S4 (Core C24 taken at this location); construction joint between gutter and deck

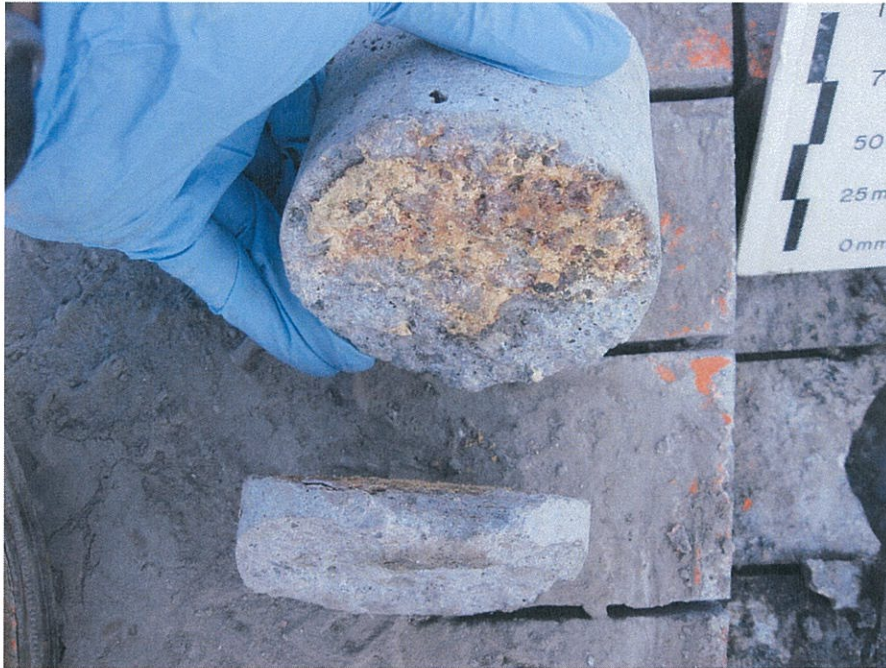
The core and sawn asphalt samples retrieved were generally in good condition with the exception of two (2) cores. Horizontal voids were noted in adjacent cores, C16 and C24. We note that these cores were taken at the construction joint of the gutter and deck interface. An unknown substance was observed between the concrete interfaces of the voids.

Photograph 13 – Unknown solid substance found in the void of core C24, 70 mm below the concrete surface

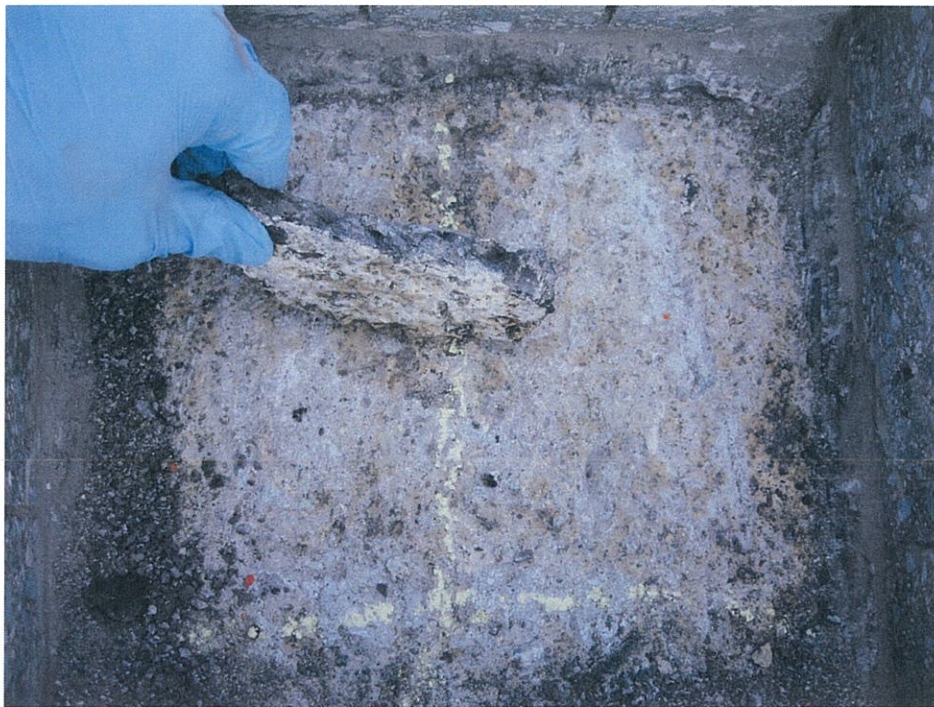
Photograph 14 – Scaling noted on concrete surface at sawn asphalt sample S5

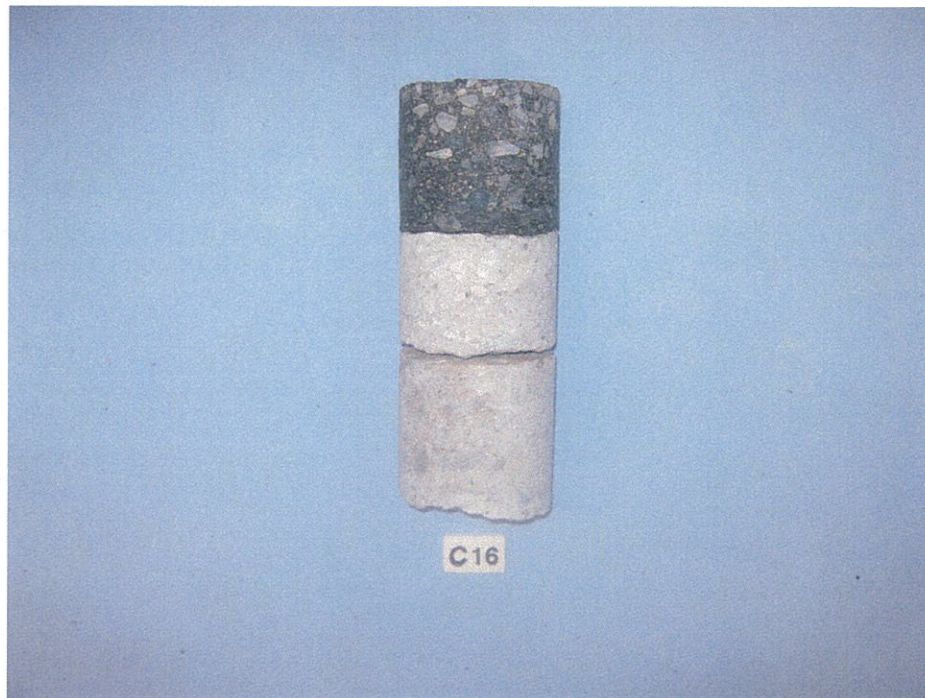
A horizontal construction joint was noted in cores C16 and C24 (see photograph 15). Both cores were retrieved from the westbound structure within the main span. Both cores were taken within 300 mm of the centre concrete median. Upon inspection of the cores, a horizontal construction joint was observed in both cores approximately 70 mm below the concrete surface. An unknown substance (powder) was noted within the concrete interface (see photographs 12 and 13). Based on the original contract drawings, the concrete joint encountered is believed to be the concrete gutter and deck joint interface. The material in the joint may be a bonding agent and / or debris build-up.

Photograph 15 – Horizontal void in core C16, Core C24 contained similar horizontal void at approximately the same depth below the concrete surface (refer to photograph 13)

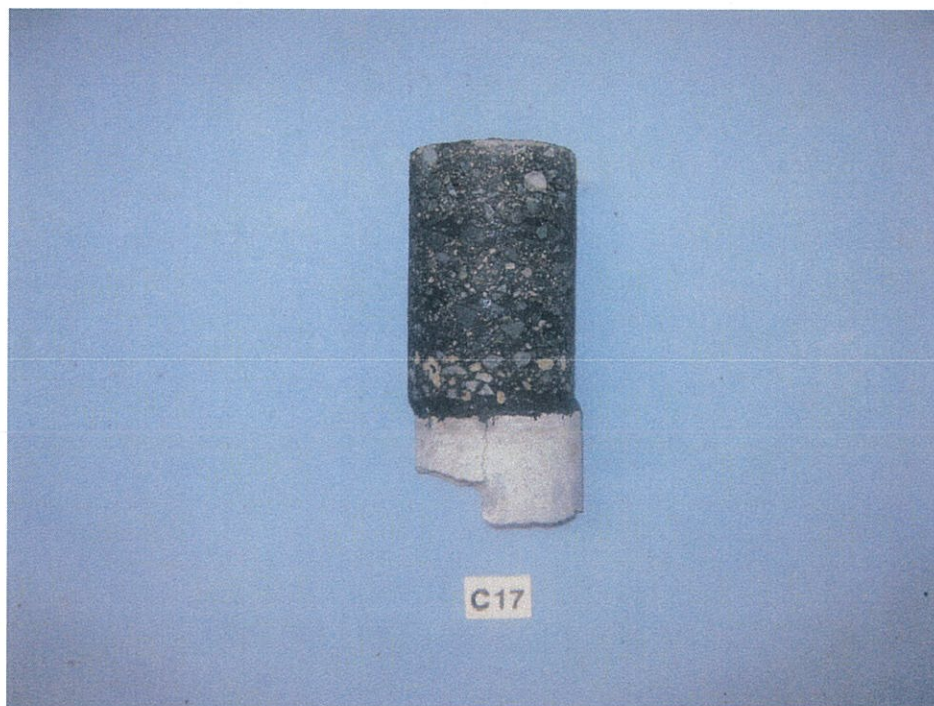
Light corrosion was noted on the reinforcing steel intercepted at core C17. Vertical cracking, in the transverse direction, was also observed in the core. The cracks extended from the top of the concrete deck surface to below the level of the reinforcing steel. Rust stains were observed within the adjacent areas of the concrete (see photograph 16).

Photograph 16 – Vertical crack in core C17

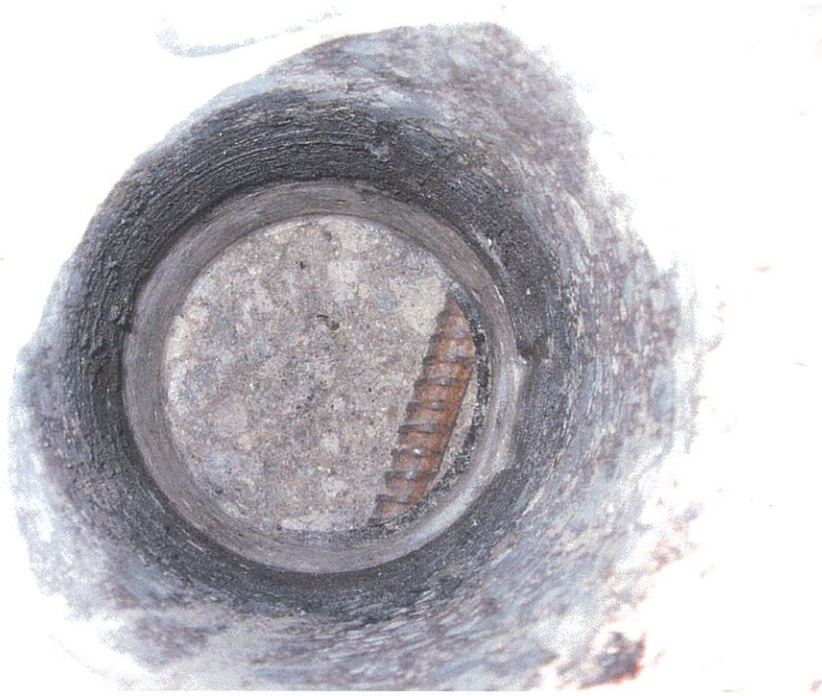
Cover meter readings at the sawn asphalt sample locations and the cover measured at core locations show that the reinforcing steel is located approximately 60 mm below the concrete surface. We note that light corrosion was observed in half of the core samples where reinforcing steel was exposed.

Photograph 17 – Light rust noted on reinforcing steel at eight (8) core sample locations (Core C15 shown)

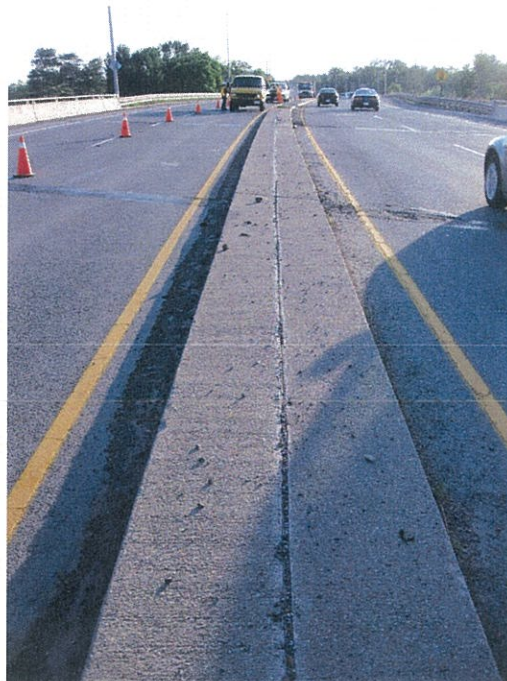
A longitudinal expansion joint is used to separate the eastbound superstructure and westbound superstructure. The original joint was replaced with a Jeene 25 mm type “W” joint seal during the rehabilitation work completed in 2004. The existing 150 mm wide waterstop was part of the original construction and has not been modified since. Condition from the above surface indicates that the joint is brittle and has little ductility. A visual inspection from below the structure confirms that the longitudinal joint is leaking (see photographs 18 and 19).

Photograph 18 – Longitudinal joint along the raised median (installed during 2004 rehabilitation contract)

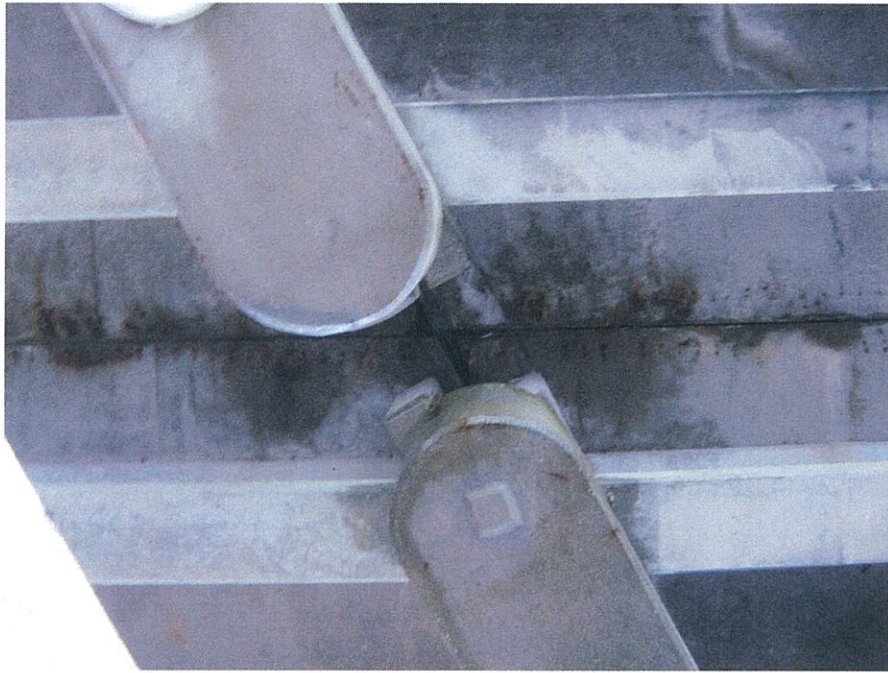
Photograph 19 – Leaking and staining underneath the longitudinal expansion joint at the west piers (typical)

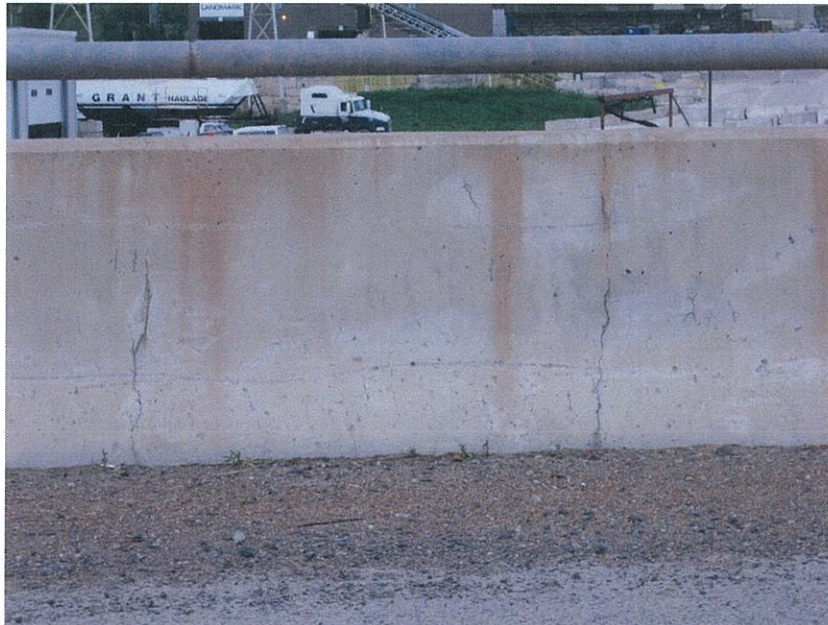
Concrete barrier walls with railing were constructed as part of the 2004 rehabilitation work. The walls are generally in fair condition. A delamination survey was completed on the south wall only. The south wall contained thirty-five (35) vertical medium cracks, most of which were noted stained (see photograph 20). A 50 x 700 mm area of spalling was noted.

Photograph 20 – Vertical medium cracking in concrete parapet walls (typical)

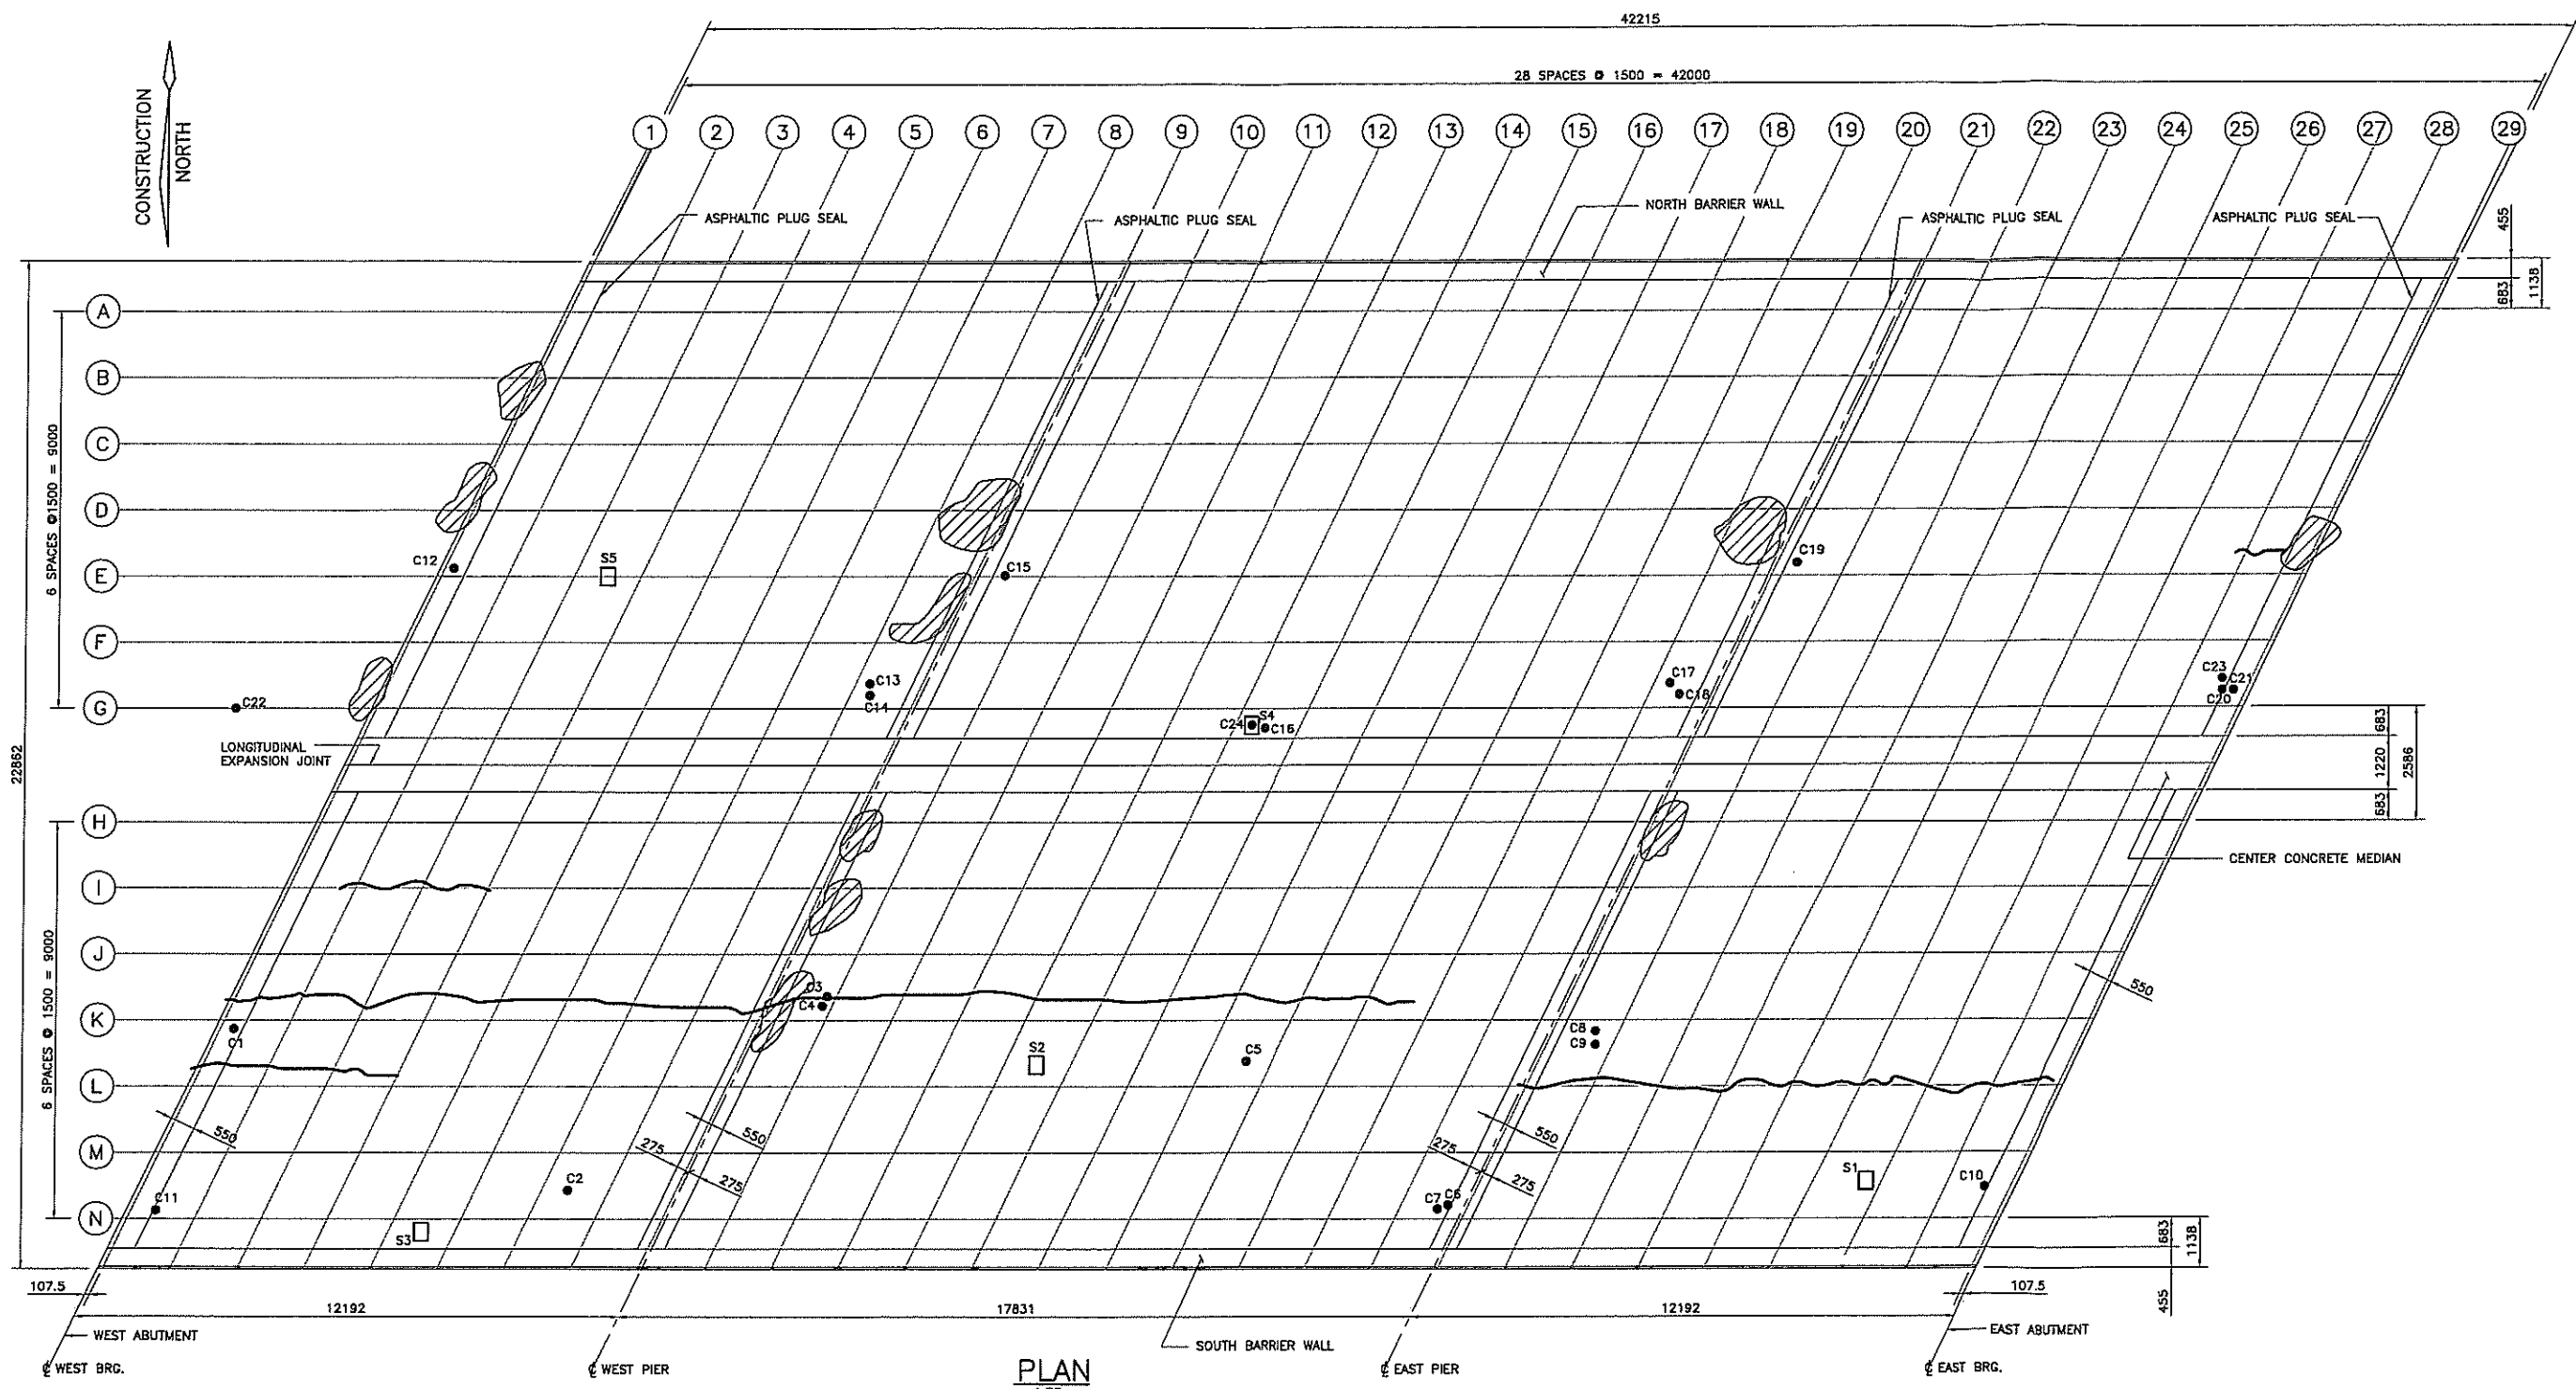
TITLE  
**GENERAL ARRANGEMENT  
DUNDAS STREET  
CNR OVERHEAD  
ASPHALT WEARING SURFACE CONDITION**

The average thickness of the asphalt wearing surface measured 132 mm at core and sawn sample locations. Asphalt thicknesses were measured at half cell reading locations and are shown in Drawing 3 of Appendix E. Asphalt was milled and replaced in the last rehabilitation and should have a thickness of 90 mm  $\pm$  as specified in the rehabilitation drawings. In addition, the asphalt plug seals were placed at the same height as the asphalt wearing surface. It is unknown whether this asphaltic plug seal height is able to provide acceptable resistance to compressive forces (i.e. traffic loads). The observed depressions in the plug seals may indicate inadequate resistance to loads. The material may be too flexible given the height.

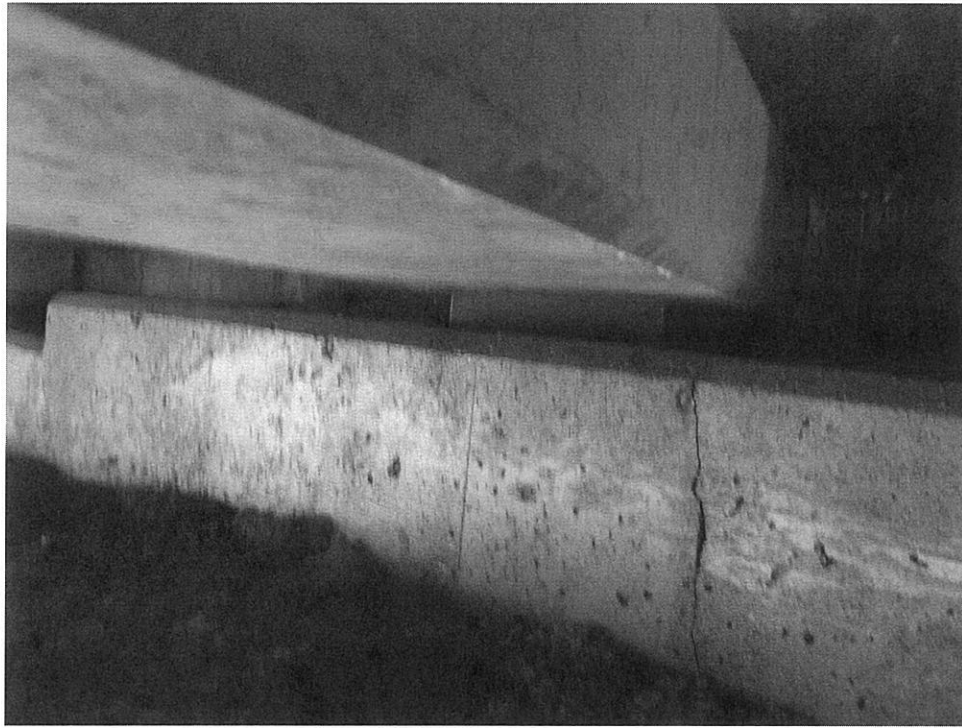
Photo 4 – Crack at West Abutment

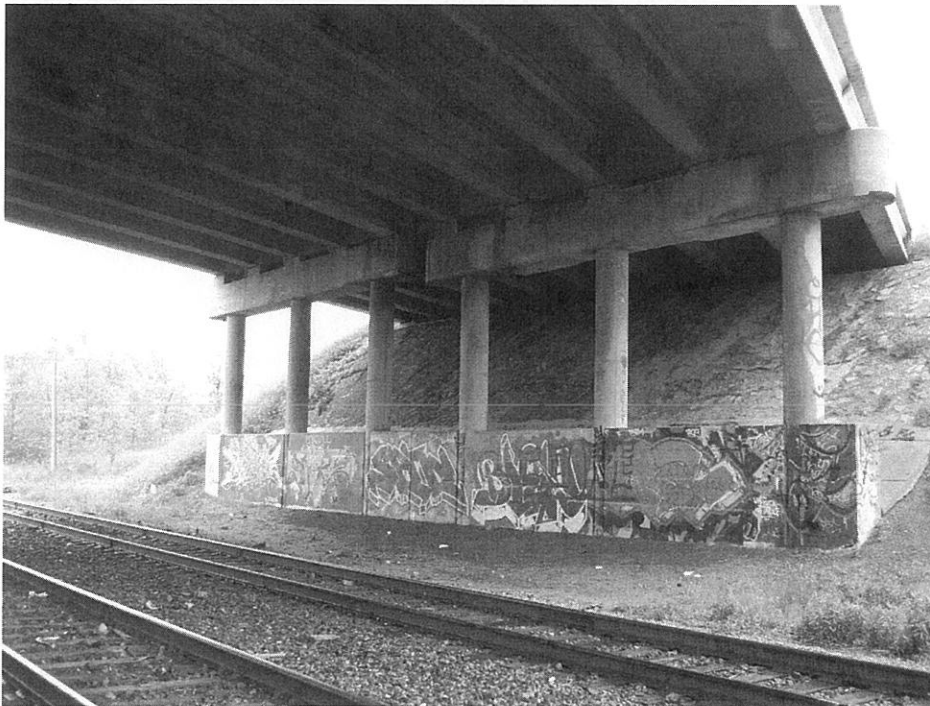
Photo 7 – Vegetation at Slope Paving
