To	Sheri Harmsworth	Page 1
Subject	Preliminary Evaluation of Integrating Trafalgar Road SWM with Pond 29 and Pond 30 (North Oakville Main-East Morrison Creek EIR/FSS)	
Prepared By	Janelle Wepler, B.Sc. (Env.), P.Eng., Water Resources Engineer	
Reviewed By	Glenn Farmer, Senior Environmental Technologist	
Date	November 4, 2013	Project Number 60119993

**Summary Action Report**  
**Structure 03-1182320 CU01 (MTO Site No. )**  
**Trafalgar Road**

Structure Number: **03-1182530 CU02**

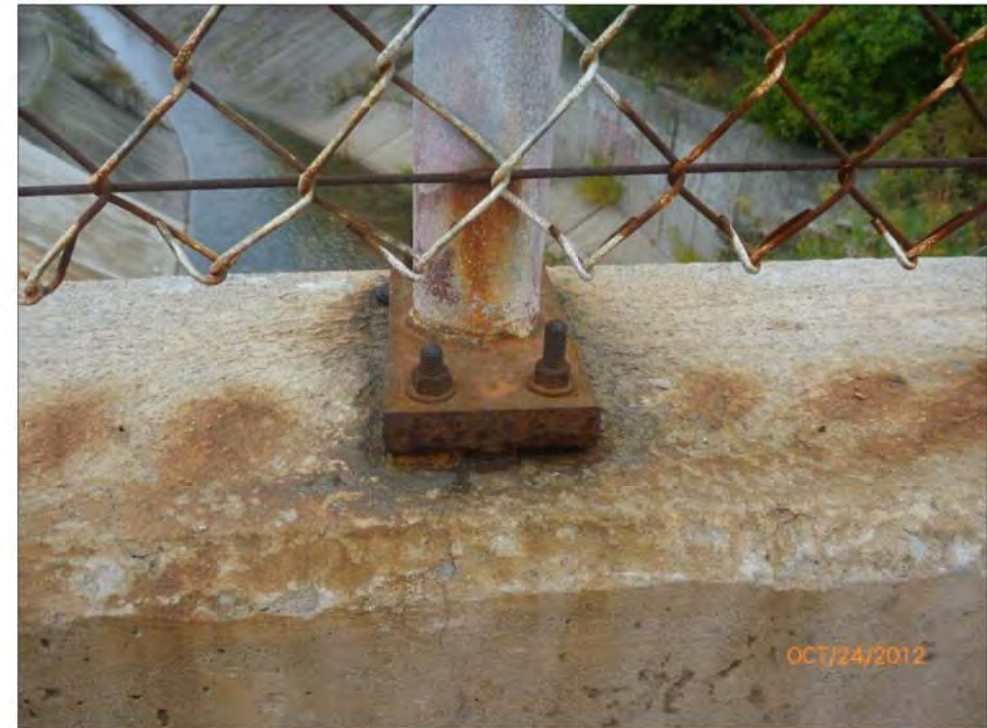
Comments: Light corrosion at bases.

Light Corrosion on Chain Link Fence Post

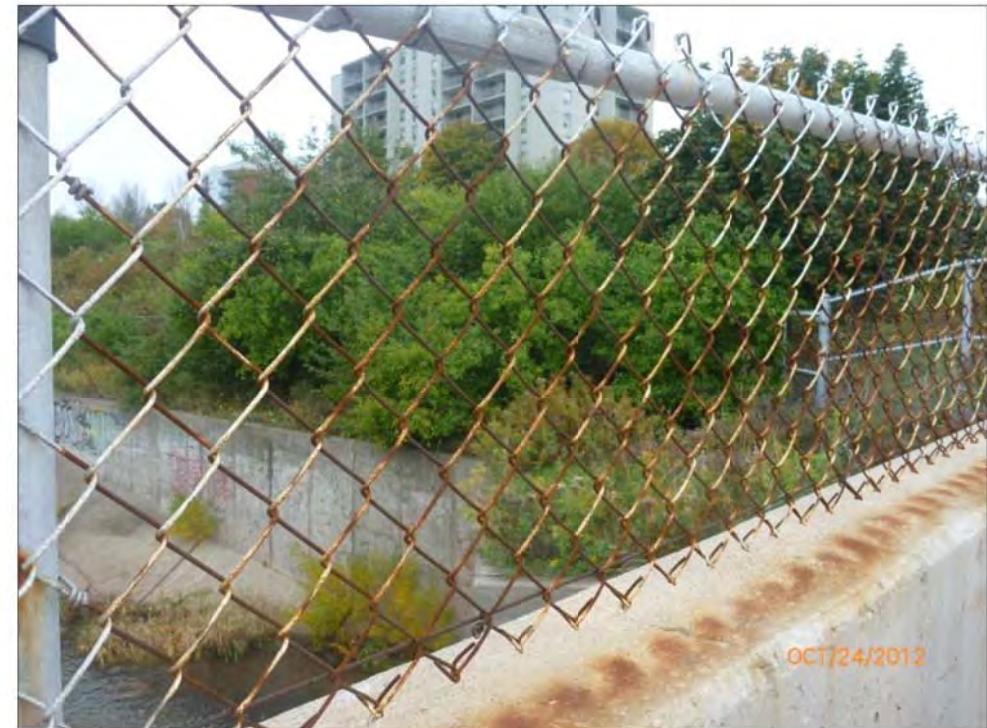
Comments: Overall light corrosion.

Light Corrosion on Chain Link Fence

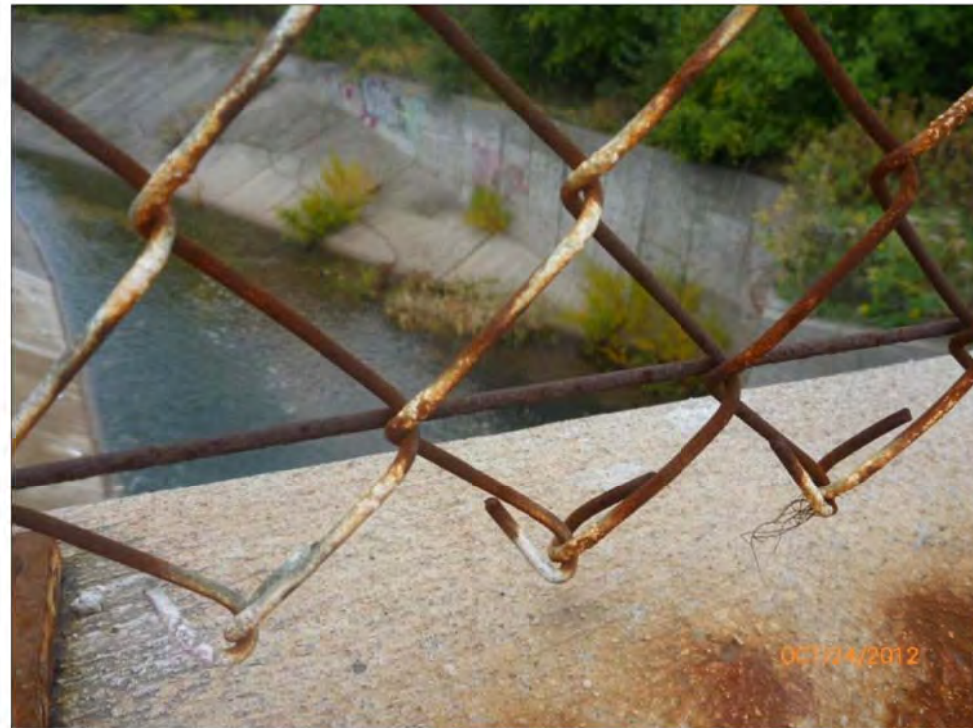
Breakdown of Galvanized Coating on Chain Link Fence

Performance Deficiencies	Maintenance Needs	Priority	Comments
None	Bridge Handrail Maintenance	2 yr	Touch up coating

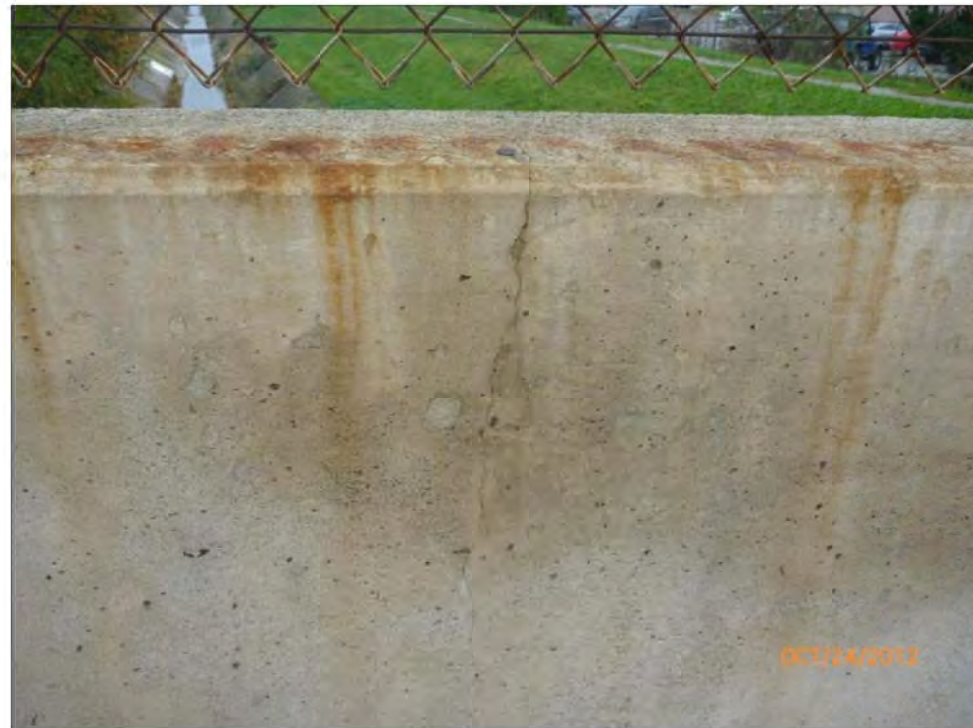
Comments: Narrow cracks.

Narrow Crack on Interior Parapet Wall

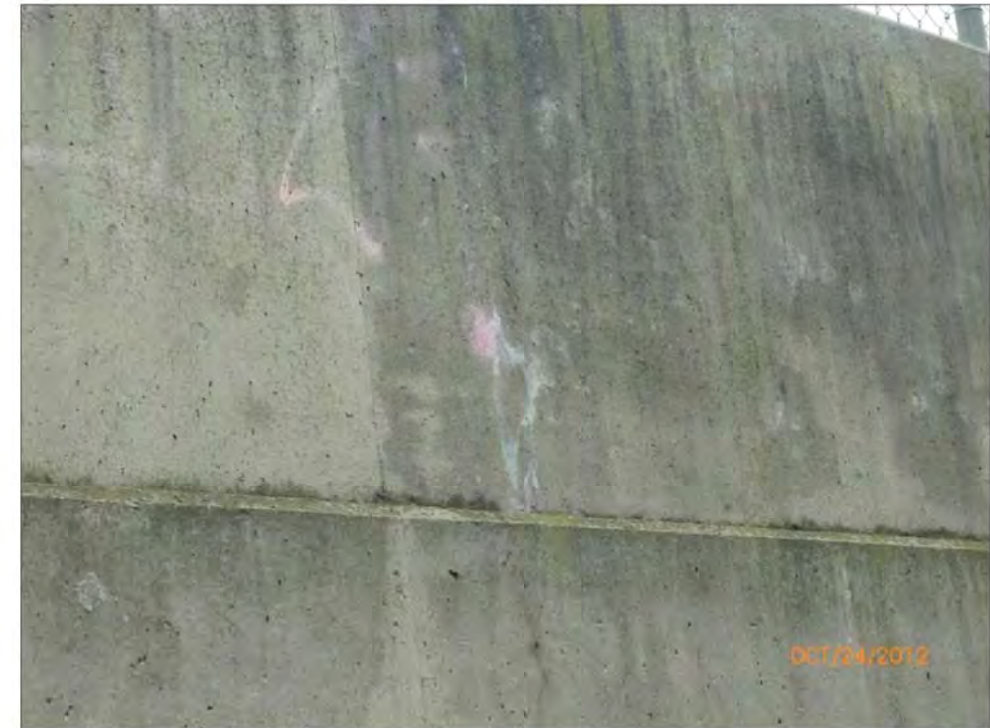
Comments: Narrow cracks.

Narrow Crack on Exterior Parapet Wall

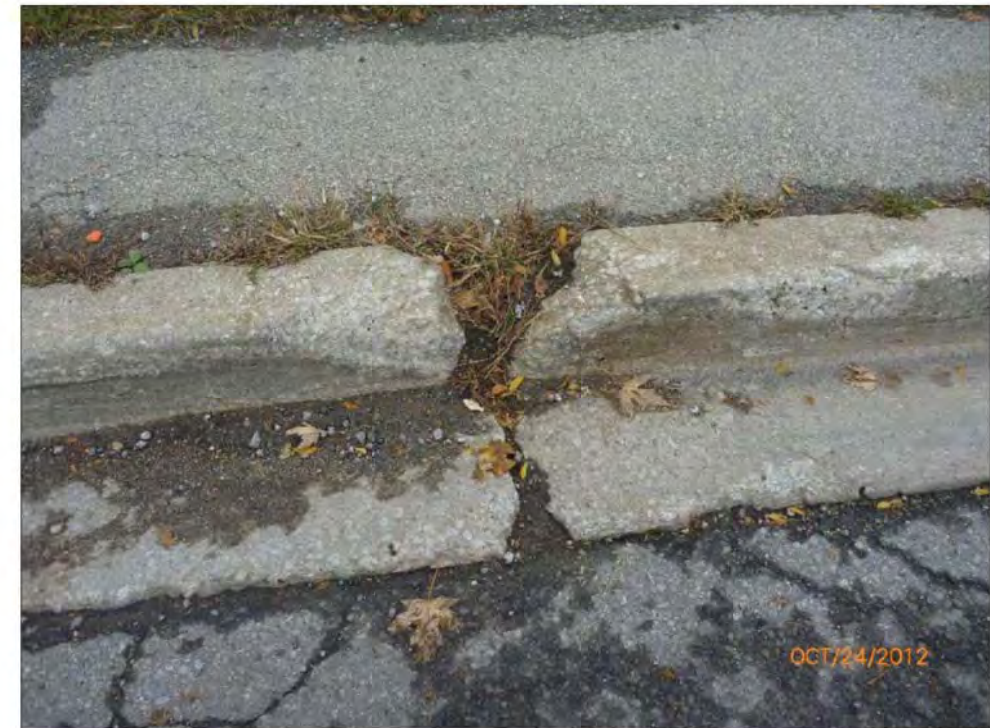
Severe Abrasion on Curb Over Deck

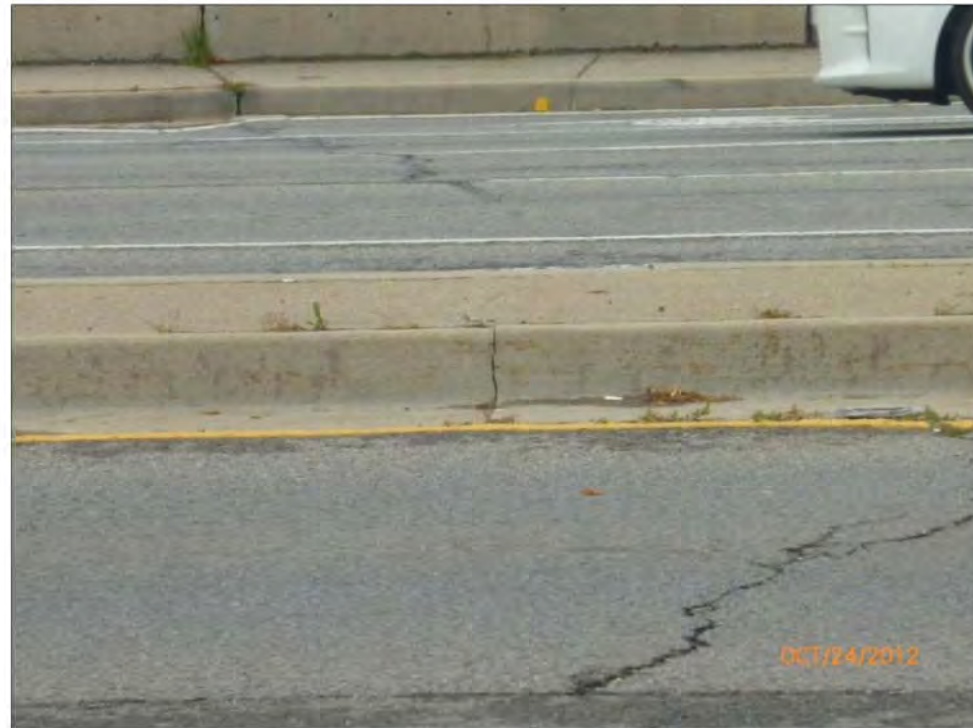
Wide Crack on Median

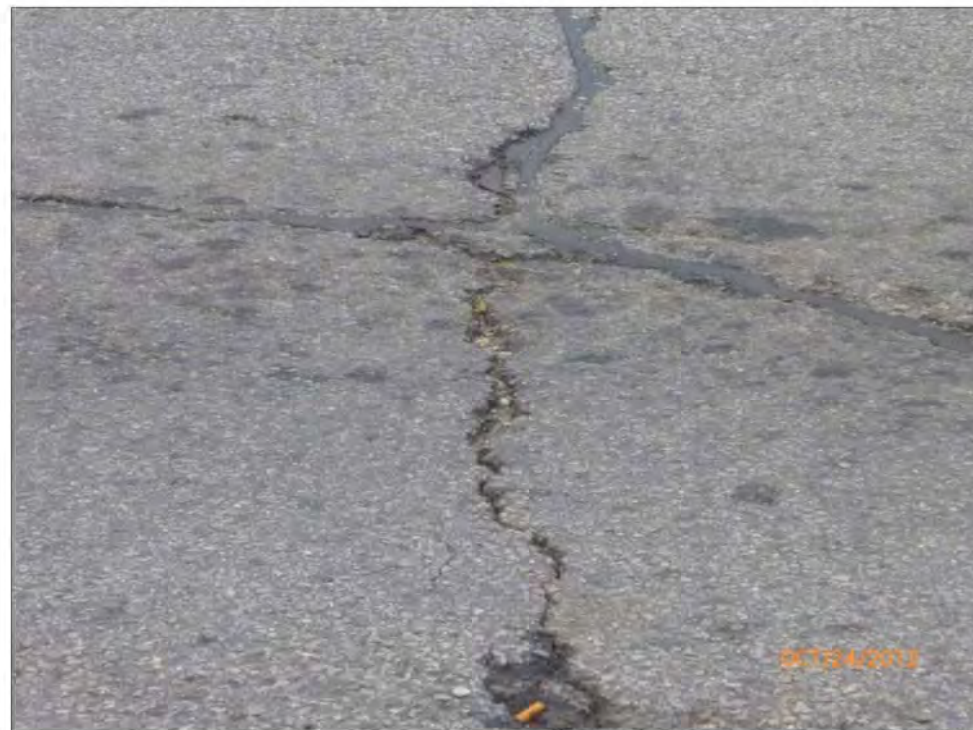
Comments: Narrow to wide cracks, sealed cracks, light ravelling.

Wide Crack on Deck Wearing Surface

Rehab/Repair Recommendations	Priority	Cost	Comments
Minor Rehabilitation	6-10 yrs	\$2,500	Seal cracks

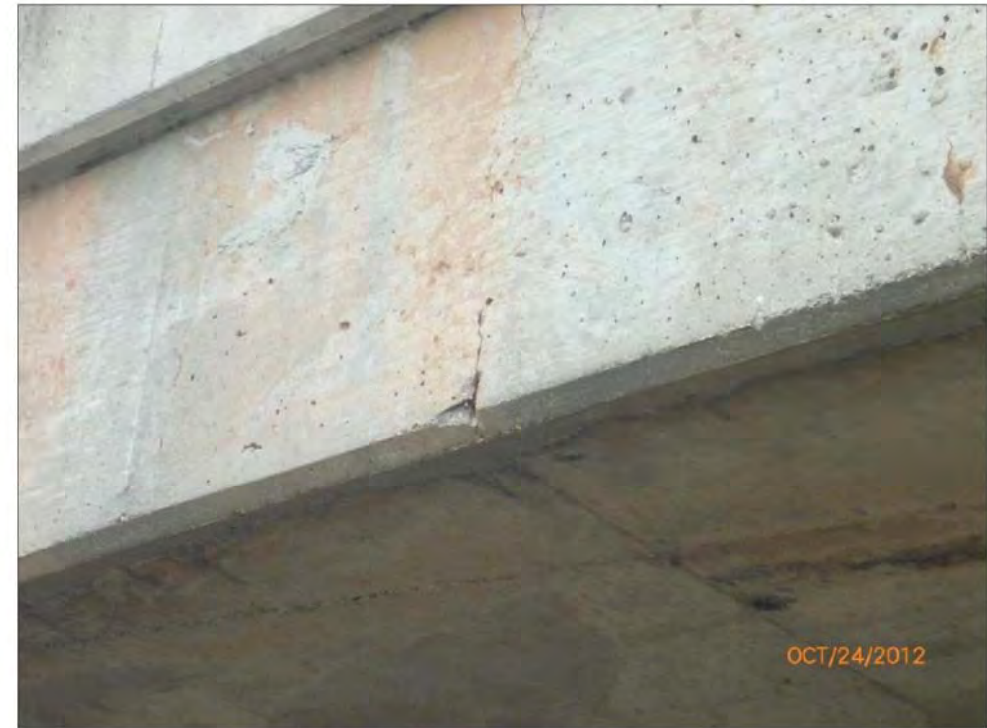
Comments: One wide crack, concrete patches.

Wide Crack on Exterior Soffit

Rehab/Repair Recommendations	Priority	Cost	Comments
Minor Rehabilitation	6-10 yrs	\$2,500	Patch repairs

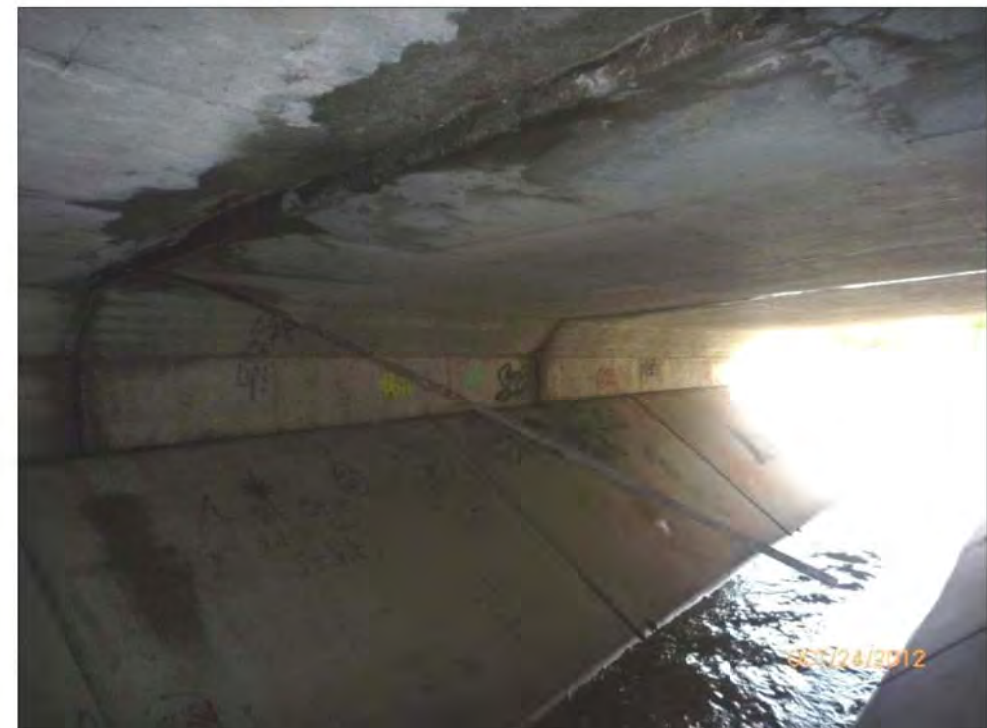
Comments: Wet areas, delaminations and severe spalling with exposed corroded rebar on the soffit adjacent to the construction joints.

Displaced Rebar on Interior Soffit

Rehab/Repair Recommendations	Priority	Cost	Comments
Minor Rehabilitation	6-10 yrs	\$15,000	Patch repairs

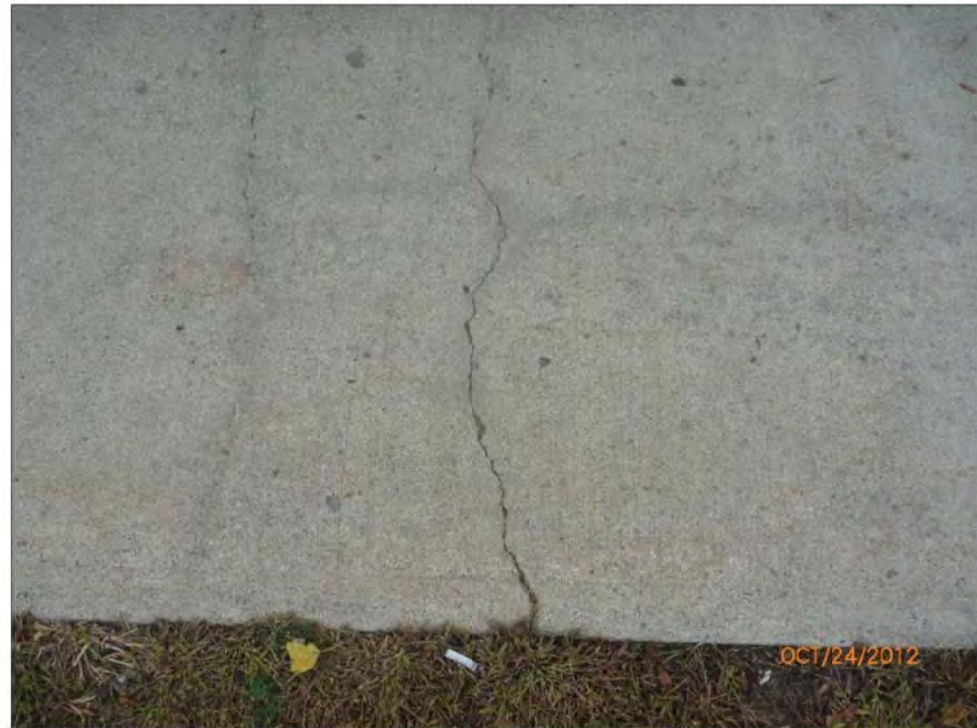
Medium Crack in Sidewalk

Rehab/Repair Recommendations	Priority	Cost	Comments
Minor Rehabilitation	6-10 yrs	\$5,000	Reconstruct sidewalk

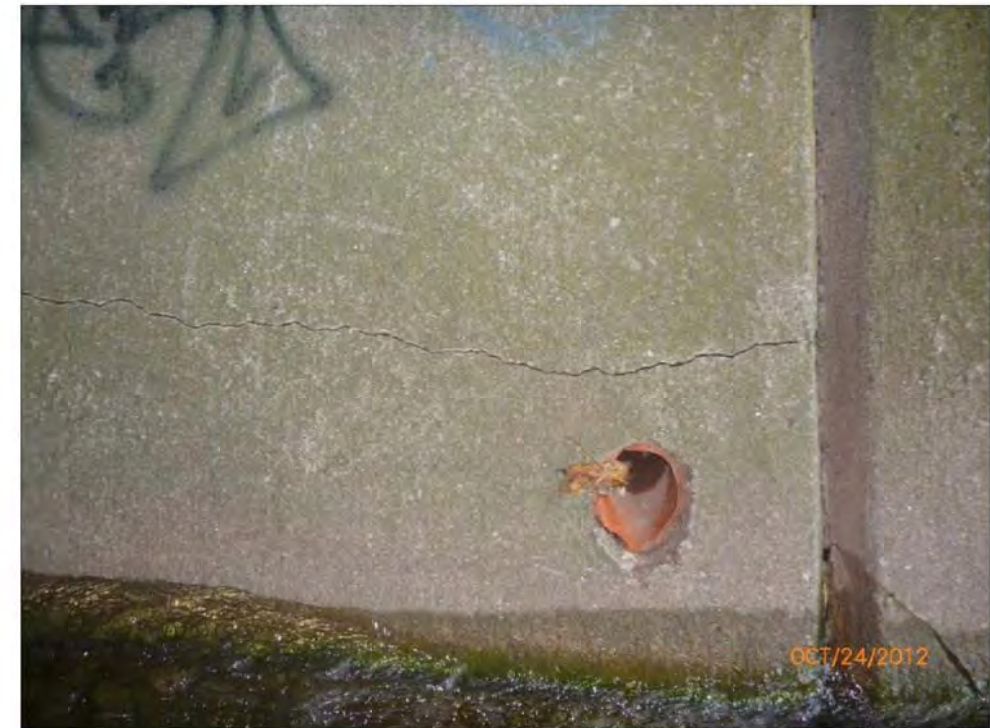
Wide Crack in Slope Protection in Front of Abutment

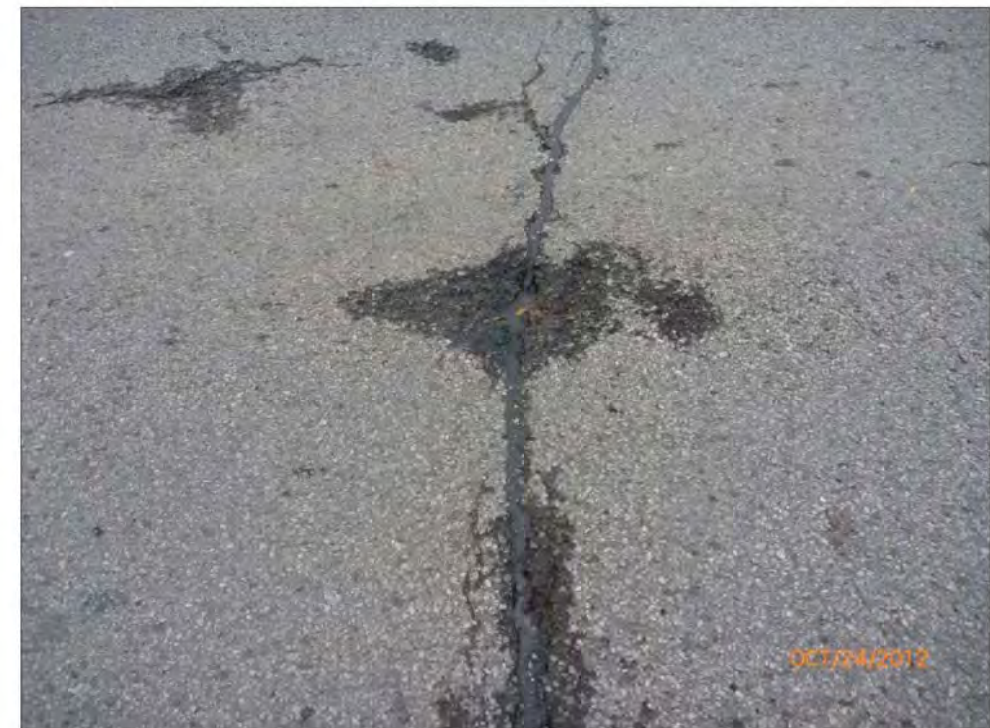
Comments: Light to severe ravelling, narrow to wide cracks, sealed cracks, minor settlement at ends of deck.  
 Performance Deficiencies: None  
 Maintenance Needs:   
 Priority:   
 Comments:   
 Rehab/Repair Recommendations:   
 Priority:   
 Cost:   
 Comments: Minor Rehabilitation 6-10 yrs \$2,500 Patch repair and seal cracks

Severe Raveling of Approach Wearing Surface

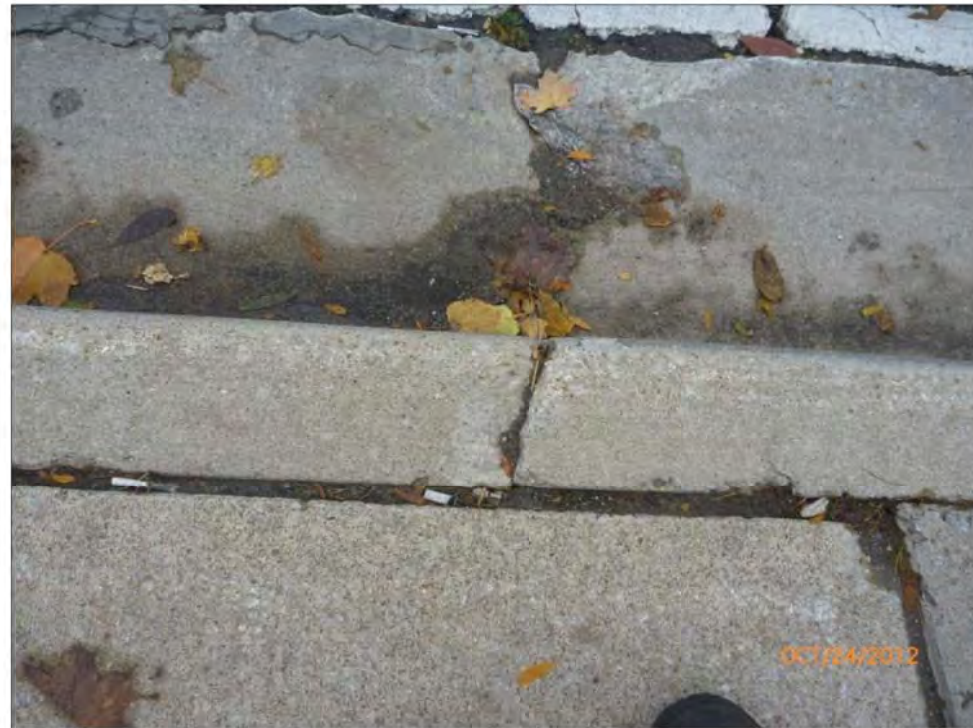
Severe  
 Comments: Wide cracks.

Wide Crack on Approach Curb

Rehab/Repair Recommendations	Priority	Cost	Comments
Minor Rehabilitation	6-10 yrs	\$2,500	Patch repairs

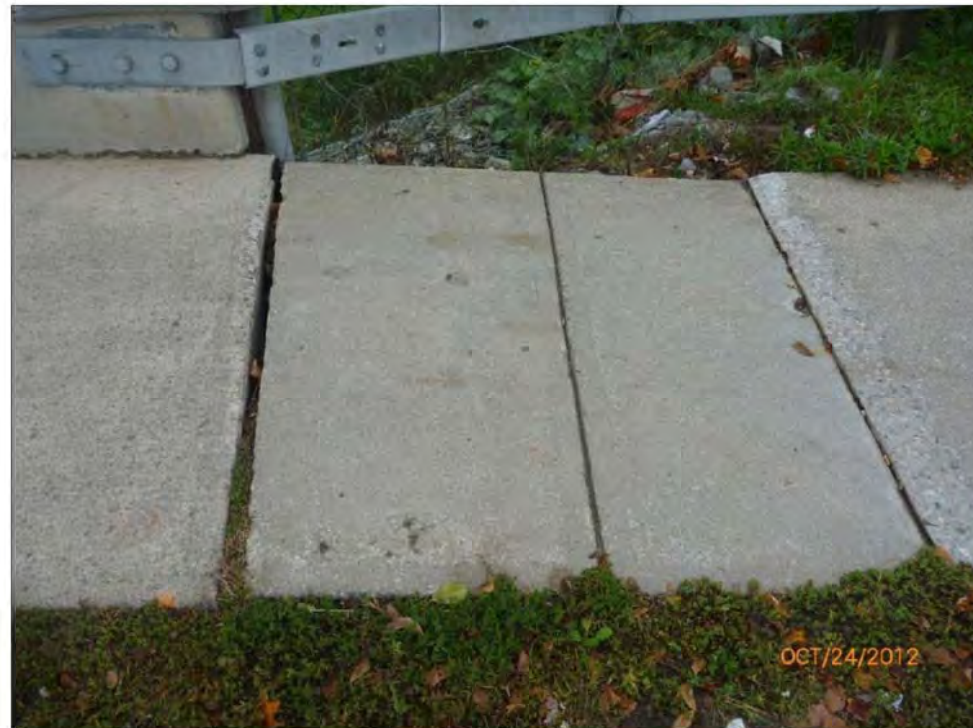
Medium Settlement of Approach Sidewalk in Southeast Quadrant

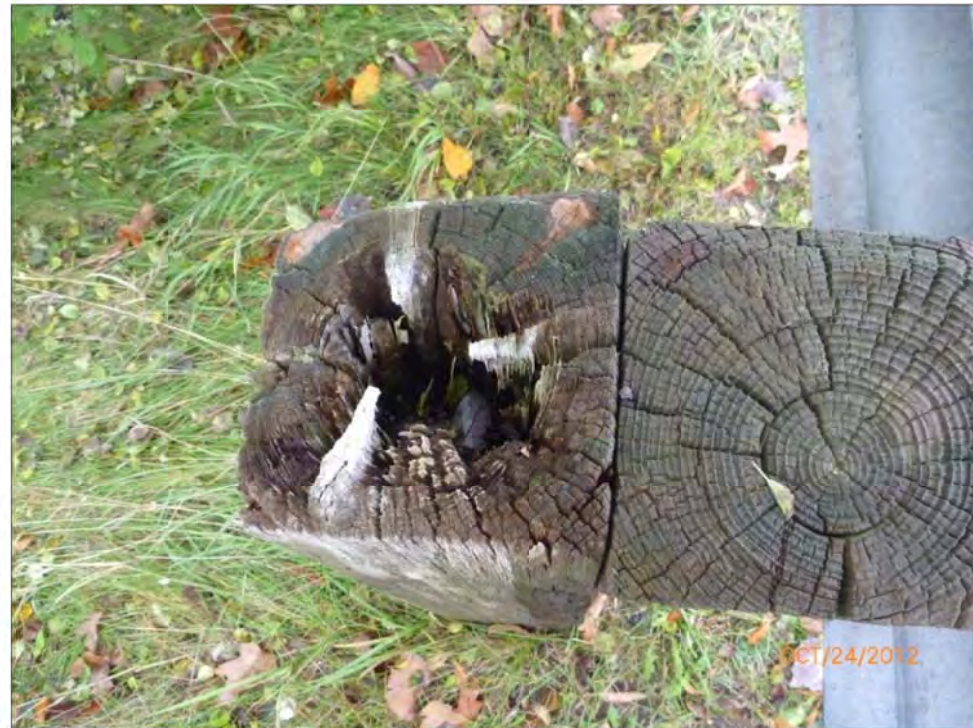
Severe End Rot on Guiderail Post

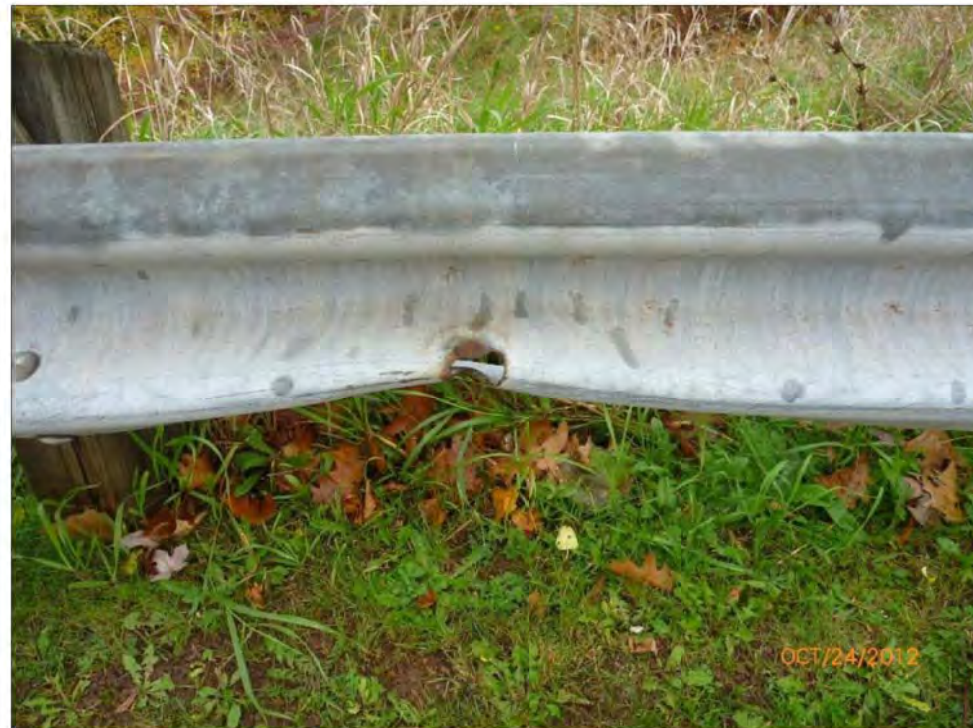
Severe Impact Damage on Flex Beam Guiderail

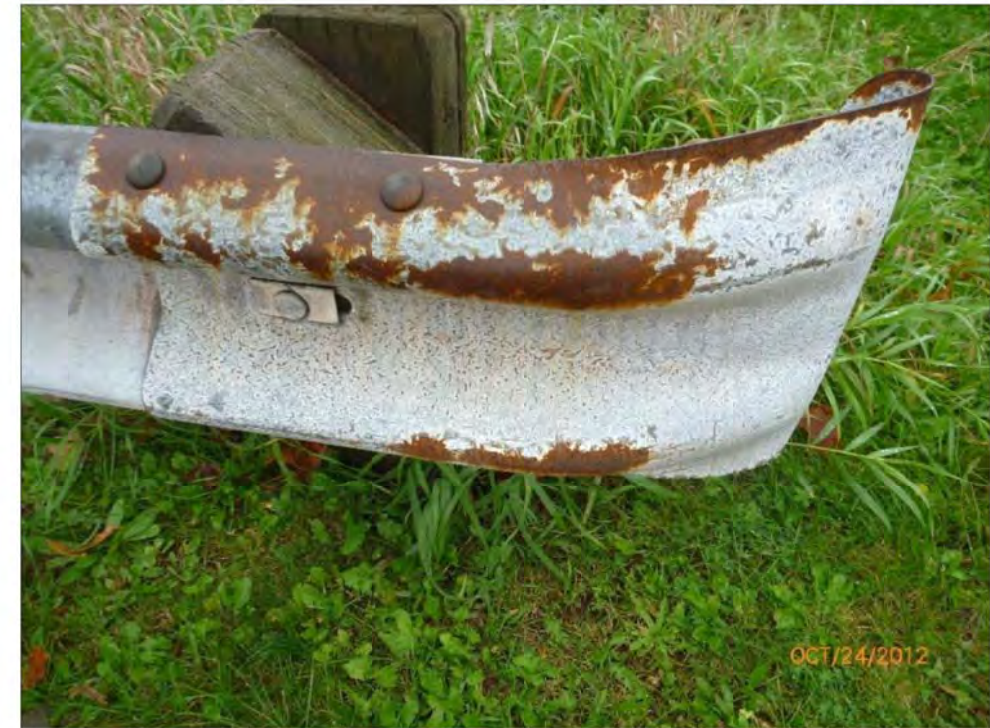
Light Corrosion on Guiderail Over Structure

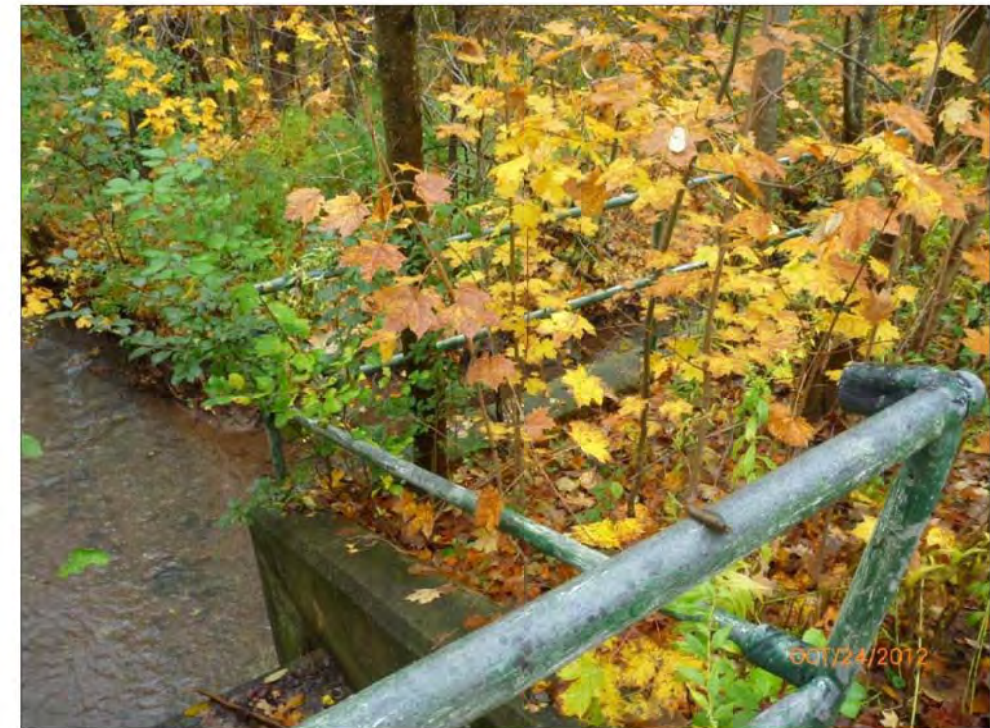
Missing Handrail at Barrel Inlet

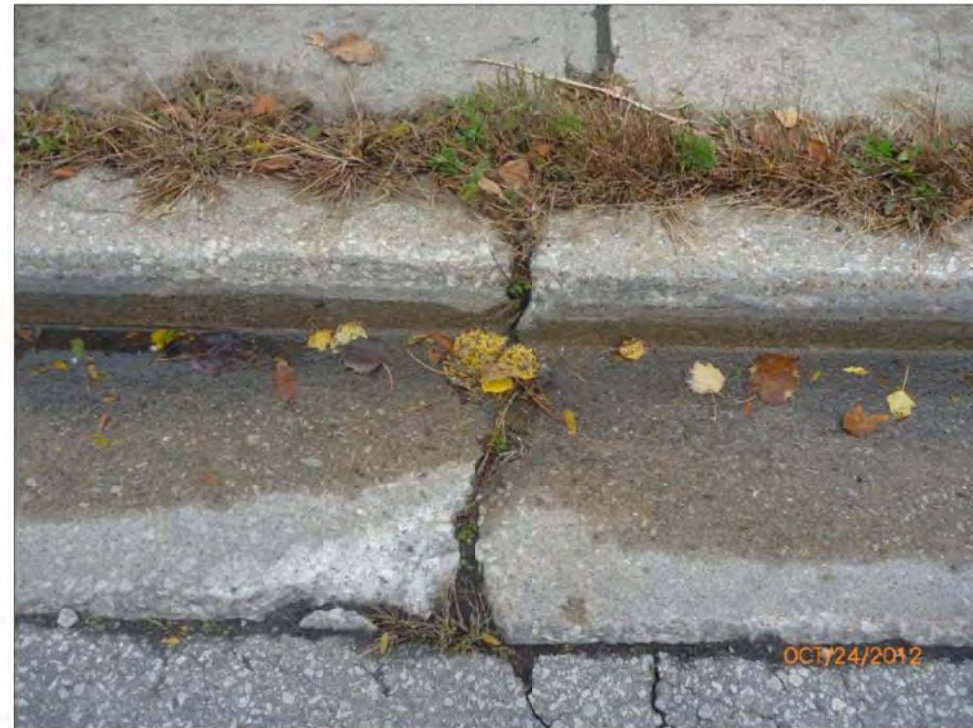
Wide Crack on Curb

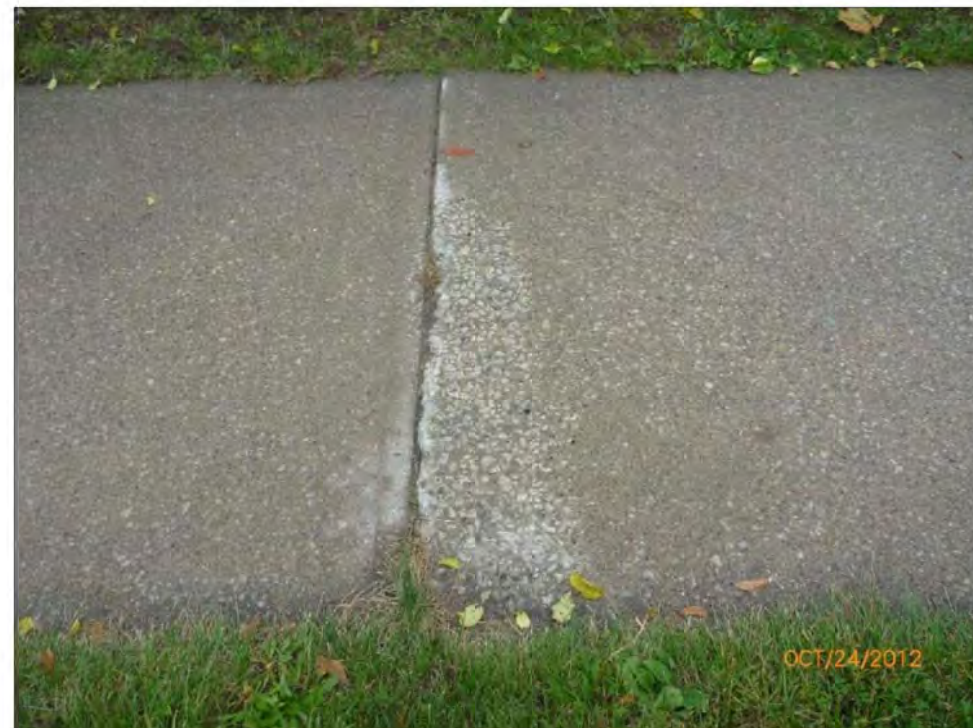
Light Scaling on Sidewalk

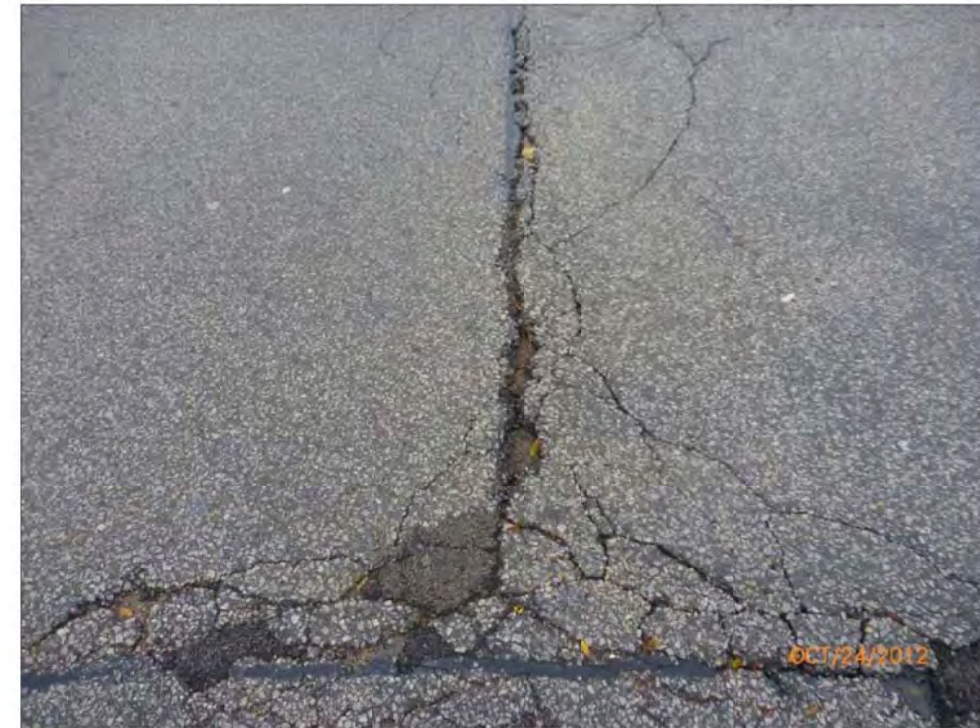
Wide Crack on Wearing Surface

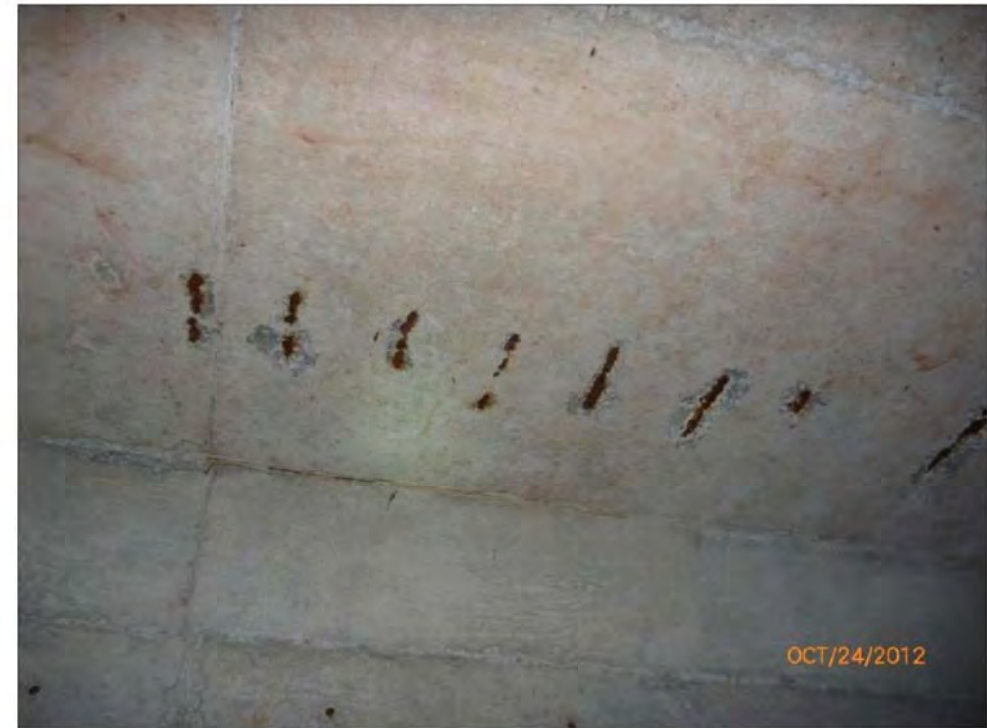
Light Spalling of Barrel Soffit

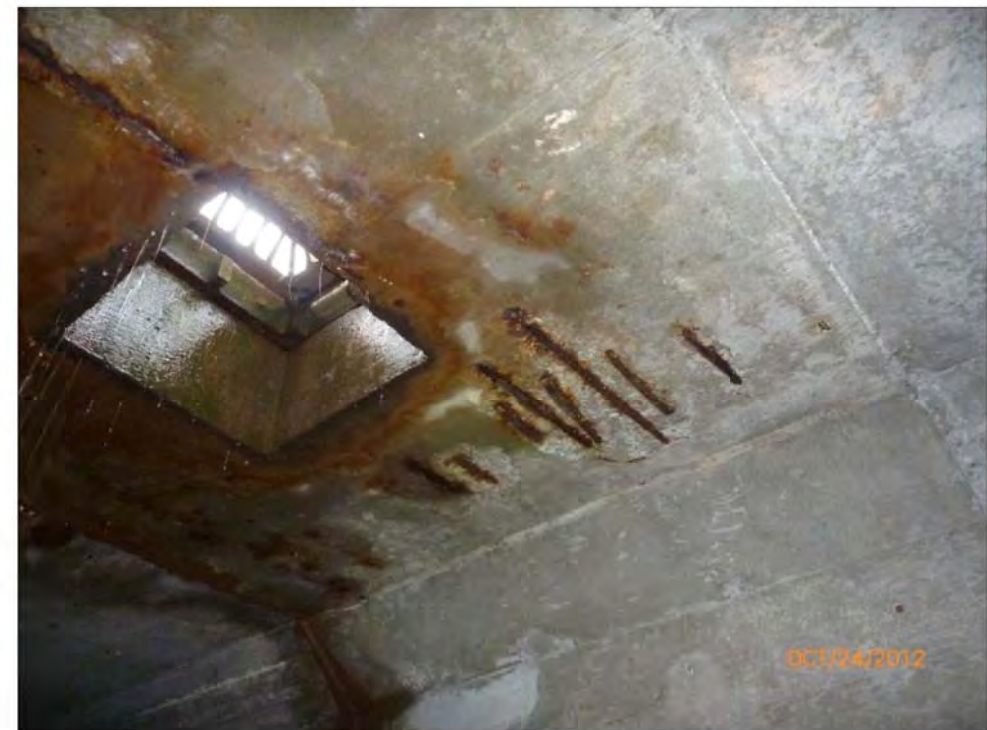
Spalling Around Storm Sewer Outlet

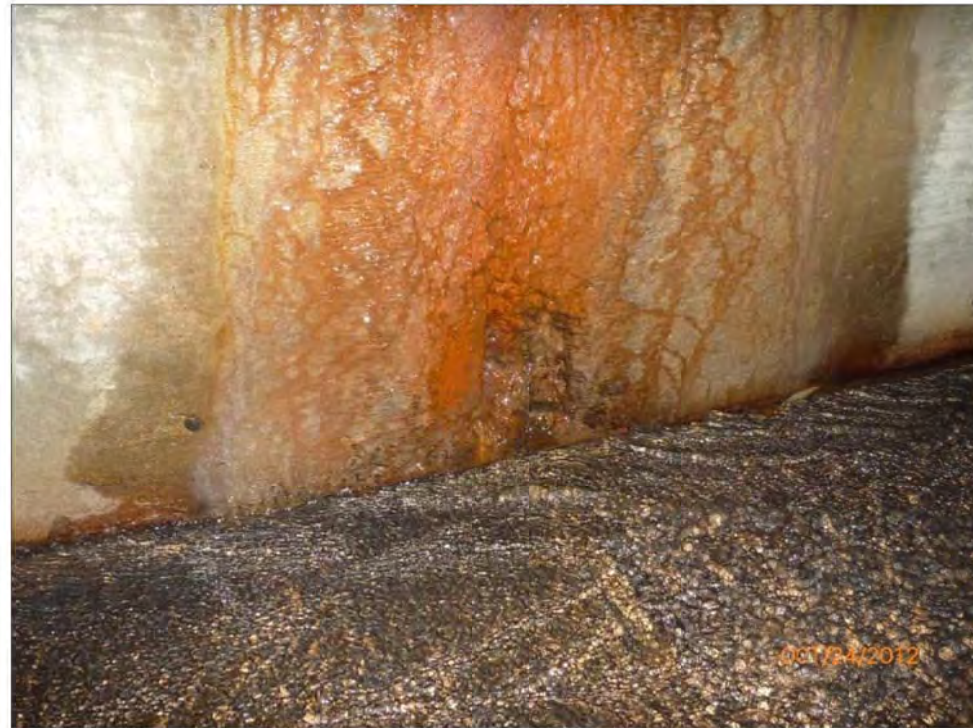
Severe Scouring of Barrel Walls

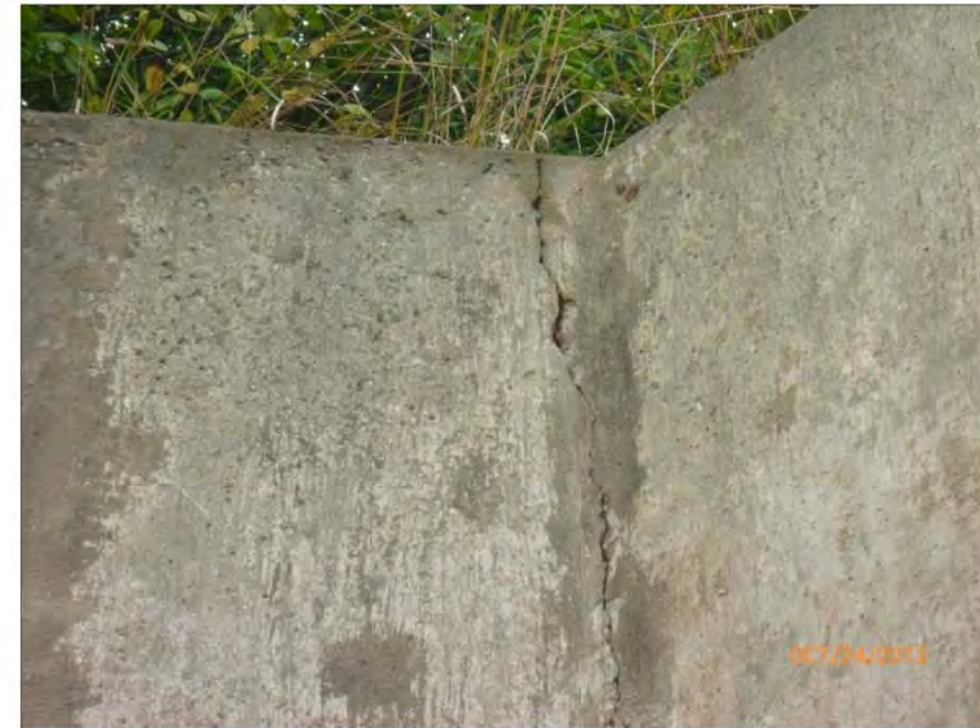
Wide Crack on Outlet Retaining Wall

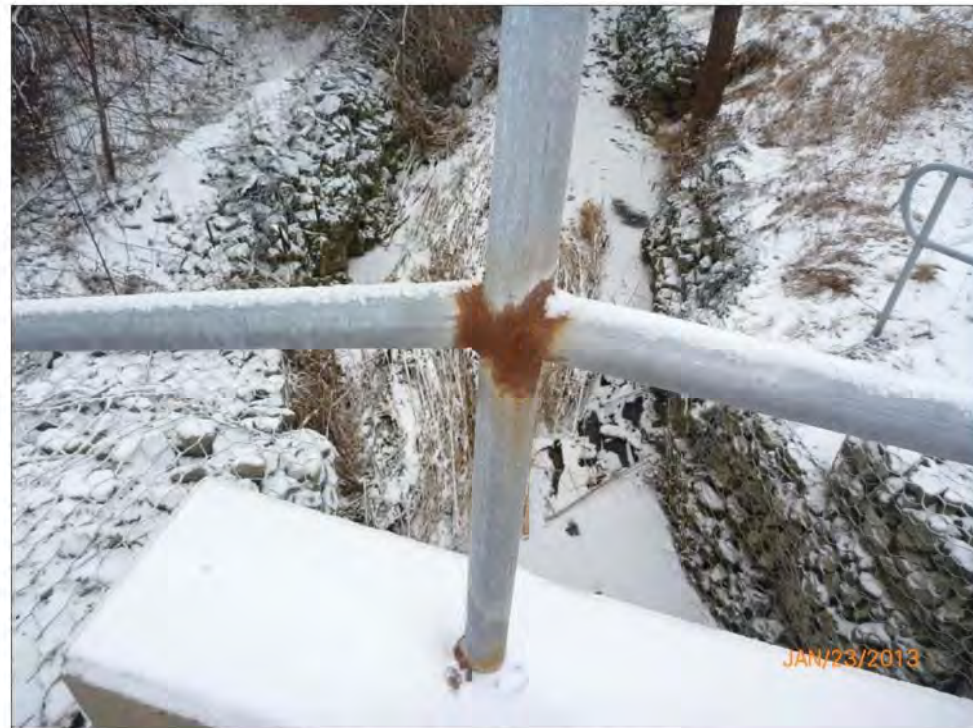
Light Corrosion of Light Pipe Handrail

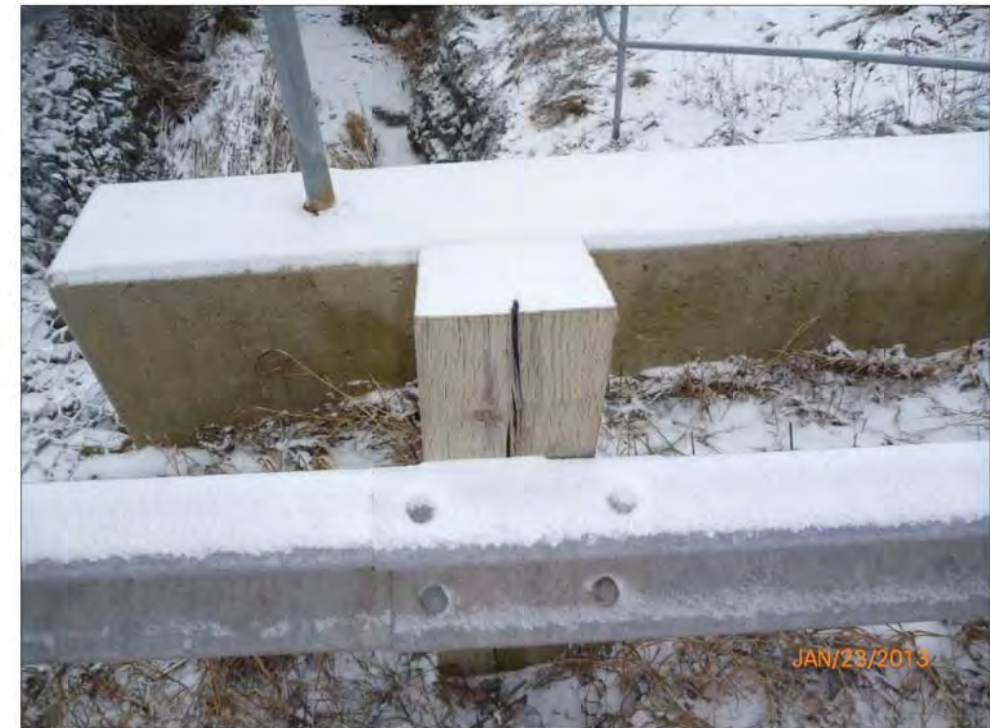
Checking of Flex Beam Wood Post

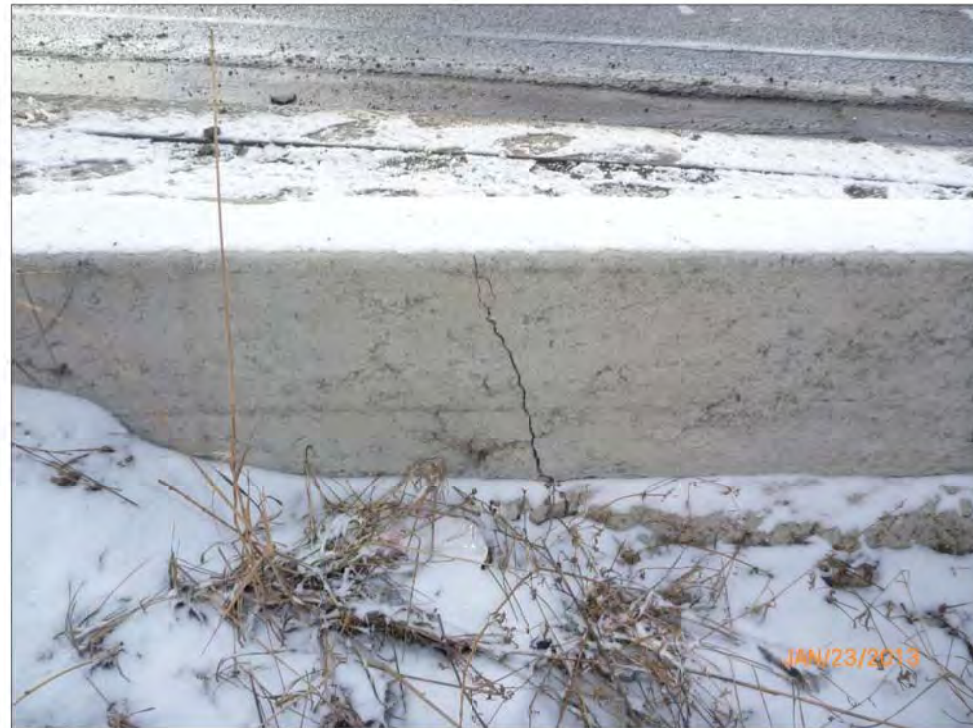
Wide Vertical Crack in East Concrete Curb

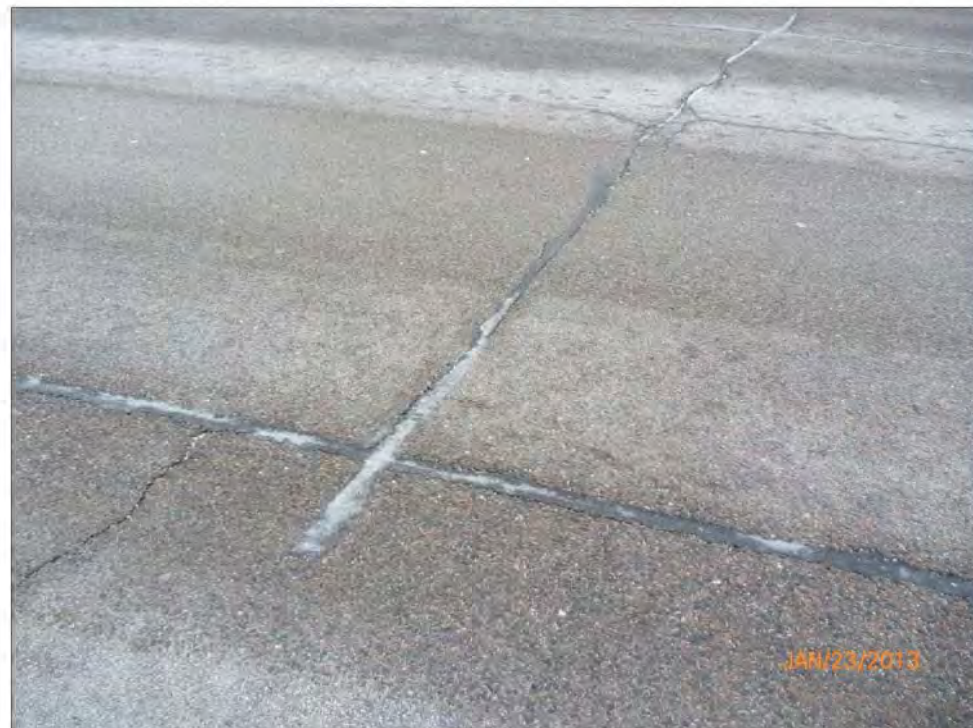
Sealed and Unsealed Narrow Cracks in Wearing Surface

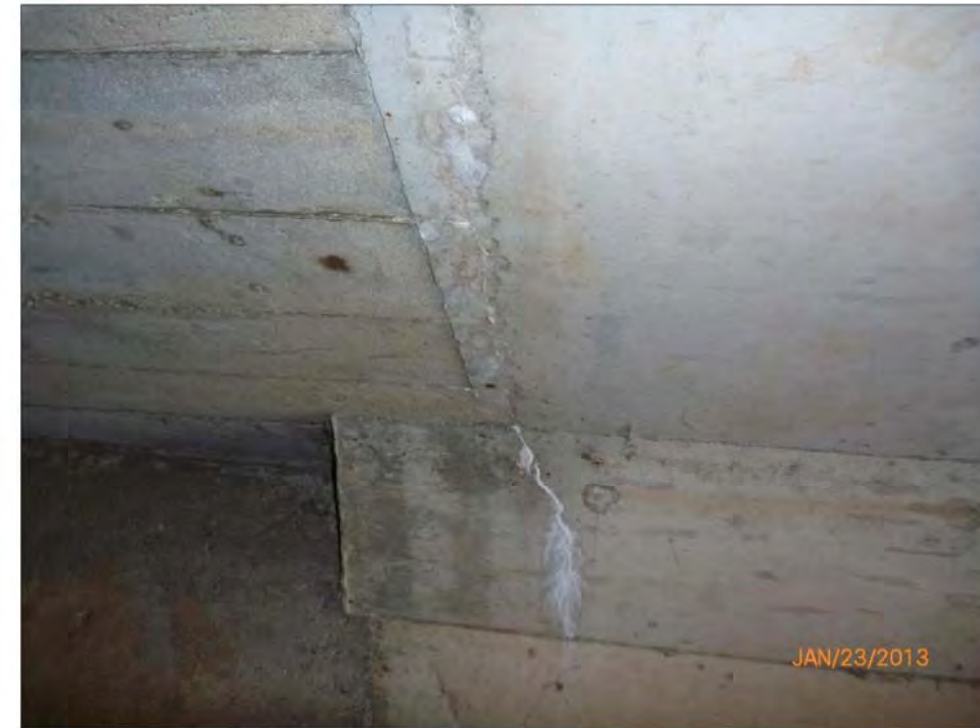
Narrow Stained Crack in Barrel Soffit Extension
