To	Sheri Harmsworth	Page 1
Subject	Preliminary Evaluation of Integrating Trafalgar Road SWM with Pond 29 and Pond 30 (North Oakville Main-East Morrison Creek EIR/FSS)	
Prepared By	Janelle Wepler, B.Sc. (Env.), P.Eng., Water Resources Engineer	
Reviewed By	Glenn Farmer, Senior Environmental Technologist	
Date	November 4, 2013	Project Number 60119993

**Summary Action Report**  
**Structure 03-1182320 CU01 (MTO Site No. )**  
**Trafalgar Road**

Structure Number: **03-1182530 CU02**

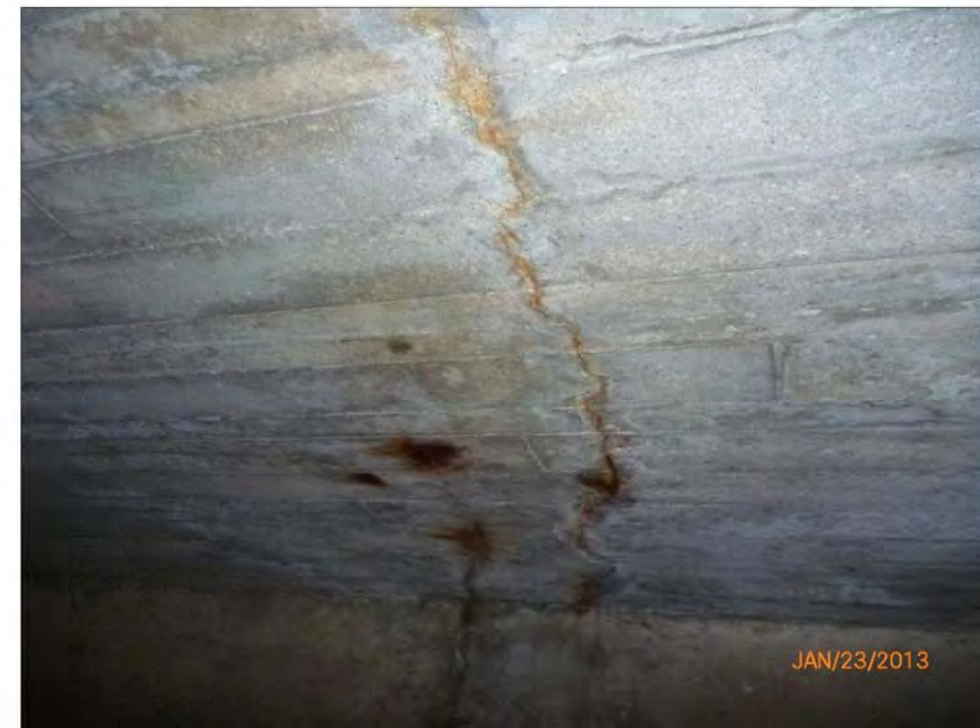
Narrow Stained Crack in Barrel Soffit

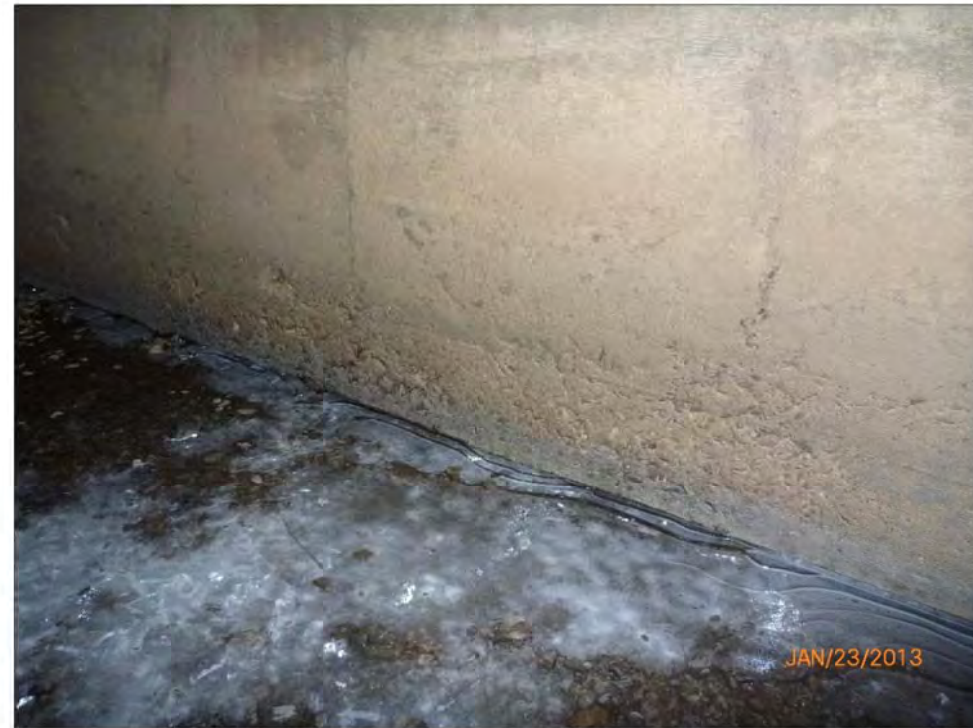
Light Scaling of Original Barrel Wall

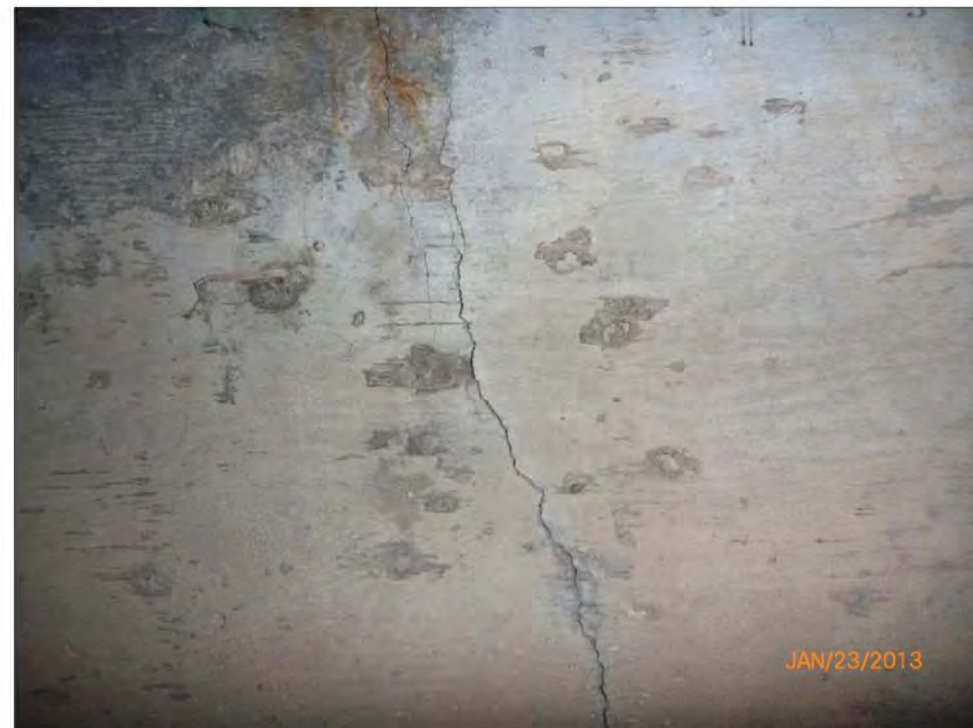
Medium Vertical Crack in Barrel Soffit

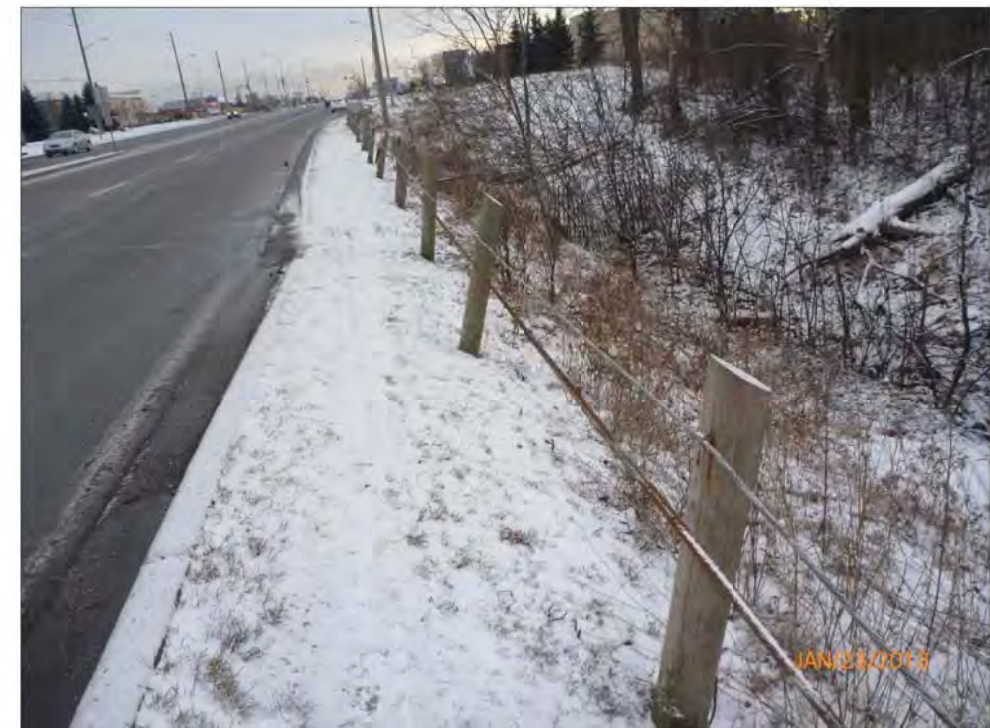
Outward Rotation of 3 Cable Guiderail (West Side)

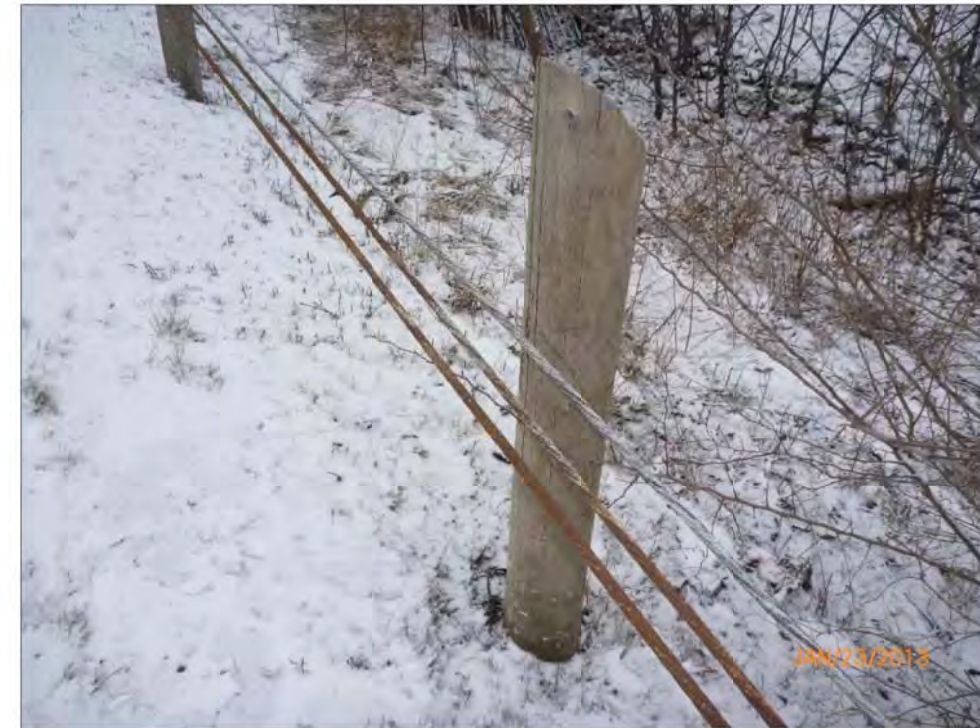
Missing Cable Stays on Timber Post

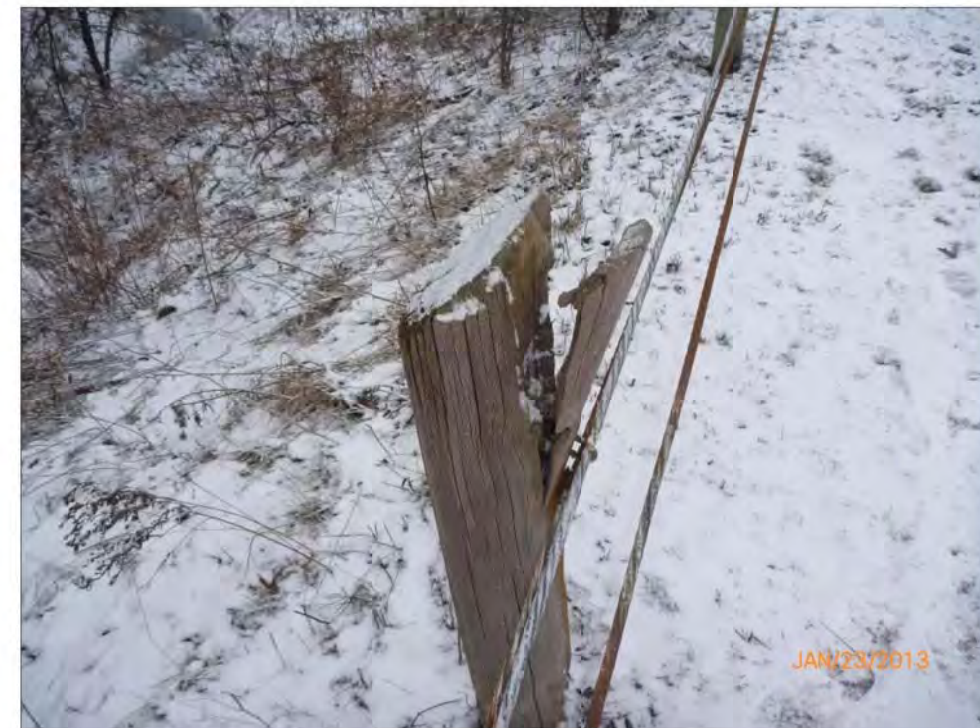
Severe Split in Timber Guiderail Post

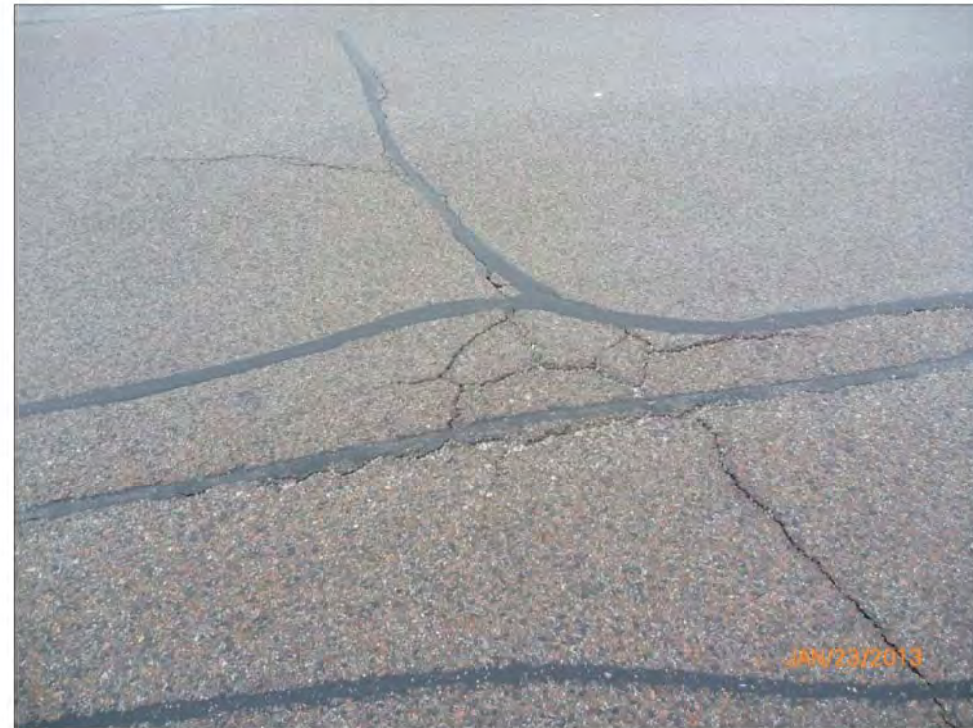
Sealed Cracks and Unsealed Narrow Cracks in Wearing Surface

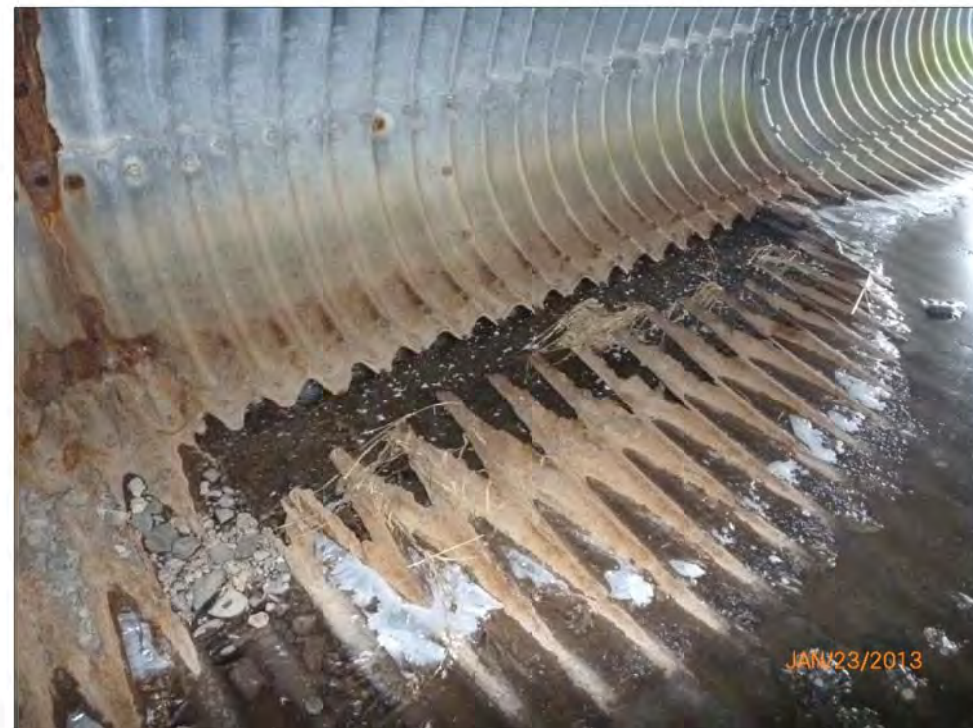
Severe Perforations in Barrel Invert

Repair/Rehabilitation Required				
Element Group	Element	Repair/Rehabilitation	Priority	Cost
Culverts	Barrels	Replace	Now	\$280,000
Barriers	Posts	Replace	Now	\$0
<b>Total Repair/Rehabilitation Cost</b>				<b>\$280,000</b>
Associated Work				
	Comments	Estimated Cost		
Approaches		\$70,000		
Detours		\$0		
Traffic Control		\$100,000		
Utilities		\$20,000		
Right-of-Way		\$0		
Environmental Study		\$10,000		
Other		\$0		
Contingencies		10%	**	\$48,000
Engineering		20%	**	\$96,000
		<b>Total Associated Work Cost</b>		<b>\$344,000</b>
		<b>Total Repair/Rehabilitation Cost</b>		<b>\$280,000</b>
		<b>Total Cost</b>		<b>\$624,000</b>
		Region of Halton Share @ 100%		\$624,000
<p>** If based on a percentage calculated values rounded-up to the nearest thousand dollars.</p>				
Justification

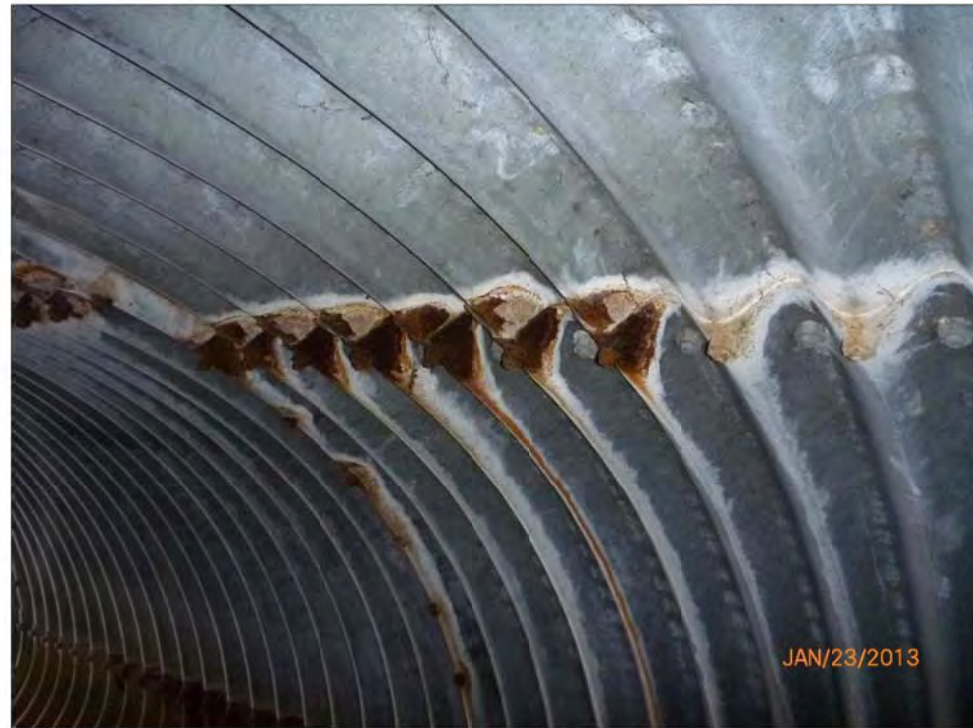
Severe Corrosion of Bolts in Barrel Obvert

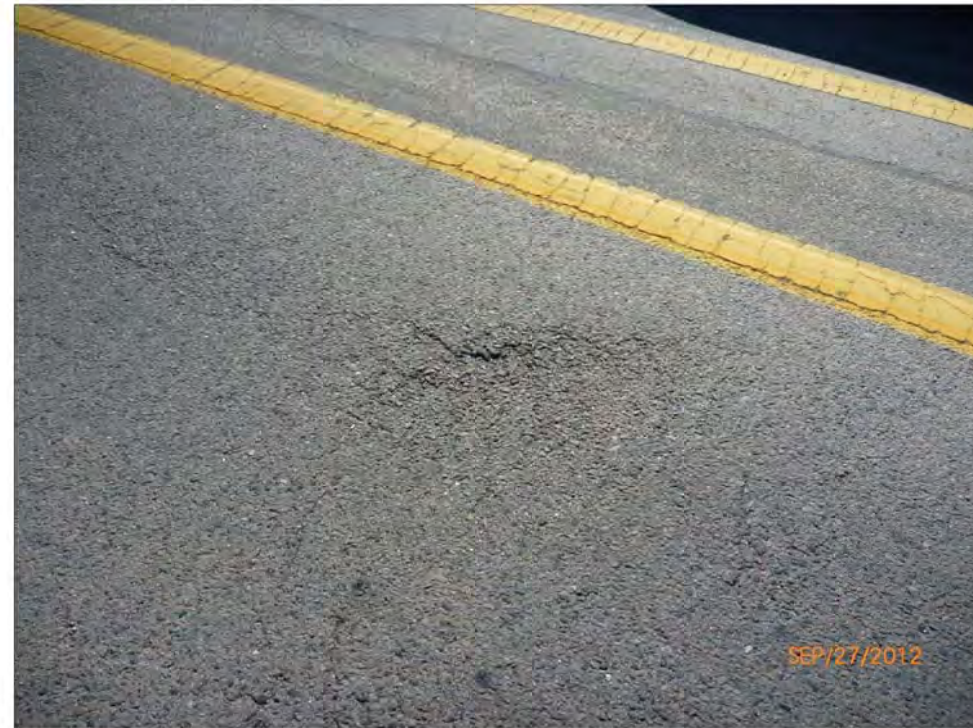
Medium Ravelling on Wearing Surface

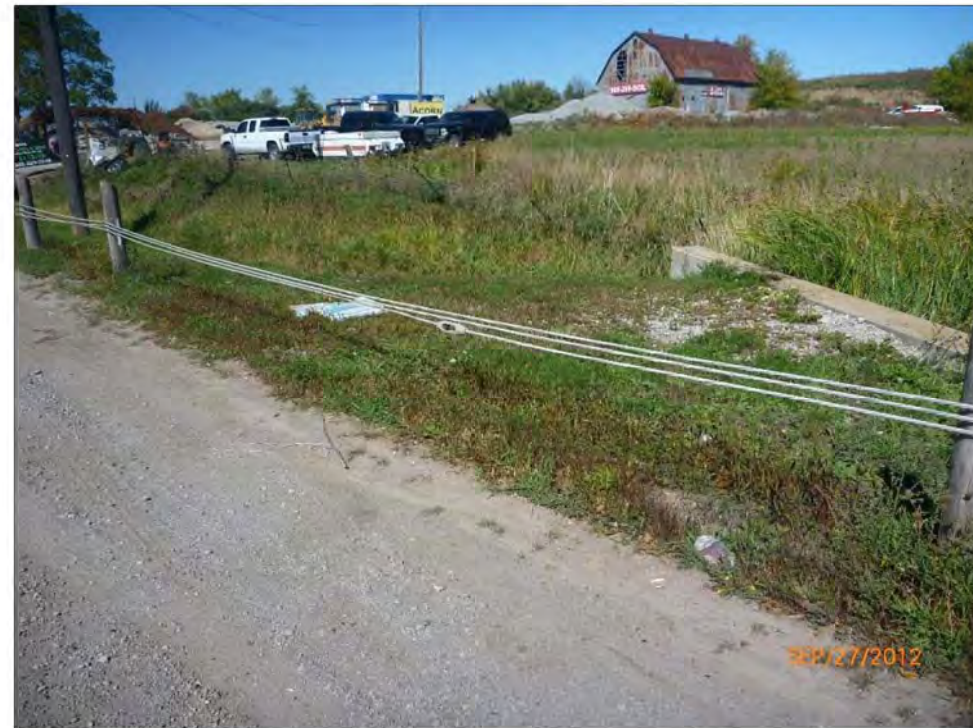
Missing Cable Guiderail Post on East Side of Structure

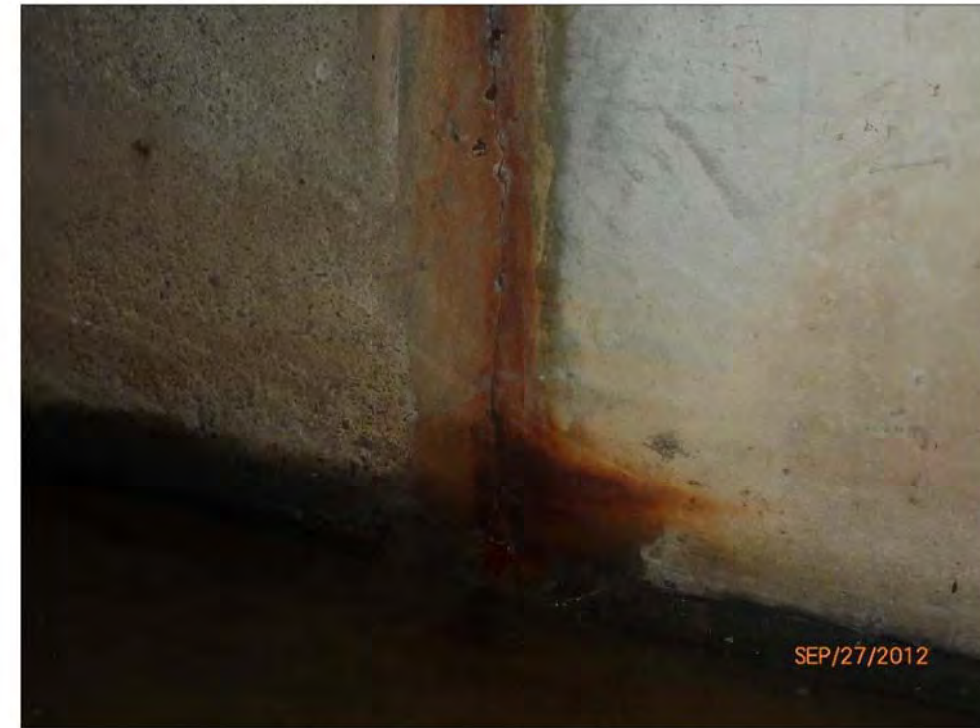
Efflorescence Staining on Barrel Wall

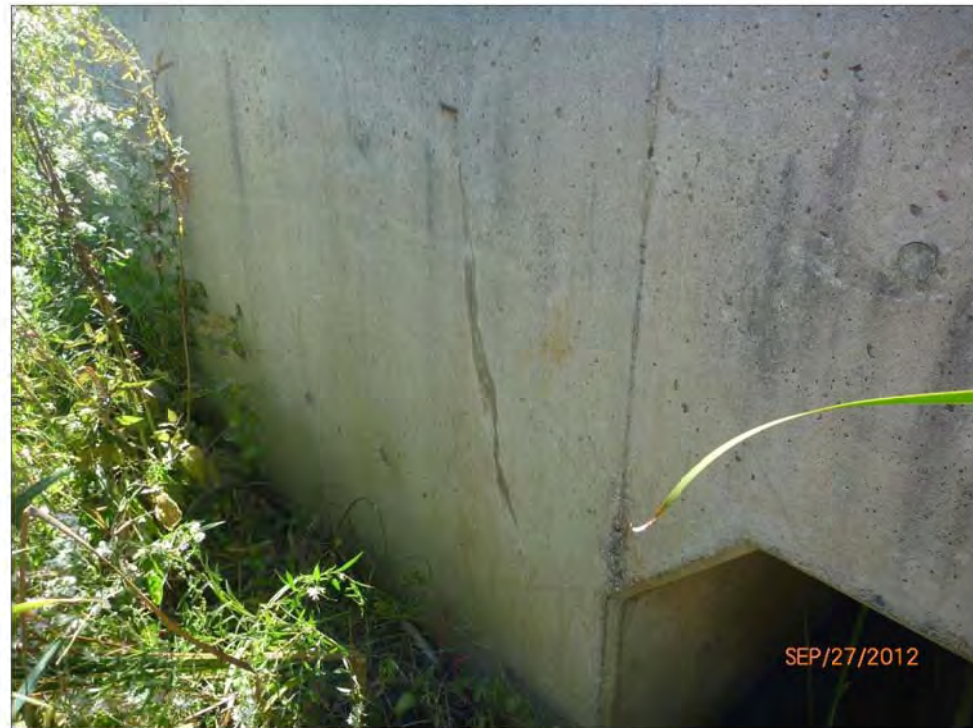
Stained Crack on Outlet Wingwall
