To: MMM Design Team Date: May 19th, 2016
 From: MMM Structural Department Job No.: 3214006
 Subject: Trafalgar Road Improvement Study - Structural Site Visit

STRUCTURE IDENTIFICATION SHEET

As part of the Class EA, a reinforced concrete rigid frame bridge (1183230 BR01) was visually inspected in accordance with the *Ontario Structure Inspection Manual, 2008* (OSIM). The following is a summary of the findings from the field investigation completed by MMM on November 5th, 2015.

There are two concrete structural box culverts in the project study area. As part of the Class EA, a reinforced concrete box culvert (1182960 CU01) and a twin cell reinforced concrete box culvert (1182960 BR01) were visually inspected in accordance with the *Ontario Structure Inspection Manual, 2008* (OSIM). The following is a summary of the findings from the field investigation completed by MMM on November 5th, 2015.

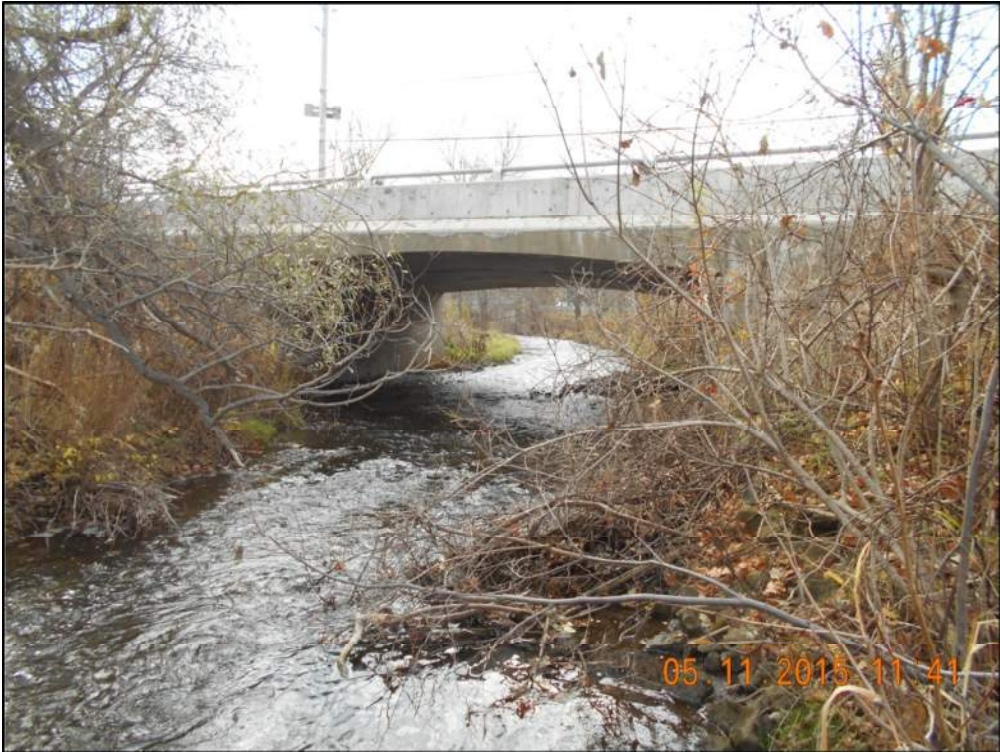
Photo 1: East elevation

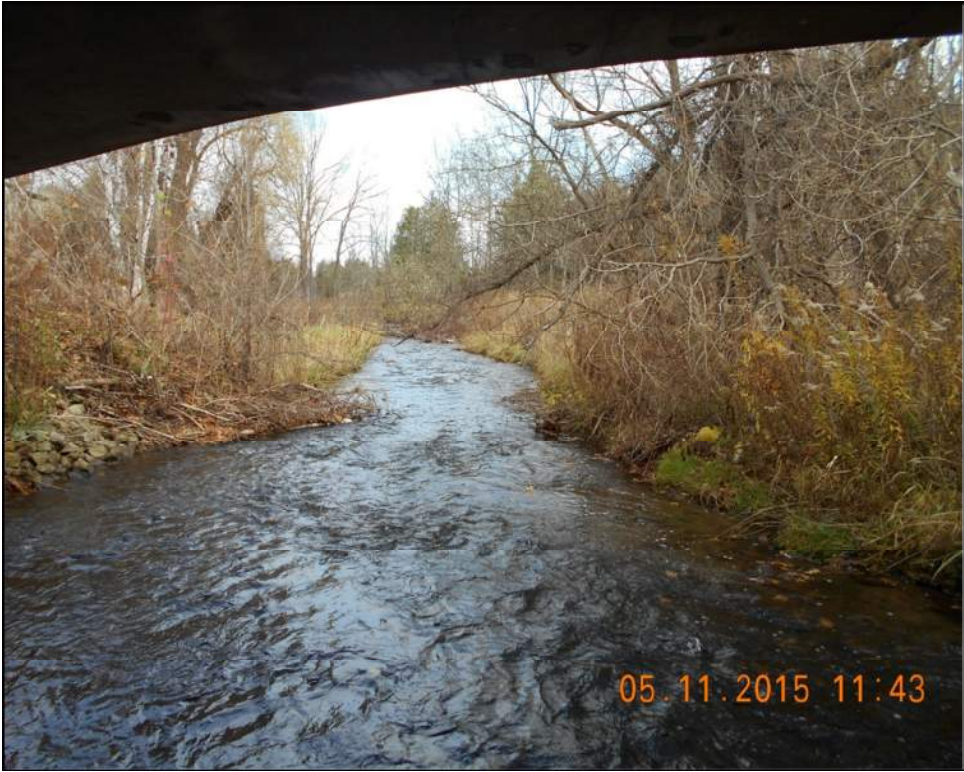
Photo 2: Downstream (west)

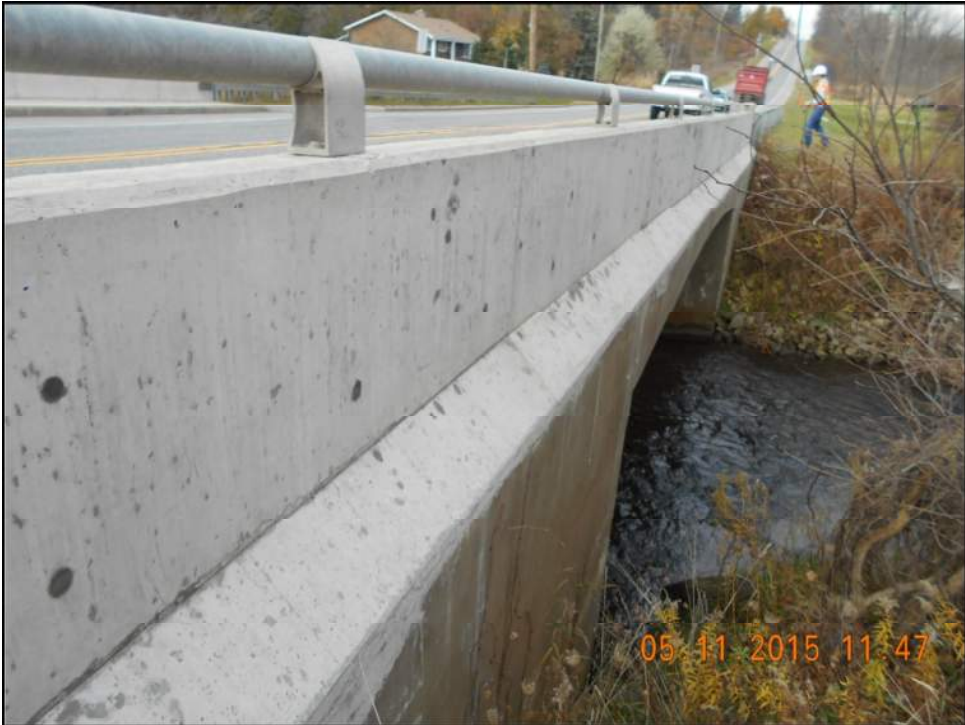
Photo 3: East fascia

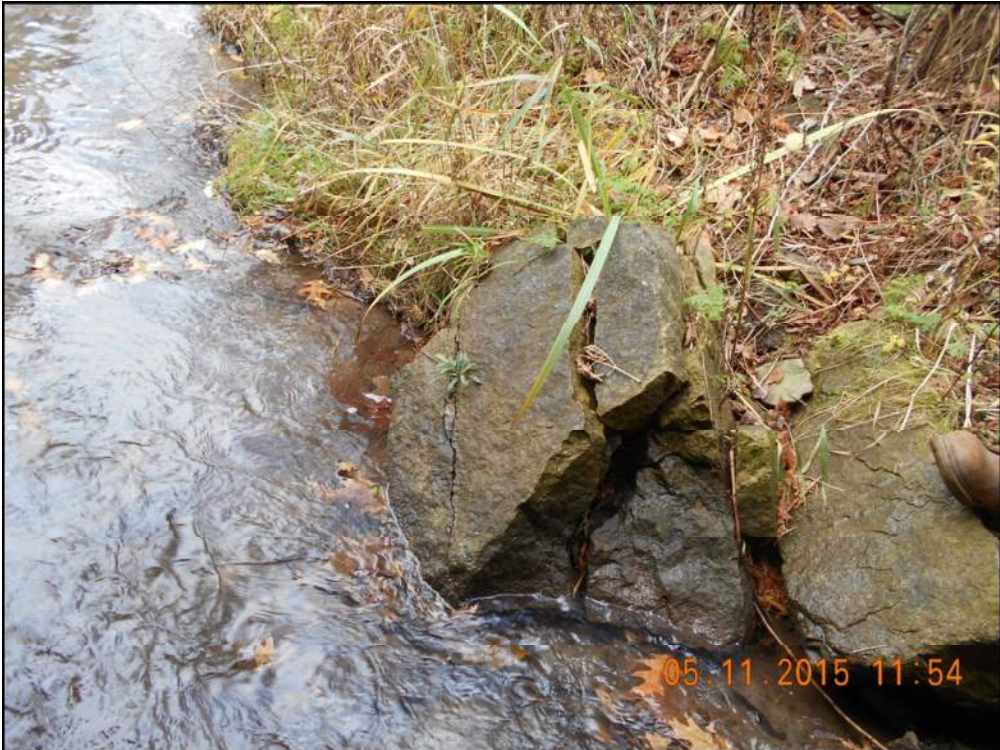
Photo 4: Southeast embankment

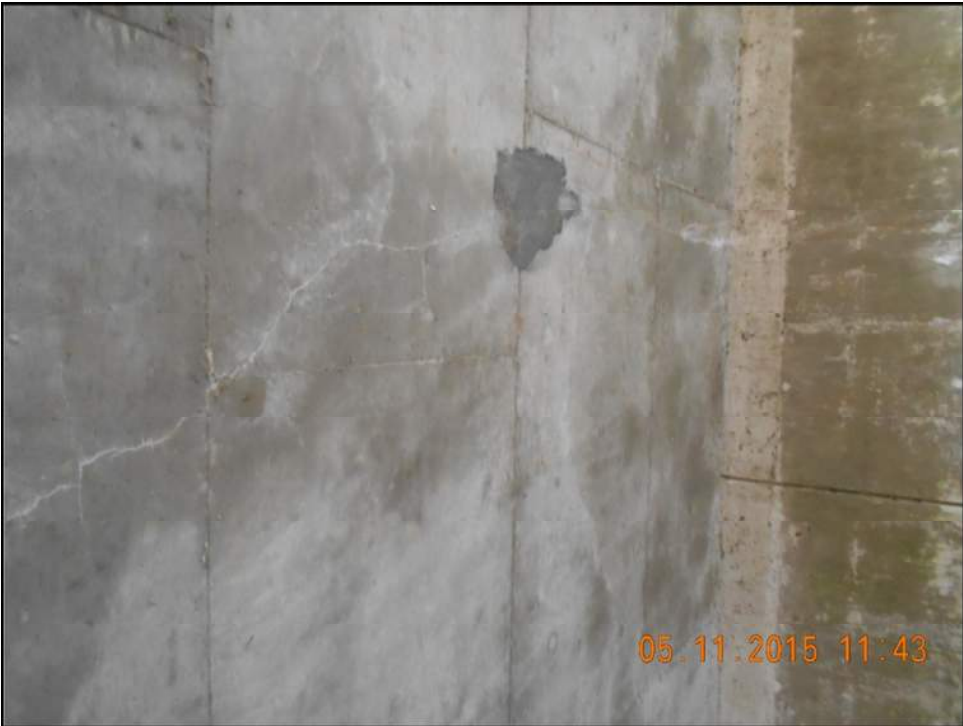
The soffit is generally in good condition with local patches and stained cracks (see Photo 5).

Photo 5: Soffit local patch repairs

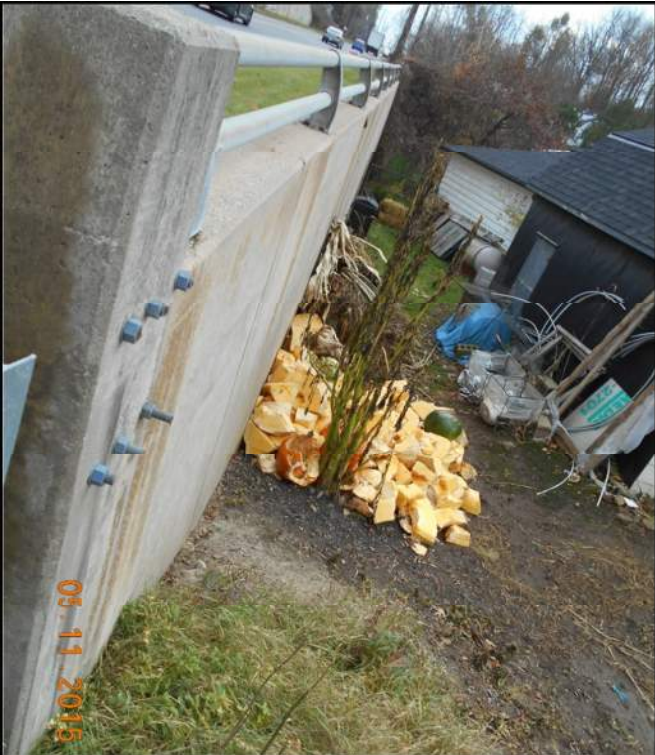
Photo 6: Retaining wall to the southwest

It is anticipated that the proposed widening will require acquisition of property east and west of the current road right-of-way. In addition, the concrete retaining walls to the southeast and southwest of the structure will both need to be relocated.

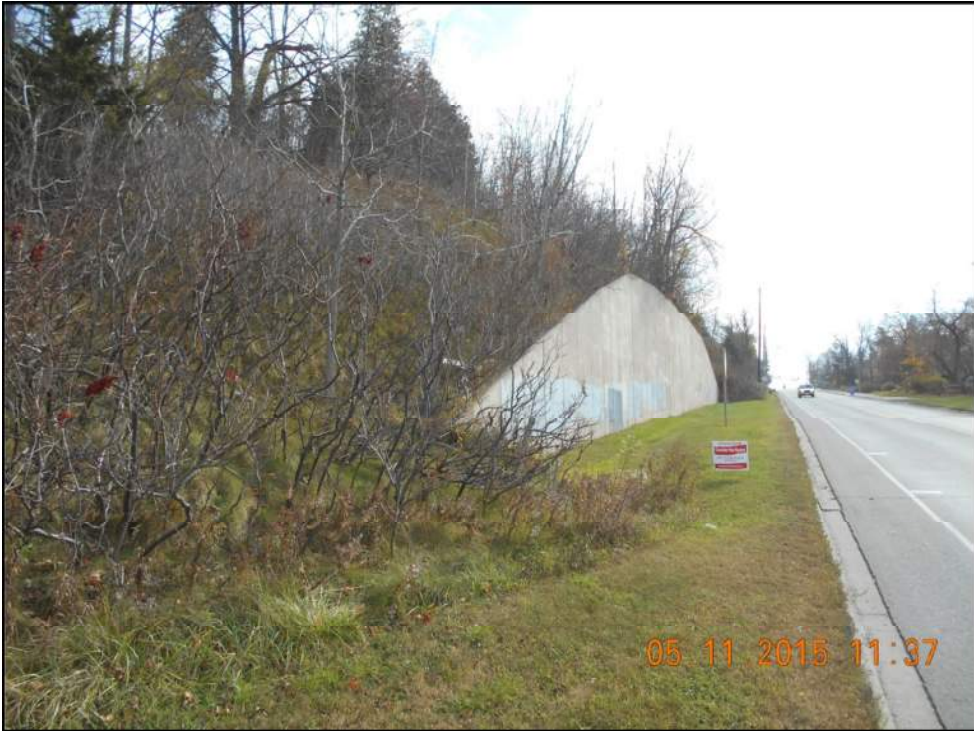
Photo 7: Retaining wall to the southeast

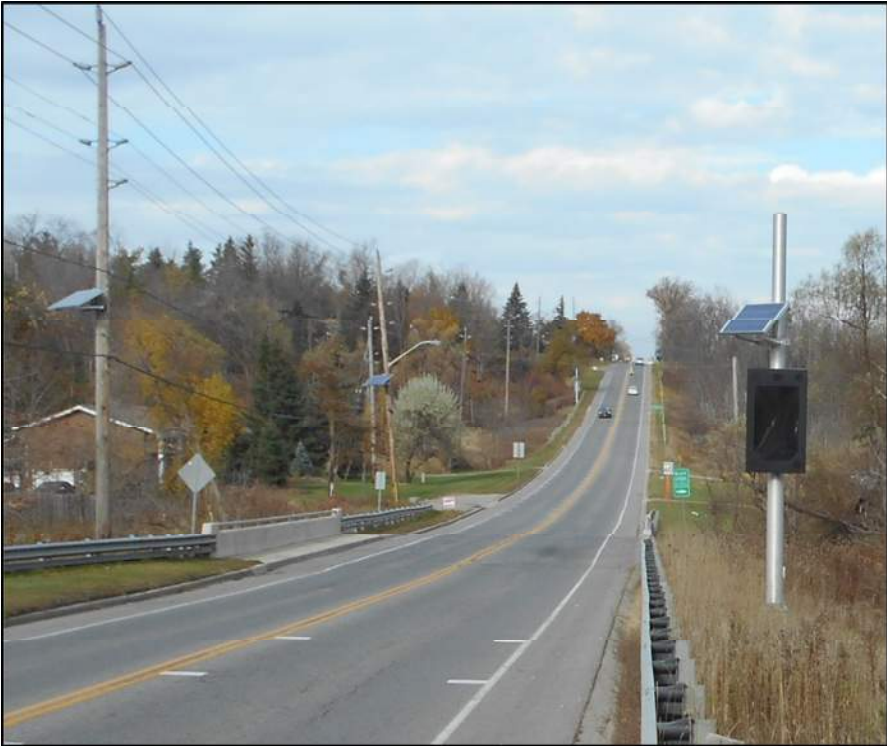
Photo 8: Looking north over structure

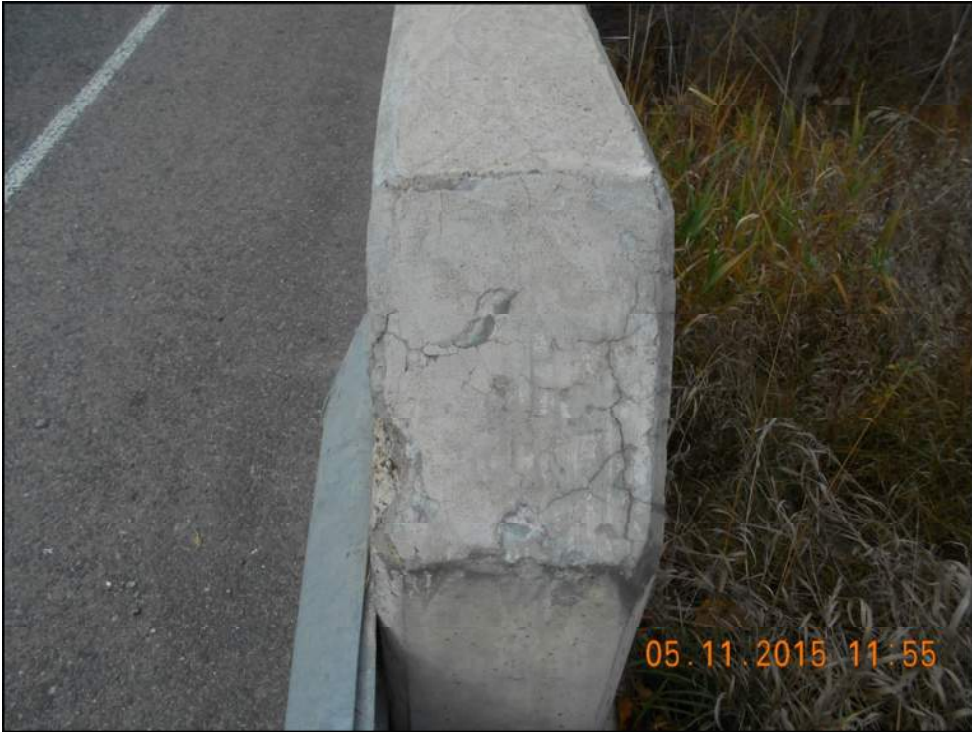
The barrier wall appears to have been replaced during the previous rehabilitation (2012) and appears in good condition. Narrow cracks and a local spall were observed at the southeast limit of the barrier wall (see Photo 9).

Photo 9: Southeast Delaminated Barrier

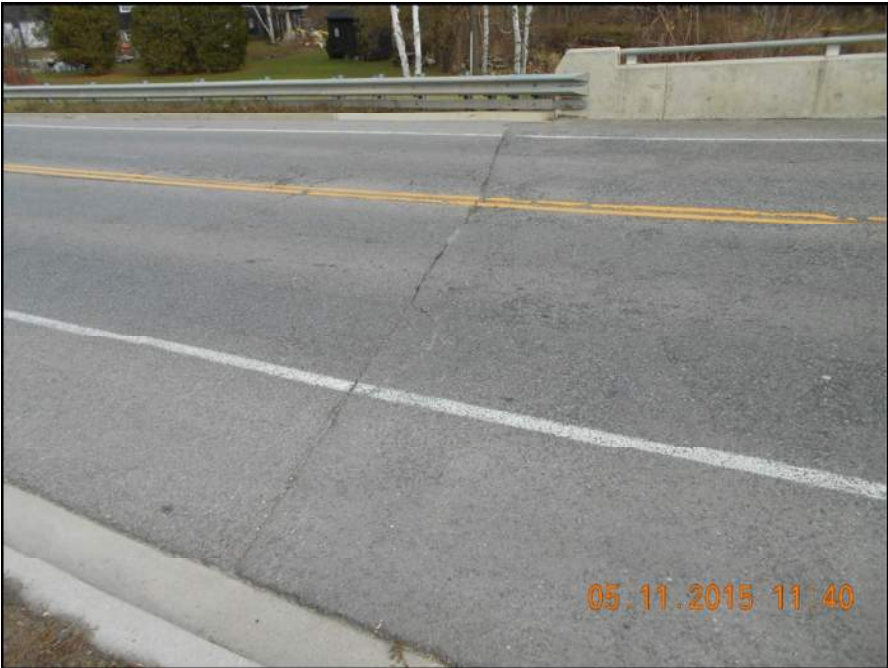
The wearing surface is in good condition with medium unsealed transverse cracks at the ends of the approach slabs (see Photo 10).

Photo 10: Unsealed Crack at North Approach (typical)

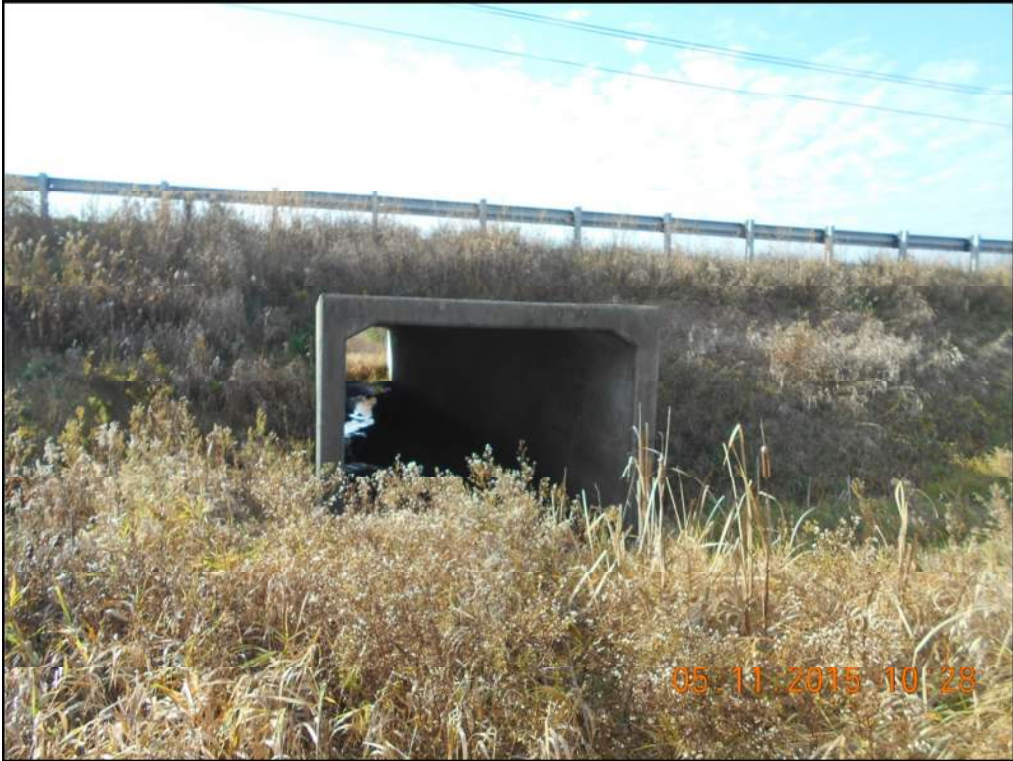
The watercourse flows from east to west and is heavily vegetated at the inlet and outlet (see Photos 1 and 2). Low flows were observed at the time of inspection.

The embankments at all four quadrants of the culvert appear stable and are well vegetated (see Photos 1 and 2).

Photo 1: East elevation

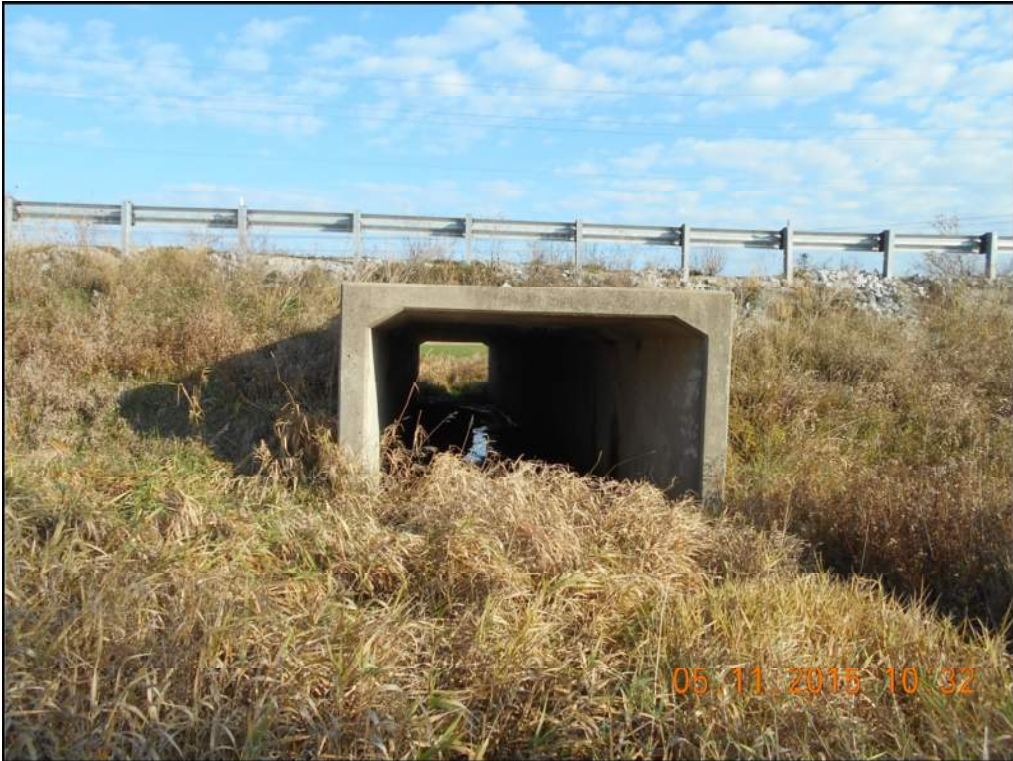
Photo 2: West elevation

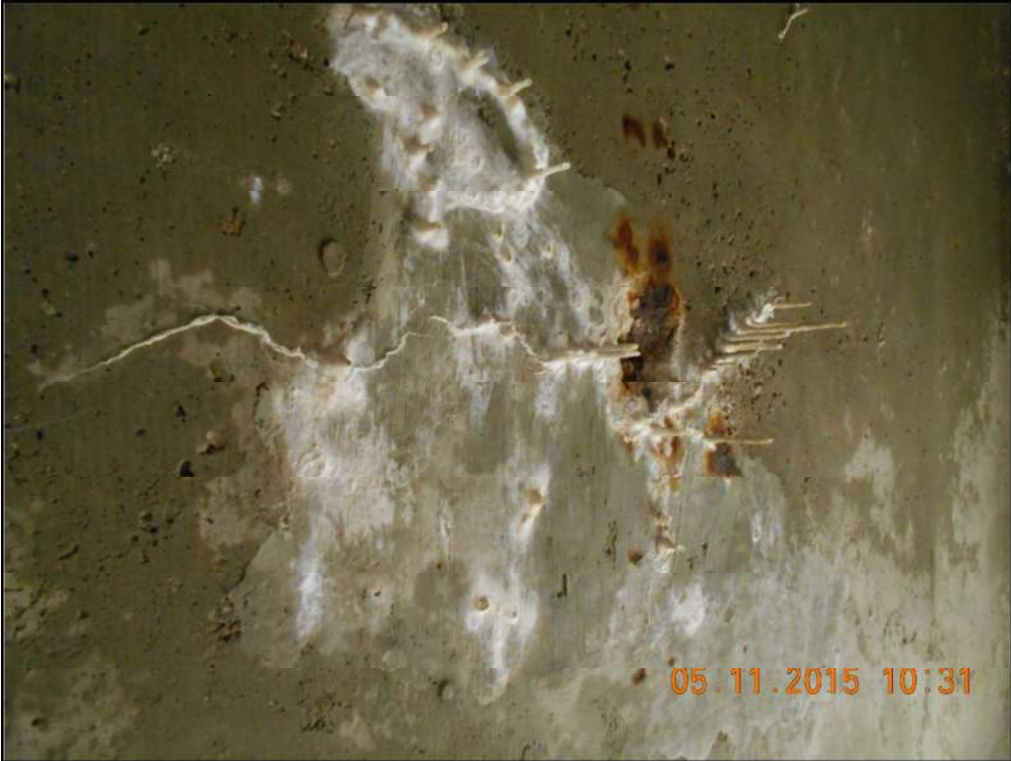
The existing box culvert is generally in good condition, with some wet cracks and efflorescence on the soffit and barrel walls (see Photos 3 and 4).

Photo 3: Efflorescence and wet staining

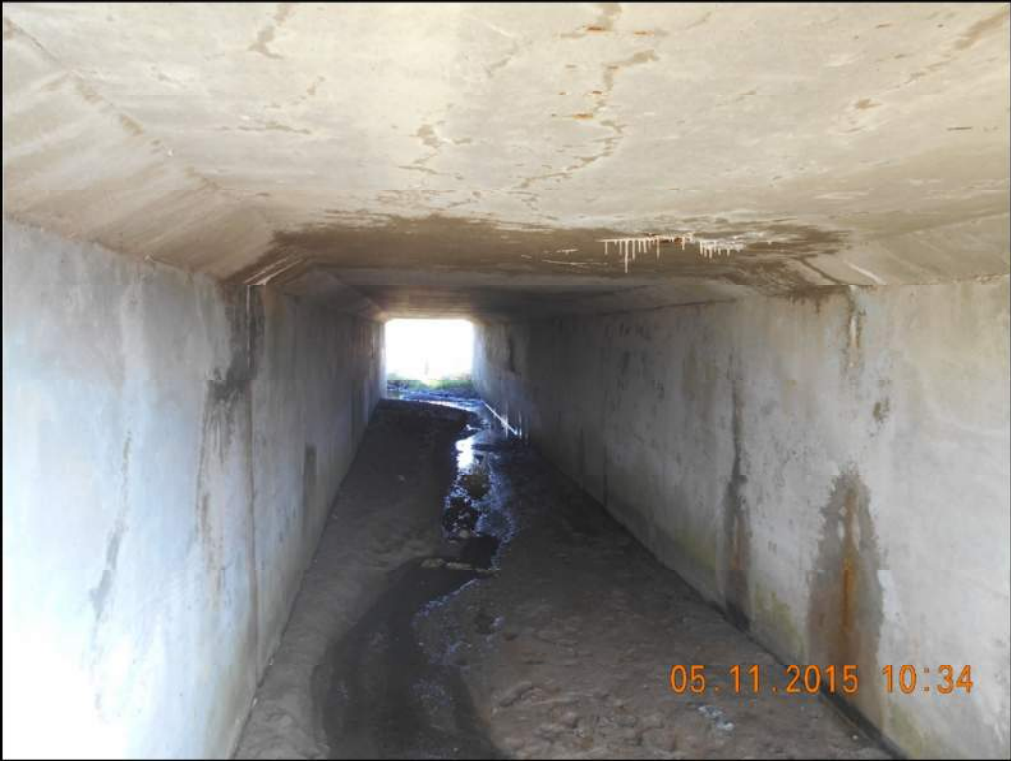
Photo 4: Wet staining along barrel

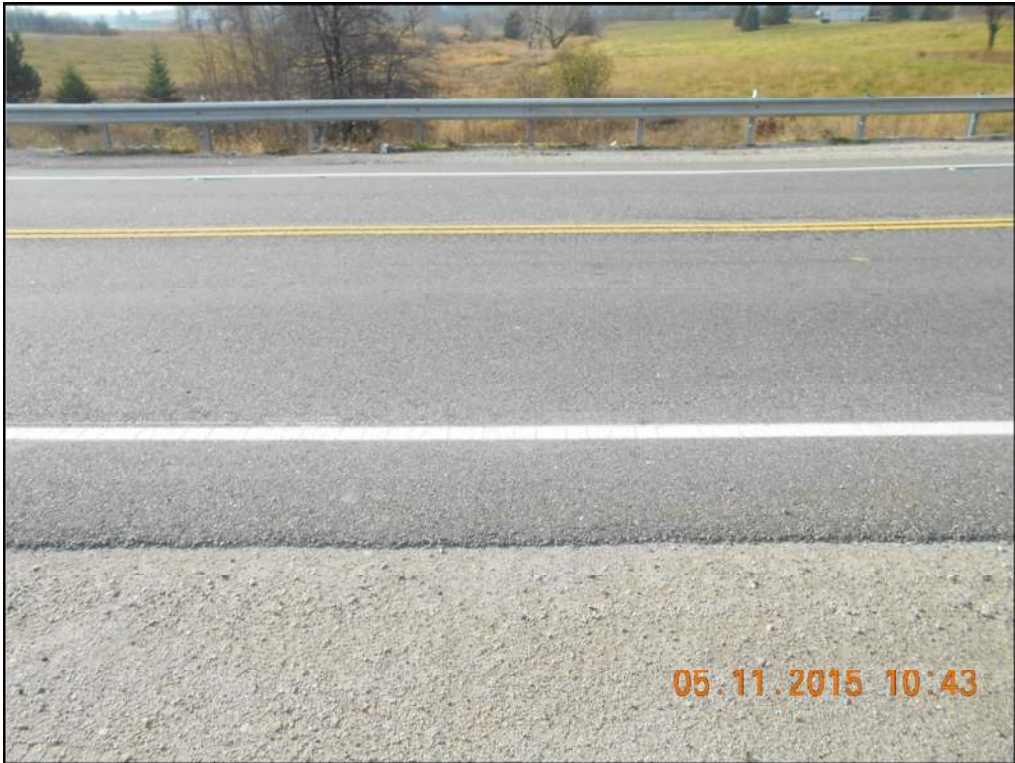
The asphalt pavement approaches are in good condition (see Photos 5 and 6).

The steel beam guide railing is in good condition (see Photos 5 and 6).

Photo 5: Wearing Surface (typical)

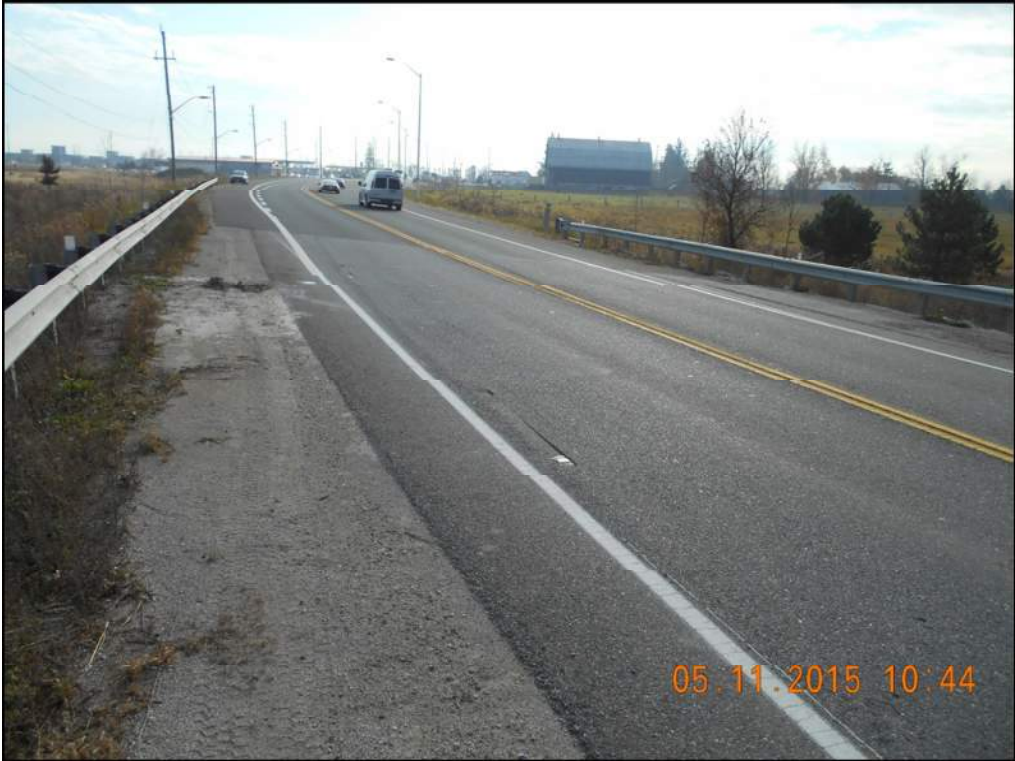
Photo 6: Approach Roadway above Culvert

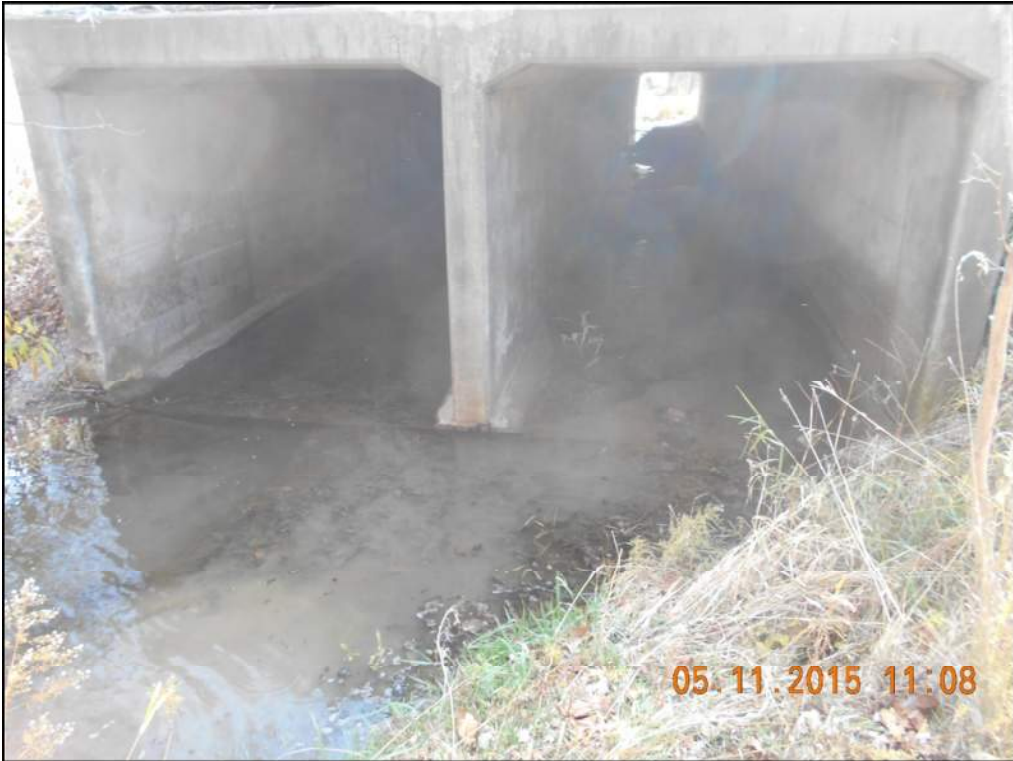
Photo 7: East elevation

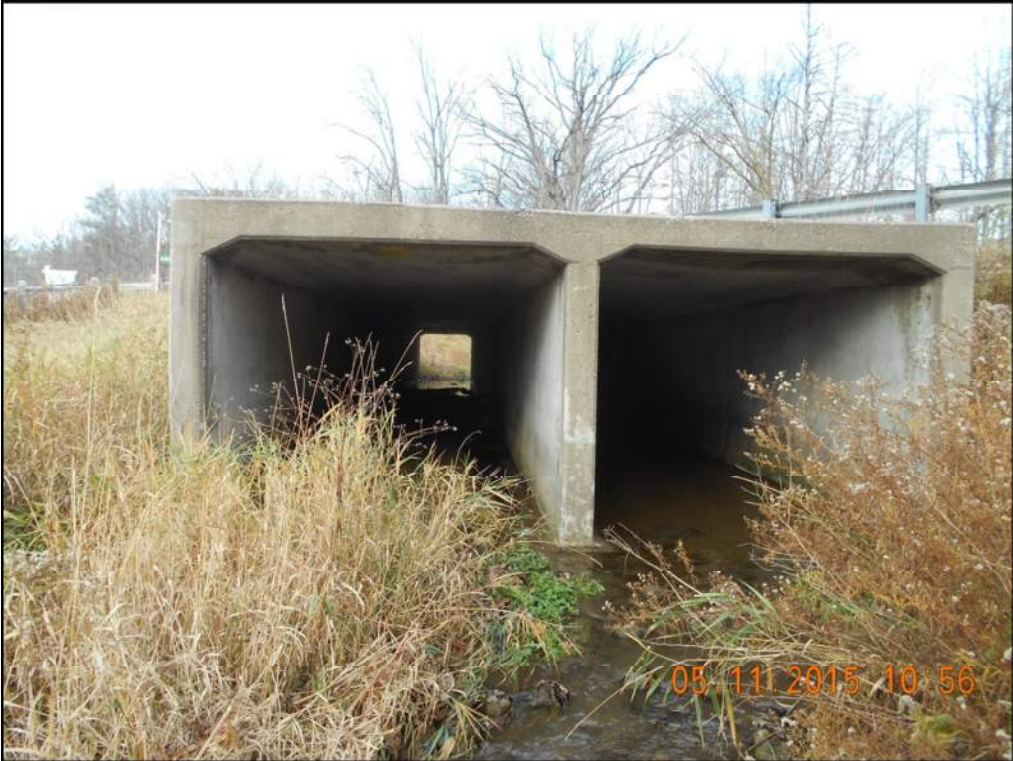
Photo 8: West elevation

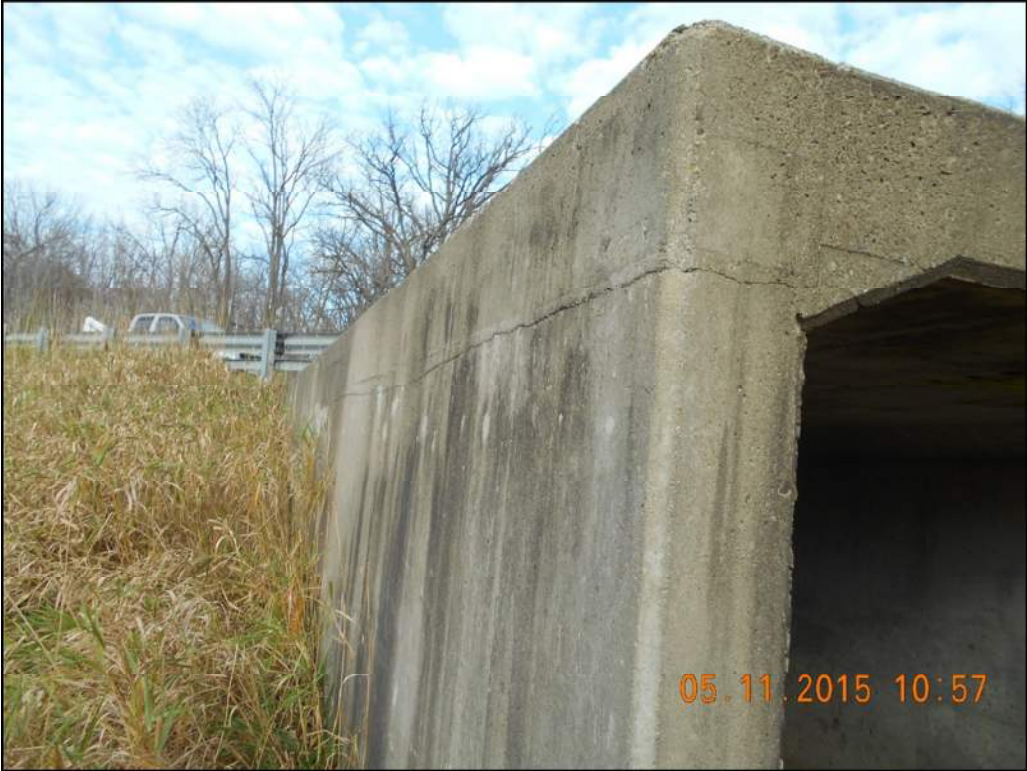
Longitudinal full depth cracks were noted along the top of the exterior and centre wall (likely a construction joint). This is not anticipated to impact the function of the structure (see Photo 9).

Photo 9: Full depth crack at top of wall (full exposed length)

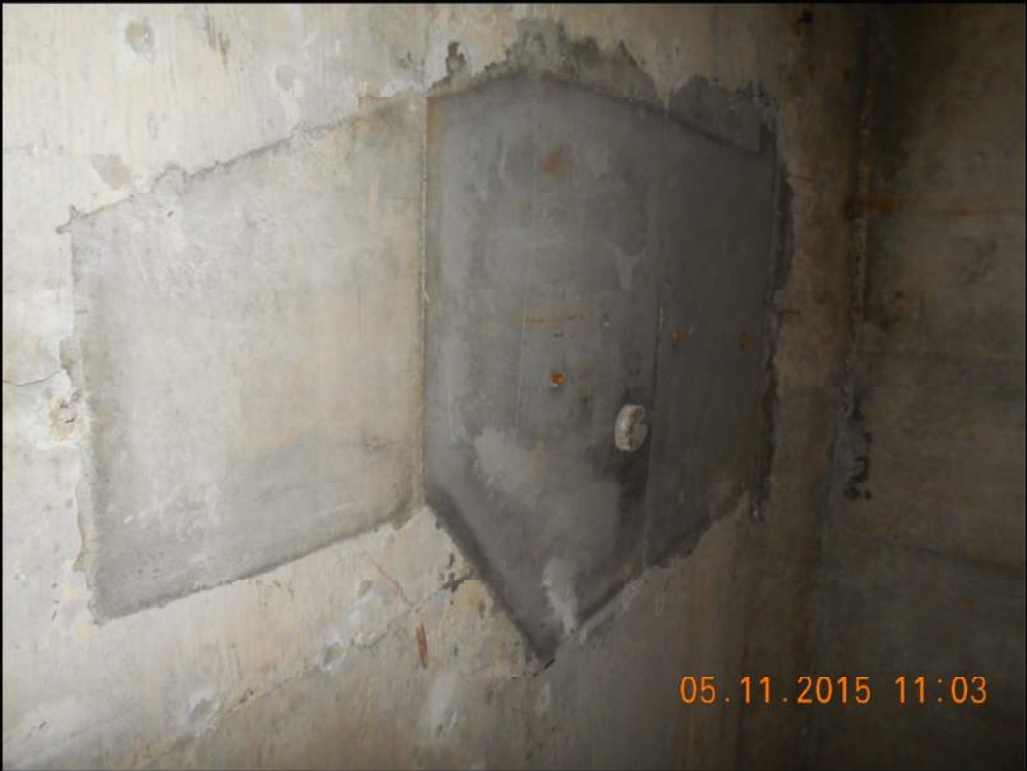
Photo 10: Soffit patch repairs (typical)

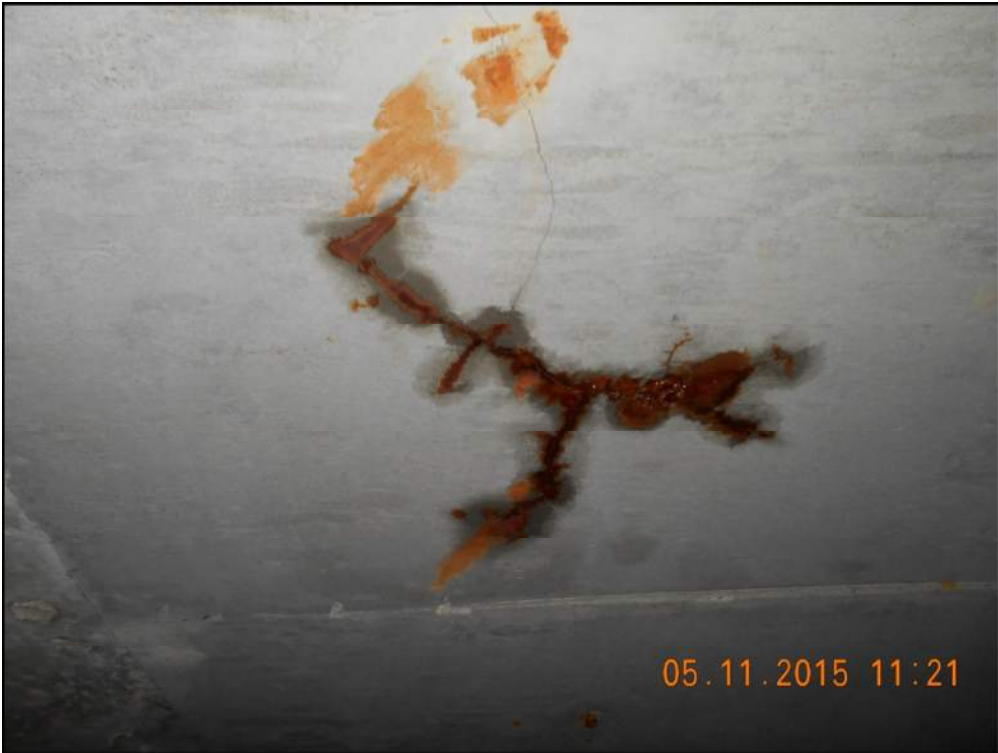
The existing twin cell box culvert is generally in good condition, with some wet cracks and efflorescence on the soffit and barrel walls. A recent rehabilitation including chip and patch repairs to the soffit was completed in 2014; however, a crack and rust staining was noted in a delaminated concrete patch. Failed patches should be removed and replaced. In addition, approximately 3 m from the east end of the south span, a partially repaired area (with saw cut only) should be chipped, scaled and patched (see Photos 11 and 14).

Photo 11: Crack and staining in patch repair (delaminated)

- removal of all delaminated and deteriorated concrete (including previous patches); and,
- local patch repairs and place additional steel reinforcement in areas when existing reinforcement is deteriorated.

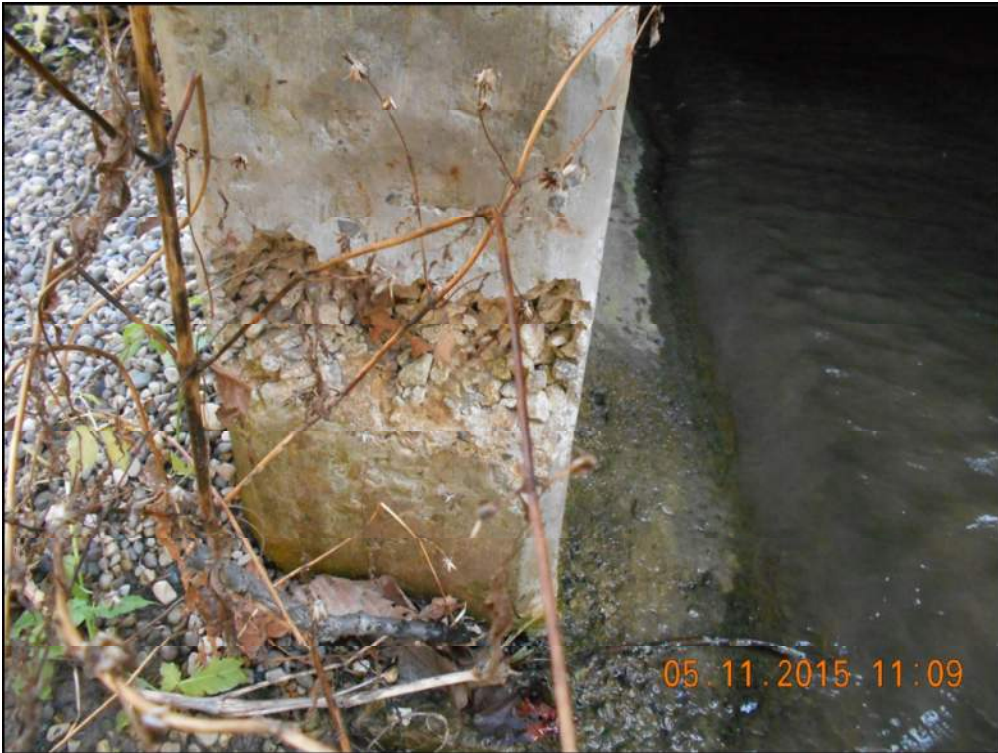
A local spall on the fascia and scour/undermining were present at the upstream (east) end of the culvert (see Photos 12 and 13). Should the culvert be extended, these deteriorations will be removed as part of the extension.

Photo 12: Spall in southeast wall face

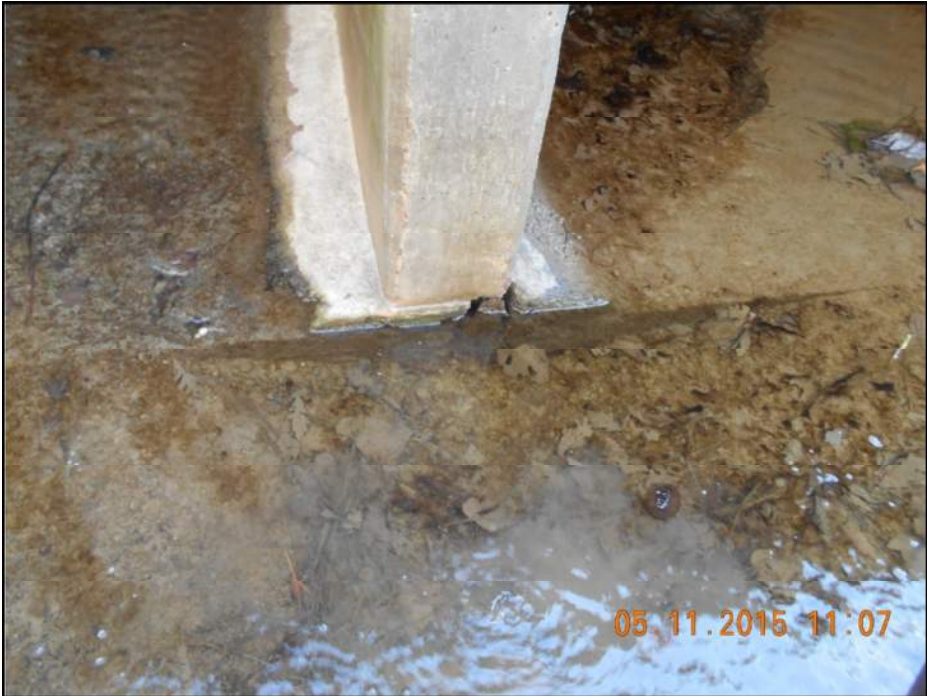
Photo 13: East end minor scour

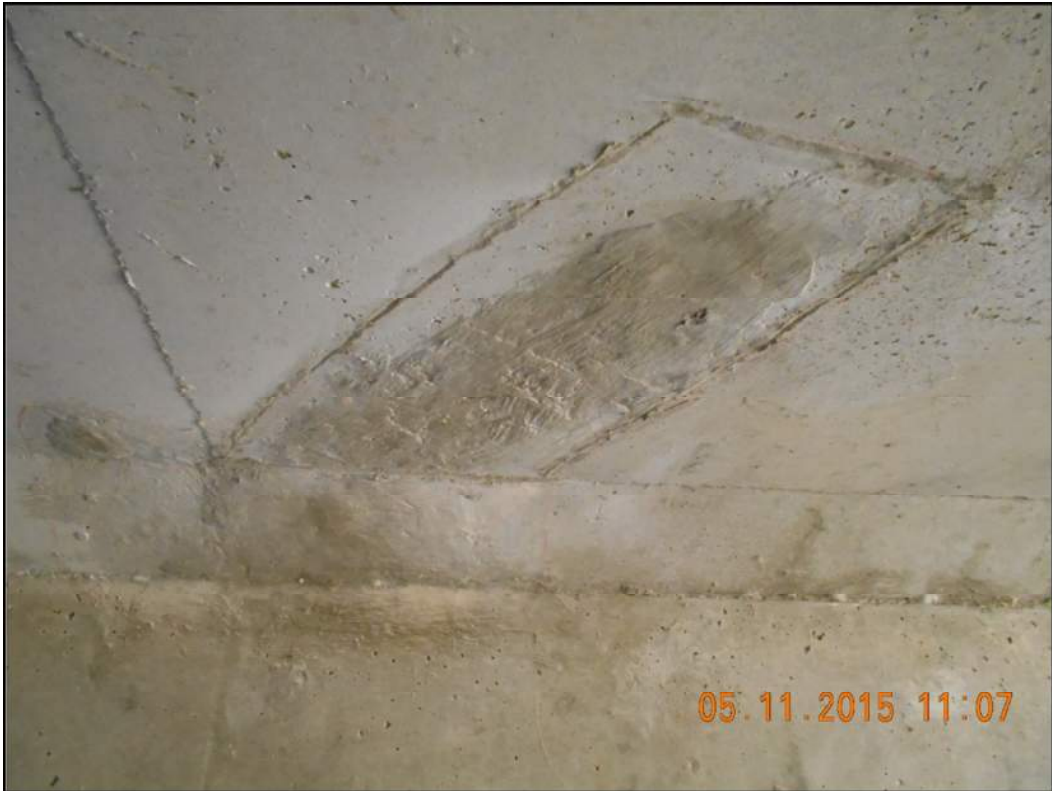
Photo 14: Saw cut in soffit not patched

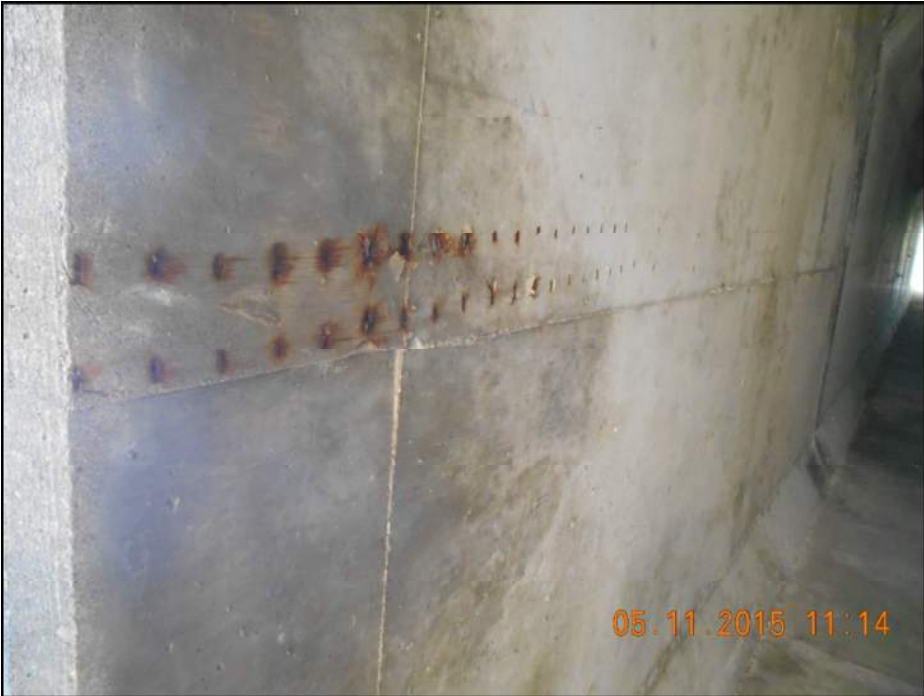
Photo 15: Rust Staining on Soffit

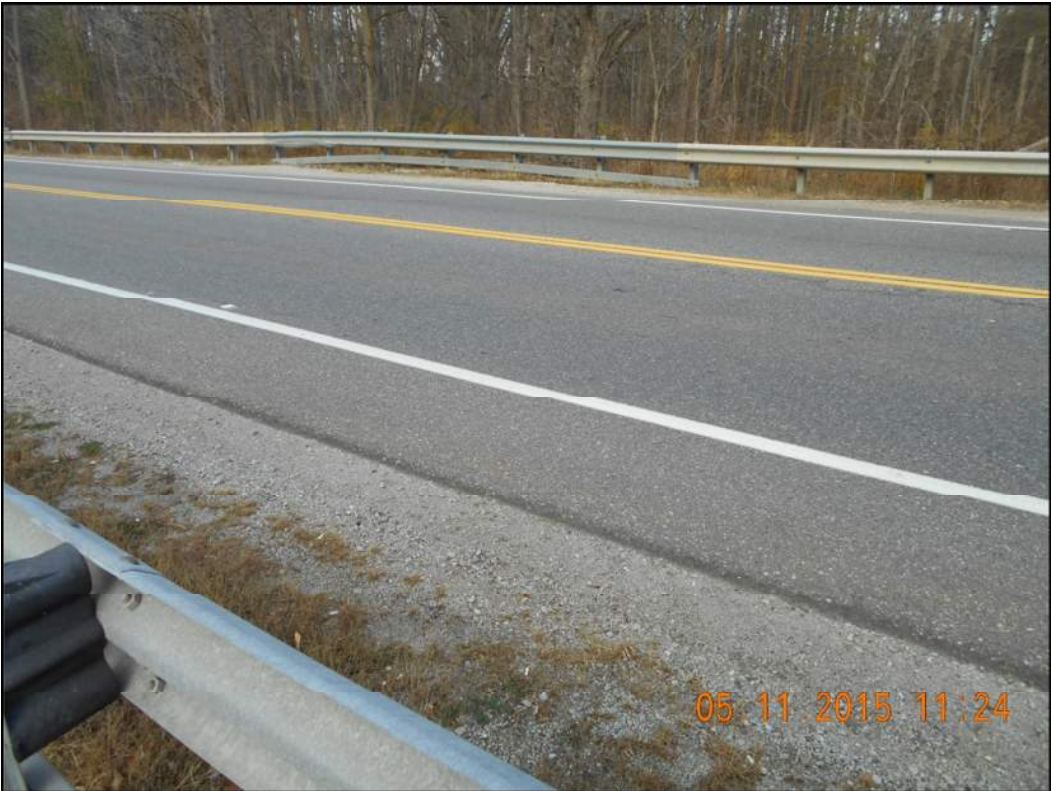
Photo 16: Asphalt Wearing Surface above Culvert

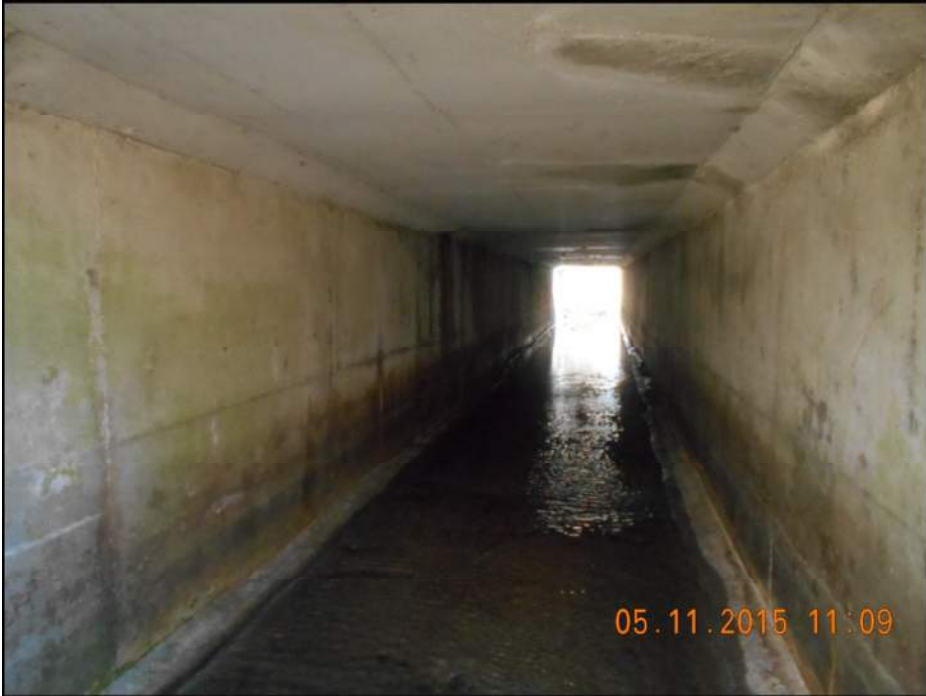
The watercourse flows from east to west and is generally free of obstruction. During the field investigation, the majority of the flow was passing through the south cell while the north cell has a higher invert elevation due to sediment accumulation (see Photos 17 and 18).

Photo 17: South Box Watercourse

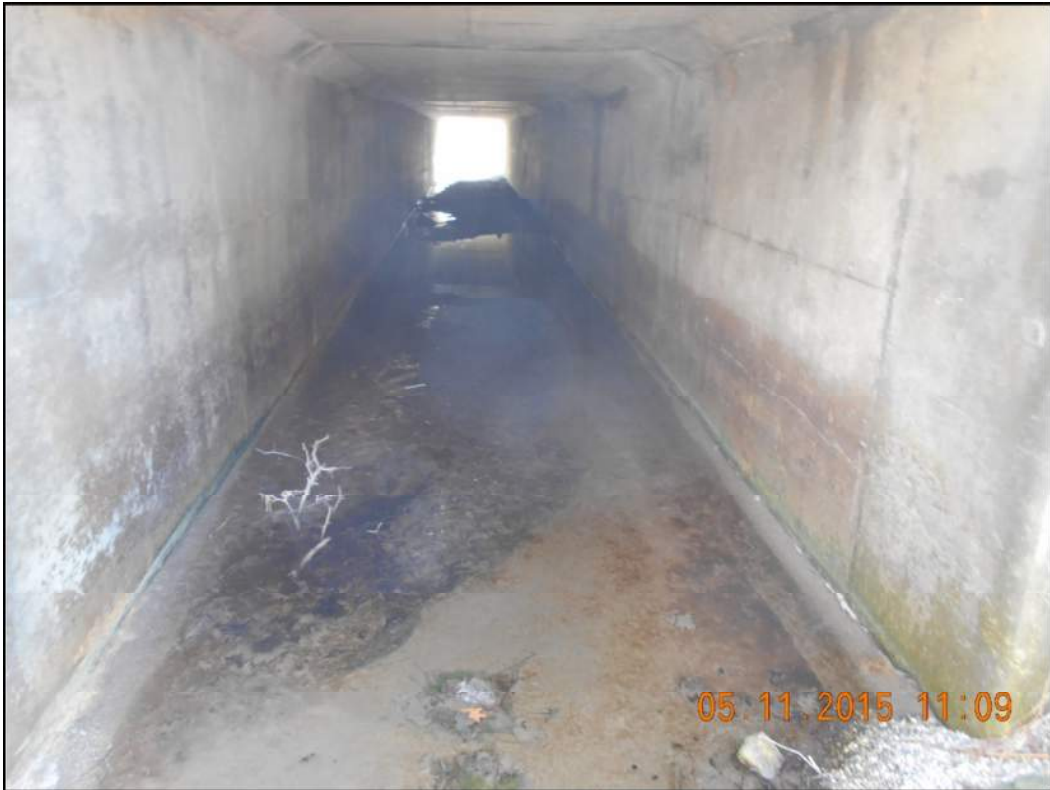
Photo 18: North Box Watercourse

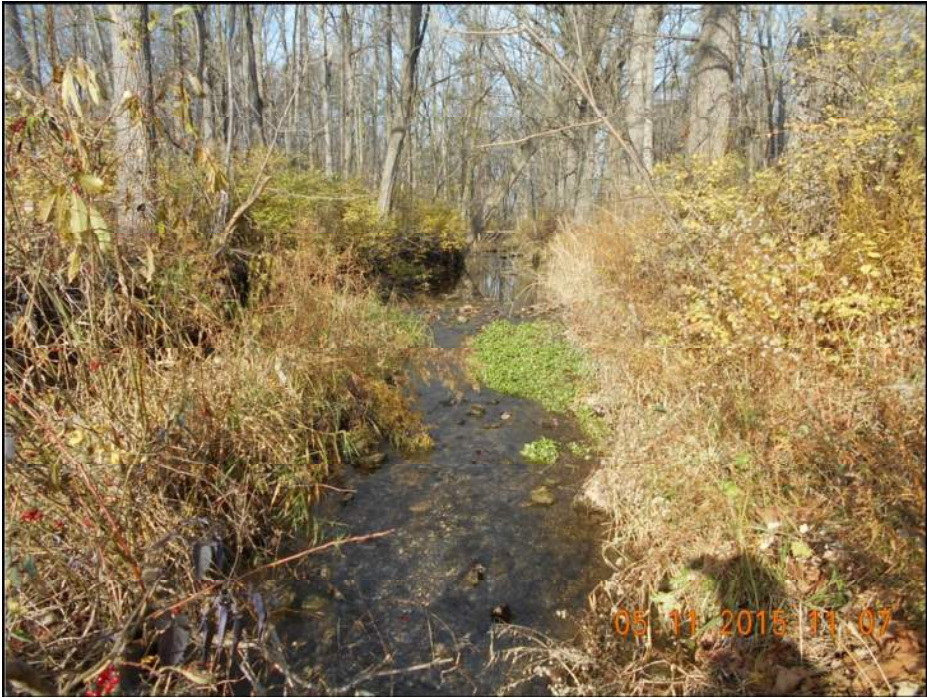
Photo 19: Upstream of Culvert

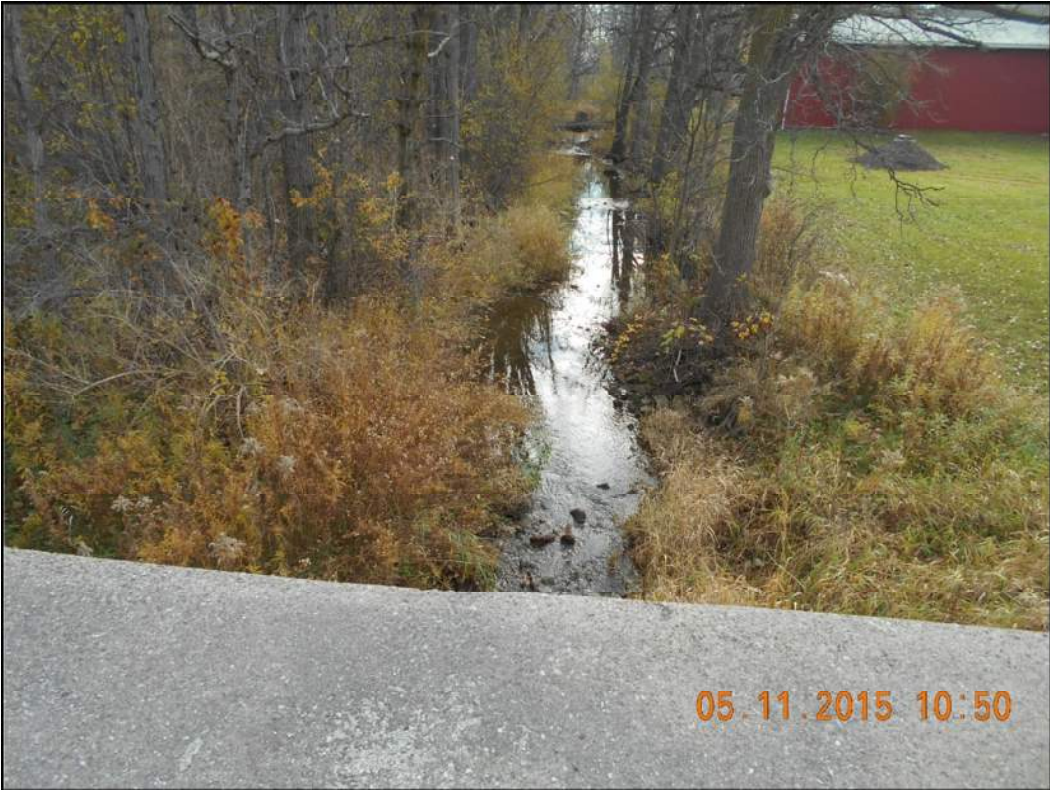
Photo 20: Downstream of Culvert
