North Milton Business Park Town of Milton, Ontario

Fluvial Geomorphological Assessment and Natural Channel Design

April 18, 2021
GEO Morphix Project No. PN21059

Report Title: North Milton Business Park, Town of Milton, Ontario –
Fluvial Geomorphological Assessment and Natural
Channel Design

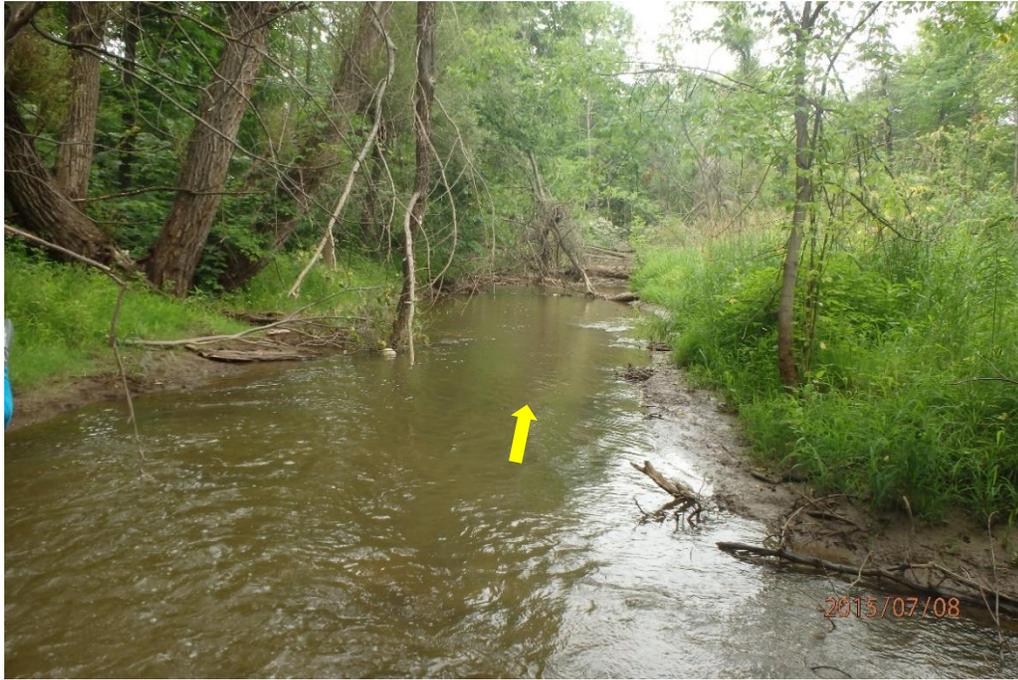
Photo 1
Reach **SM1**: Sixteen Mile Creek, northeastern corner of subject property, Milton

Riparian vegetation consisted mainly of trees and grasses. Yellow arrow indicates flow direction.

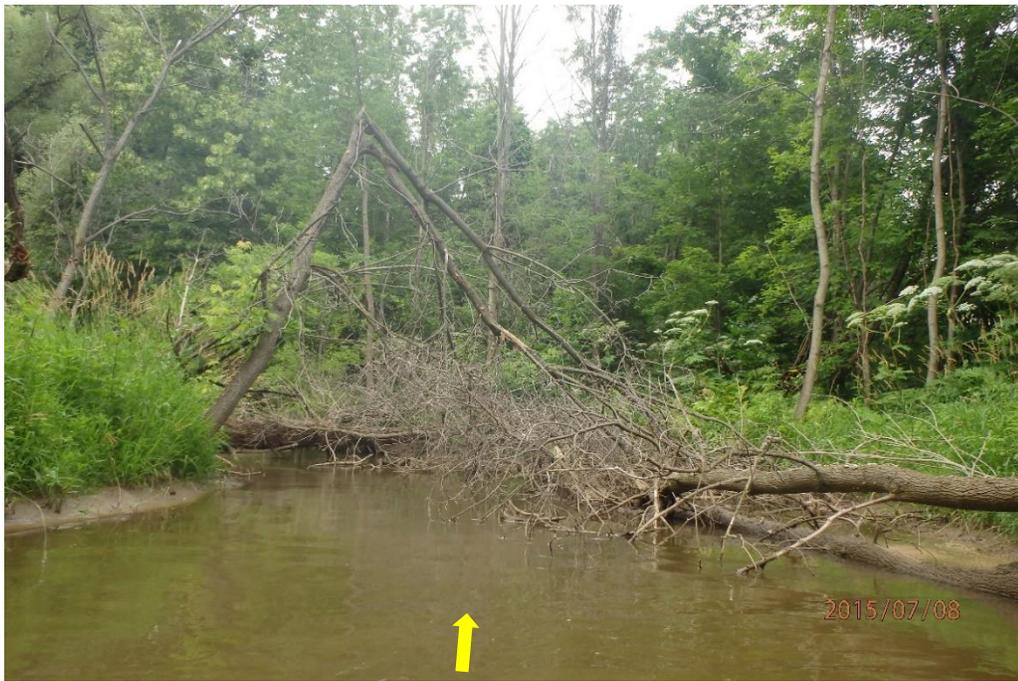
Photo 2
Reach **SM1**: Sixteen Mile Creek, northeastern corner of subject property, Milton

Woody debris jams were common throughout the reach.

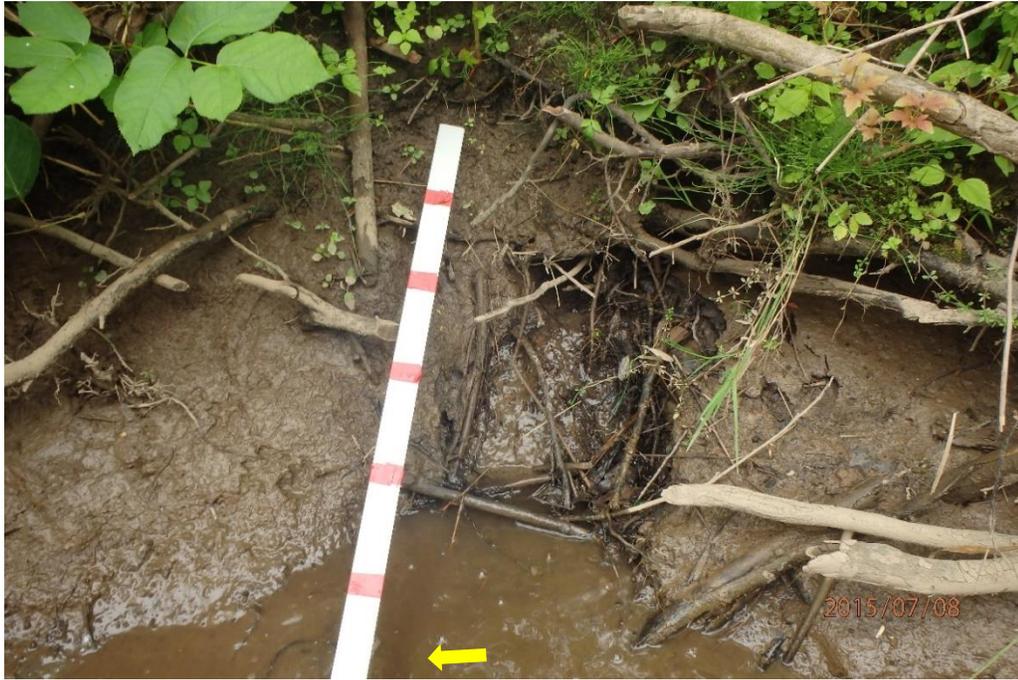
Photo 3
Reach **SM1**: Sixteen Mile Creek, northeastern corner of subject property, Milton

Photograph taken of the right (west) bank. Groundwater seepage was observed in a few locations along the banks.

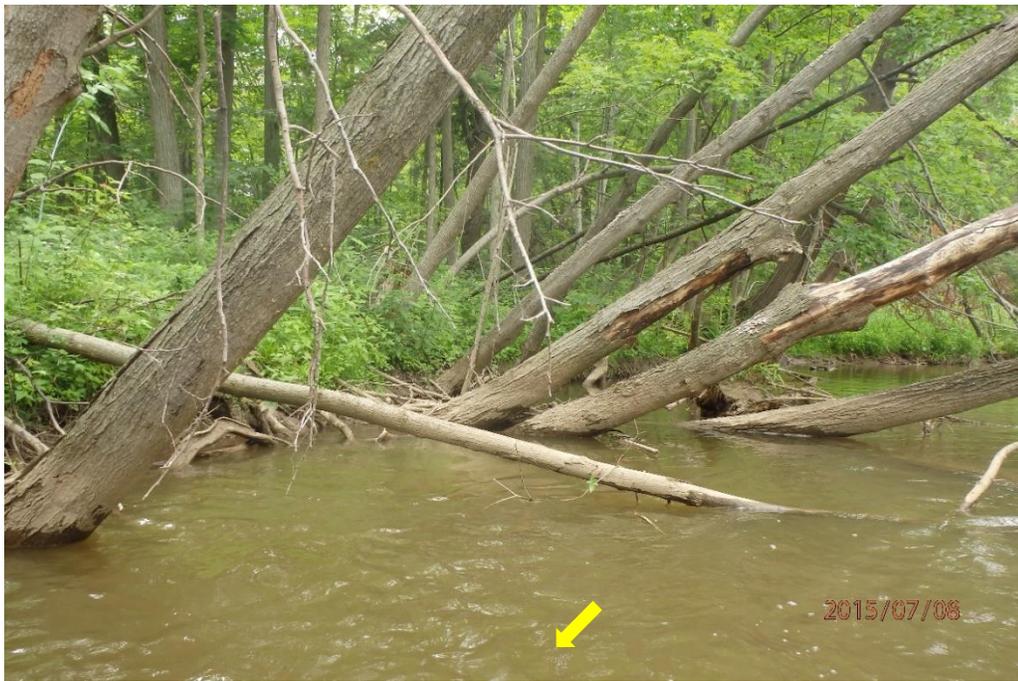
Photo 4
Reach **SM1**: Sixteen Mile Creek, northeastern corner of subject property, Milton

Photograph showing mature, leaning trees. This is evidence for channel widening.

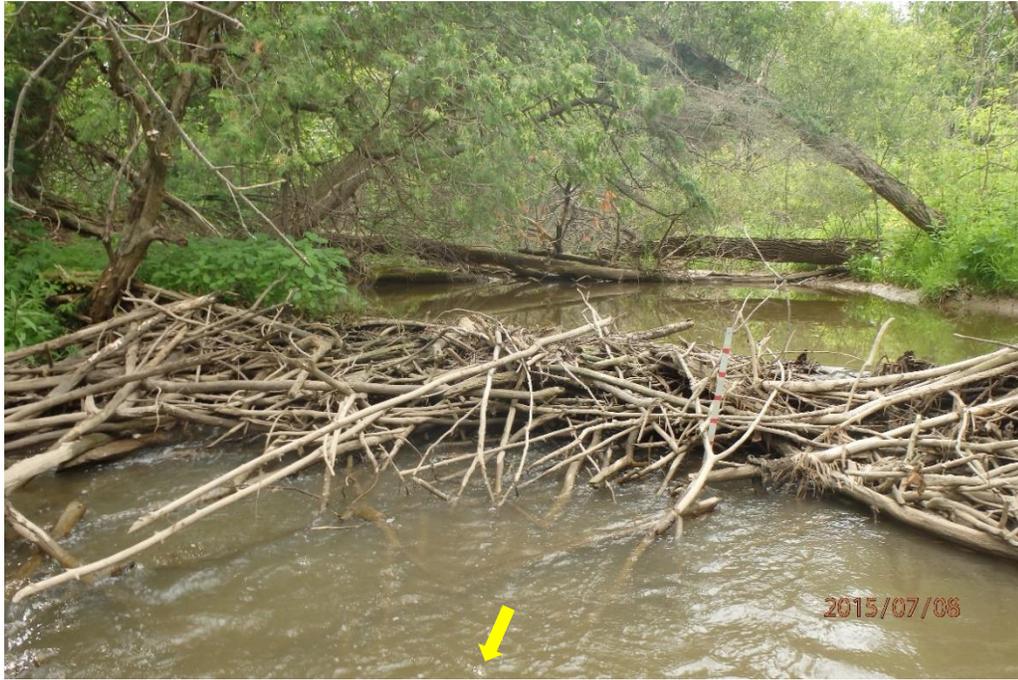
Reach **SM1**: Sixteen Mile Creek, northeastern corner of subject property, Milton

Photograph of a beaver dam. Water behind the dam was approximately 0.40 m deep.

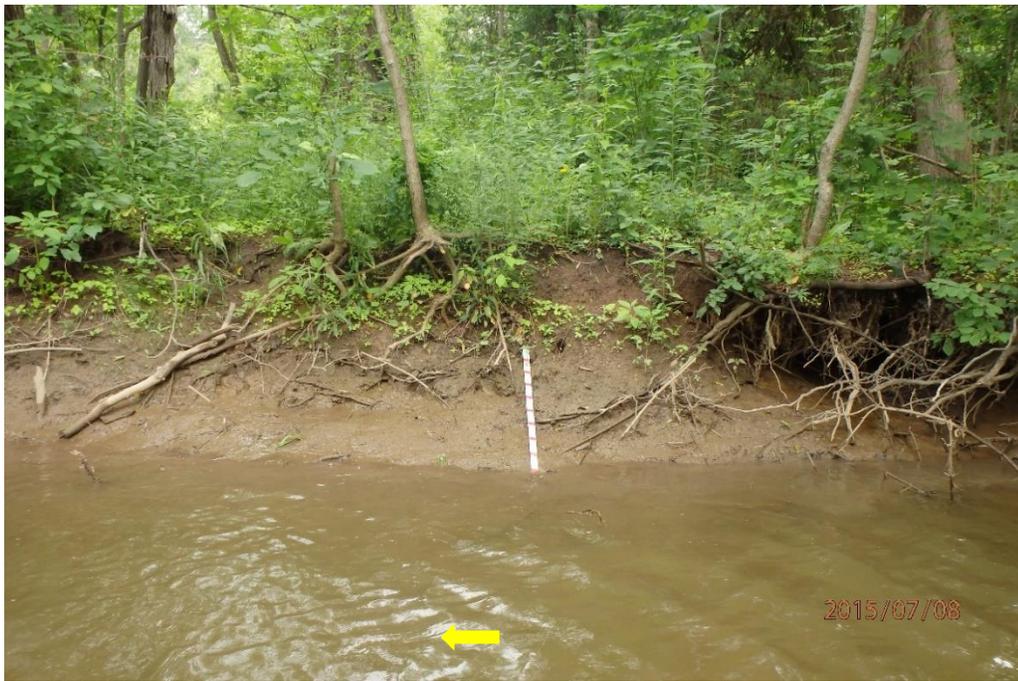
Reach **SM1**: Sixteen Mile Creek, northeastern corner of subject property, Milton

Photograph of the right bank (southwest) displaying wide undercutting and exposed roots. Measured undercuts ranged from 0.26 to 1.25 m.

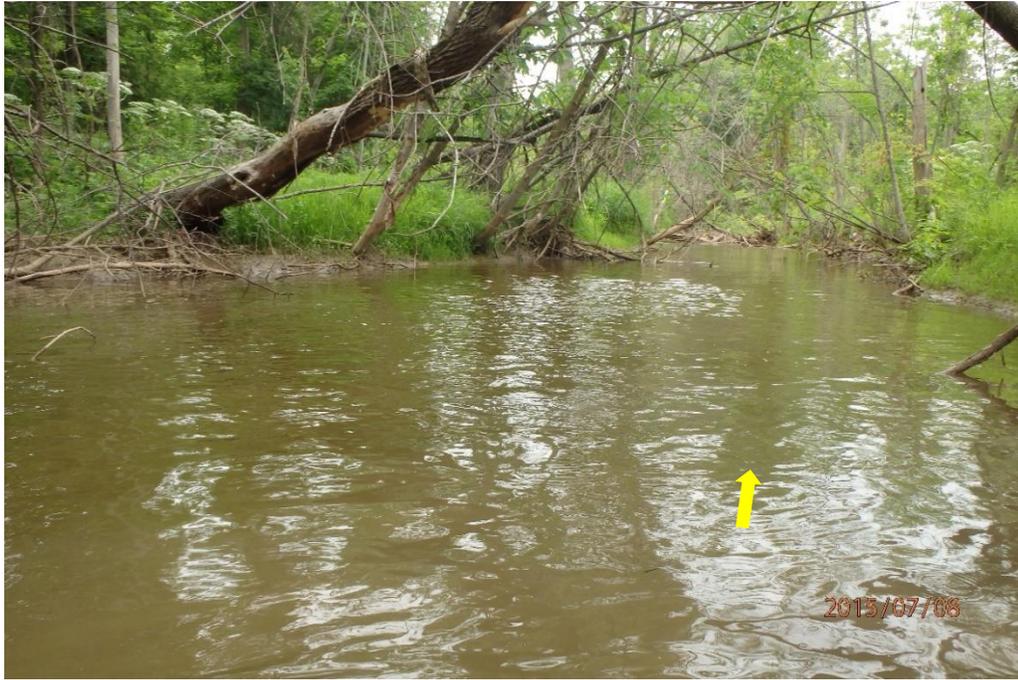
Reach **SM1**: Sixteen Mile Creek, northeastern corner of subject property, Milton

Photograph of the deepest pool observed. Pools and runs made up the majority of the geomorphic units in this channel.

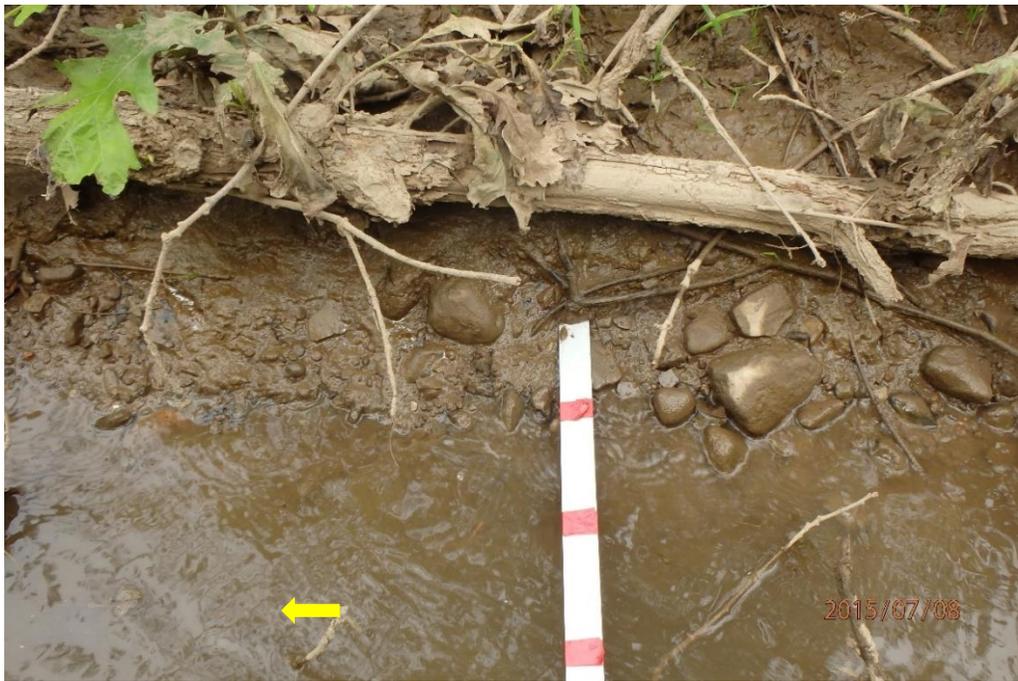
Reach **SM1**: Sixteen Mile Creek, northeastern corner of subject property, Milton

Bed and bank materials ranged from clay to cobbles.

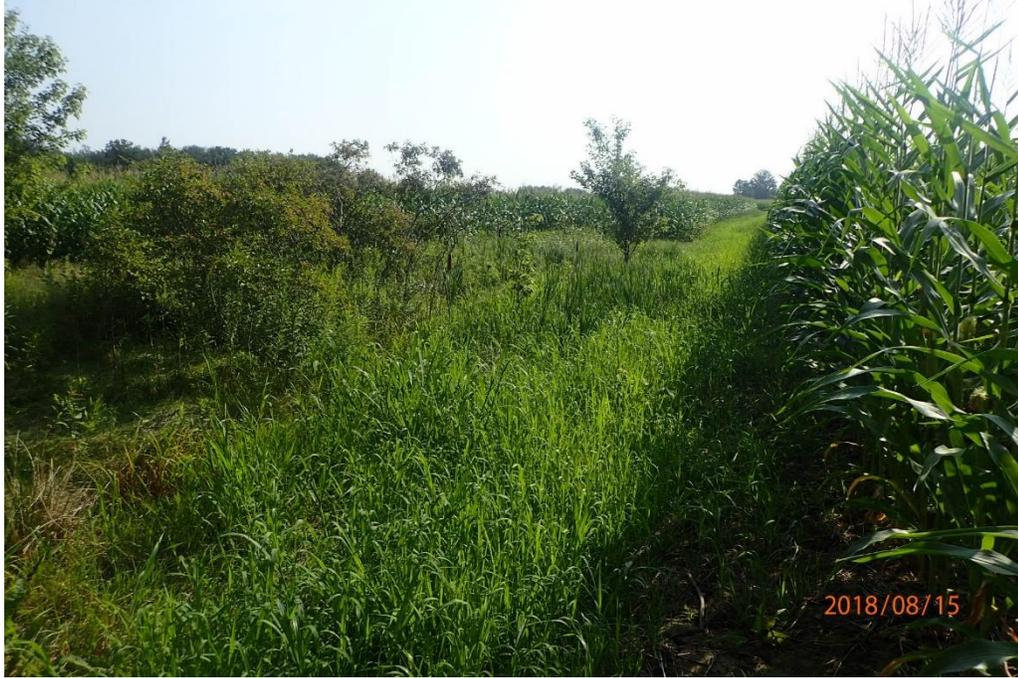
Photo 9
Reach **R3S1**: Sixteen Mile Creek Tributary, central portion of subject property, Milton

General overview of tributary through subject property. Note extensive vegetation encroachment and farm crop planted to edge of feature.

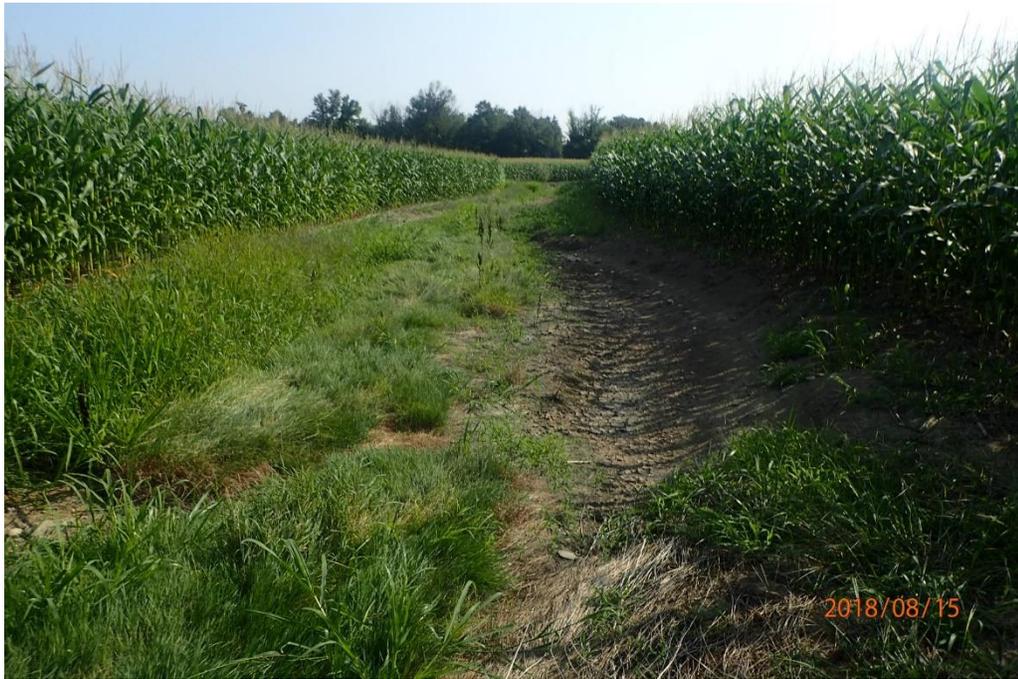
Photo 10
Reach **R3S1**: Sixteen Mile Creek Tributary, central portion of subject property, Milton

General overview of tributary through subject property. Note vegetation encroachment and farm crop planted to edge of feature.

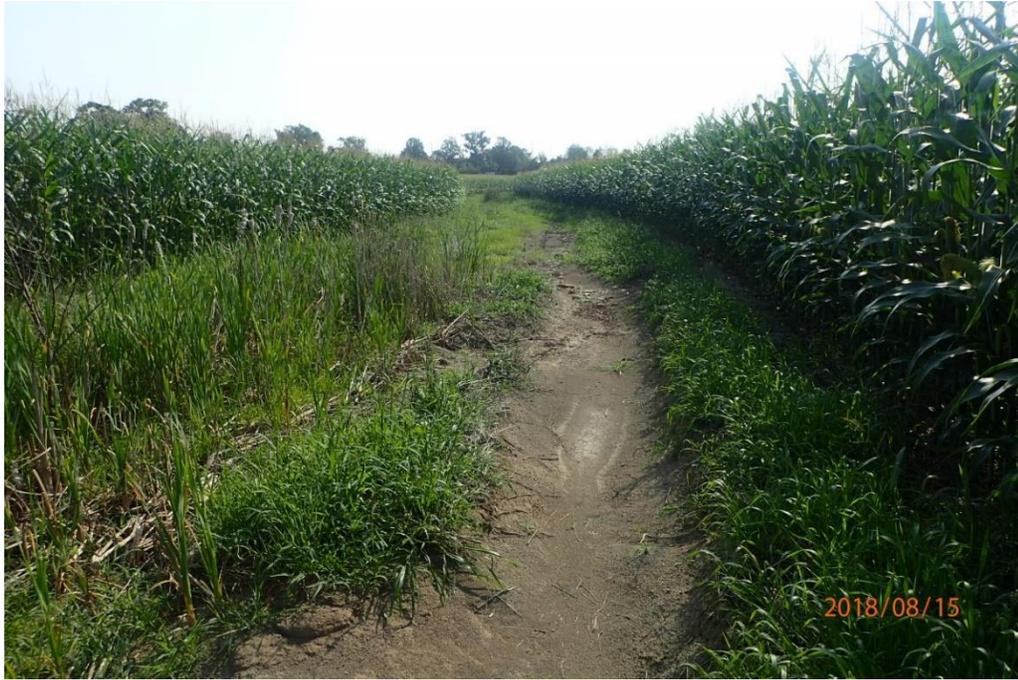
Photo 11
Reach **R3S1**: Sixteen Mile Creek Tributary, central portion of subject property, Milton

Area with less instream vegetation. Note small flow path area within larger excavated feature contains uniform substrate. No flow or water on the day.

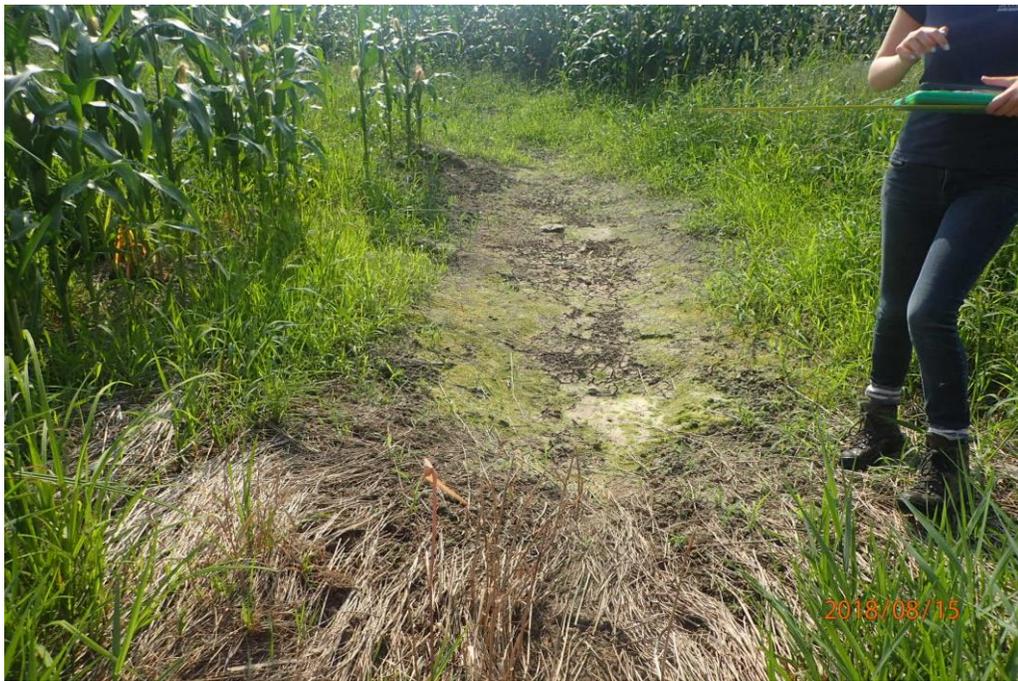
Photo 12
Reach **R3S1**: Sixteen Mile Creek Tributary, central portion of subject property, Milton

Area with less instream vegetation. feature contains uniform substrate. No flow or water on the day. No observed geomorphic units.

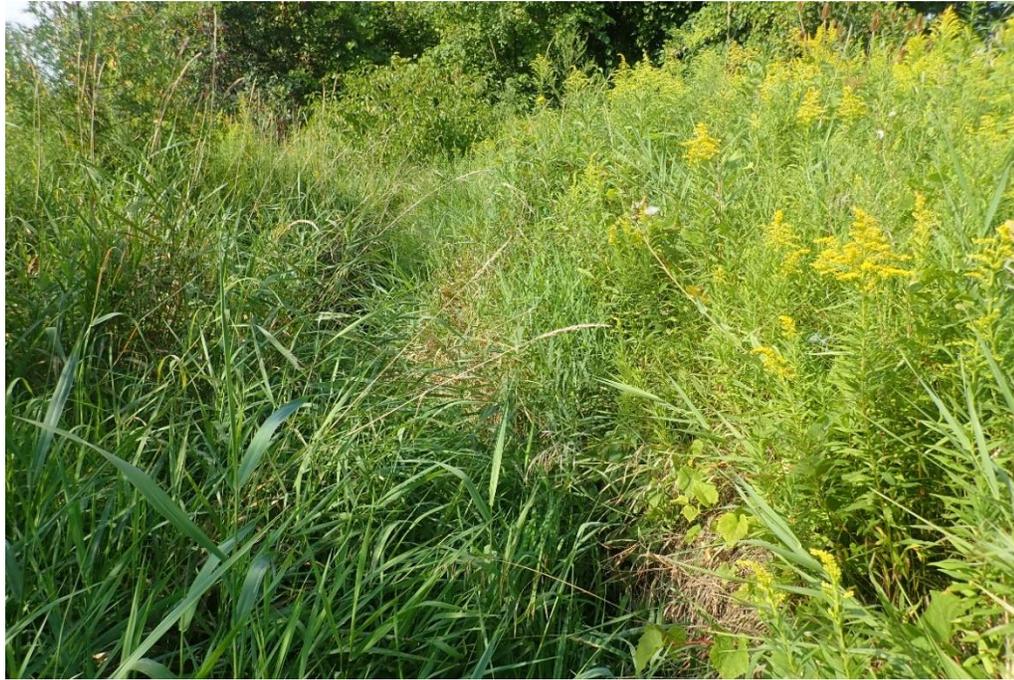
Photo 13
Reach **R3S0C**: Sixteen Mile Creek Tributary, downstream of subject property, Milton

General overview of tributary. Riparian vegetation is characterized by grasses and occasional trees. Encroachment into the channel was relatively high.

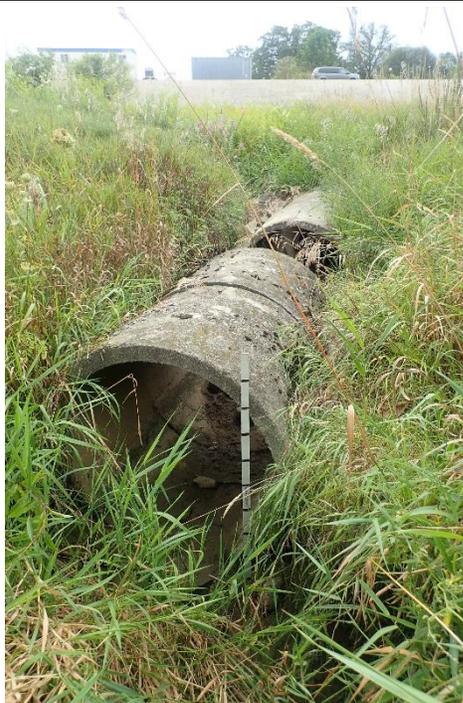
Photo 14
Reach **R3S0C**: Sixteen Mile Creek Tributary, downstream of subject property, Milton

A moderately outflanked and degraded crossing was observed at the upstream extent of the sub-reach, indicating some level of planform adjustment.

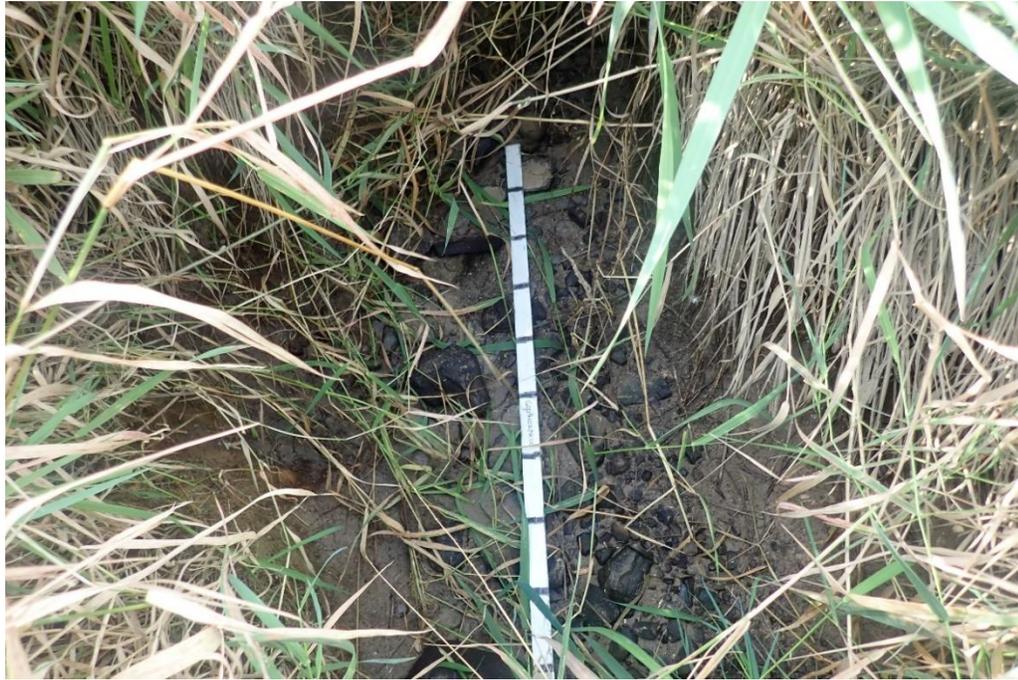
Photo 15
Reach **R3S0C**: Sixteen Mile Creek Tributary, downstream of subject property, Milton

Bed materials in **R3S0C** is predominantly clay and silt. Trace amounts of gravel are present in patches throughout.

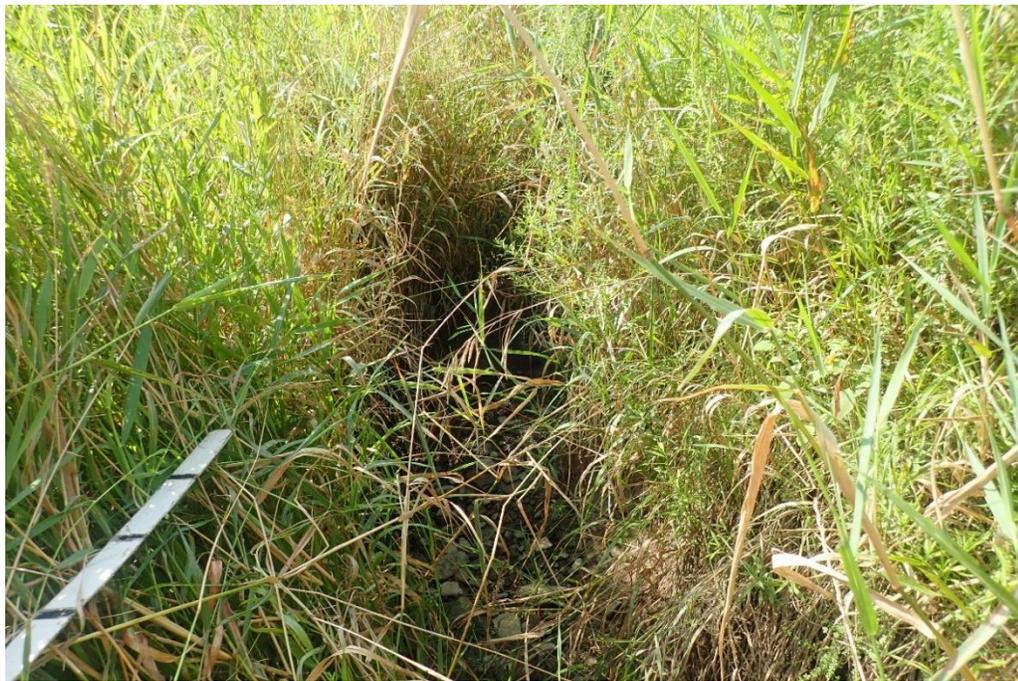
Photo 16
Reach **R3S0C**: Sixteen Mile Creek Tributary, downstream of subject property, Milton

The channel generally exhibits a U-shaped geometry with moderate entrenchment. Geomorphic units are often poorly defined.

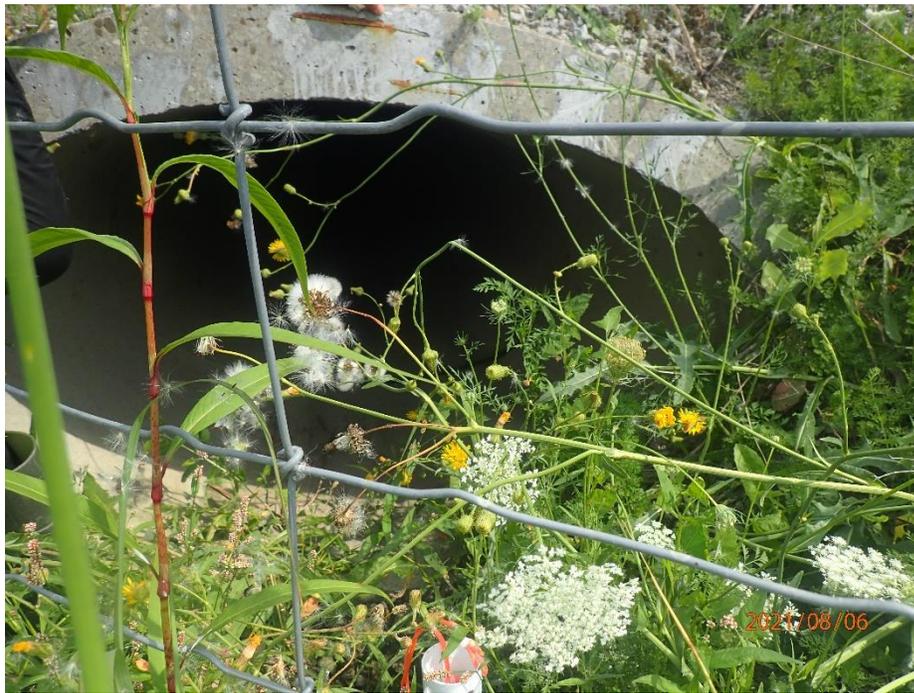
Photo
1

Photograph facing downstream from site **MN1** during baseflow conditions where the channel was dry.

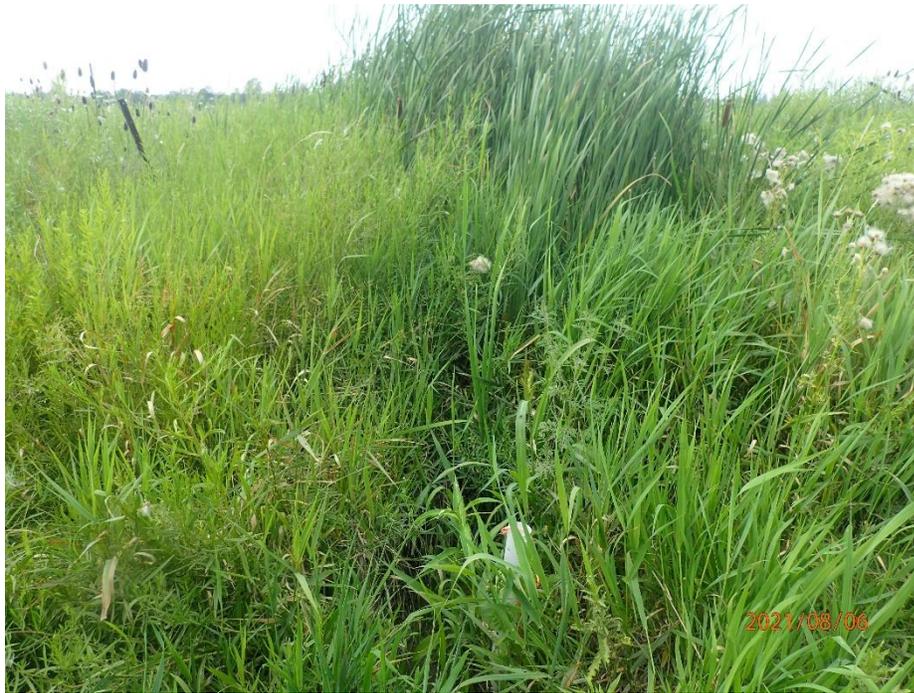
Photo
3

Photograph facing upstream towards site **MN2** during baseflow conditions where the channel was dry.

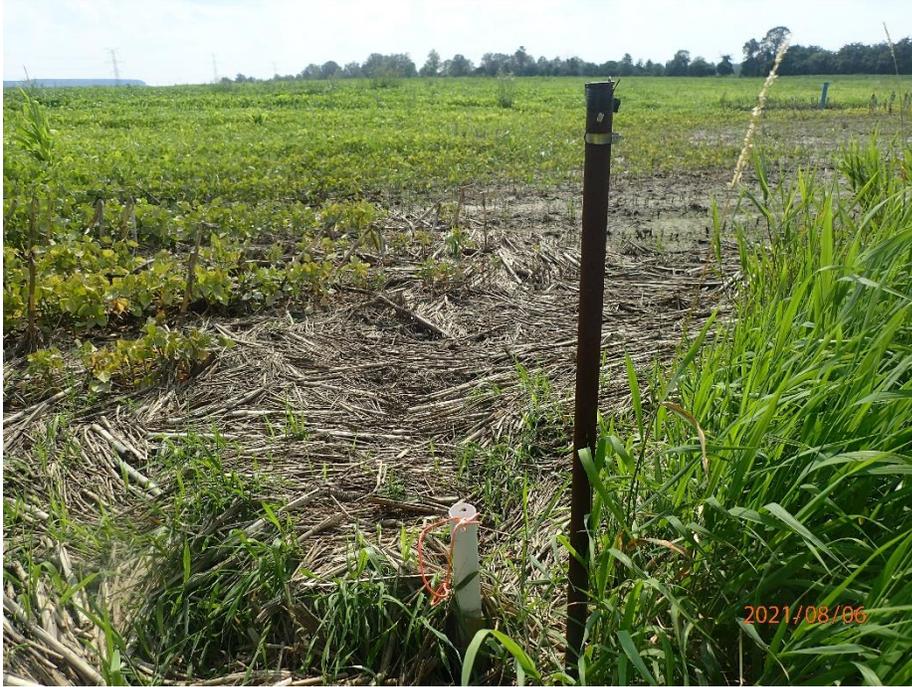
Photo
5

Photograph facing upstream towards site **MN3** during baseflow conditions where the channel was dry.
