Appendix B

Tree Inventory

Technical Memorandum

Project Name: John St. WWPS Class EA - Arborist Report

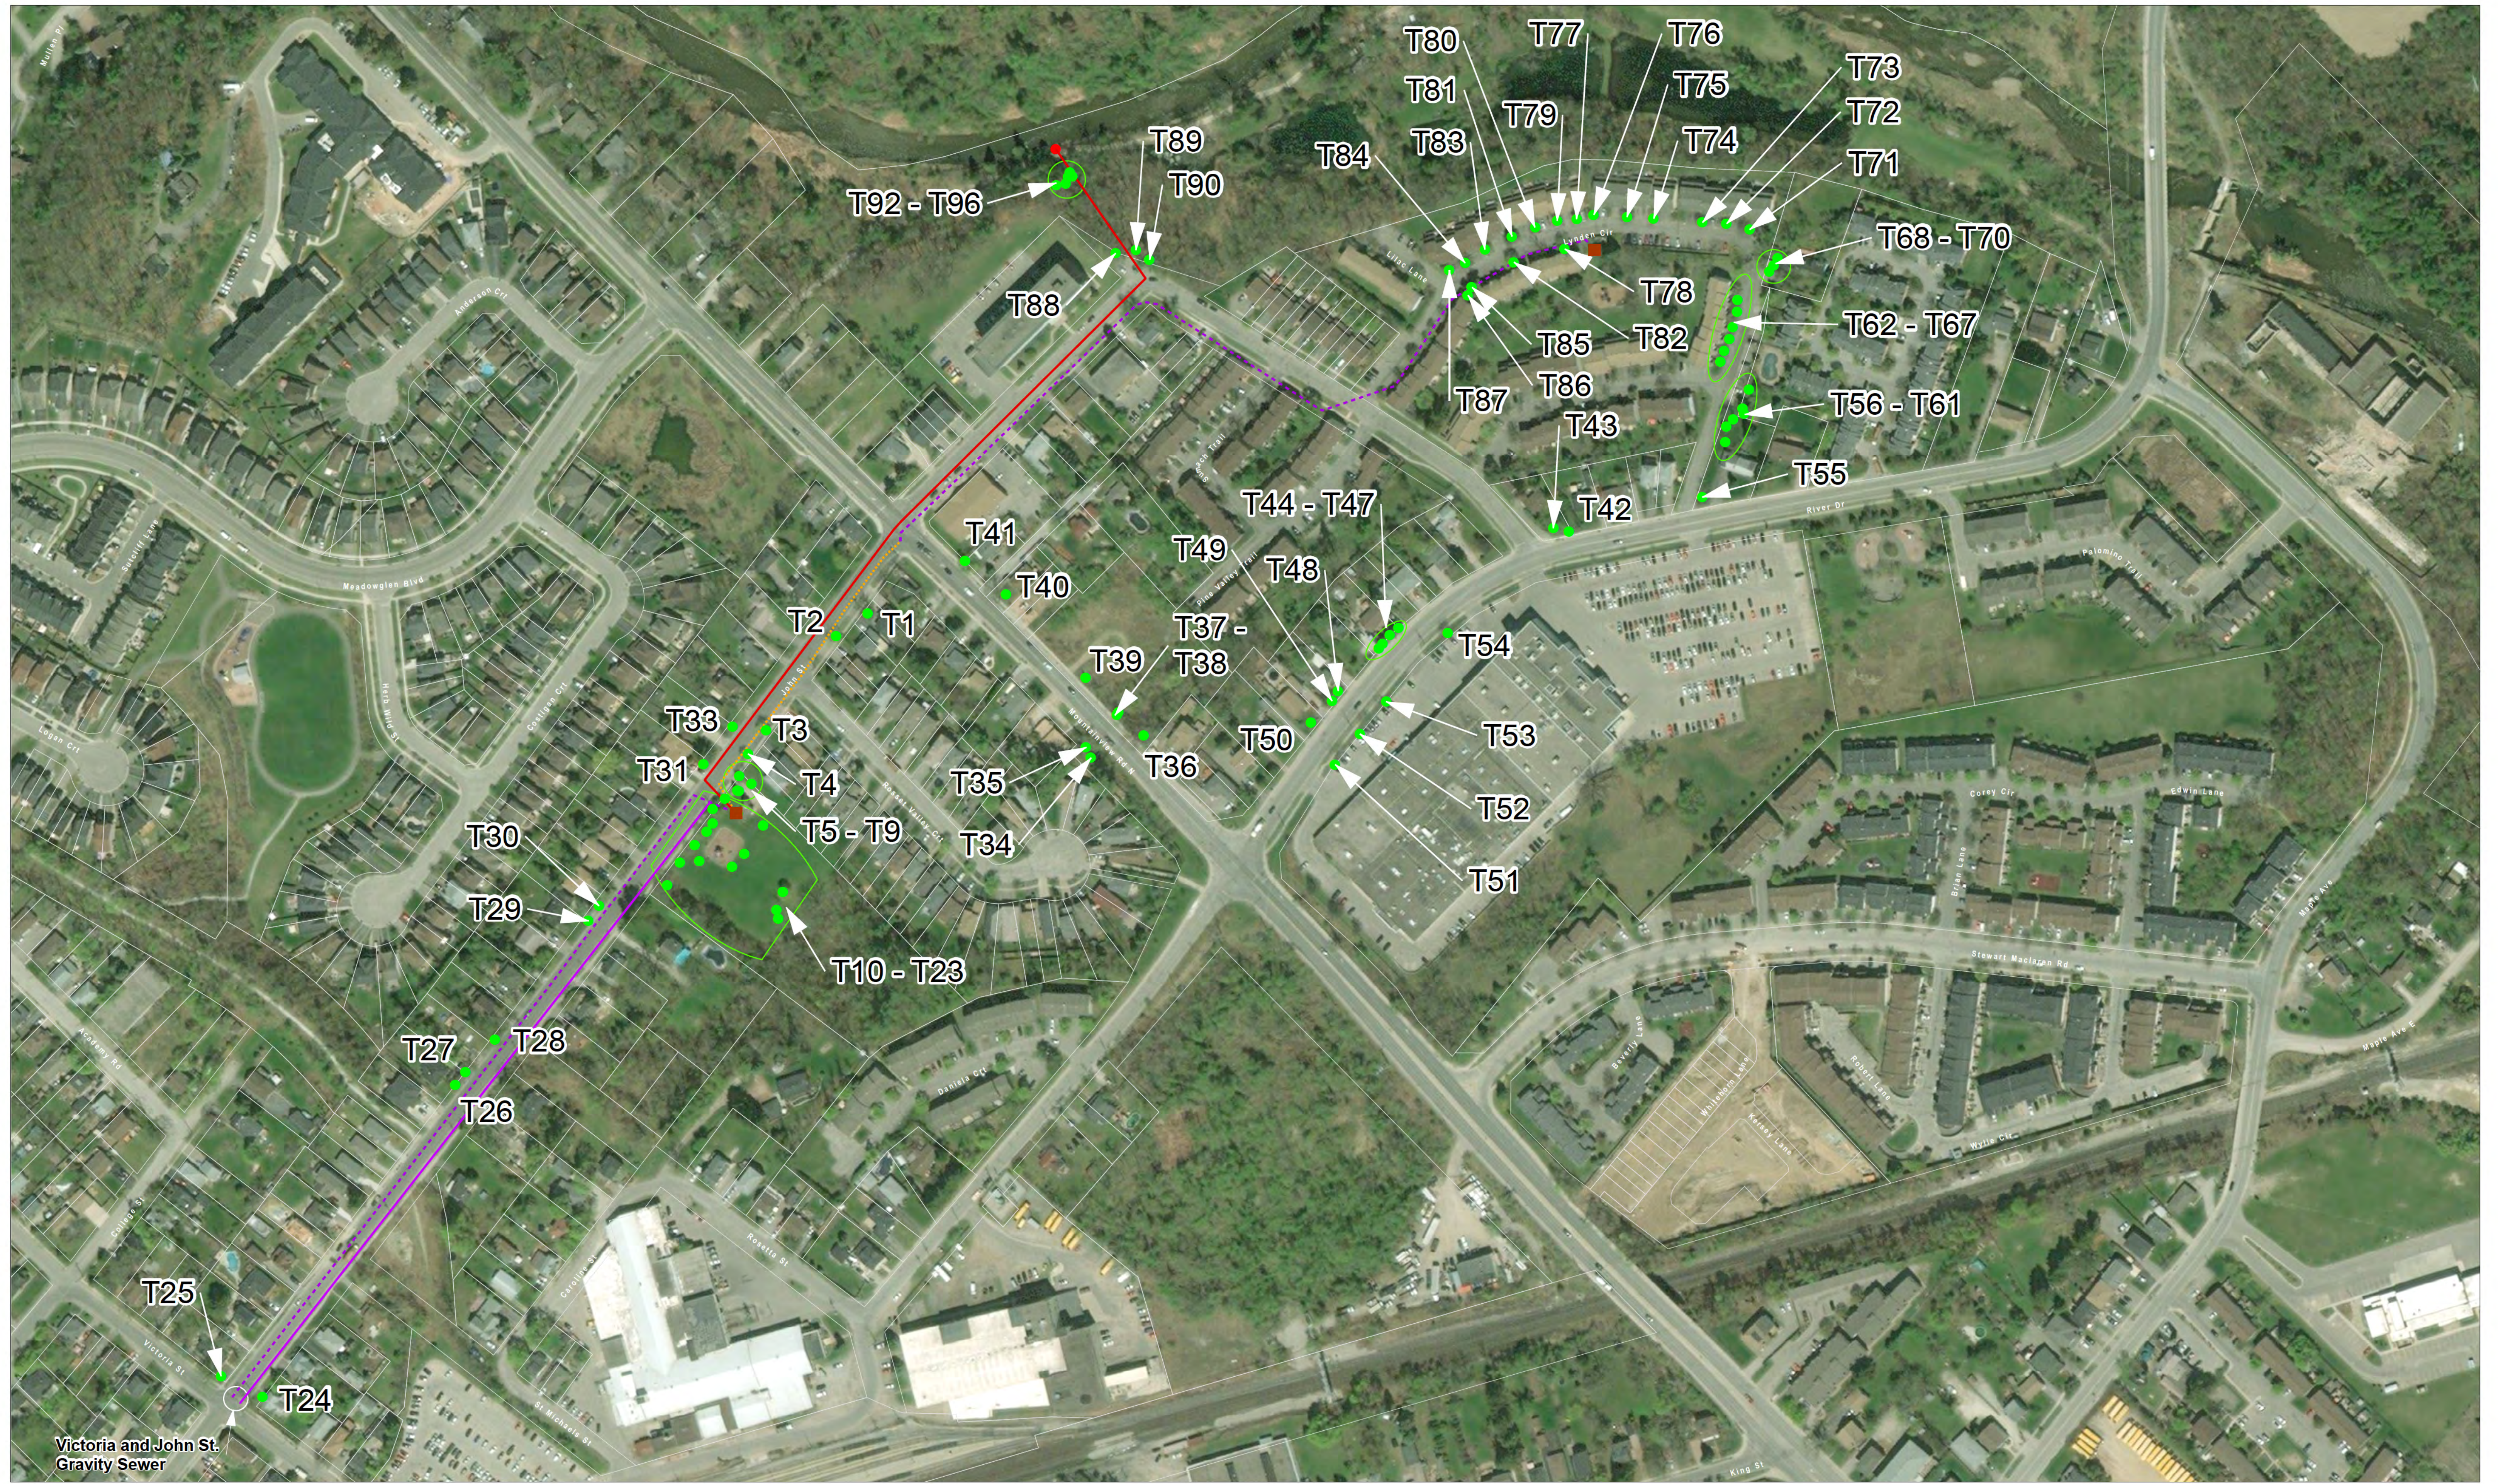
Map Title					
JOHN ST WWPS EA TREE INVENTORY PLAN ALTERNATIVE 2					
Drawn	Checked	Designed	Checked	Date	Map No.
HN	KB	SC	KB	2017/10/06	1/3
Scale	Project No.		Revision No.		
H 1:1,500	300039946		0

Preservation recommendations (i.e., preserve or remove) are provided based on the existing condition of each tree. A tree is recommended for preservation if it has been assigned a fair or good condition rating. A tree is recommended for removal if it has been assigned a poor condition rating.

A total of 94 trees were included in the investigation within the study area where the alternatives have identified areas of potential impact. A total of 94 trees were assigned Good or Fair condition ratings. The remaining 10 trees are recommended for removal based on their poor condition ratings.

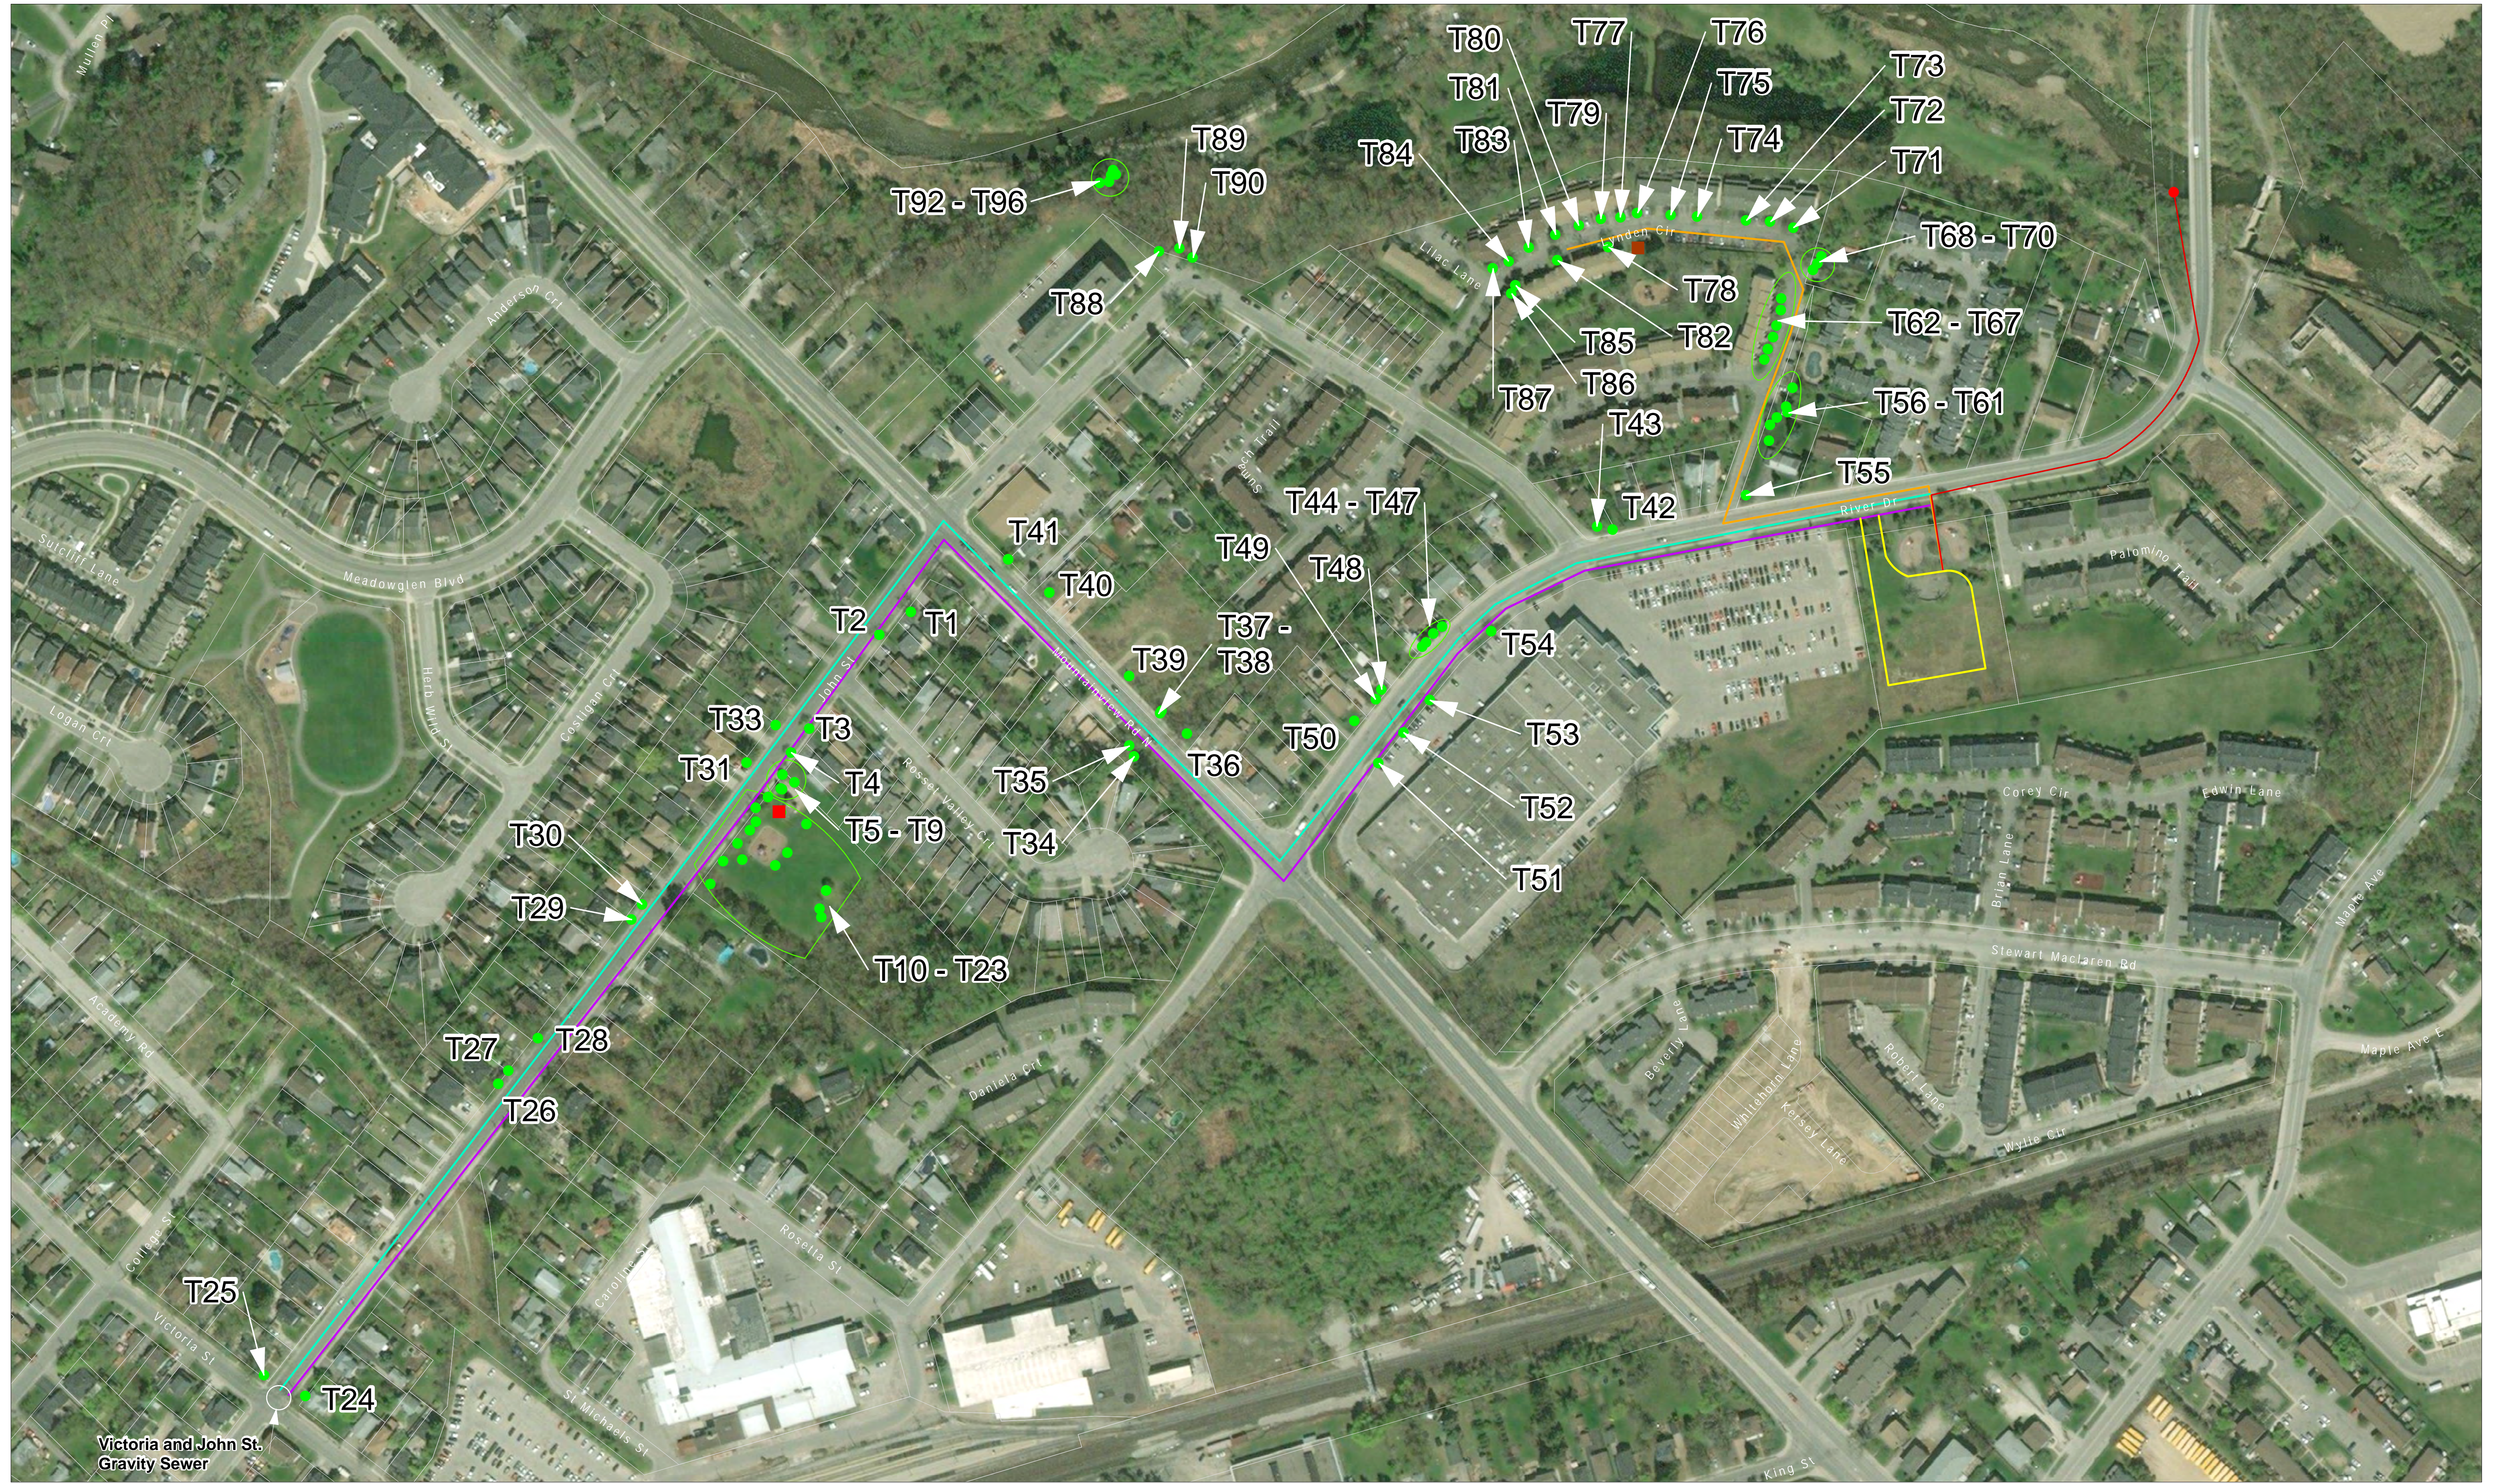
Map Title
**JOHN ST WWPS EA
 TREE INVENTORY PLAN
 ALTERNATIVE 4**

4. Trees with root zones extending into any construction zones will be subject to significant grading and / or excavation such as the area surrounding overflow discharge which extends to the Credit River valley (adjacent to the River Street bridge) in Alternative 4.
