**BRITANNIA ROAD TRANSPORTATION CORRIDOR IMPROVEMENTS:
TREMINE ROAD TO HIGHWAY 407 CLASS EA STUDY**

ENVIRONMENTAL STUDY REPORT – FLUVIAL GEOMORPHOLOGY STUDY

Aquafor Beech Limited

June, 2013

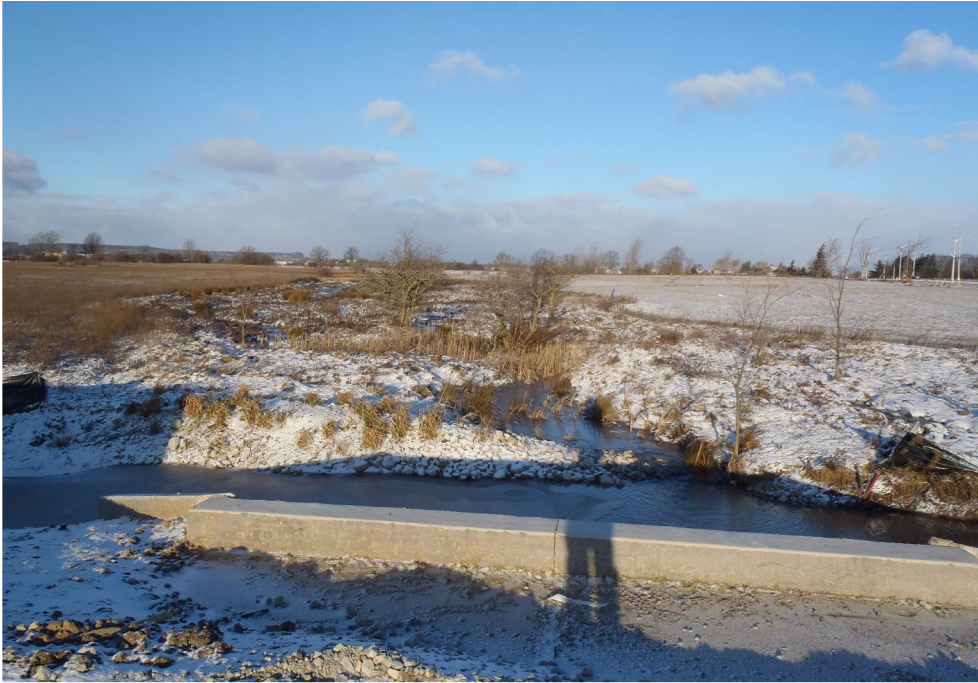
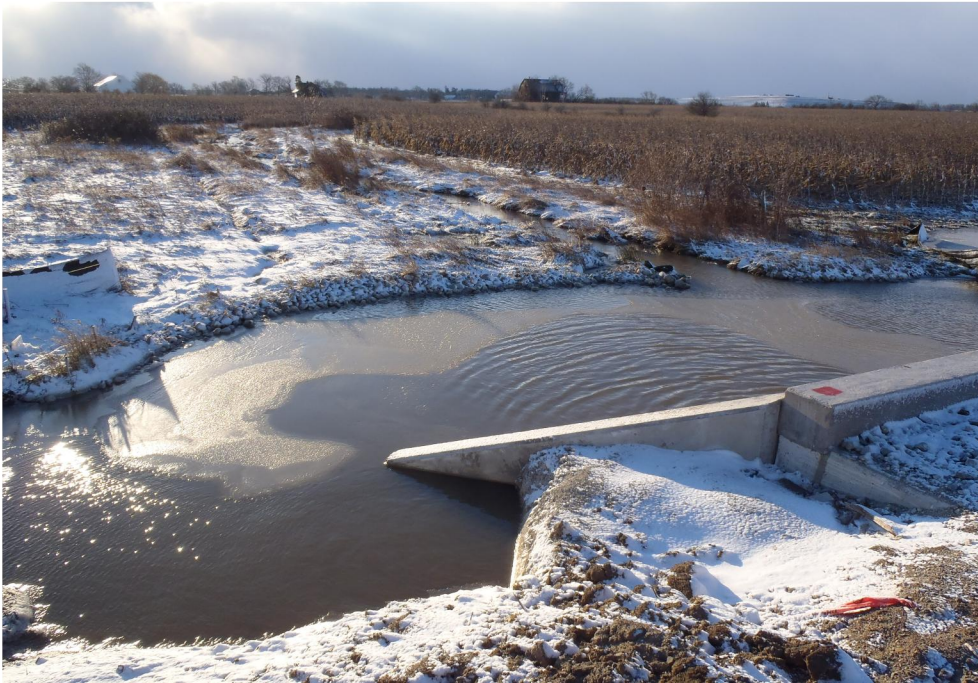
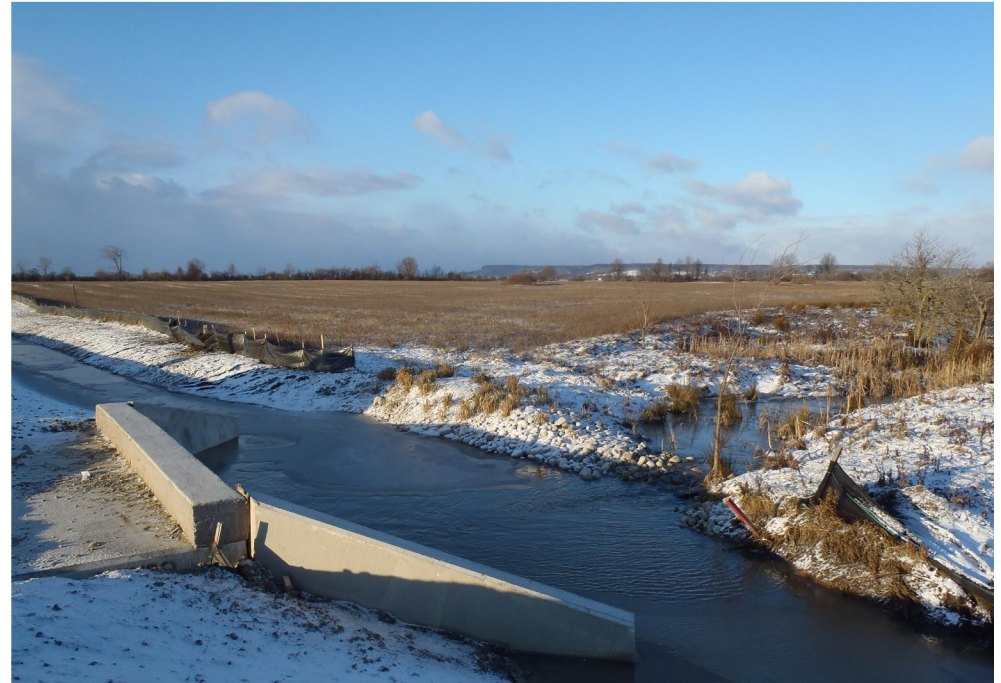
Updated Photos for Crossing 6, taken January 20, 2013
(upper left) - looking upstream
(lower left) - looking downstream
(lower right) - looking at upstream culvert face

Crossing 6 – Crossing 6 – The culvert at Crossing 6 was recently replaced in 2012 (associated with intersection upgrades at Regional Road 25). While it is recommended that the culvert be replaced to meet hydraulic criteria under the EA Study, it has been assumed in this analysis that the existing perpendicular culvert alignment will be extended. Should culvert replacement be considered during detailed design to meet the hydraulic and ecological criteria outlined in the Britannia EA study (and with further consultation with regulatory agencies), then other culvert alignment options may be explored.
