**Cultural Heritage Assessment Report:
Built Heritage Resources and Cultural Heritage Landscapes**

**Britannia Road Transportation Corridor Improvements
Tremaine Road to Highway 407
Class Environmental Assessment Study,
Town of Milton, Regional Municipality of Halton, Ontario**

ASI File 10EA-183

September 2011 (February 2012)

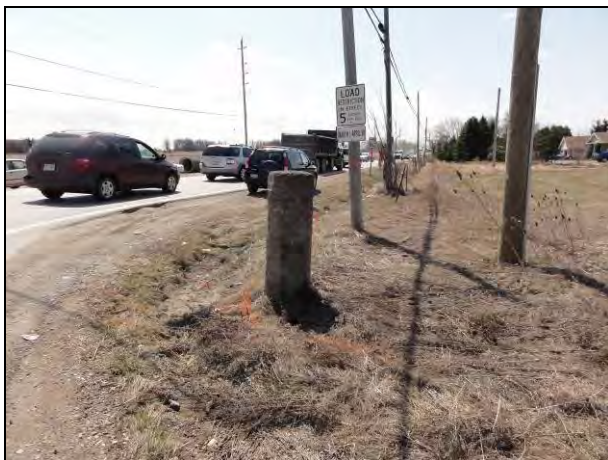
Plate 3: Example of a plain, cylindrical poured concrete corner fence post.

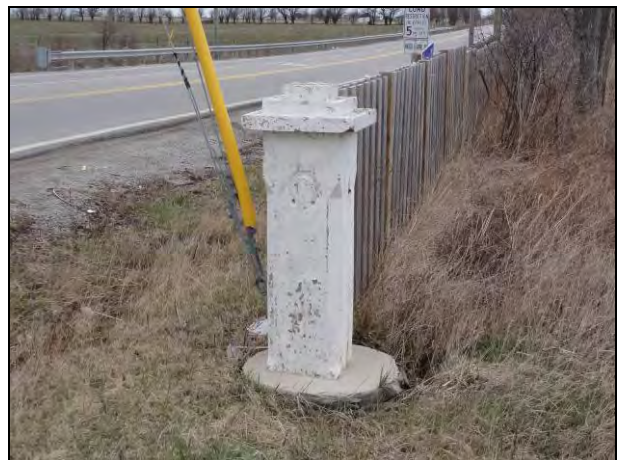
Plate 4: Example of a more intricate concrete corner fence post.

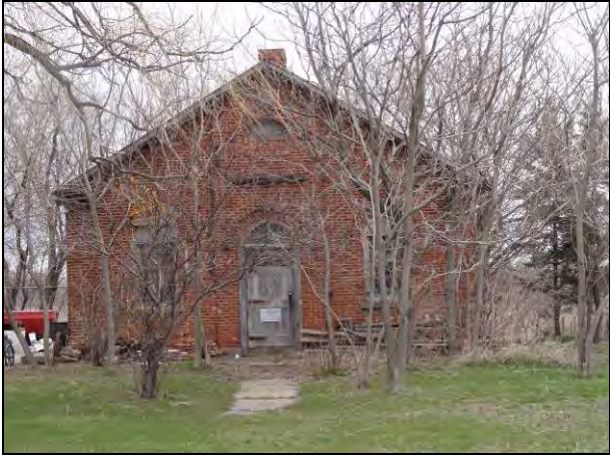
Table 2: Britannia Road EA - Identified Built Heritage Resources (BHR) and Cultural Heritage Landscapes (CHL)		
Feature	Inventory Description	Photograph(s)
BHR 1	<p>The former schoolhouse features design elements typical of nineteenth-century schoolhouses, including: gable roof, three-bay symmetrical front façade, round-headed window and door openings topped with decorative brick voussoirs, and a semi-circular window opening in the gable peak. The structure is of frame construction with a brick veneer and the roof is clad in metal sheeting. The former schoolhouse, now a private residence, is part of the historic settlement of Boyne and is illustrated on the 1877 historic atlas map. (see Sheet 2)</p> <p>Location: 6035 Regional Road 25 Feature Type: Former schoolhouse Recognition: Listed, Town of Milton Heritage Inventory</p>

<p>West elevation of the built heritage resource.</p>
BHR 2	<p>The one-and-a-half storey, frame residence features a gambrel roof with a gable dormer, a covered porch with a hipped roof, synthetic siding, modern one-over-one pane sash windows, and textured concrete block foundations. Constructed in the mid-twentieth century, the structure exhibits details reminiscent of the Dutch Colonial style. (see Sheet 2)</p> <p>Location: 8161 Britannia Road Feature Type: Residence Recognition: Listed, Town of Milton Heritage Inventory</p>

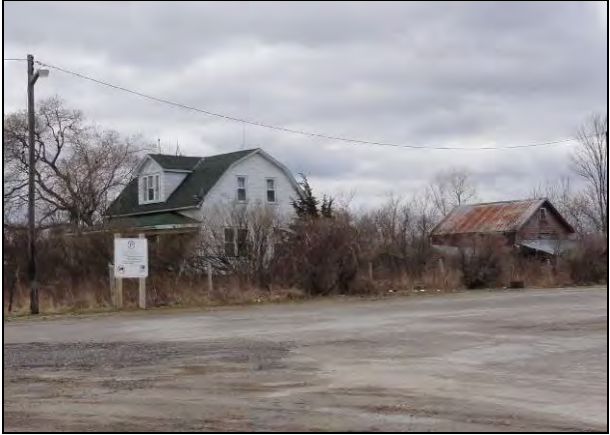
<p>South and west elevations of the built heritage resource.</p>

It is recommended that the following resources be subject to heritage documentation activities, the result of which are compiled into one report and which is archived with local repositories and filed with the Town of Milton: BHR 2, BHR 12, CHL 5, CHL 8, CHL 10, CHL 14, CHL 22, CHL 23, CHL 27, CHL 28, CHL 29, CHL 31, CHL 32, CHL 33, and CHL 34.

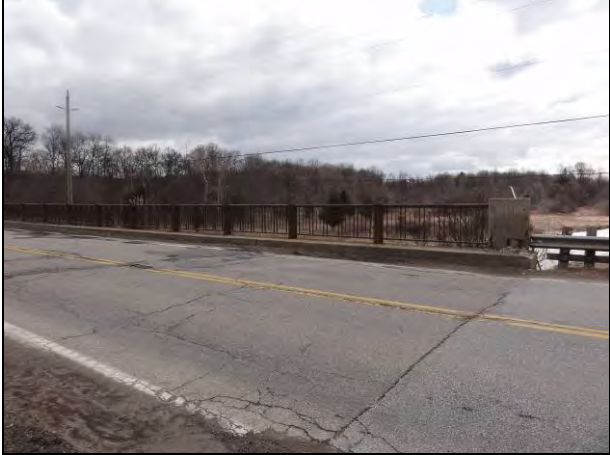
BHR 3	<p>The bridge carries Britannia Road over Sixteen Mile Creek and consists of a single span concrete rigid frame road bridge featuring steel vertical bar handrails. The bridge was constructed in 1962. (see Sheet 3)</p> <p>Location: Britannia Road at Sixteen Mile Creek (west of Thompson Road) Feature Type: Bridge Recognition: Identified, Boyne Survey Secondary Plan</p>

<p>South railing of the bridge.</p>

4. Where bridges are older than 40 years or age and are expected to be impacted by replacement or widening to accommodate the introduction of a six-lane right-of-way, resource-specific heritage impact assessments should be completed in advance, or at the earliest possible stages of the detailed design phase. Resources recommended for completion of a heritage impact assessment within this context include: BHR 3 and BHR 15.

- The following resources are expected to be impacted by replacement or widening: BHR 3 and BHR 15.
- The results of impact screening confirmed that several identified cultural heritage resources are not expected to be negatively impacted by the proposed undertaking:

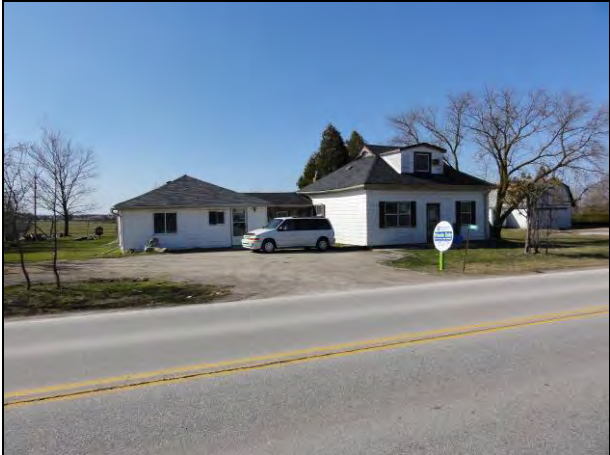
Table 2: Britannia Road EA - Identified Built Heritage Resources (BHR) and Cultural Heritage Landscapes (CHL)		
Feature	Inventory Description	Photograph(s)
BHR 4	<p>The single-storey vernacular residence features frame construction, a hipped roof, a three-bay front façade, modern windows and doors, and synthetic siding. A gable dormer is a more recent addition and so is the walkway connecting the main residence to a smaller, hipped roof structure. According to the Town of Milton, this residence is one of two workers' cottages that were constructed around the 1930s. The heritage resource is part of the historic settlement of Omagh. (see Sheet 4)</p> <p>Location: 9905 Britannia Road Feature Type: Residence Recognition: Listed, Town of Milton Heritage Inventory</p>

<p>West and south elevations of the built heritage resource.</p>
BHR 5	<p>The single-storey vernacular residence features frame construction, a hipped roof, a three-bay front façade, concrete foundations, and potentially original two-over-two pane sash windows. According to the Town of Milton, this residence is one of two workers' cottages that were constructed around the 1930s. The heritage resource is part of the historic settlement of Omagh. (see Sheet 4)</p> <p>Location: 9965 Britannia Road Feature Type: Residence Recognition: Listed, Town of Milton Heritage Inventory</p>

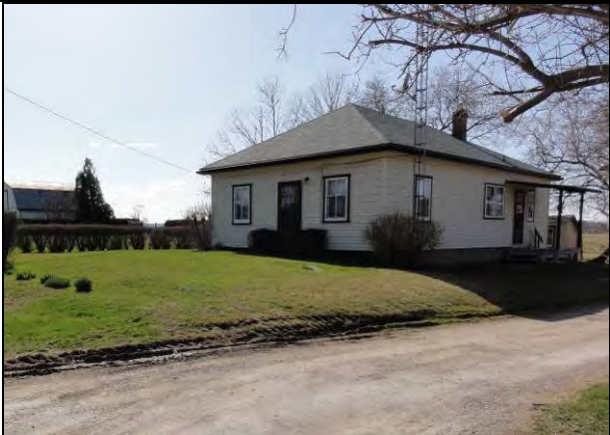
<p>South and east elevations of the built heritage resource.</p>

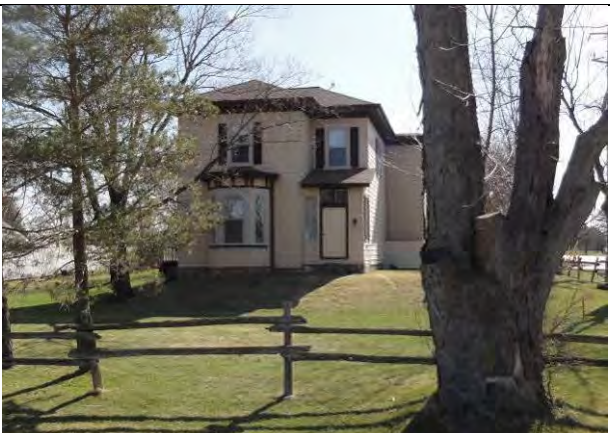
BHR 6	<p>The late-nineteenth century residence features frame construction, a two-storey scale, a hipped roof, stone foundations, and a single-storey bay window with decorative brackets on the front façade (east elevation). The structure has been altered and features synthetic siding and modern windows and doors. The residence, which is located in the historic settlement of Omagh, is reputedly the former parsonage of Church of Christ Disciples (UMA 2010: 24). (see Sheet 4)</p> <p>Location: 9950 Britannia Road Feature Type: Residence Recognition: Listed, Town of Milton Inventory</p>

<p>East elevation of the built heritage resource.</p>

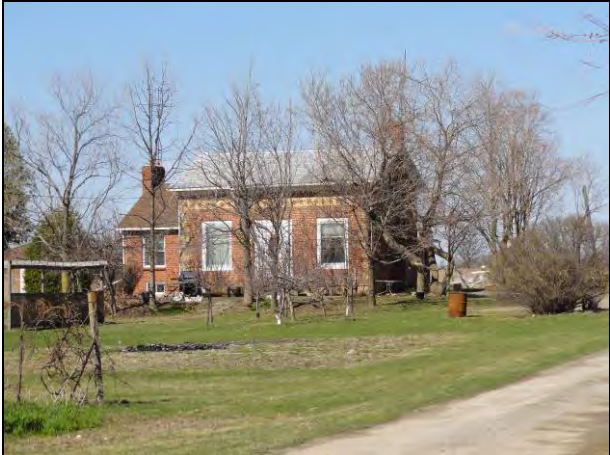
<p>West elevation of the built heritage resource.</p>
BHR 8	<p>The one-and-a-half storey vernacular residence features frame construction, a gable roof, a steep centre gable on the front façade, an enclosed porch, and triangular lintels over the two-over-two pane sash windows. Mature and established trees surround the structure. Located in the historic settlement of Omagh, the residence is historically associated with the Smith and Ford families (UMA 2010: 21). (see Sheet 4)</p> <p>Location: 1599 Fourth Line Feature Type: Residence Recognition: Listed, Town of Milton Heritage Inventory</p>

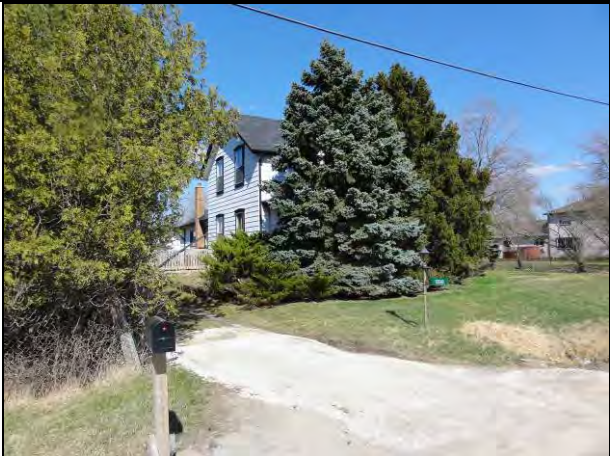
<p>North elevation of the built heritage resource.</p>

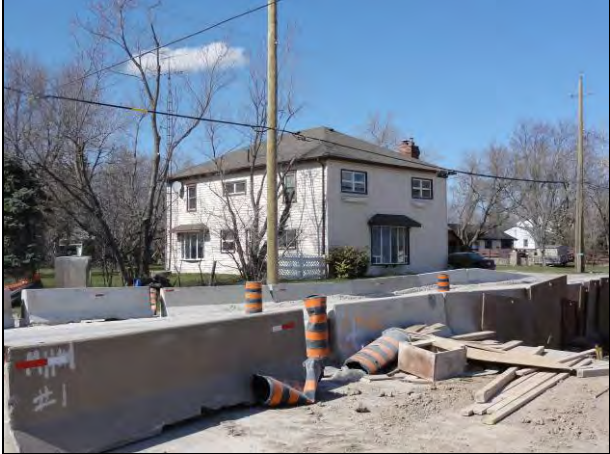
BHR 9	<p>The two-storey structure features frame construction, a hipped roof, an external chimney with a brick stack, as well as modern windows and synthetic siding. Part of the historic settlement of Omagh, the structure was used as a hotel and general store. The Town of Milton reports that the residence may have been constructed by John Howell in the 1850s (UMA 2010: 23). (see Sheet 4)</p> <p>Location: 10025 Britannia Road Feature Type: Residence Recognition: Listed, Town of Milton Inventory</p>

<p>West and south elevations of the built heritage resource.</p>

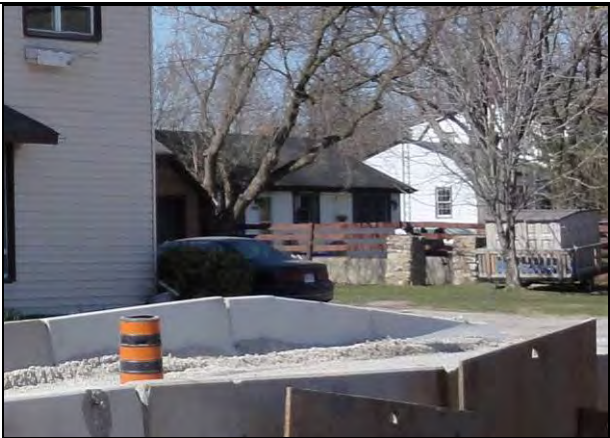
Table 2: Britannia Road EA - Identified Built Heritage Resources (BHR) and Cultural Heritage Landscapes (CHL)		
Feature	Inventory Description	Photograph(s)
BHR 10	<p>The one-storey residence is reported to have been built in 1949 with material from the Omagh General Store building (UMA 2010: 23). It features a gable roof and concrete foundations. It is located in the historic settlement of Omagh. Due to active construction activities at the time of the field review, more detailed assessment and photo documentation was not possible. (see Sheet 4)</p> <p>Location: 10043 Britannia Road Feature Type: Residence Recognition: Identified, Boyne Survey Secondary Plan</p>

<p>South elevation of the built heritage resource.</p>
BHR 11	<p>The one-and-a-half storey residence features frame construction, a gambrel roof with two gable dormers, and a symmetrical five-bay front façade. Located in the historic settlement of Omagh, it is reported that this twentieth-century structure was built using materials from the former Omagh school house that originally stood on this site (UMA 2010: 22). Due to active construction activities at the time of the field review, more detailed assessment and photo documentation was not possible. (see Sheet 4)</p> <p>Location: 10095 Britannia Road Feature Type: Residence Recognition: Listed, Town of Milton Heritage Inventory</p>

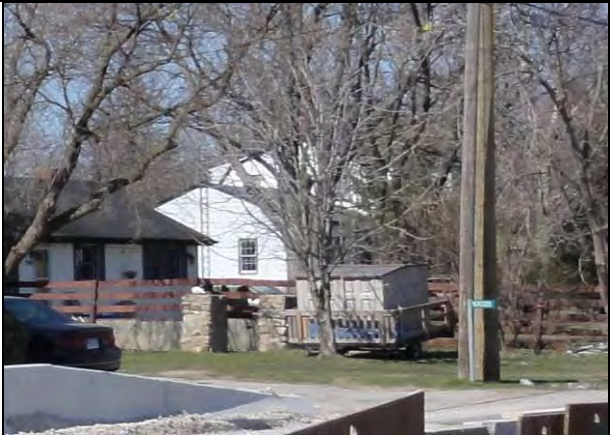
<p>West elevation of the built heritage resource.</p>

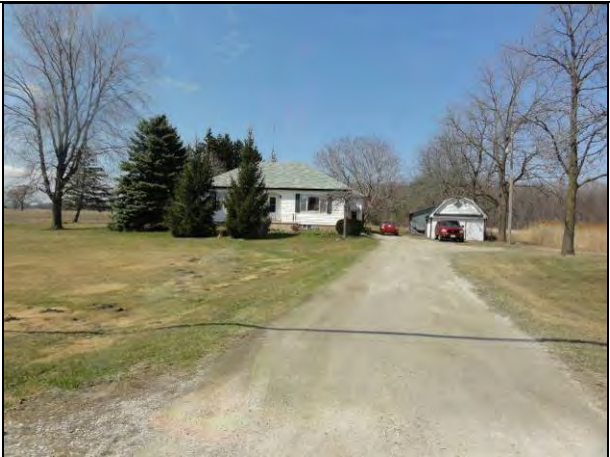
BHR 12	<p>The one-storey residence features frame construction, a single-storey rear accretion, a hipped roof, textured concrete block foundations, a symmetrical three-bay front façade, and a recessed front entrance. Stylistically, this residence is of typical mid-twentieth century vernacular architecture. However, a residence associated with William Tolson is illustrated at this location on the 1877 atlas map. Established tree lines surround the rectangular property parcel, the west boundary of which was established by 1877. (see Sheet 6)</p> <p>Location: 12365 Britannia Road Feature Type: Residence Recognition: Identified, Review of historic mapping and field assessment</p>

<p>South elevation of the built heritage resource.</p>

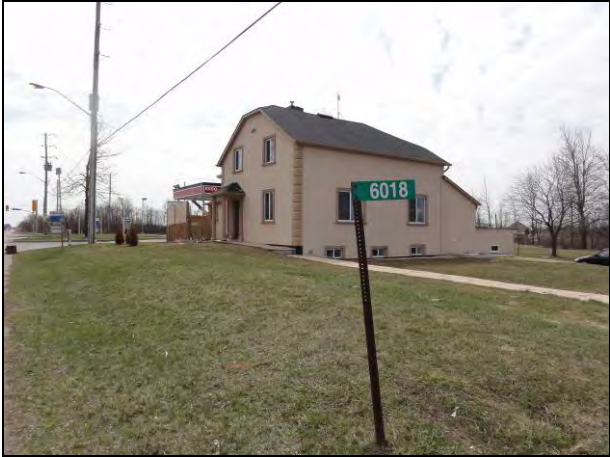
Table 2: Britannia Road EA - Identified Built Heritage Resources (BHR) and Cultural Heritage Landscapes (CHL)		
Feature	Inventory Description	Photograph(s)
BHR 13	<p>The frame structure has an L-shaped footprint comprised of a one-and-a-half storey front section with a hipped gable roof on the front façade, and a rear two-storey section with a hipped roof. The residence features an internal chimney as well as two enclosed porches with hipped roofs. The structure has been altered and is currently clad in stucco. It is located within the historic settlement of Drumquin. (see Sheet 6)</p> <p>Location: 6018 Trafalgar Road Feature Type: Residence Recognition: Listed, Town of Milton Heritage Inventory</p>

<p>East and north elevations of the built heritage resource.</p>
BHR 14	<p>The frame structure features a one-and-a-half storey scale, a gable roof, a one-storey rear tail, an internal chimney with a brick stack, and a four-bay front façade. Mature trees and fence lines surround the residence and associated outbuildings. The residence, which is part of the historic settlement of Drumquin, was potentially constructed in the mid- to late-nineteenth century. (see Sheet 7)</p> <p>Location: 6007 Trafalgar Road Feature Type: Residence Recognition: Listed, Town of Milton Heritage Inventory</p>

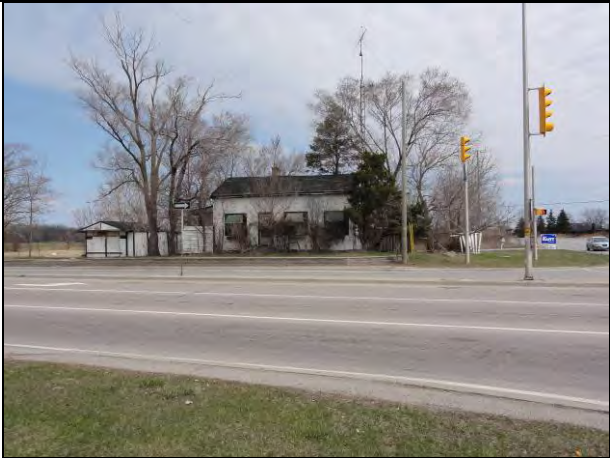
<p>West elevation of the built heritage resource.</p>

1. Any proposed road projects and preferred alternative designs within the study area should be suitably planned in a manner that avoids any identified, above ground, cultural heritage resources.
2. Where resources have the potential to be removed due to significant encroachment, resource-specific heritage impact assessments should be completed in advance, or at the earliest possible stage of the detailed design stage. Resources recommended for completion of a heritage impact assessment within this context include: BHR 14.

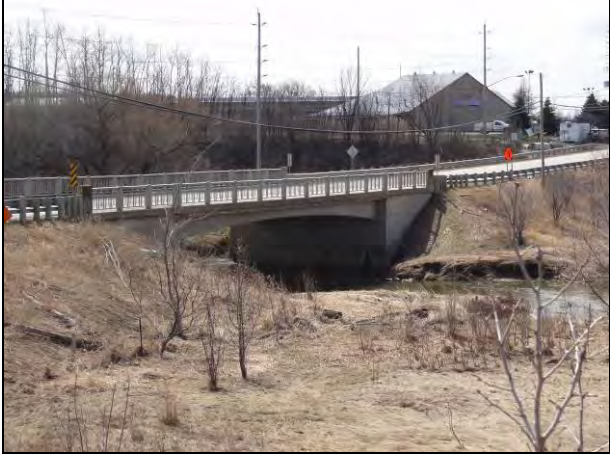
BHR 15	<p>The bridge carries Britannia Road over Sixteen Mile Creek, just west of Trafalgar Road. The bridge consists of a single span concrete rigid boat frame bridge featuring steel vertical bar handrails. The bridge was constructed in 1960</p> <p>(see Sheets 6-7)</p> <p>Location: Britannia Road over Sixteen Mile Creek, west of Trafalgar Road Feature Type: Bridge Recognition: Identified, Field assessment</p>

<p>South elevation of the built heritage resource.</p>

Feature	Impacts
BHR 15 Bridge Sixteen Mile Creek crossing, west of Trafalgar	<ul style="list-style-type: none"> • Full displacement (III.1) by replacement or alteration (III.2) through widening of the existing bridge • Alteration to the surrounding setting through the conversion of the bridge crossing from a two-lane road to a six-lane road
BHR 16 Commemorative cairn West of 12705 Britannia Road	<ul style="list-style-type: none"> • Alteration (III.2) of the setting of the subject resource through encroachment; • The widening of Britannia Road has the potential to limit accessibility to the cairn in its present location (III.4)
CHL 1 Farmscape 5703 Tremaine Road	<ul style="list-style-type: none"> • Based on available information, the subject resource is not expected to be negatively impacted by the proposed undertaking • Subject resource is located outside the affected area
CHL 2 Farmscape 6081 Tremaine Road	<ul style="list-style-type: none"> • Based on available information, the subject resource is not expected to be negatively impacted by the proposed undertaking • Subject resource is located outside the affected area

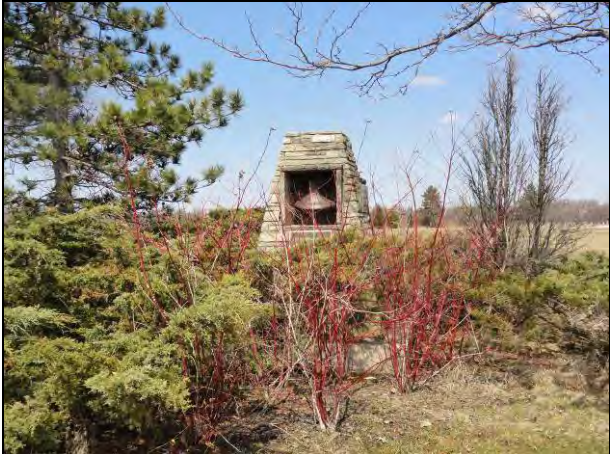
Table 2: Britannia Road EA - Identified Built Heritage Resources (BHR) and Cultural Heritage Landscapes (CHL)		
Feature	Inventory Description	Photograph(s)
BHR 16	<p>This cairn commemorates the rural school sections that closed in 1958 following the opening of the Percy W. Merry Public School. The cairn, which features an old school bell, was erected in 1970 by the Drumquin Women's Institute. An additional plaque commemorating the Percy W. Merry Public School was added to the cairn in 2003 following its own closure.</p> <p>(see Sheet 6)</p>

<p>View of the stone cairn.</p>
	Location: West of 12705 Britannia Road	
	Feature Type: Commemoration	
	Recognition: Identified, Field assessment

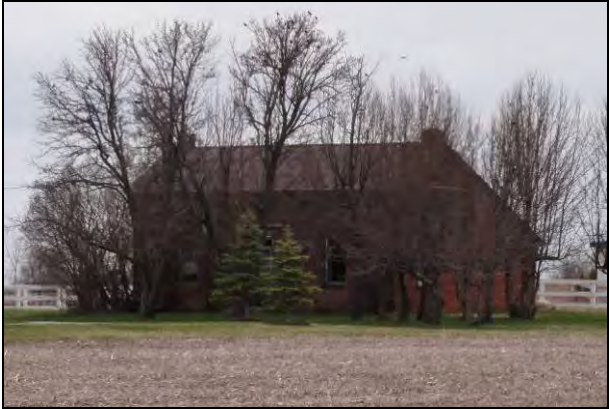
Table 2: Britannia Road EA - Identified Built Heritage Resources (BHR) and Cultural Heritage Landscapes (CHL)		
Feature	Inventory Description	Photograph(s)
CHL 1	<p>The farmscape includes two farmhouses, three gable-roofed outbuildings, and a number of landscape features evocative of earlier agricultural land use. The earliest residence, which dates to the nineteenth century, features a one-and-a-half storey scale, brick construction and/or veneer, a salt-box roof clad in metal sheeting, a symmetrical three-bay front façade, external chimneys at both gable ends, and potentially original twelve-over-twelve pane sash windows. The second residence, which was potentially constructed in the late-nineteenth or early twentieth century, features a two-and-a-half storey scale, a brick construction and/or veneer, a veranda that runs along two sides, and a hipped roof with multiple gables featuring returned eaves and round-top windows.</p> <p>A farmhouse with orchard associated with John Hunter is illustrated at this location on the 1877 atlas map.</p> <p>The property is located more than 300 m south of Britannia Road and should not be impacted by the proposed undertaking.</p> <p>(see Sheet 1)</p>	  <p>West and south elevations of the main farmhouse.</p>

<p>West and south elevation of the older farmhouse.</p>   <p>View of the farmscape from Tremaine Road</p>

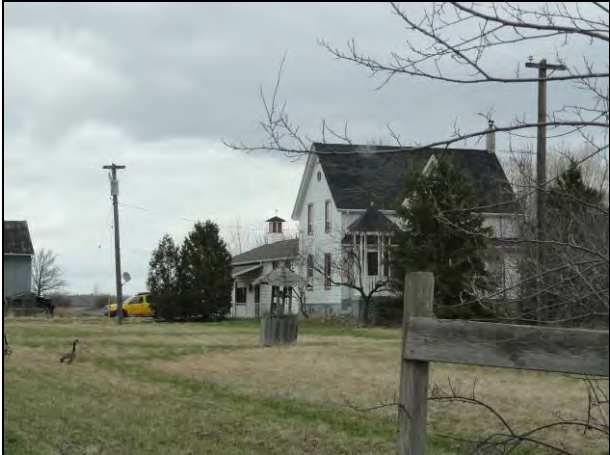
Table 2: Britannia Road EA - Identified Built Heritage Resources (BHR) and Cultural Heritage Landscapes (CHL)		
Feature	Inventory Description	Photograph(s)
CHL 2	<p>The farmscape includes a nineteenth-century vernacular farmhouse with Ontario Gothic detailing, at least two outbuildings, and a number of landscape features evocative of early agricultural land use. The one-and-a-half storey frame residence features a single-storey rear accretion, a gable roof with a centre gable on the front façade, a belvedere on the rear accretion, an external chimney with a brick stack, a covered front veranda, decorative brackets, and vergeboard in the centre gable. Landscape features include a long gravel driveway that leads from Tremaine Road to the built structures, fence lines, and mature trees.</p> <p>A farmhouse with orchard associated with James Weir is illustrated at this location on the 1877 atlas map.</p> <p>The property is located over 300 m north of Britannia Road and should not be impacted by the proposed undertaking.</p> <p>(see Sheet 1)</p>

<p>West and north elevations of the farmhouse.</p>

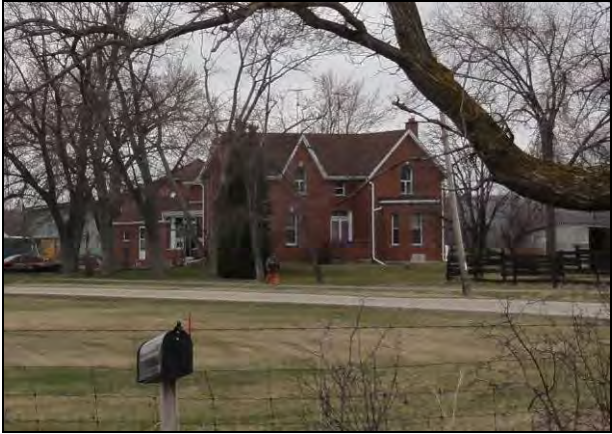
Table 2: Britannia Road EA - Identified Built Heritage Resources (BHR) and Cultural Heritage Landscapes (CHL)		
Feature	Inventory Description	Photograph(s)
CHL 3	<p>The farmscape includes a late-nineteenth century farmhouse, a barn and a number of other outbuildings, a race track, as well as a number of landscape features evocative of early agricultural land use. The residence features a one-and-a-half storey scale, a single-storey rear accretion, brick construction and/or veneer, and a cross-gable roof with two gables on the front façade each with rounded-top window openings. The structure has been altered and features modern windows and doors. A long gravel driveway leads from Tremaine Road to the built structures which are surrounded by mature trees.</p>

<p>East elevation of the farmhouse.</p>
	<p>A farmhouse with orchard associated with James Weir is illustrated at this location on the 1877 atlas map.</p> <p>The property is located about 300 m north of Britannia Road and should not be impacted by the proposed undertaking.</p> <p>(see Sheet 1)</p>

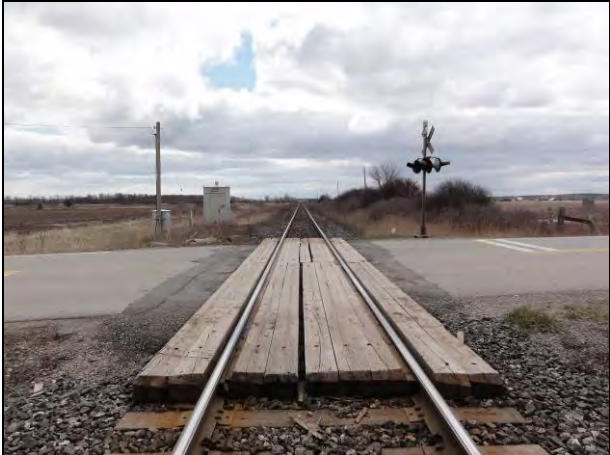
Table 2: Britannia Road EA - Identified Built Heritage Resources (BHR) and Cultural Heritage Landscapes (CHL)		
Feature	Inventory Description	Photograph(s)
CHL 5	<p>Now part of the Canadian National (CN) Rail, the railscape follows the route of the Hamilton & Lake Erie Railway which was incorporated in 1875. Shortly thereafter, it was reorganized as the Hamilton and North Western Railway and is illustrated as such in the 1877 atlas map. In 1879, the HNWR amalgamated with the Northern Railway of Canada as Northern & Northwestern Railway, and in 1888 became part of the Grand Trunk Railway. CN took over in 1923 (UMA 2010: 39). The railway consists of a single track on a slightly raised embankment. Wooden planks facilitate vehicular crossing on Britannia Road.</p> <p>(see Sheet 1)</p>

<p>Looking south along the rail line from Britannia Road.</p>

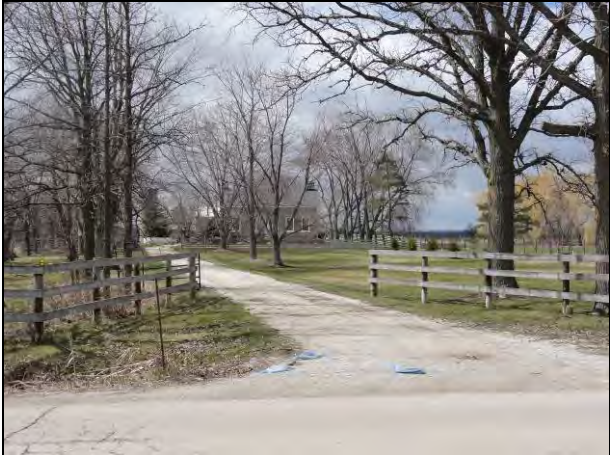
Table 2: Britannia Road EA - Identified Built Heritage Resources (BHR) and Cultural Heritage Landscapes (CHL)		
Feature	Inventory Description	Photograph(s)
CHL 6	<p>The farmscape includes: a one-and-a-half storey stone farmhouse; a large gable barn, silo, and a number of other outbuildings; as well as various landscape features evocative of early settlement and agricultural land use. The residence features a gable roof, two internal chimneys, a symmetrical five-bay front façade, and a one-and-a-half storey rear accretion. The farmhouse reportedly has a date stone of 1849 and is believed to have been constructed by Andrew Suitor (UMA 2010: 40). It is associated with Robert Suiter in the 1877 atlas. According to the Town of Milton, the farmhouse represents one of the oldest residences in the former Township of Trafalgar and is one of the few remaining stone residences. The long gravel drive from Bronte Street South is lined with mature trees.</p> <p>(see Sheet 1)</p>

<p>View of the farmhouse from Bronte Street South.</p>

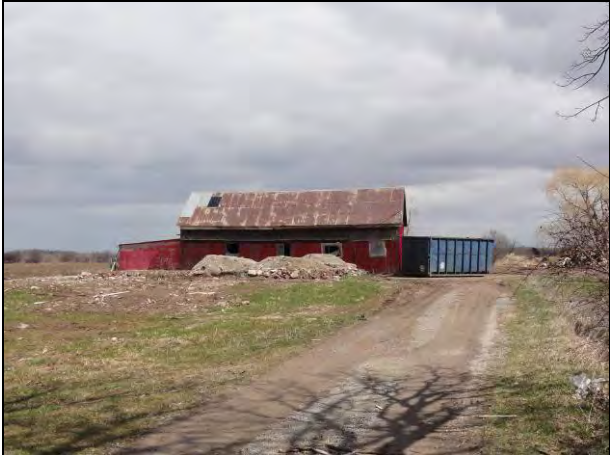
Table 2: Britannia Road EA - Identified Built Heritage Resources (BHR) and Cultural Heritage Landscapes (CHL)		
Feature	Inventory Description	Photograph(s)
CHL 7	<p>The built structures on the property at 5761 Bronte Street South were demolished or in the process of being demolished at the time of the field assessment. Remaining structures included a small gable barn and the partial foundations of another. A review of available online aerial mapping reveals that the farmhouse was situated to the west of the extant barn and that the property also featured a large gambrel barn that had been expanded as well as a silo. The property still retains mature trees and older post-and-rail fence lines.</p> <p>A farmhouse associated with John Bowes is illustrated at this located on the 1877 atlas map.</p> <p>(see Sheets 1-2)</p>

<p>View of the location of the demolished farmhouse from Bronte Street South.</p>

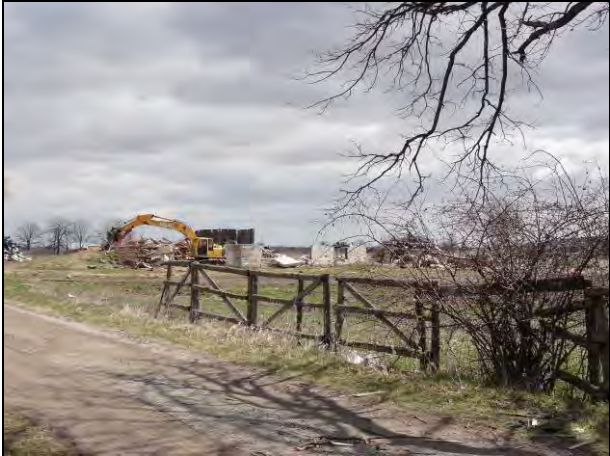
<p>View of the ongoing demolition of outbuildings from Bronte Street South.</p>
	<p>Location: Bronte Street South/First Line</p> <p>Feature Type: Roadscape</p> <p>Recognition: Identified, Field assessment</p>

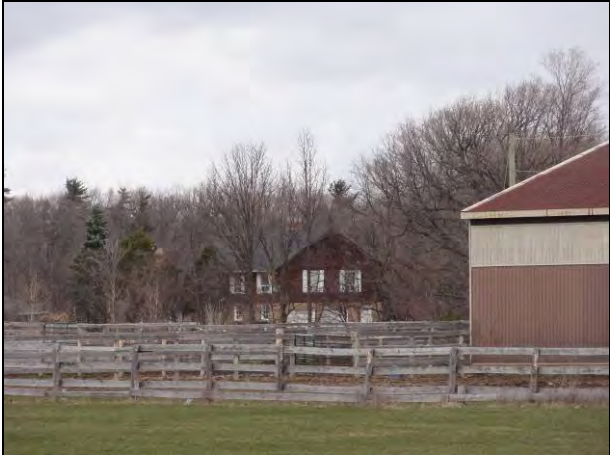
Table 2: Britannia Road EA - Identified Built Heritage Resources (BHR) and Cultural Heritage Landscapes (CHL)		
Feature	Inventory Description	Photograph(s)
CHL 12	<p>The farmscape, presently known as Rivermore Stable, is comprised of a two-storey residence, an older gable barn, as well as a number of more recent stable buildings and other outbuildings. The Boyne Survey Secondary Plan suggests that the residence dates to the late-twentieth century, the presence of an internal chimney suggests that it might be older. Its location far back from Britannia Road precluded a more detailed analysis.</p> <p>A review of the 1877 atlas map reveals that a farmhouse associated with William Alderson was located closer to Britannia Road, around the location of the current outbuildings. A farmhouse and orchard are also illustrated just outside the limits of the property, on the west side of Sixteen Mile Creek. The atlas also reveals that the irregular property boundaries, which seem to follow the high banks of the creek, were in place by 1877.</p> <p>(see Sheets 2-3)</p>

<p>South and west elevations of the farmhouse.</p>

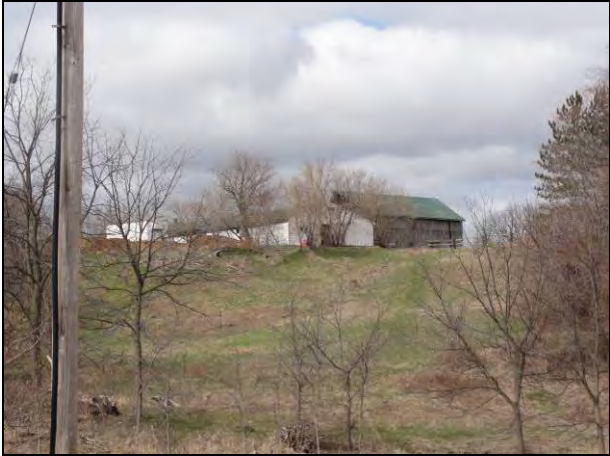
<p>View of the older outbuildings on this farmscape.</p>

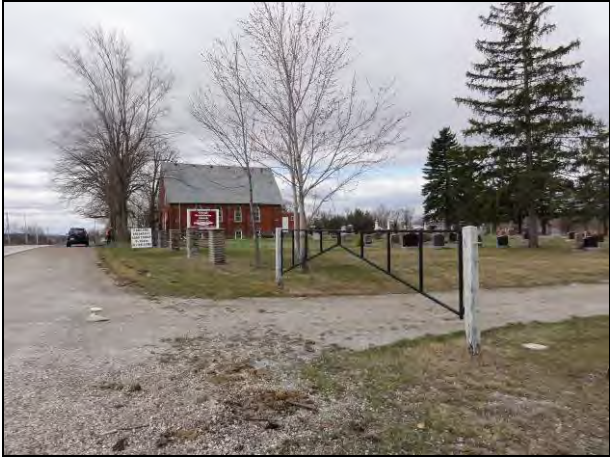
Table 2: Britannia Road EA - Identified Built Heritage Resources (BHR) and Cultural Heritage Landscapes (CHL)		
Feature	Inventory Description	Photograph(s)
CHL 13	<p>The Omagh Presbyterian Church and cemetery was founded on May 4th, 1838. The current church, which was constructed in 1909, is of frame construction with a red brick veneer, a front gable roof, stone foundations and sills, and Gothic-style architectural details such as pointed arch window and door openings. The cemetery is located to the side and rear of the church, which is located quite close to the Britannia Road right-of-way. Mature and established trees are found on the property.</p>

<p>Omagh Church and Cemetery.</p>
	<p>Location: 8815 Britannia Road Feature Type: Church and cemetery Recognition: Listed, Town of Milton Heritage Inventory</p>

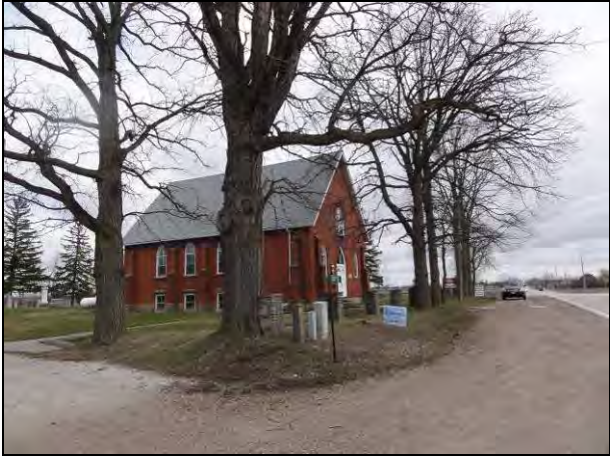
<p>South and west elevations of the Omagh Church.</p>

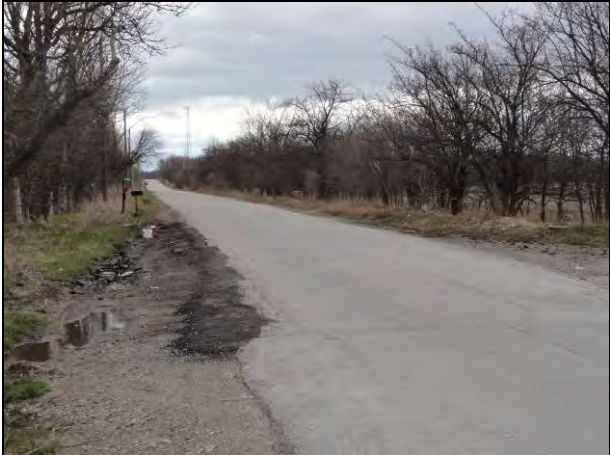
Feature	Inventory Description	Photograph(s)
CHL 14	<p>Historically, Thompson Road forms the road allowance between Concessions III and IV in the Township of Trafalgar North. The roadscape is characterized by a narrow, two-lane paved road with little to no shoulders and shallow ditches. It is framed by agricultural fields to the north of Britannia Road, and tree-lined properties to the south.</p> <p>(see Sheet 3)</p>

<p>View south along Thompson Road from Britannia Road.</p>

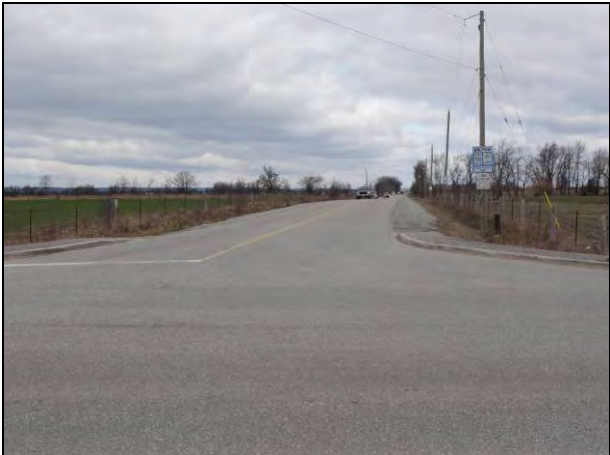
<p>View north along Thompson Road from Britannia Road.</p>
	<p>Location: Thompson Road Feature Type: Roadscape Recognition: Identified, Field Assessment</p>

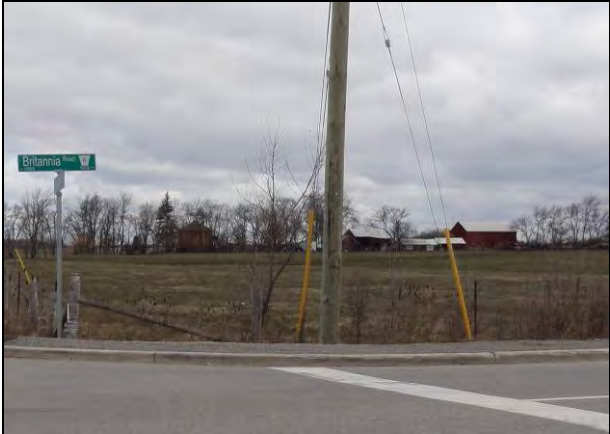
Table 2: Britannia Road EA - Identified Built Heritage Resources (BHR) and Cultural Heritage Landscapes (CHL)		
Feature	Inventory Description	Photograph(s)
CHL 15	<p>The farmscape is comprised of a two-storey farmhouse, a gable barn and other outbuildings, and a number of landscape features evocative of early agricultural land use. The residence features a hipped roof, brick construction and/or veneer, and potentially dates to c. 1930s (UMA 2010: 27). Mature trees surround the built structures and tree lines form boundaries between different fields. While the large agricultural property extends to and along Britannia Road, the built structures are located approximately 300 metres from the right-of-way.</p> <p>A farmhouse associated with Robert Elliot is illustrated at this location on the 1877 atlas map.</p> <p>(see Sheet 3)</p>

<p>View of the farmscape from Britannia Road.</p>

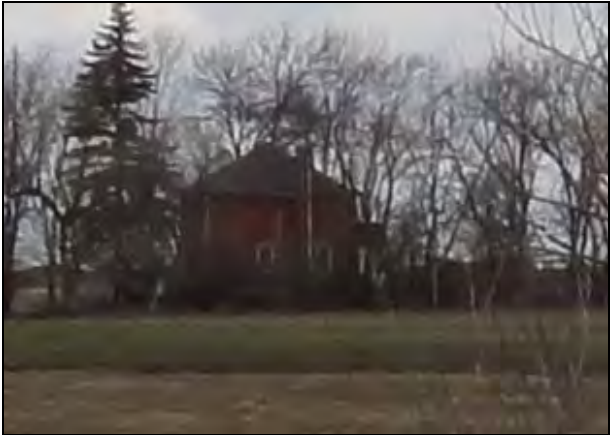
<p>South elevation of the farmhouse.</p>

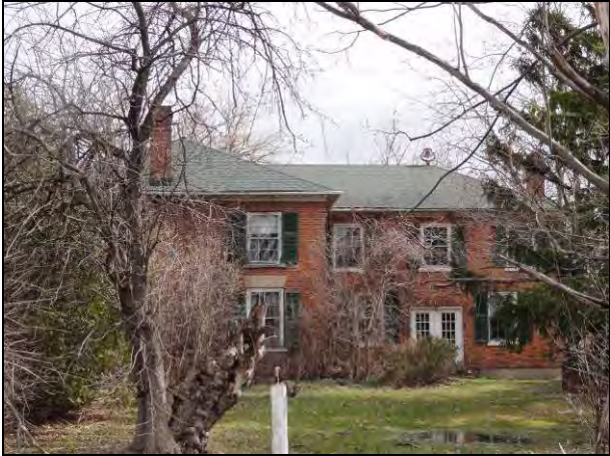
Table 2: Britannia Road EA - Identified Built Heritage Resources (BHR) and Cultural Heritage Landscapes (CHL)		
Feature	Inventory Description	Photograph(s)
CHL 16	<p>This farmscape consists of a nineteenth-century farmhouse, a large nineteenth-century barn complex with various other modern outbuildings, and a number of landscape features evocative of early settlement and agricultural land use. The farmhouse, which dates to c.1860s-70s features a two-storey scale, solid brick construction, a hipped roof, a two-storey rear accretion, a symmetrical five-bay front façade, a deep and covered front veranda, a central enclosed porch on the upper-storey, two end brick chimneys, and potentially original windows and doors. The barn complex includes at least three barns that sit on stone foundations, the larger of which has a gambrel roof and is banked on the north elevation facing Britannia Road. The other two feature gable roofs.</p> <p>A small woodlot is located to the rear of the residence, a small orchard is found north and west of the residence, and mature and established trees are found throughout the property. A small creek flows between the residence and the farm buildings and there is a small pond immediately south of the Britannia Road right-of-way. A remnant fence line featuring concrete posts is found along the northern and western limit of the property.</p> <p>Two farmhouses and a large orchard associated with George Buck are illustrated at this location on the 1877 atlas map.</p> <p>(see Sheet 3)</p>	  <p>South elevation of the farmhouse.</p>

<p>West elevation of the farmhouse.</p>   <p>View of the outbuildings from Britannia Road.</p>

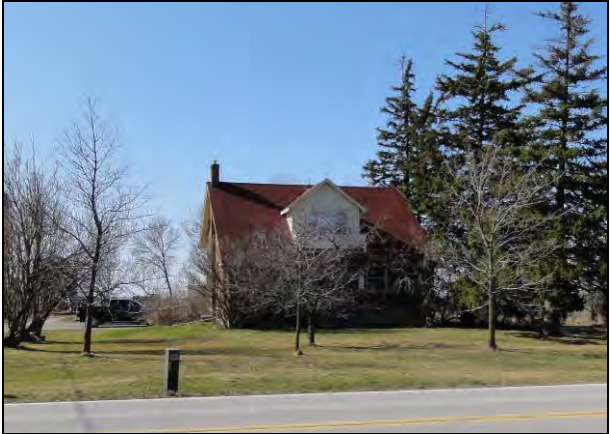
Table 2: Britannia Road EA - Identified Built Heritage Resources (BHR) and Cultural Heritage Landscapes (CHL)		
Feature	Inventory Description	Photograph(s)
CHL 17	<p>The farmscape consists of a c.1920s farmhouse, a large nineteenth-century barn, two silos, and a number of other agricultural outbuildings of various ages. The residence consists of a one-and-a-half storey Arts and Crafts bungalow with a side gable roof, a gable front dormer, an enclosed veranda, brick construction and/or veneer, and an external brick chimney. The extensive barn complex sits prominently on the flat and open landscape.</p> <p>According to the Town of Milton, the c.1920s residence is one of the few remaining such houses within Trafalgar Township.</p> <p>(see Sheets 3-4)</p>

<p>South elevation of the farmhouse.</p>

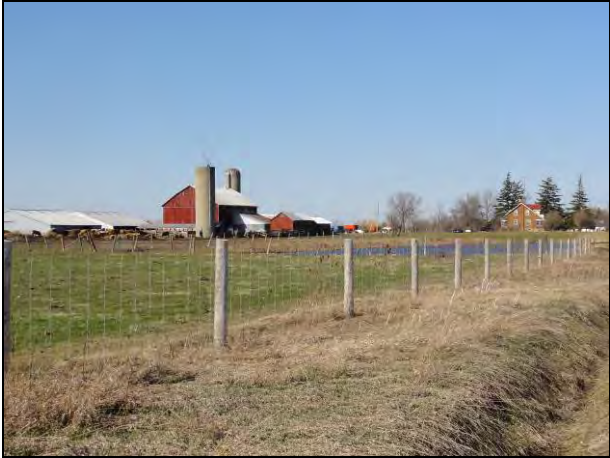
<p>View of the farmscape from Britannia Road.</p>
	Location: 9815 Britannia Road	
	Feature Type: Farmscape

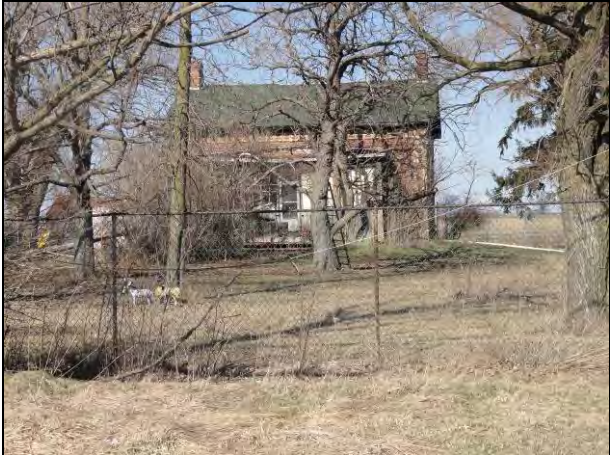
Table 2: Britannia Road EA - Identified Built Heritage Resources (BHR) and Cultural Heritage Landscapes (CHL)		
Feature	Inventory Description	Photograph(s)
CHL 20	<p>The farmscape is comprised of a nineteenth-century farmhouse, two large gable barns, a silo, various other outbuildings, as well as a number of landscape features evocative of early settlement and agricultural land use. The residence features a one-and-a-half storey scale, brick construction, a side gable roof, and chimneys with brick stacks at both gable ends. The red brick structure is characterized by buff brick quoining and banding under the roof line. The structure also features a single-storey rear tail with a covered veranda.</p>

<p>East elevation of the farmhouse.</p>
	<p>The gravel drive is lined with mature trees and the property features a number of fence lines of different styles, including older post-and-beam fencing within the property. A review of aerial mapping reveals that a small creek meanders through the large property and that a pond is located behind the barn complex.</p>

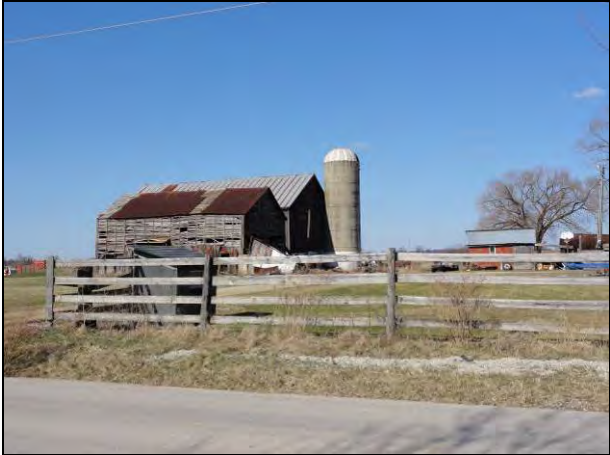
<p>View of the outbuildings from Fourth Line.</p>

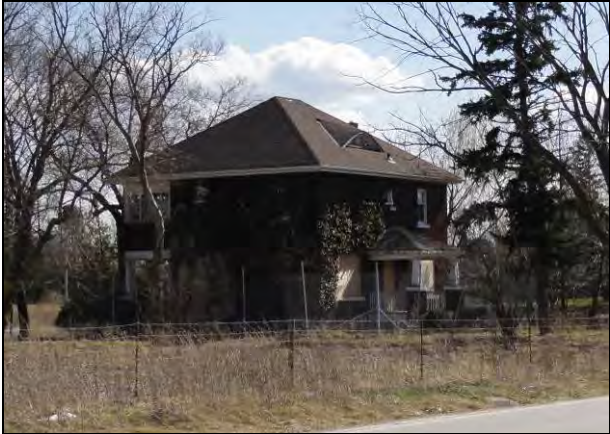
Table 2: Britannia Road EA - Identified Built Heritage Resources (BHR) and Cultural Heritage Landscapes (CHL)		
Feature	Inventory Description	Photograph(s)
CHL 21	<p>The farmscape is comprised of an early-twentieth century farmhouse and landscape features evocative of early agricultural land use. A review of available aerial mapping and the Boyne Survey Secondary Plan (UMA 2010: 22) indicates that, until recently, the property also featured a large gambrel barn and other outbuildings. At the time of the field assessment, these structures were no longer extant and a large area to the southeast of the residence was surrounded by temporary fencing.</p> <p>The farmhouse, which appears to be presently abandoned, features a two-and-a-half storey scale, textured concrete block foundations, a hipped roof with an eyebrow dormer (also known as a witch's eye), and a symmetrical three-bay front façade with a covered porch. Established trees line the driveway and the agricultural fields on the large property are still active.</p> <p>(see Sheet 4)</p>

<p>East and north elevations of the farmhouse.</p>

6. Encroachment of lands close to built heritage features and cultural landscape units should be avoided wherever possible. Where encroachment is expected, appropriate vehicular access to the resources and appropriate setbacks between structures and the road should be ensured to promote their long-term viability. Appropriate landscape screening and noise abatement measures should be developed for these resources as part of the detailed design phase. Resources that are recommended for these measures include: BHR 2, BHR 12, BHR 14, BHR 16, CHL 9, CHL 11, CHL 12, CHL 13, CHL 16, CHL 19, CHL 21, CHL 24, and CHL 31.

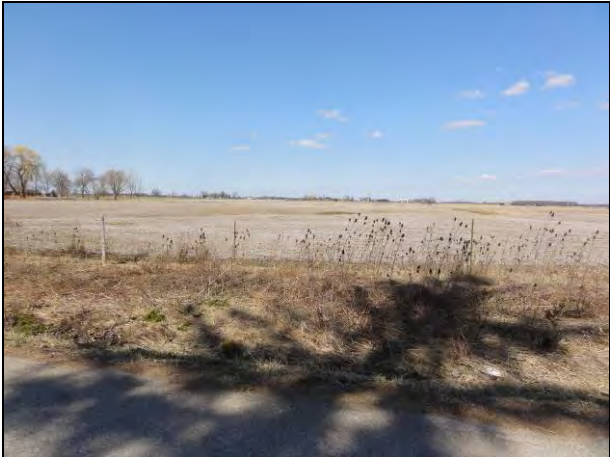
<p>Looking east from Fourth Line along the approximate location of Alignment 5C through the property.</p>

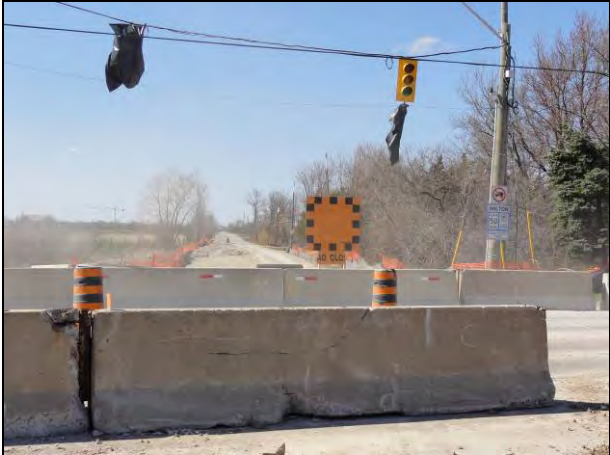
Table 2: Britannia Road EA - Identified Built Heritage Resources (BHR) and Cultural Heritage Landscapes (CHL)		
Feature	Inventory Description	Photograph(s)
CHL 22	<p>Historically, Fourth Line forms the road allowance between Concessions IV and V in the Township of Trafalgar North. The roadscape is characterized by a narrow, two-lane paved road with little to no shoulders and shallow ditches. It is framed by remnants of the historic crossroad settlement of Omagh, as well as active agricultural fields to the north and south of Britannia Road.</p> <p>(see Sheet 4)</p>

<p>View north along Fourth Line from Britannia Road.</p>

It is recommended that the following resources be subject to heritage documentation activities, the result of which are compiled into one report and which is archived with local repositories and filed with the Town of Milton: BHR 2, BHR 12, CHL 5, CHL 8, CHL 10, CHL 14, CHL 22, CHL 23, CHL 27, CHL 28, CHL 29, CHL 31, CHL 32, CHL 33, and CHL 34.

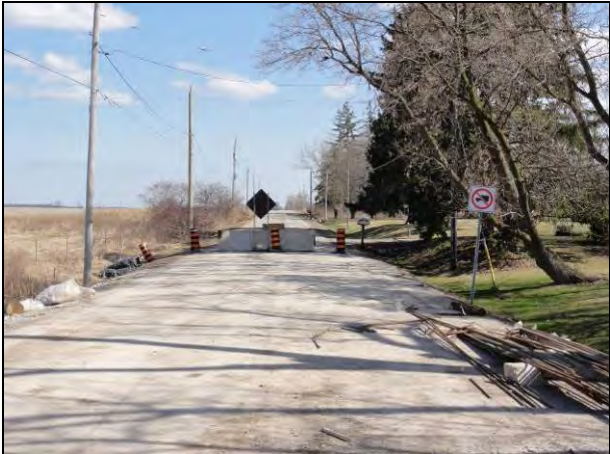
<p>View south along Fourth Line from Britannia Road.</p>
	Location: Fourth Line	
	Feature Type: Roadscape	
	Recognition: Identified, Field Assessment	
CHL 23	<p>The historic settlement of Omagh developed at the intersection of Britannia Road and Fourth Line. Today, the settlement features a small grouping of nineteenth and twentieth century residences, neighbouring farm complexes, and churches. According to the Town of Milton, Omagh is the largest and most significant of the historic settlements that remain from the former Township of Trafalgar and are recommending that it be designated as a Heritage Conservation District (see Sheet 4)</p>

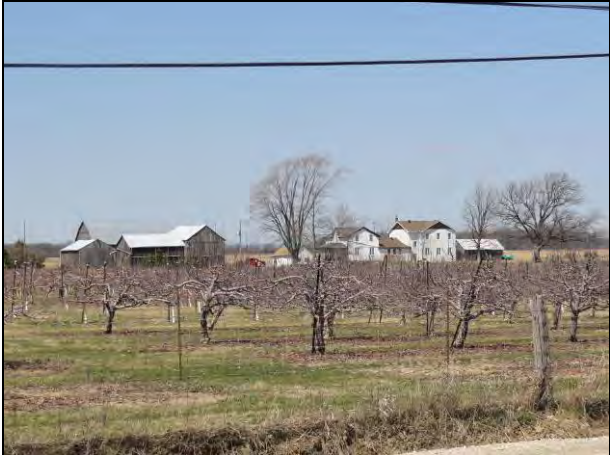
Table 2: Britannia Road EA - Identified Built Heritage Resources (BHR) and Cultural Heritage Landscapes (CHL)		
Feature	Inventory Description	Photograph(s)
CHL 26	<p>The farmscape is comprised of a large residential complex, a number of gable barns, a large orchard, agricultural fields, and other landscape features evocative of early settlement and agricultural land use. The residential structure seems to be comprised of two separate houses that have been connected by a third, single-storey section. The eastern part of the residence is a one-and-a-half storey Ontario Gothic house with a centre gable and a covered veranda. The western part of the residence is a two-storey, vernacular structure with an L-shaped footprint and a cross gable roof. The barn complex features a gambrel barn and at least three gable barns, all with metal roofs and vertical board siding. A few mature trees are located near the built structures.</p> <p>A farmhouse with orchard associated with Robert Bigger is illustrated on the 1877 atlas map. The property currently operates as the Willis Family Fruit Farm and Market. While the large agricultural property extends to, and along, Britannia Road, the built structures are located approximately 250 m from the right-of-way.</p> <p>(see Sheet 5)</p>

<p>View of the farmscape from Britannia Road.</p>

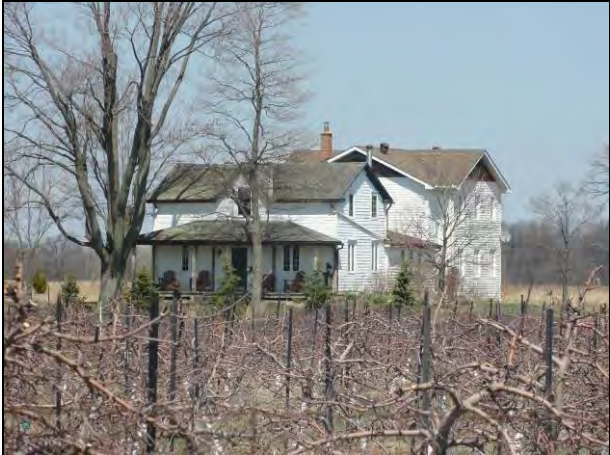
<p>East elevation of the farmhouse from Fifth Line.</p>
	<p>Location: Fifth Line</p> <p>Feature Type: Roadscape</p> <p>Recognition: Identified, Field assessment</p>

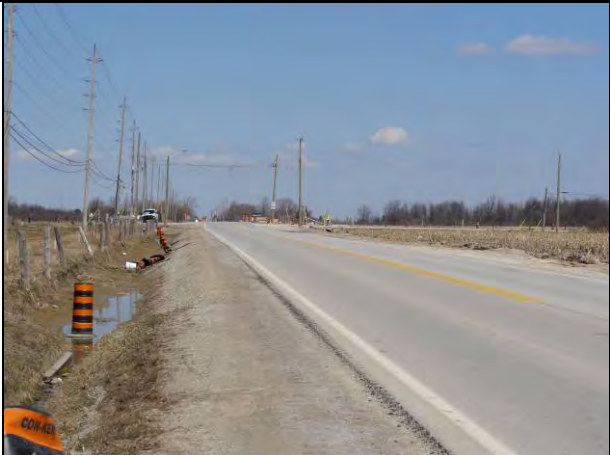
<p>Looking east along Britannia Road toward the intersection with Fifth Line.</p>
	<p>Historically, Fifth Line forms the road allowance between Concessions V and VI in the Township of Trafalgar North. The roadscape is characterized by a narrow, two-lane paved road with little to no shoulders and shallow ditches. It is framed by active farmsteads both north and south of Britannia Road.</p> <p>(see Sheet 5)</p>

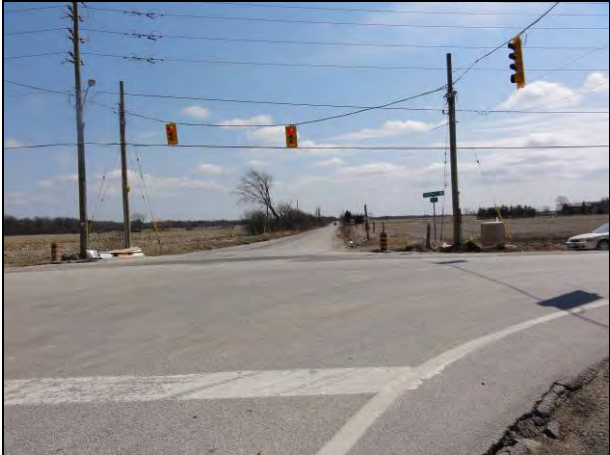
Table 2: Britannia Road EA - Identified Built Heritage Resources (BHR) and Cultural Heritage Landscapes (CHL)		
Feature	Inventory Description	Photograph(s)
CHL 28	<p>Historically, Sixth Line forms the road allowance between Concessions VI and VII in the Township of Trafalgar North. The roadscape is characterized by a narrow, two-lane paved road with little to no shoulders and shallow ditches. It is framed by active farmsteads both north and south of Britannia Road.</p> <p>(see Sheet 6)</p>

<p>View south along Sixth Line from Britannia Road.</p>

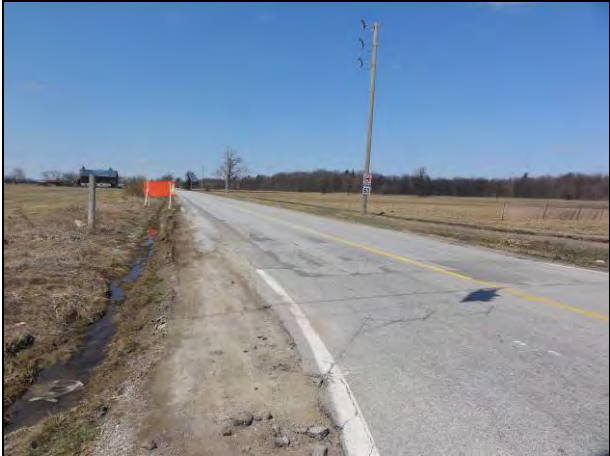
<p>View north along Sixth Line from Britannia Road.</p>
	Location: Sixth Line	
	Feature Type: Roadscape	
	Recognition: Identified, Field assessment	
CHL 29	<p>The historic crossroads community of Drumquin, which was founded around 1820, developed at the intersection of what is now Britannia Road and Trafalgar Road. Today, the historic settlement features a small grouping of nineteenth and twentieth-century residences, adjacent farmsteads, and a modern gas station.</p> <p>(see Sheets 6-7)</p>
