**Cultural Heritage Assessment Report:
Built Heritage Resources and Cultural Heritage Landscapes**

**Britannia Road Transportation Corridor Improvements
Tremaine Road to Highway 407
Class Environmental Assessment Study,
Town of Milton, Regional Municipality of Halton, Ontario**

ASI File 10EA-183

September 2011 (February 2012)

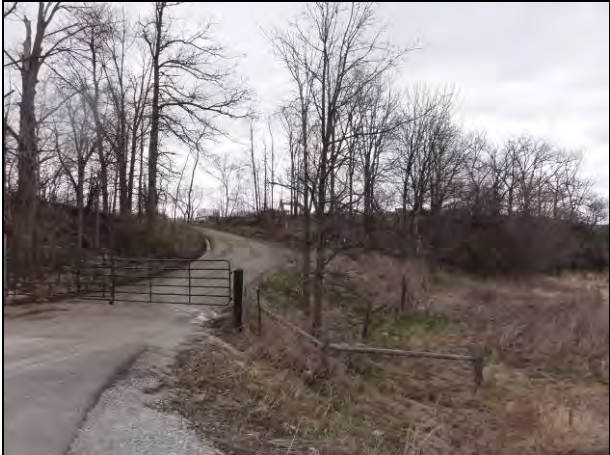
Table 2: Britannia Road EA - Identified Built Heritage Resources (BHR) and Cultural Heritage Landscapes (CHL)		
Feature	Inventory Description	Photograph(s)
CHL 30	<p>The remnant farmscape at 6119 Trafalgar Road is located on the high tablelands on the east bank of Sixteen Mile Creek (east branch), and is effectively shielded from the road through a combination of topography and vegetation. According to the Town of Milton, the structure(s) on this property might have been previously demolished. The large agricultural property, which extends to and along Britannia Road, features at least one extant outbuilding with a gable roof clad in metal sheeting, a winding gravel driveway with a gate, post-and-wire fencing, part of Sixteen Mile Creek, and large open fields. At the time of the field assessment, an excavator was parked on the site. The driveway leading to the remnant built structure(s) is located approximately 375 m from Britannia Road.</p> <p>A farmhouse and orchard associated with William Hood are illustrated at this location on the 1877 atlas map.</p> <p>(see Sheet 7)</p>

<p>View up the drive at 6119 Trafalgar Road.</p>

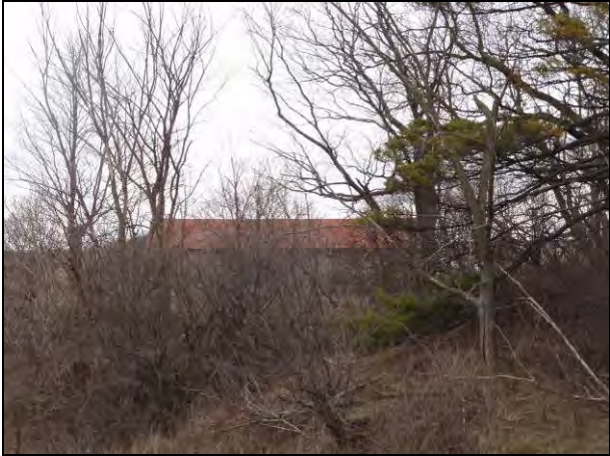
<p>View of an extant outbuilding.</p>

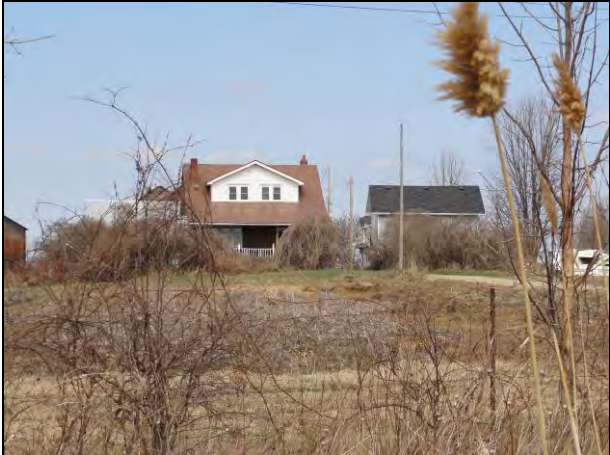
Table 2: Britannia Road EA - Identified Built Heritage Resources (BHR) and Cultural Heritage Landscapes (CHL)		
Feature	Inventory Description	Photograph(s)
CHL 31	<p>The farmscape is comprised of two residences, a large gable barn and other agricultural outbuildings, an orchard, agricultural fields, and other landscape features evocative of early agricultural land use. One of the farmhouses was constructed around the 1920s in the Arts and Crafts style (top photo) and features a one-and-a-half storey scale, a side gable roof with a large front gable dormer, a covered veranda, and chimneys at both gable ends. The other farmhouse (middle photo) features a two-storey frame dwelling with a single-storey rear accretion. The scale and visible material fabric of the latter could suggest a more recent construction date. However, it's location on the landscape in relation to the gable barn and its T-shaped footprint are evocative of late-nineteenth century residential development patterns.</p> <p>An orchard, but no farmhouse, is illustrated at this approximate location on the 1877 atlas map.</p> <p>(see Sheet 7)</p>

<p>South elevation of the 1920s farmhouse.</p>

6. Encroachment of lands close to built heritage features and cultural landscape units should be avoided wherever possible. Where encroachment is expected, appropriate vehicular access to the resources and appropriate setbacks between structures and the road should be ensured to promote their long-term viability. Appropriate landscape screening and noise abatement measures should be developed for these resources as part of the detailed design phase. Resources that are recommended for these measures include: BHR 2, BHR 12, BHR 14, BHR 16, CHL 9, CHL 11, CHL 12, CHL 13, CHL 16, CHL 19, CHL 21, CHL 24, and CHL 31.

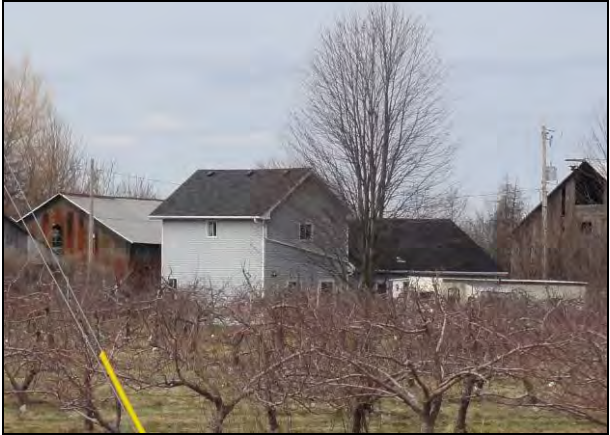
<p>South and east elevations of the second farmhouse.</p>

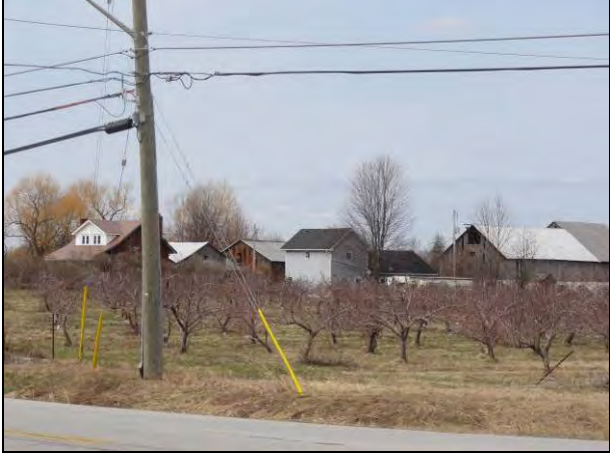
<p>View of the farmscape from the intersection of Britannia Road and Eighth Line.</p>

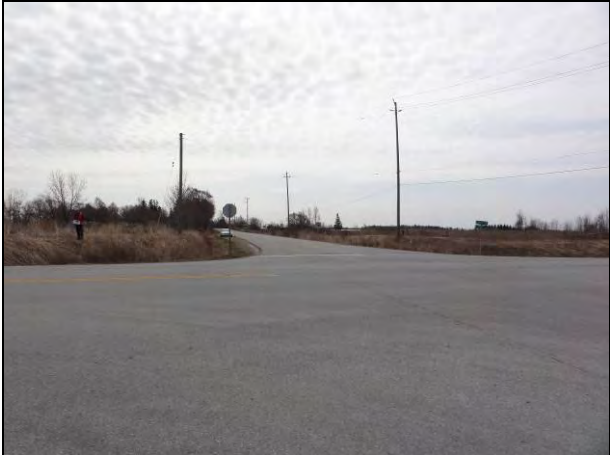
Table 2: Britannia Road EA - Identified Built Heritage Resources (BHR) and Cultural Heritage Landscapes (CHL)		
Feature	Inventory Description	Photograph(s)
CHL 32	<p>Historically, Eighth Line forms the road allowance between Concessions VIII and IX in the Township of Trafalgar North. The roadscape is characterized by a narrow, two-lane paved road with little to no shoulders and shallow ditches. It is framed by active farmsteads both north and south of Britannia Road.</p> <p>(see Sheet 7)</p>

<p>View south along Eighth Line from Britannia Road.</p>

It is recommended that the following resources be subject to heritage documentation activities, the result of which are compiled into one report and which is archived with local repositories and filed with the Town of Milton: BHR 2, BHR 12, CHL 5, CHL 8, CHL 10, CHL 14, CHL 22, CHL 23, CHL 27, CHL 28, CHL 29, CHL 31, CHL 32, CHL 33, and CHL 34.

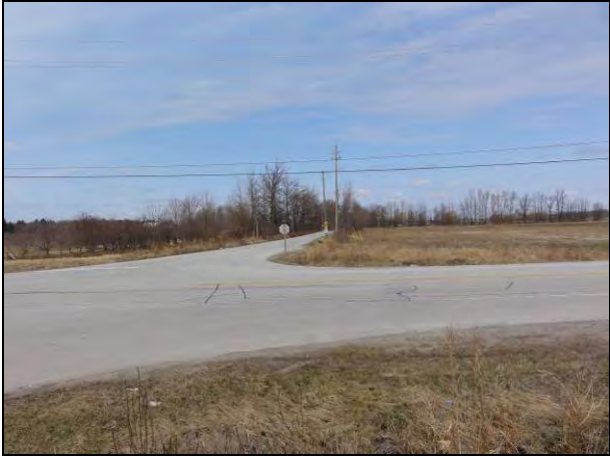
<p>View north along Eighth Line from Britannia Road.</p>
	Location: Eighth Line	
	Feature Type: Roadscape	
	Recognition: Identified, Field Assessment

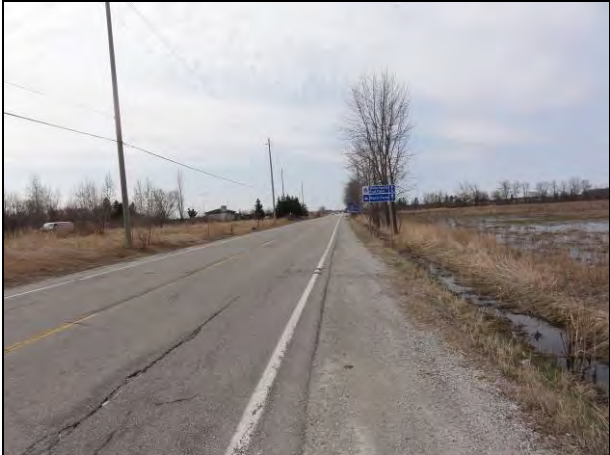
Table 2: Britannia Road EA - Identified Built Heritage Resources (BHR) and Cultural Heritage Landscapes (CHL)		
Feature	Inventory Description	Photograph(s)
CHL 33	<p>Historically, Britannia Road forms the road allowance between Lots 5 and 6 in the Township of Trafalgar North. Generally, the roadscape is characterized by a narrow, two-lane paved road with gravel shoulders and shallow ditches. In some areas, the right-of-way has been improved, such as at the intersection of more major north-south routes such as Trafalgar Road, James Snow Parkway, and Regional Road 25. The landscape it travels through is one generally characterized by active farmsteads dating to the nineteenth and early twentieth centuries. It also intersects three historic settlements and crosses two branches of Sixteen Mile Creek.</p> <p>(see Sheets 1-8)</p>

<p>View west along Britannia Road near the eastern end of the study corridor.</p>

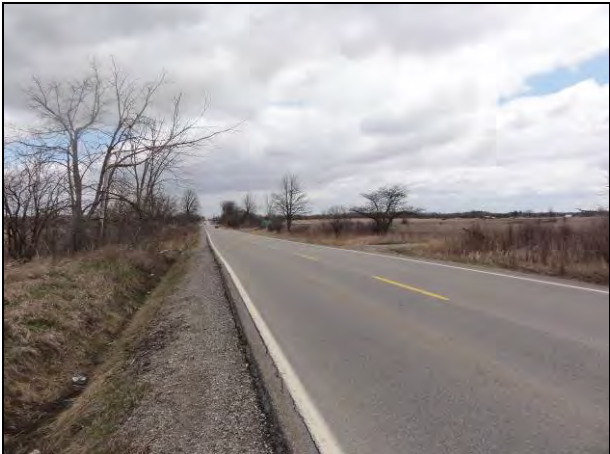
<p>View east along Britannia Road near the western end of the study corridor.</p>

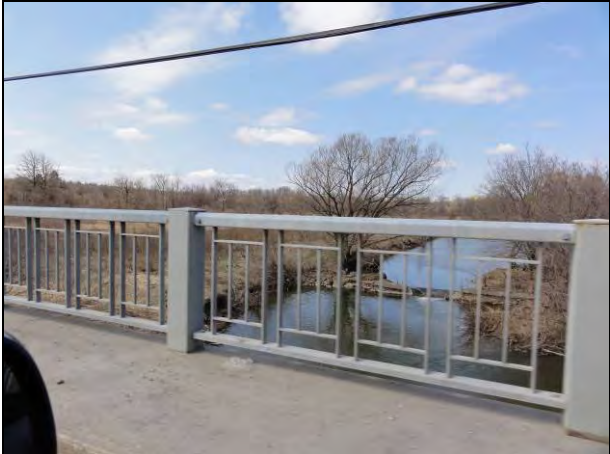
Table 2: Britannia Road EA - Identified Built Heritage Resources (BHR) and Cultural Heritage Landscapes (CHL)		
Feature	Inventory Description	Photograph(s)
CHL 34	<p>The various branches of Sixteen Mile Creek flow southward through the Region of Halton into Lake Ontario in Oakville. As early settlement tended to take place in the vicinity of waterways, Sixteen Mile Creek is historically associated with the agricultural settlement of the land in the former Township of Trafalgar and continues to contribute to the character of the existing rural agricultural landscape.</p> <p>(see Sheets 1 and 7/8)</p>

<p>Sixteen Mile Creek on the north side of Britannia Road, west of Trafalgar Road.</p>

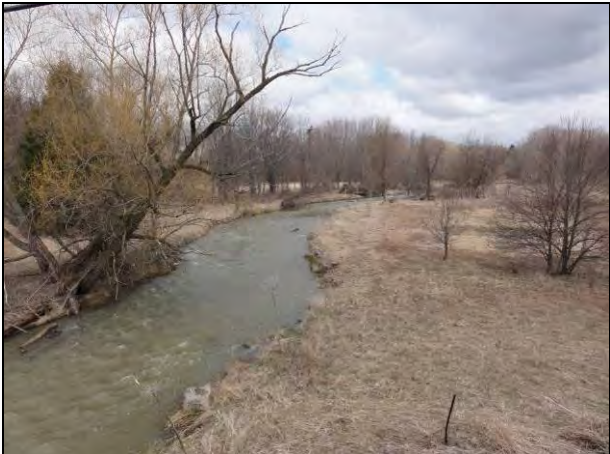
<p>Sixteen Mile Creek on the north side of Britannia Road, east of Regional Road 25.</p>
	Location: Sixteen Mile Creek, two branches	
	Feature Type: Waterscape	
	Recognition: Identified, Field Assessment
