APPENDIX F
Designated Substance Report

**DESIGNATED SUBSTANCES AND
HAZARDOUS MATERIALS ASSESSMENT
SPECIFIC TO THE POTENTIAL DECOMMISSIONING AND
DEMOLITION PROJECT**

Junction Street Pumping Station
2137 Lakeshore Road
Burlington, Ontario
L7R 1A4

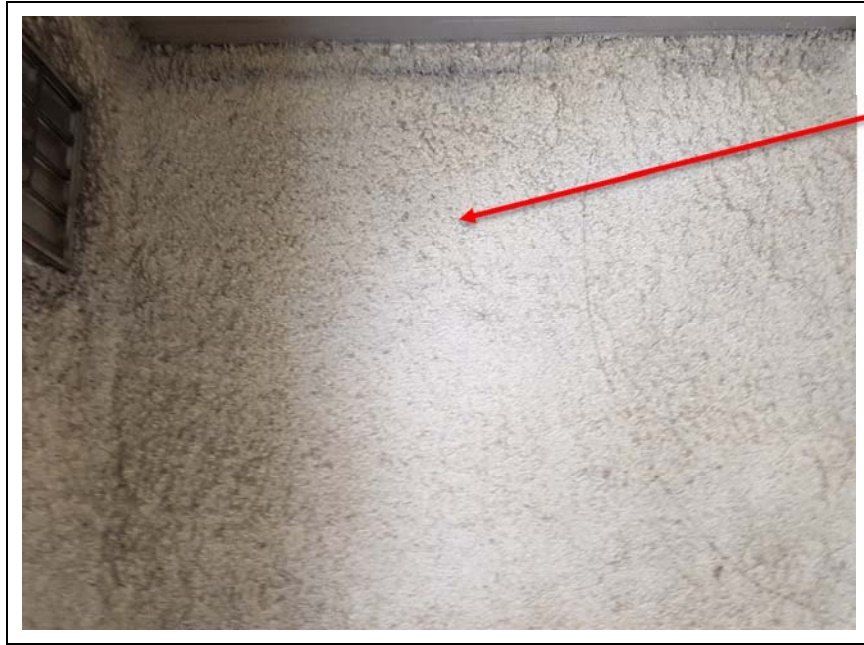
P1 – Junction Street Pumping Station

View of non-asbestos containing sprayed fireproofing that was observed and sampled.

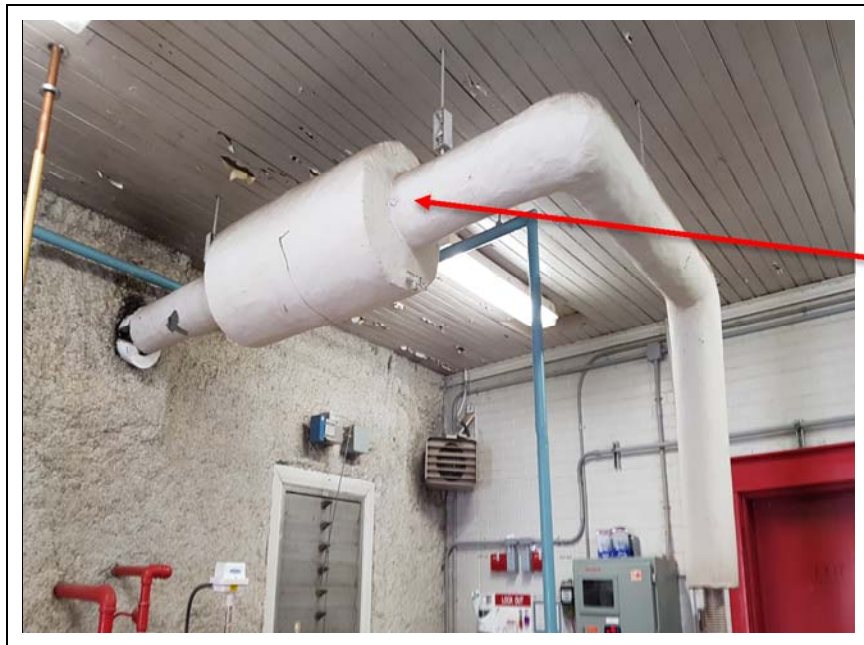
P2 – Junction Street Pumping Station

View of non-asbestos containing parging cement on mechanical pipe that was observed and sampled.
