Regional Municipality of Halton

Trafalgar Road (Regional Road 3) Improvements Class Environmental Assessment Study Natural Environment Existing Conditions Report

AECOM

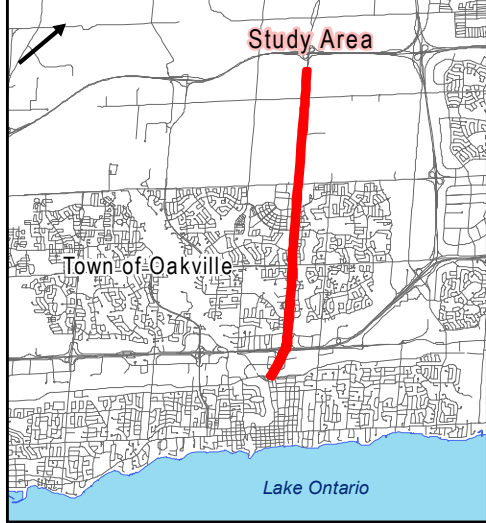
120m Development Buffer	Stream Corridor Constraints High Constraint
Trafalgar Road	High Constraint (Requiring Rehabilitation)
Waterflow	Medium Constraint
Roads	Low Constraint
Study Area Sections	Area of Investigation
Linkages	50m
Provincially Significant Wetlands	120m
Candidate Significant Woodland	
Removed Woodlands

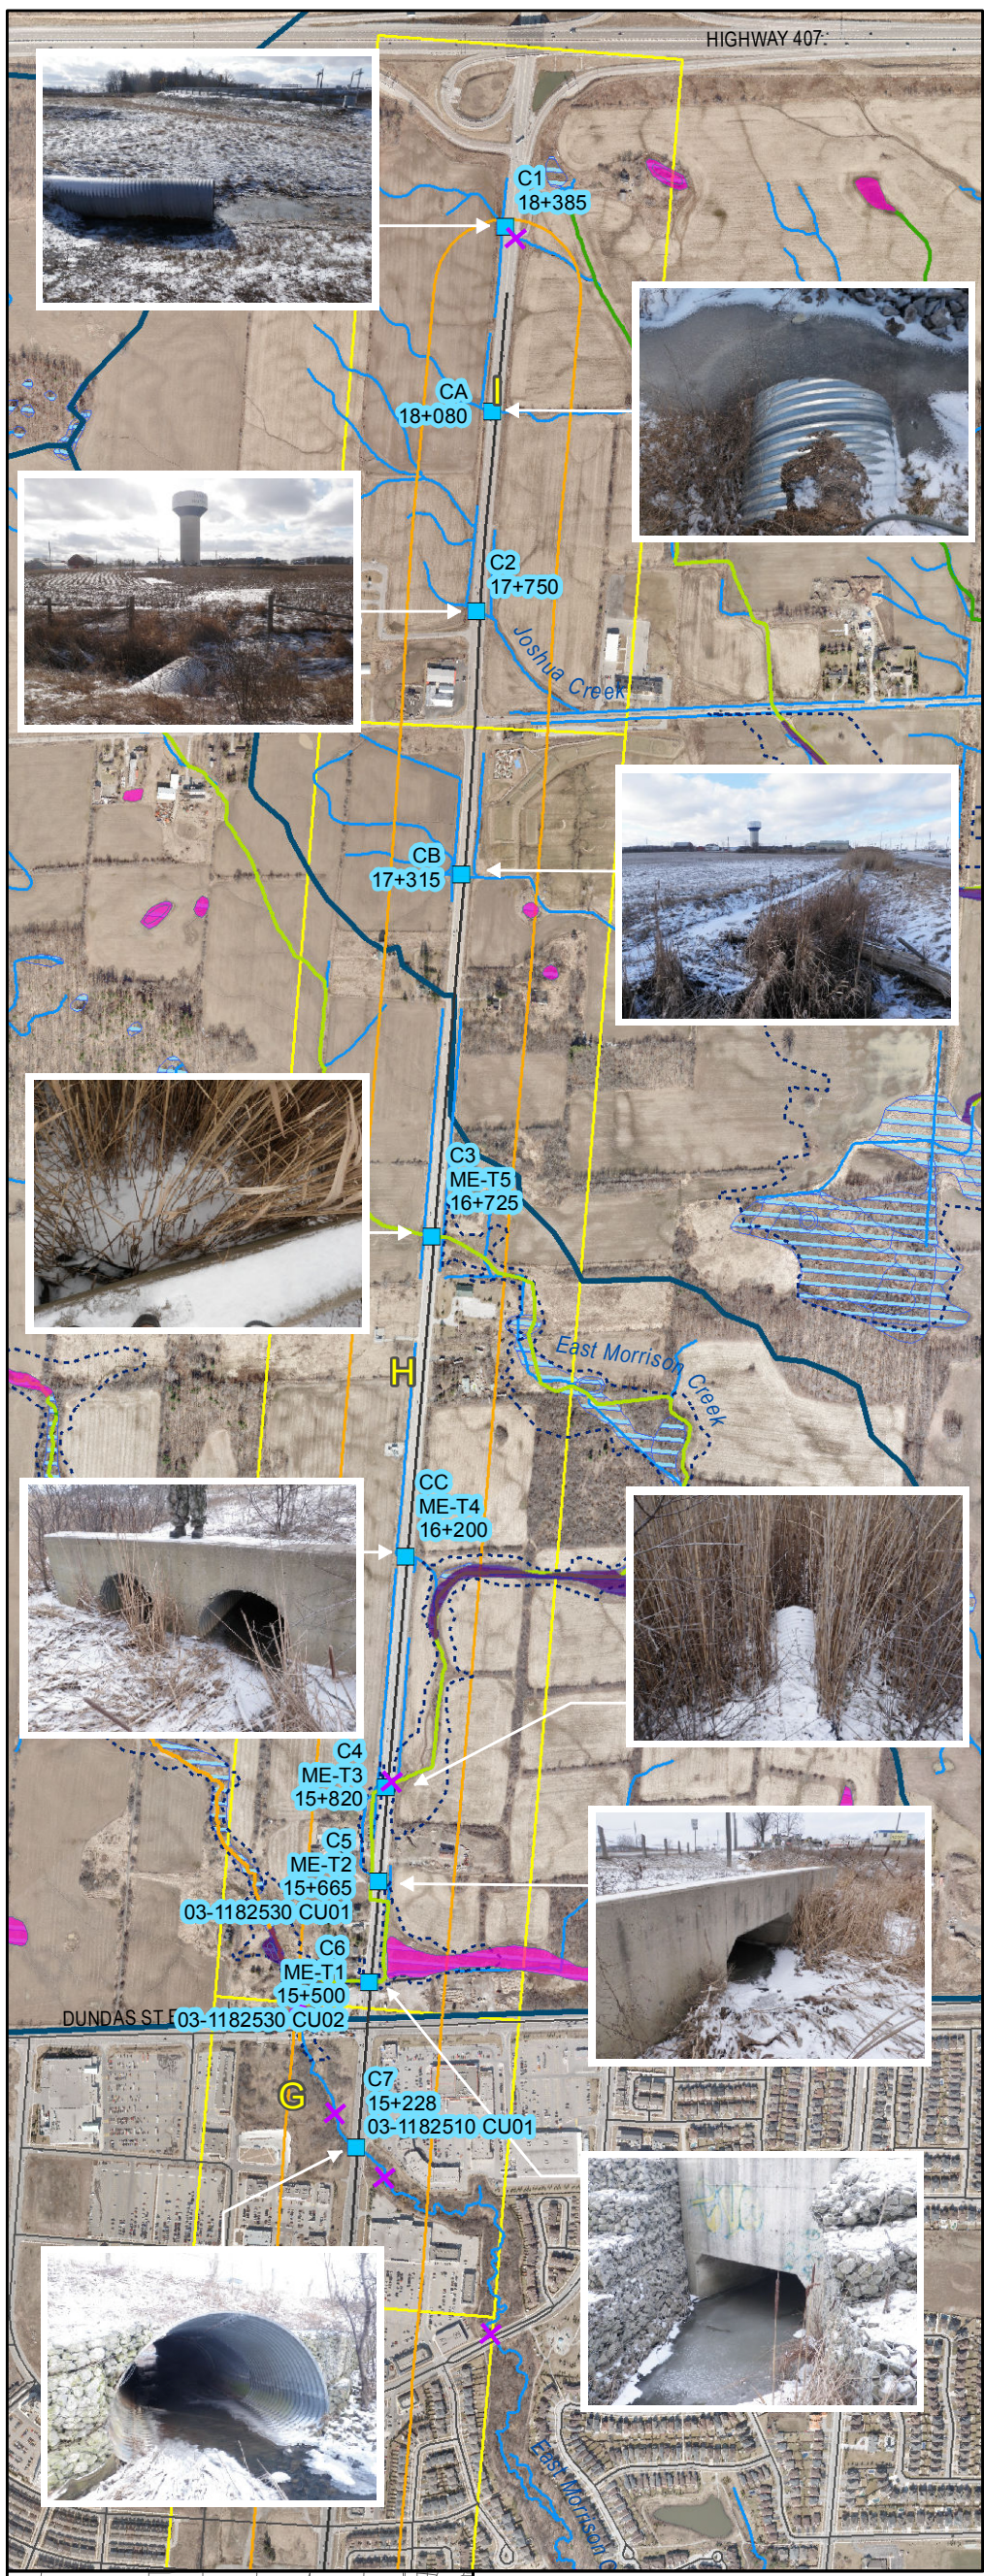
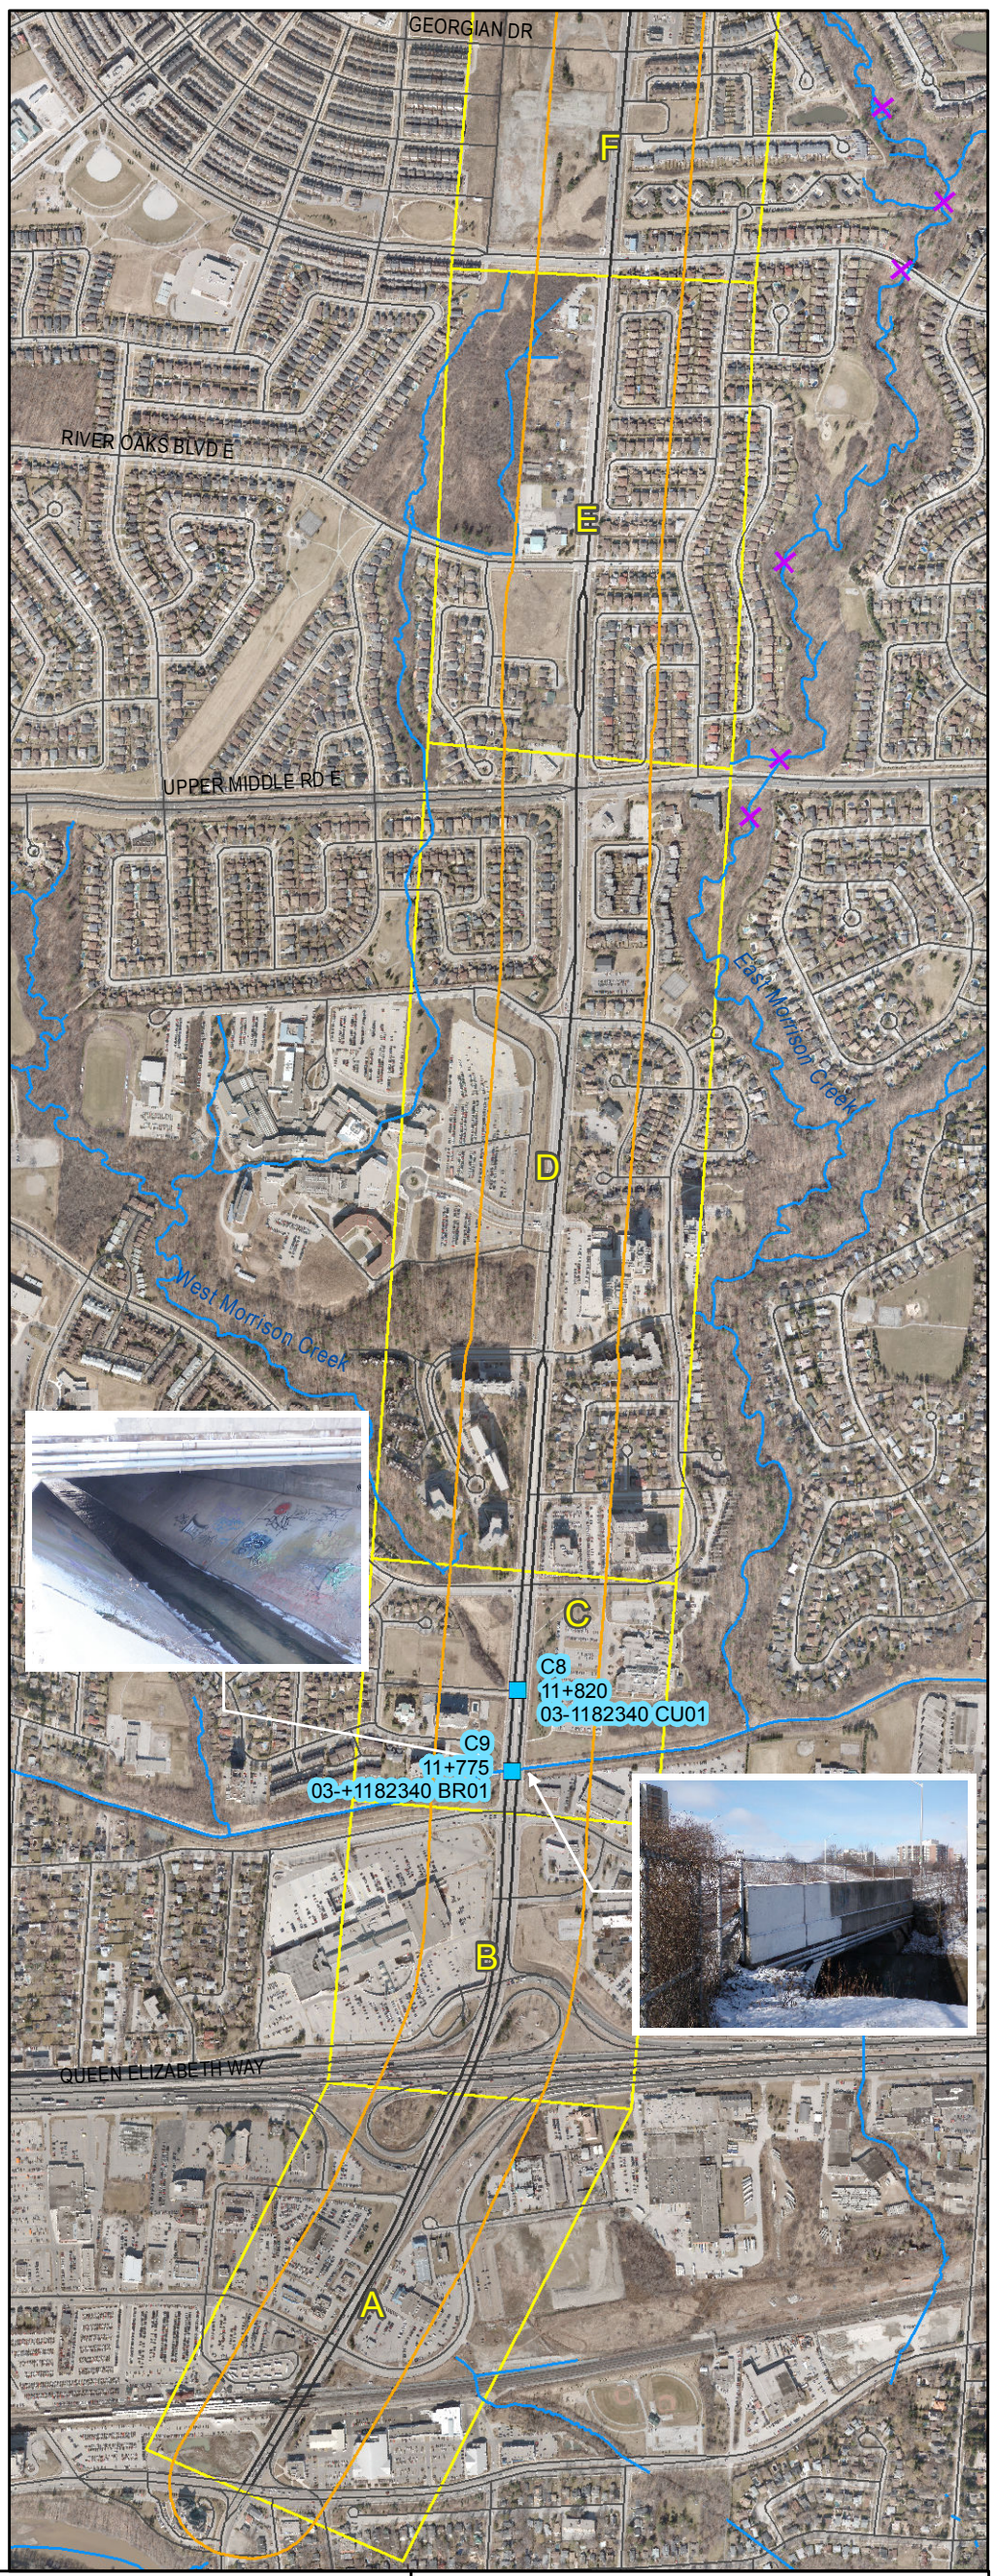
Within these sections there are twelve culvert crossings which will be impacted by the proposed works. These watercourse crossing locations are shown on **Figure 2**.

Section	2009 Field Investigations	Distance from Road	Other Observations	2013 Field Investigations
Section I – West Side	<p><i>Terrestrial Findings:</i> Mostly Active Agricultural Fields with a ditch along both sides. Vegetation includes: common reed grass, cattail, Canada goldenrod, purple loosestrife, wild carrot, and chicory.</p> <p><i>Aquatic Findings:</i> North of Burnhamthorpe Road to Highway 407, three 1 m CSP culverts were located 150 and 400 m north of Burnhamthorpe Road and 250 m south of Highway 407. These culverts convey surface water from adjacent agricultural fields. At the time of the field visit the systems were generally dry and choked with <i>Phragmites</i>.</p>			<p><i>Terrestrial Findings:</i> 2009 field investigation data remains relevant.</p> <ul style="list-style-type: none"> Newly construction GO parking lot <p><i>Aquatic Findings:</i> 150 m of Burnhamthorpe Road (C2, on Figure 2) is a small CSP, no water was observed and choked with reed canary and cattails</p> <ul style="list-style-type: none"> 400 m north of Burnhamthorpe Road (CA, on Figure 2) was a small CSP; water was frozen at the culvert opening during investigations 250 m south of Highway 407 (C1, on Figure 2) is one CSP conveying water under Trafalgar Road

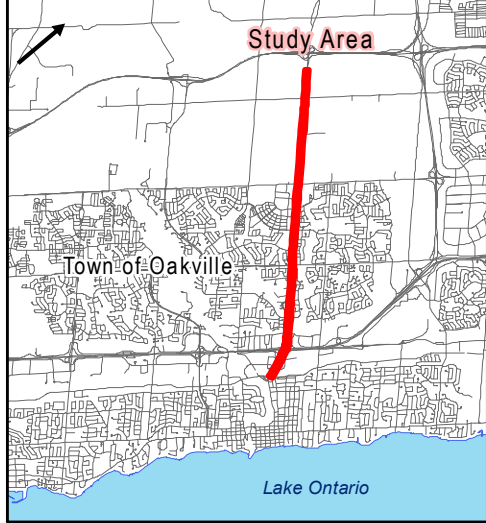
- + MNR Fish Sampling Stations
- Water Crossings (Culverts)
- 120m Development Buffer
- Trafalgar Road
- Waterflow
- Roads
- Floodlines
- Study Area Sections
- Provincially Significant Wetlands

Figure 2 (refer to Section 1) presents the existing watercourse crossing locations

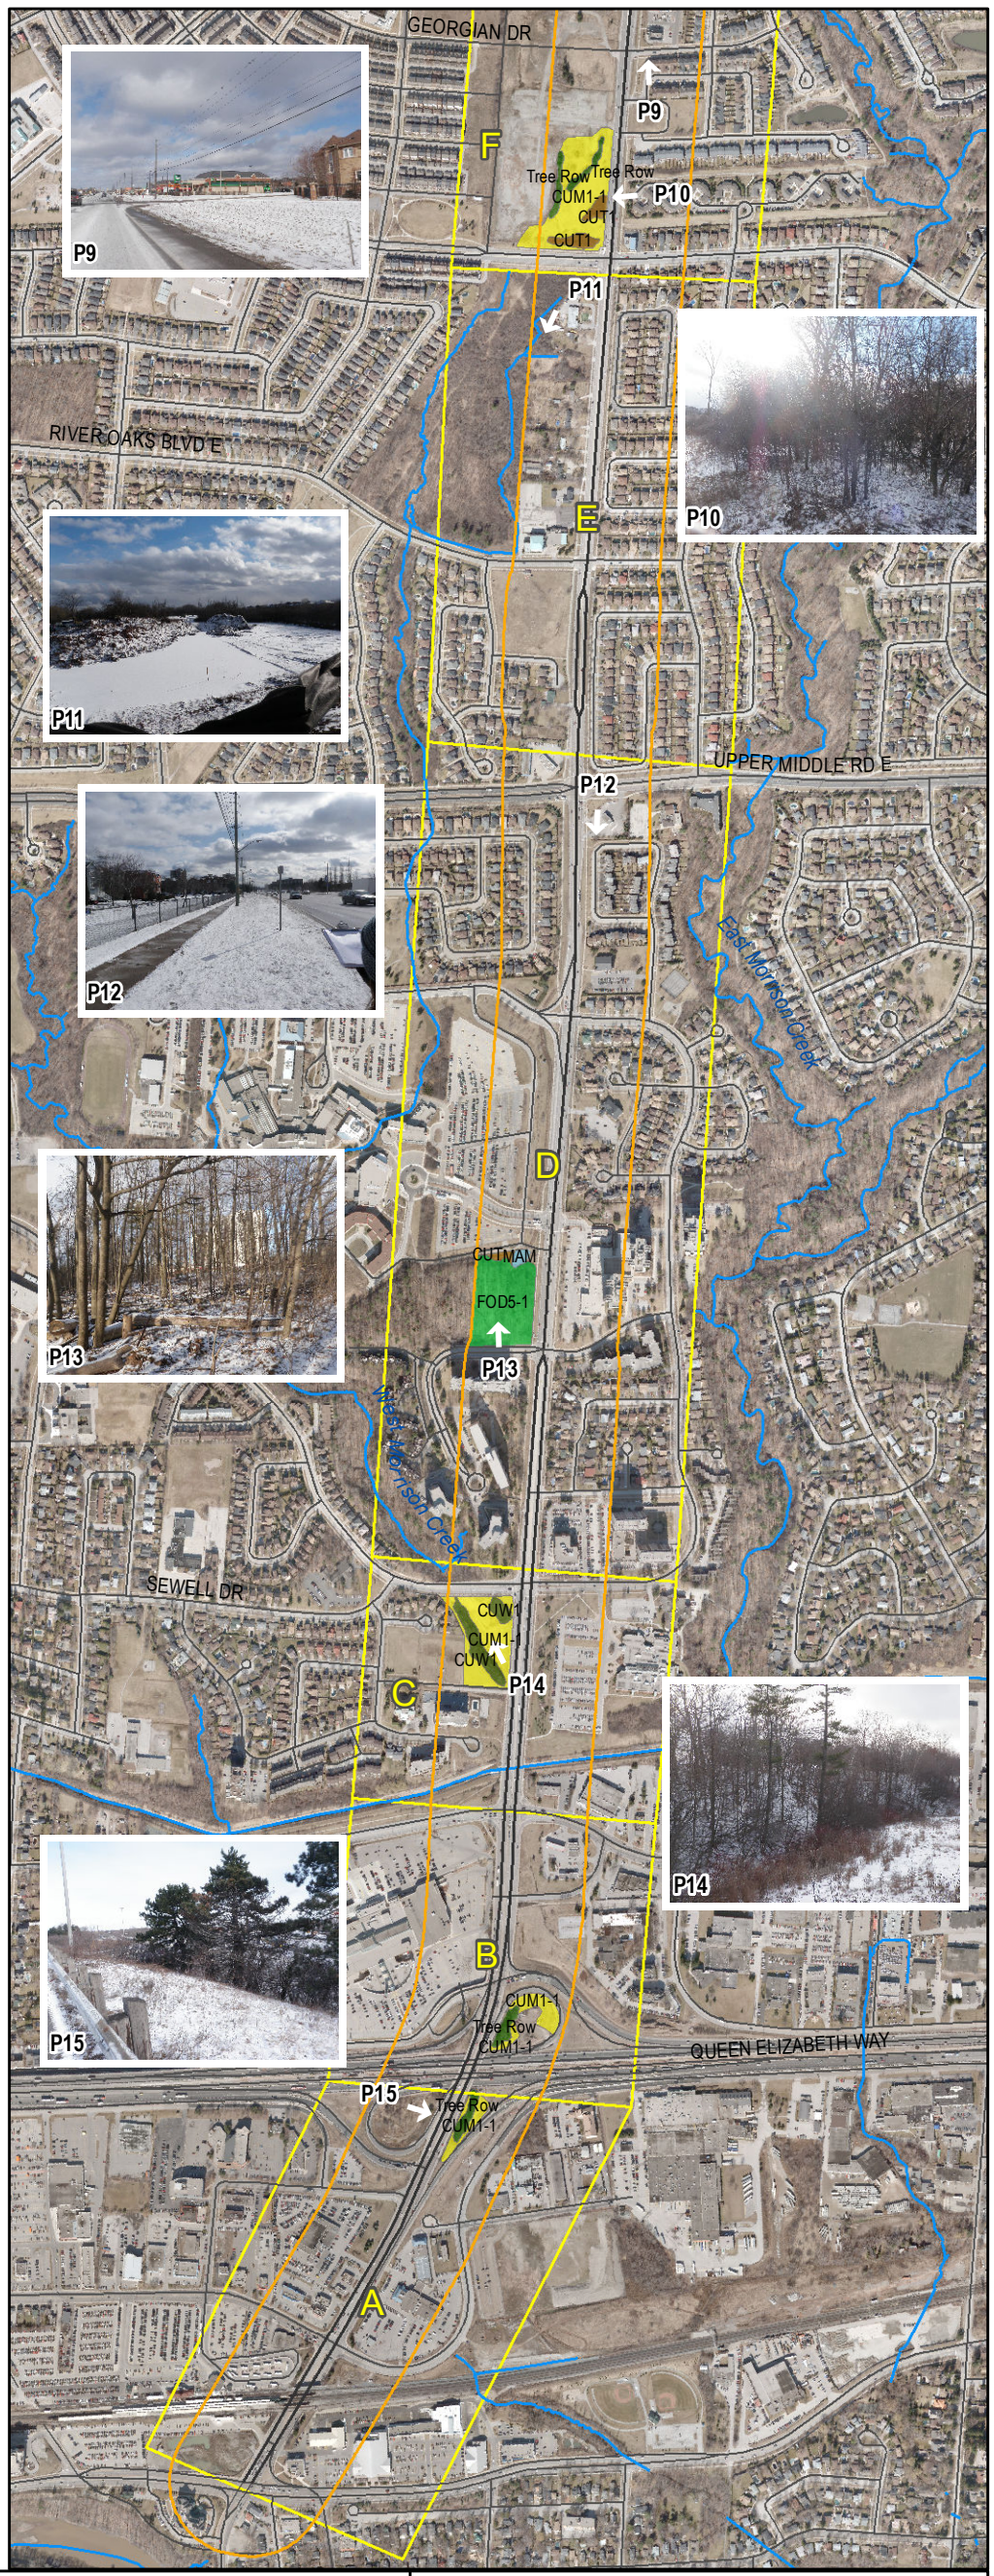
Two additional woodland features found along Trafalgar Road north of Dundas Street are identified as candidate significant woodlands. These areas are associated with two abandoned house properties. These properties were not accessed for field investigations as they are located on private property; therefore field investigations were completed via roadside investigations. Both can be classified as Mineral Cultural Woodlands as represented by CUW1a and CUW1b on **Figure 3**.

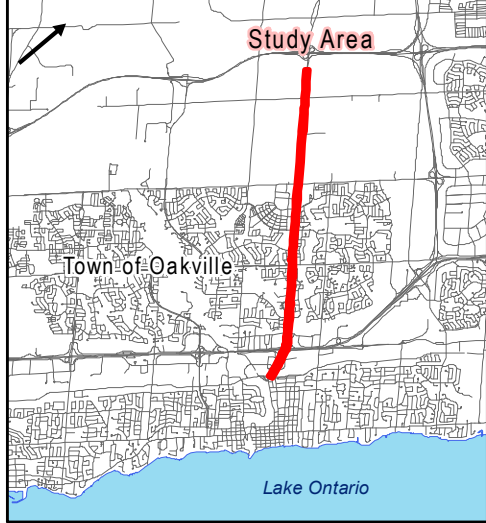
ELC Code	Description
CUM1-1	Dry-Moist Old Field Meadow Type
CUT	Cultural Thicket
CUT1	Mineral Cultural Thicket Ecosite
CUW	Cultural Woodland
CUW1a/b	Mineral Cultural Woodland
FOD24	Dry-Fresh Oak-Hardwood Deciduous Forest Type
FOD4-1	Dry-Fresh Beech Deciduous Forest Type
FOD5-1	Dry-Fresh Sugar Maple Deciduous Forest Type
FOD5-6	Dry-Fresh Sugar Maple-Basswood Deciduous Forest Type
FOD5-7	Dry-Fresh Sugar Maple-Black Cherry Deciduous Forest Type
FOD7	Fresh-Moist Lowland Deciduous Forest Ecosite
FOD7-1	Fresh-Moist White Elm Lowland Deciduous Forest Type
MAM2	Mineral Meadow Marsh Ecosite
