**Trafalgar Road (Regional Road 3)
Improvements Class Environmental
Assessment Study**

Fluvial Geomorphology Assessment

60119993

April 6, 2015

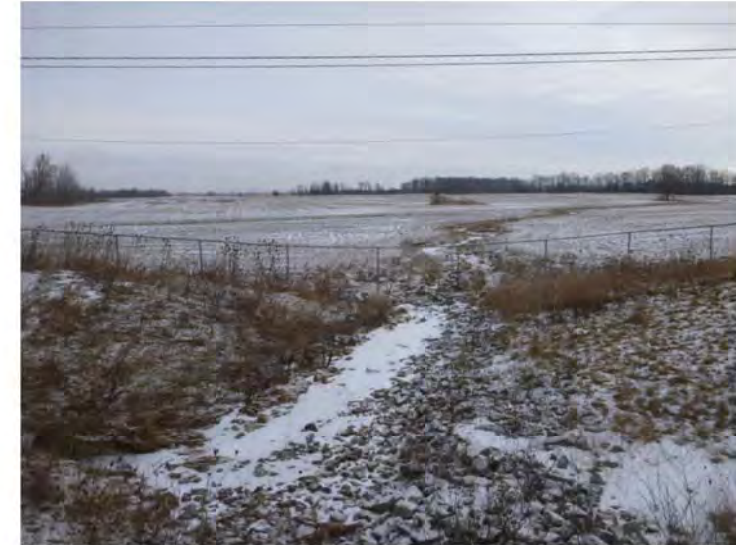
Photograph 1. Joshua Creek Crossing C1. ↑
*Downstream of Trafalgar Road.
The channel exhibits bank scour within the agricultural field*

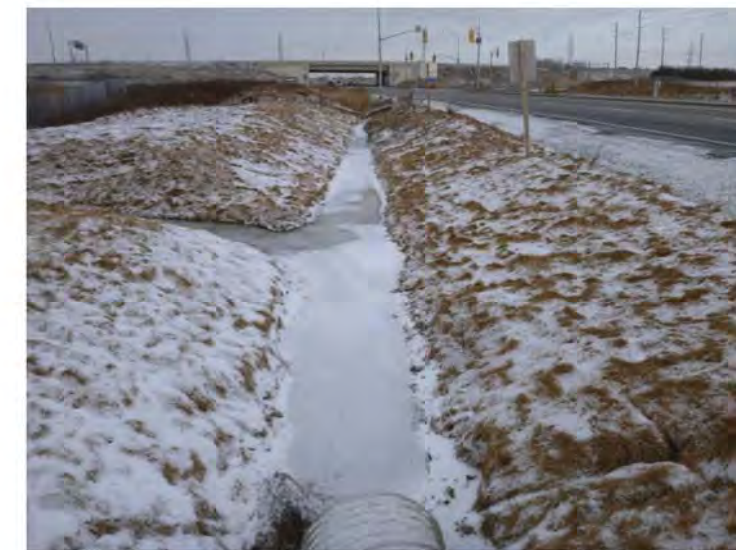
Photograph 2. Joshua Creek Crossing C1 ↑
*Upstream view on west side of Trafalgar Road. Steep channel flanks GO parking lot
and comes into the roadside ditch from the west side*

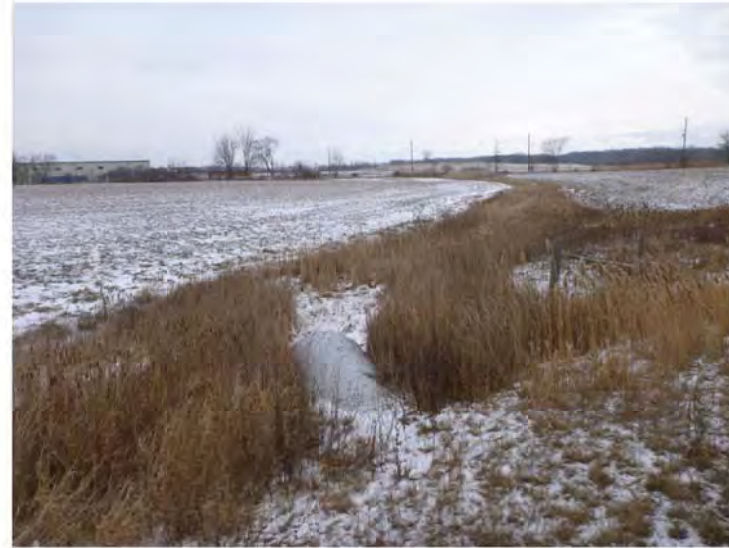
Photograph 3. Joshua Creek Headwater C2 ↑
Channel is not well defined

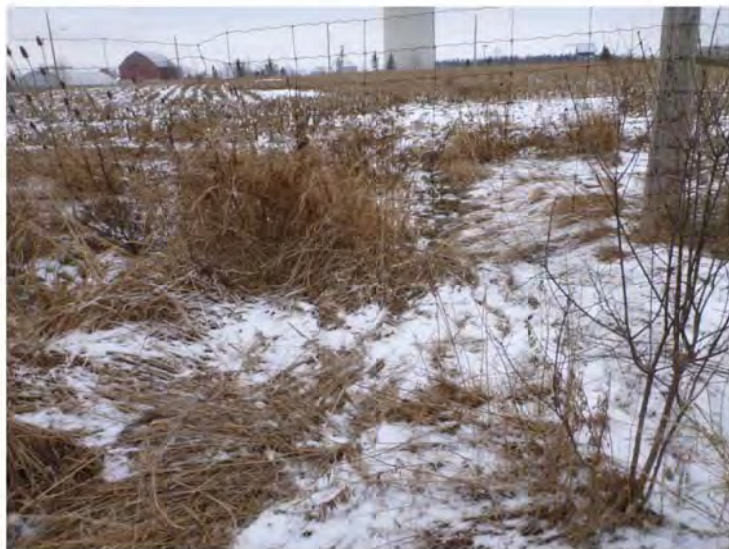
Photograph 4. Joshua Creek Headwater C2 ↑
No defined channel visible in landscape

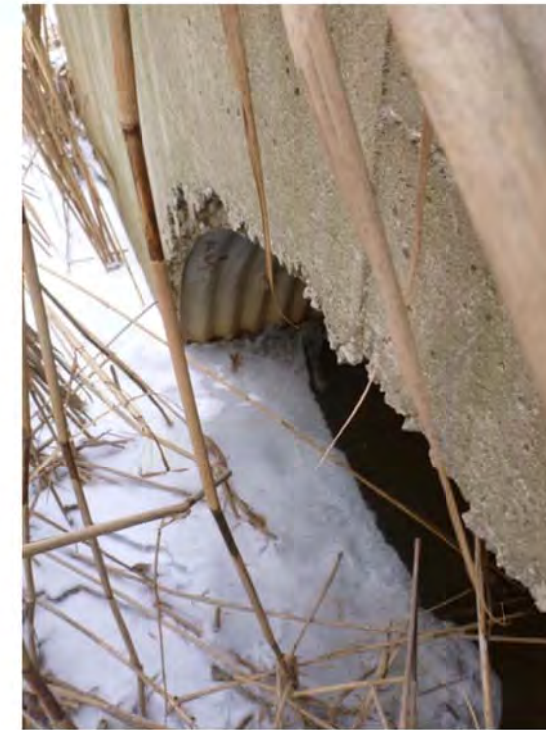
Photograph 5. East Morrison Creek – East Tributary C3 ↑
Channel is choked with vegetation on east side of culvert

3			1.3 km N of Dundas Street, in the vicinity of a church	1.5 m CSP in concrete headwall	East Morrison Tributary	MOC-6 Tributary (Town of Oakville 2006)	The inlet and outlet of the culvert was hidden by dense in-channel vegetation. No well-defined channel was observed upstream of this culvert. Hydro poles are situated within the roadside ditch.
4		15+820	0.4 km N of Dundas Street; upstream Oak Park Pet Hospital	Two 1.0 m CSP culverts in concrete headwall	East Morrison Tributary	MOC-2 (Town of Oakville 2006)	Creek enters culvert from the east side of Trafalgar Road and splits into two channels (roadside ditch parallel to Trafalgar Road and a small watercourse feature oriented westward). The channel is vegetation controlled.
5	03-1182530 CU01	15+665	0.2 km N of Dundas Street, downstream of Oak Park Pet Hospital	Span 1.8 m, Height 1 m, concrete box culvert	East Morrison Tributary	MOC-2	Creek flows through a densely vegetated channel before entering the culvert's west side. Sedimentation occurs within the culvert. Dense vegetation occurs at the culvert outlet. A roadside ditch north of the culvert, along the east side of Trafalgar Road joins the channel at the culvert outlet. Channel width is not well defined.

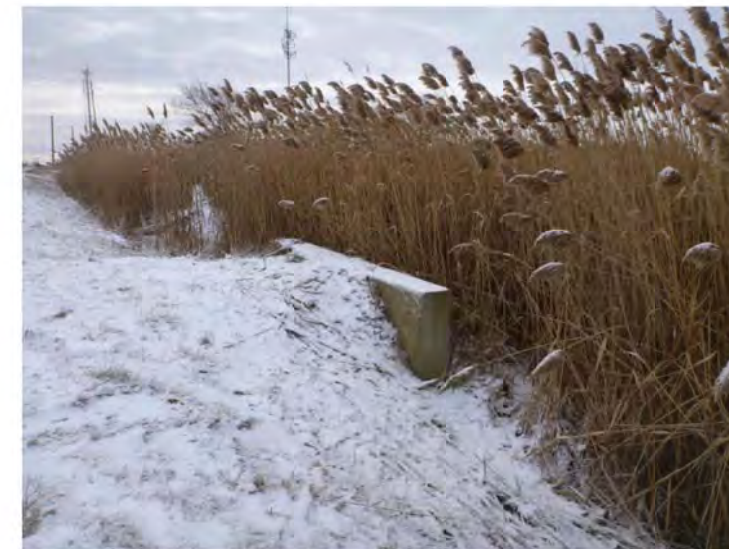
Photograph 6. East Morrison Creek – East Tributary C3 ↑
Channel is choked with vegetation on west side of culvert

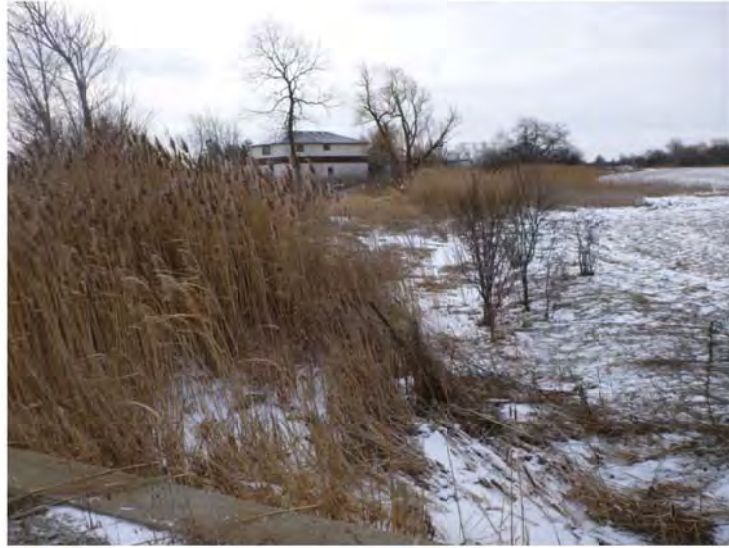
Photograph 7. East Morrison Creek – East Tributary C4 ↑
Dense vegetation occurs in channel on east side of culvert

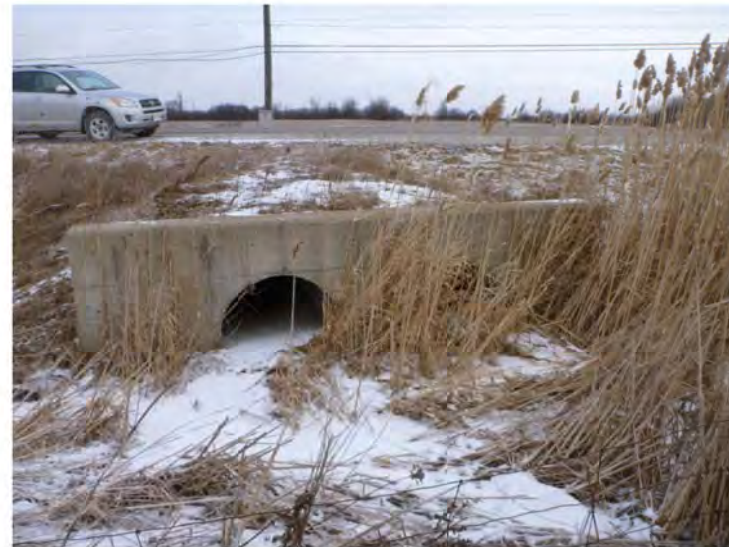
Photograph 8. East Morrison Creek – East Tributary C4 ↑
Channel is choked with vegetation on west side of culvert and exhibits a wide and shallow form. Definition increases in the downstream direction.

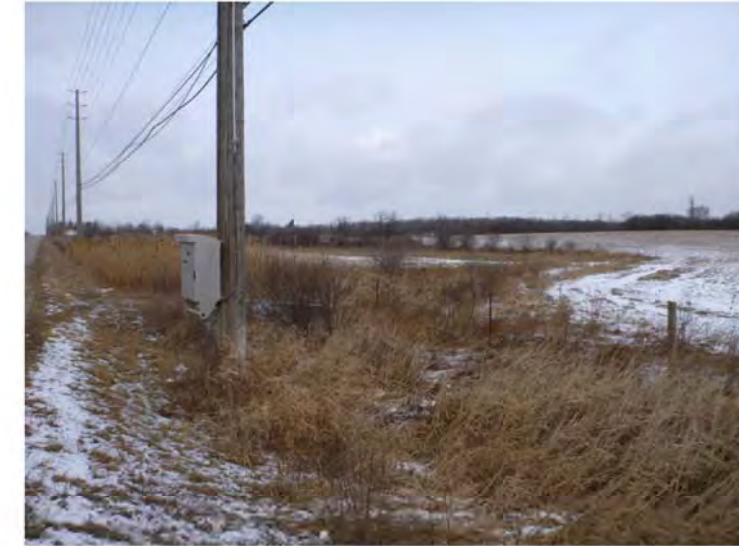
Photograph 9. East Morrison Creek – East Tributary C4 ↑
Upsteam view of tributary along east side of Trafalgar Road.

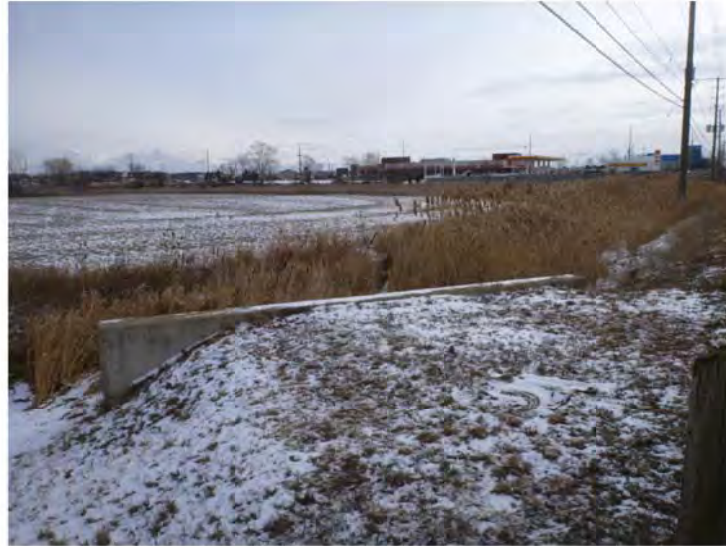
Photograph 10. East Morrison Creek – East Tributary C5 ↑
Dense vegetation occurs in channel on east side of culvert. Creek goes from west to east through culvert

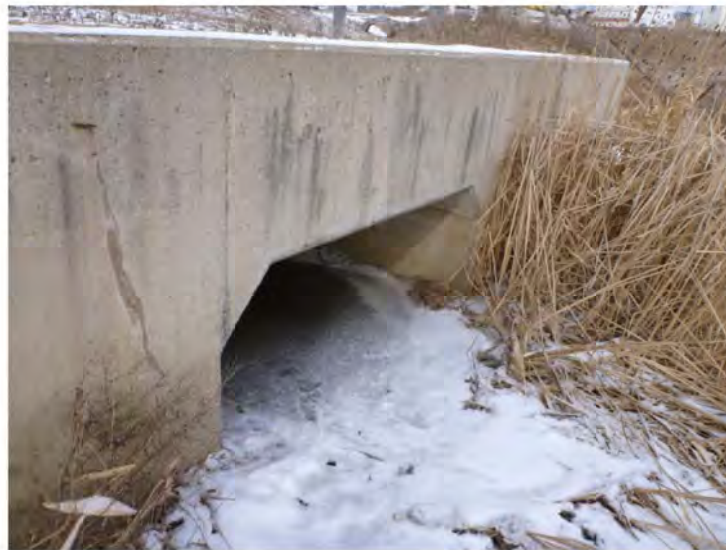
Photograph 11. East Morrison Creek – East Tributary C5 ↑
West side of culvert, conveying flow to east side

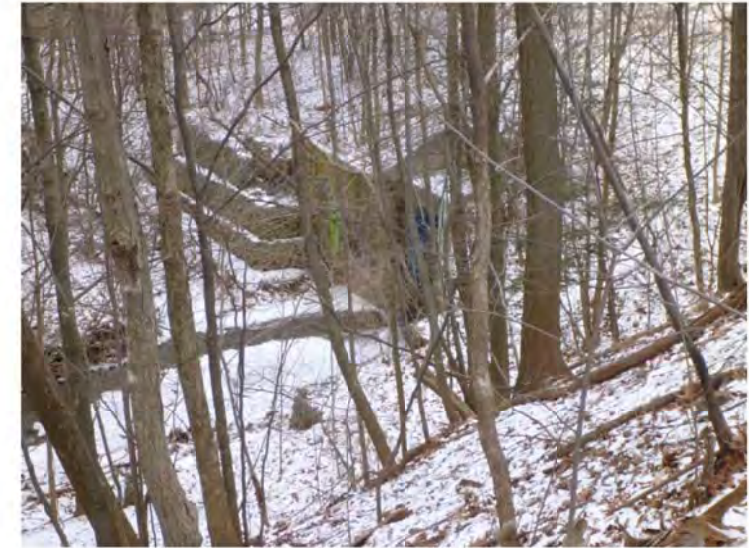
Photograph 18. West Morrison Creek C8 ↑
West Morrison Creek enters a flow diversion channel under McCraney Street East

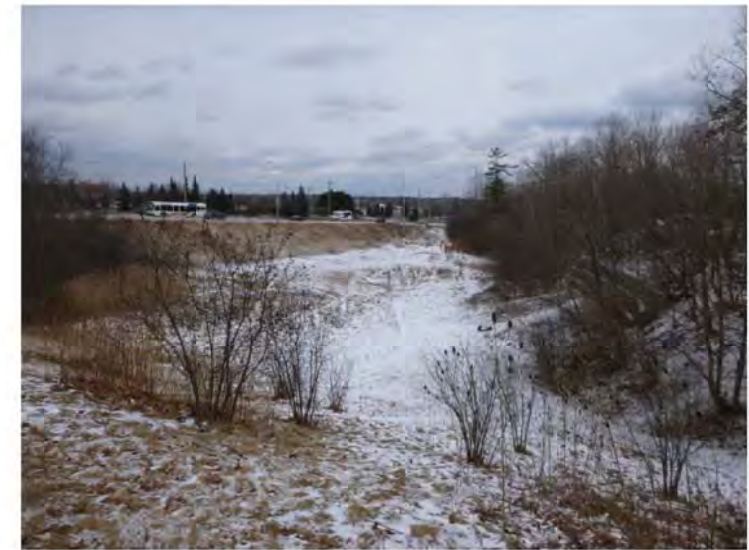
Photograph 19. West Morrison Creek C8 ↑
No channel exists within the valley downstream of McCraney Street East

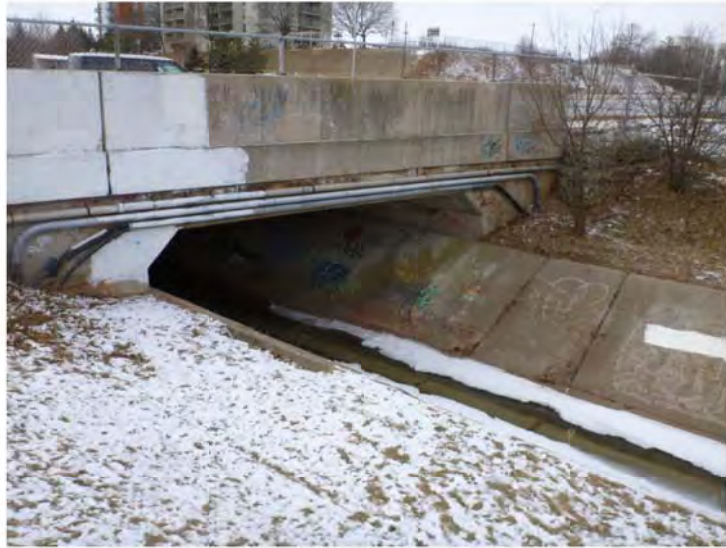
Photograph 20. Morrison Wedgewood Diversion C9 ↑
East side of concrete lined diversion channel under Trafalgar Road, captures water from several tributaries and conveys this to Sixteen Mile Creek
