## Proposed Burlington Quarry Expansion JART COMMENT SUMMARY TABLE – Visual Impact Assessment

**Proposed Burlington Quarry Expansion  
JART COMMENT SUMMARY TABLE – Visual Impact Assessment**

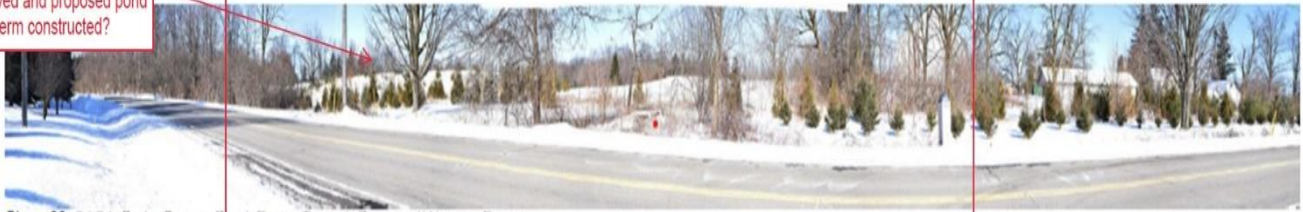
Photo 22: 5050 Cedar Springs Road. Facing Towards Proposed Western Extension.

What will this view look like once hills have been removed and proposed pond and berm constructed?

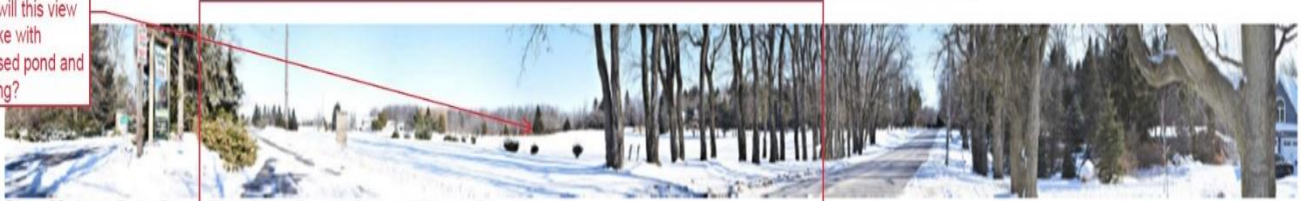
Photo 32: 5234 Cedar Springs Road. Facing Towards Proposed Western Extension.

What will this view look like with proposed pond and berming?

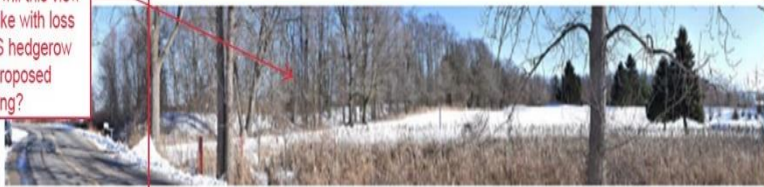
Photo 43: 2129, 2139 Colling Road. Facing Towards Proposed Western Extension.

What will this view look like with loss of N-S hedgerow and proposed berming?

<p>Table 1 states that the proposed pond may be visible from Colling Road (see Photo 43, 57 and 58). This appears to be an error: please clarify</p>	<p>Mention of possible views has been removed.</p> <p>See updated report dated May 2022.</p>
<p>Several viewpoints were assessed in the VIA as being moderately or highly impacted by aggregate operations and mitigation was recommended (see Table 1, Photo 13, 17, 22-23, 28-33, 43, 50, 57-58). Visual impact assessment must assess any physical changes including berming and rehabilitation, not just extraction operations.</p> <p>Further study is required to fully understand visual impacts associated with proposed mitigation measures (pond and berm) and changes to the open landscape character for several key views of concern. Please provide photo simulations for these representative viewpoints and address these outstanding issues with further analysis in the VIA:</p> <ul style="list-style-type: none"> <li>• <b>View from Cedar Springs Road to hilly terrain and vegetation (Photo 22 - shown below with JART mark-up)</b> – What are the visual impacts associated with constructing a pond here? How will existing landform be altered? What vegetation will be lost? Will the proposed berm be visible beyond the pond? Is a pond really needed here to mitigate visual impacts?</li> <li>• <b>View from Cedar Springs Road to golf course and forests beyond (Photo 32 - shown below with JART mark-up)</b> – What are the visual impacts of constructing a berm and pond here? What will the pond look like? How will the berm be screened from view?</li> <li>• <b>View from Colling Road southwest across wetland towards golf course (Photo 43 right side - shown below with JART mark-up)</b> – What is the impact to open landscape character? What is the visual impact associated with constructing a berm here? How will the berm be screened from view?</li> <li>• <b>View from No. 2 Sideroad south to quarry entrance (Photo 50 - shown below with JART mark-up)</b> – What is the visual impact of constructing such large berms so close to the road? How will proposed vegetation mitigate the impacts? What will the large opening between berms look like? Does it need to be that large? What visual impacts will be associated with a crossing? What will the north side of the road look like?</li> </ul> <p>Note: Some photos may need to be re-shot or cropped for use in the production of photo simulations to ensure technical accuracy. A terms of reference outlining the detailed methodology for the production of photo simulations will be required for NEC review prior to a re-submission. NEC has prepared a redline of key photos to accompany this request for photo</p>	<p>Expected changes to views as a result of implementing the rehabilitation plan has been added.</p> <p>Photo simulations have been provided to show proposed mitigation measures. Photos have been re-taken to correct the accuracy issues resulting from the panoramic photo bases.</p> <p>It is noted that the infiltration pond is not being proposed for visual mitigation purposes, but for hydrological purposes. Due to the berms around the pond, it will be screened from view. See sections and photo simulations.</p> <p>See updated report dated May 2022.</p>

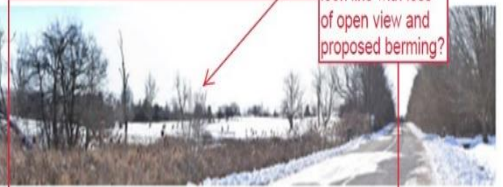
What will this view look like with loss of open view and proposed berming?

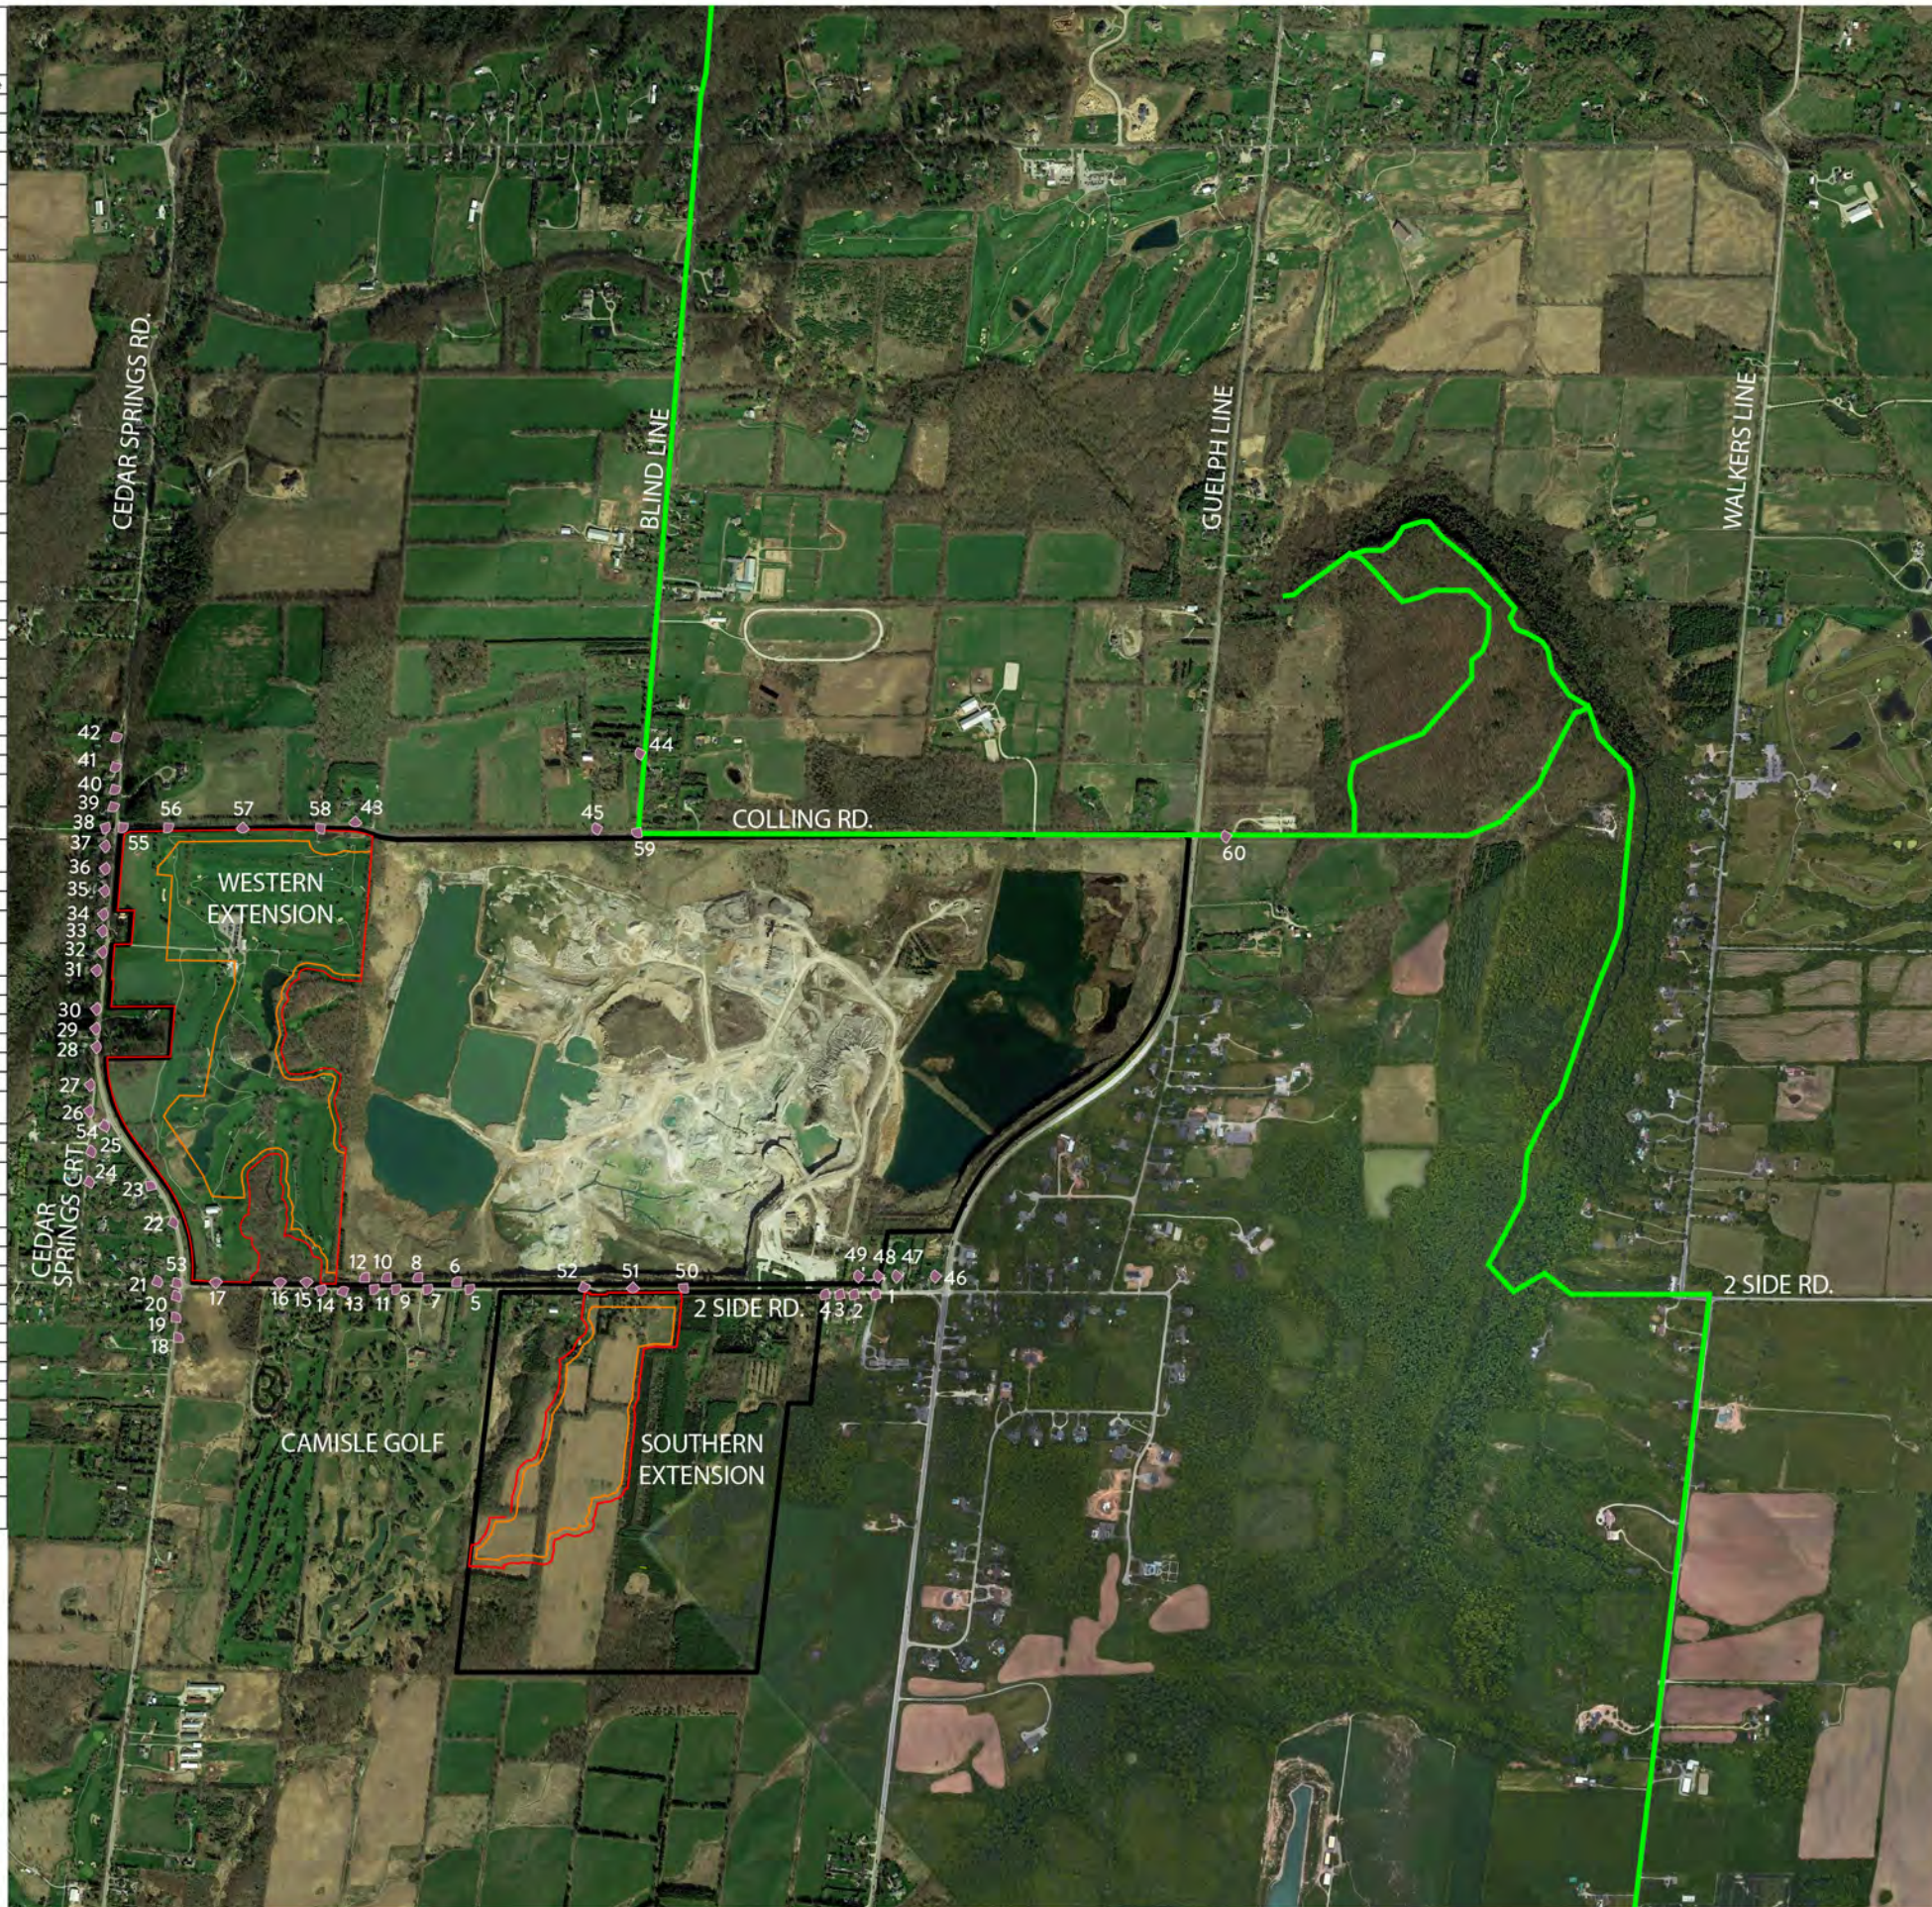
Figure 4  
Assessed Views Photo Location Map

Site reviews were undertaken in Winter 2020 and Winter of 2021 during leaf-off condition to illustrate worst case scenario. The analysis and location of the 49 studied viewpoints are included in this chapter and are identified on **Figure 4 (Assessed Views Photo Location Plan), and 4A to 4P (Photo Records of Assessed Views)**. The site reviews included evaluation of potential receptors and views within 1 km of the proposed extensions and were chosen specifically in locations where visual impacts could potentially be expected. Refer to **Table 1** for a summary of the locations and associated evaluations of the identified potential receptors along the mentioned public roadways.

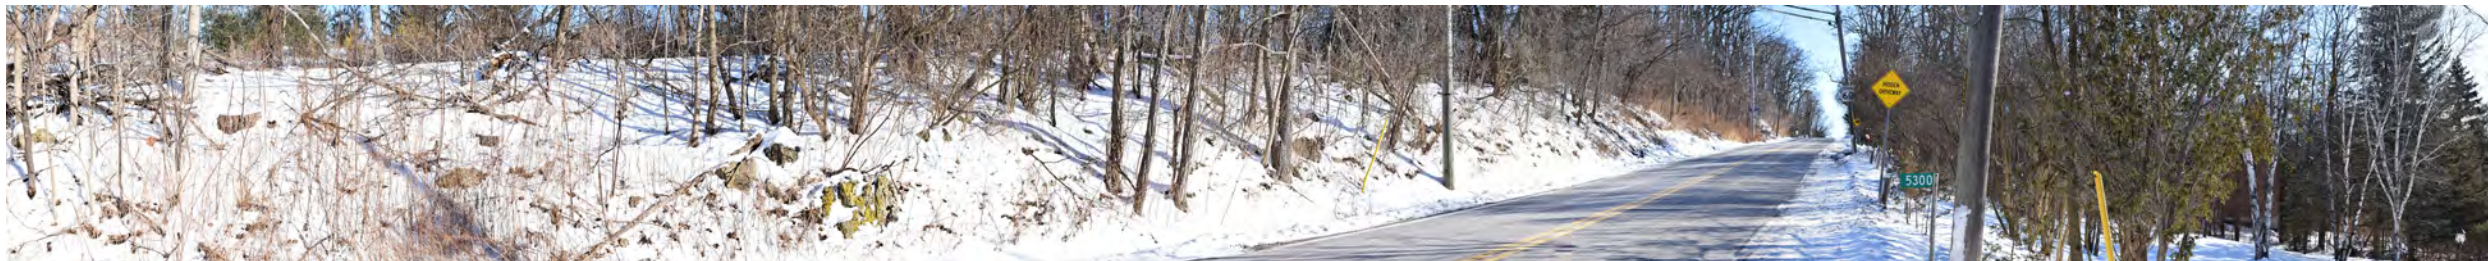
Photo 37: 5300 Cedar Springs Road. Facing Towards Proposed Western Extension.

<b>Photo 35</b>	5264 Cedar Springs Road (Towards Western Extension)	Views of deciduous vegetation along existing berm. Existing topography provides significant/full screening.	None	-	-	Mitigation measures not required.
<b>Photo 36</b>	5268 Cedar Springs Road (Towards Western Extension)	Views of deciduous vegetation along existing berm. Existing topography provides significant/full screening. House at significantly lower grade than the road.	None	-	-	Mitigation measures not required.
<b>Photo 37</b>	5300 Cedar Springs Road (Towards Western Extension)	Views of deciduous vegetation along existing berm. Some coniferous vegetation visible extending above berm. Existing topography provides significant/full screening. House at significantly lower grade than the road.	None	-	-	Mitigation measures not required.
<b>Photo 38</b>	5318 & 5328 Cedar Springs Road (Towards Western Extension)	Views of mixed vegetation along existing berm. Berm begins to taper down towards intersection revealing raised topography behind. Photo taken between 5318 & 5328. Existing berm provides significant/full screening. 5318 at significantly lower grade than other side of the road. 5328 is set back from the road by several hundred metres.	None	-	-	Mitigation measures not required.

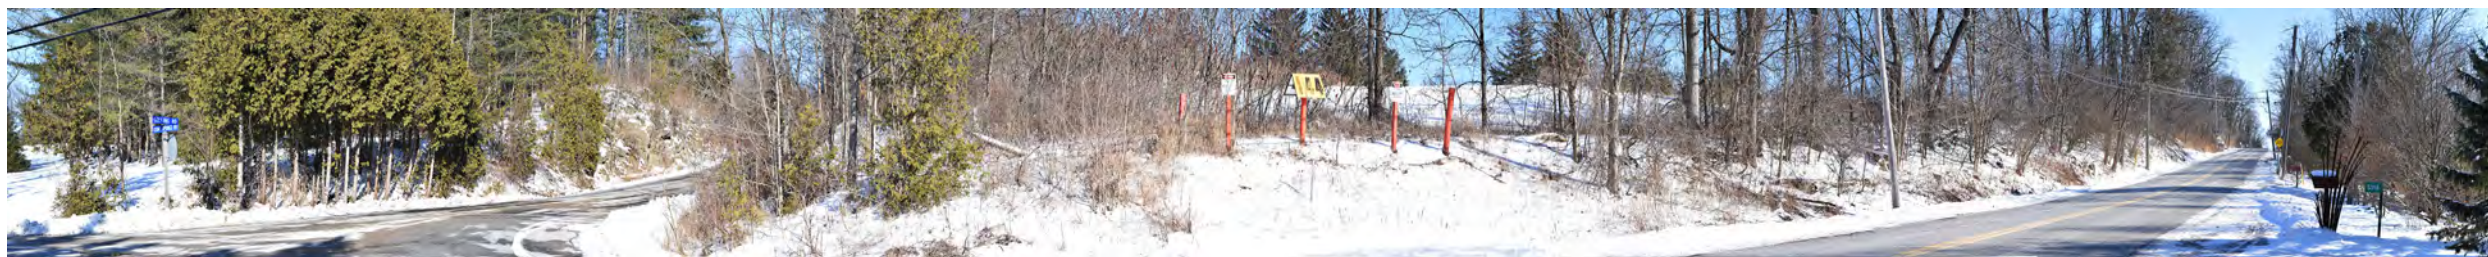
Photo 38: 5318, 5328 Cedar Springs Road. Taken Between 5318 and 5328, Facing Towards Proposed Western Extension.

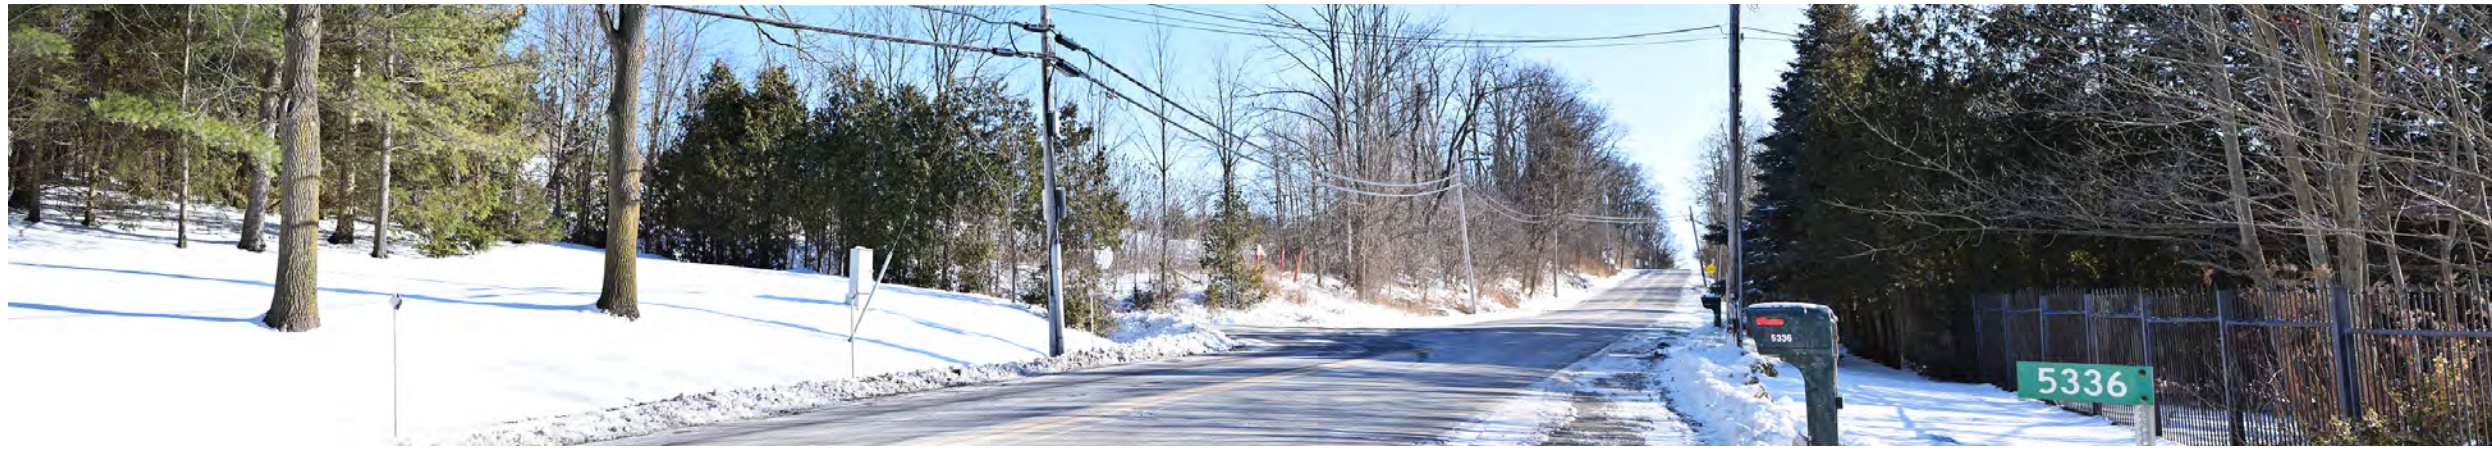
Photo 39: 5336 Cedar Springs Road. Facing Towards Proposed Western Extension.

<b>Photo 39</b>	5336 Cedar Springs Road (Towards Western Extension)	Views of mixed vegetation on private property. Some distant vegetation along the raised topography at the corner of the intersection is visible. Existing topography and vegetation	None	-	-	Mitigation measures not required.

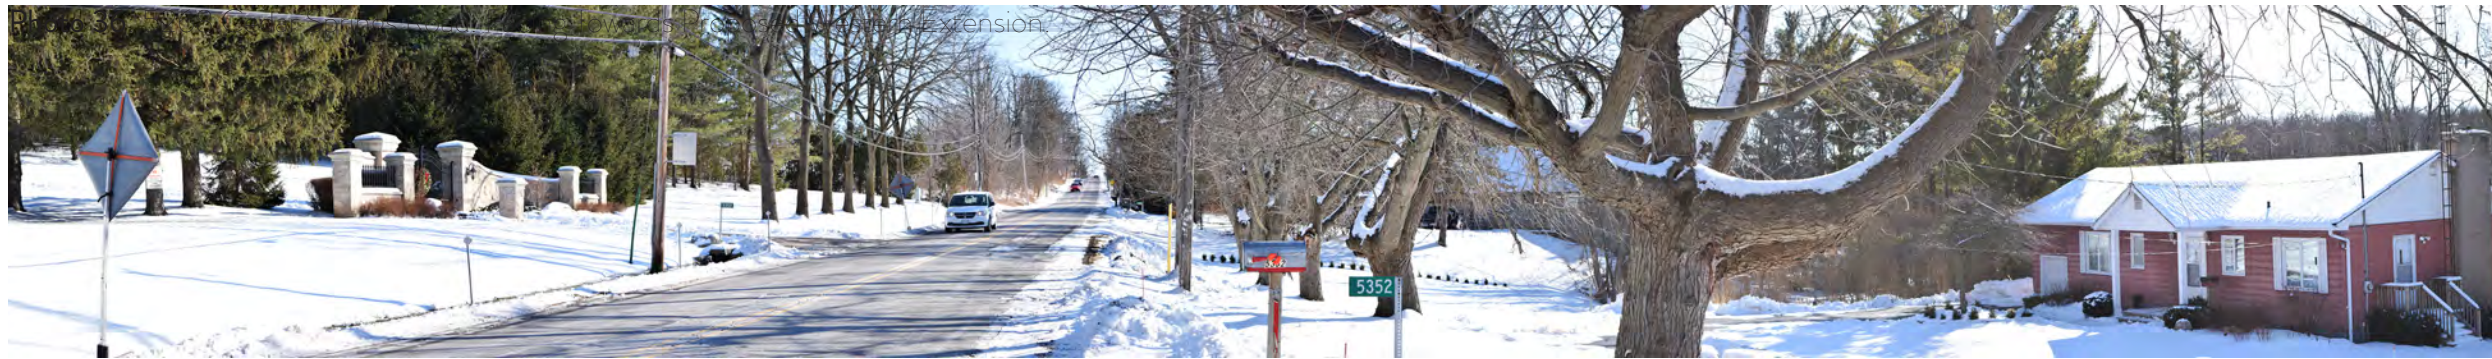
Photo 40: 5352 Cedar Springs Road. Facing Towards Proposed Western Extension.

provides full screening of potential views.				
<b>Photo 40</b>	5352 Cedar Springs Road (Towards Western Extension)	Views of mixed vegetation on private property and roadside. Existing topography and vegetation provides full screening of potential views.	None	-	-	Mitigation measures not required.
<b>Photo 41</b>	5360, 5370, 5380 Cedar Springs Road (Towards Western Extension)	Views of mixed vegetation on private property and roadside. Photo taken between 5360 & 5370.	None	-	-	Mitigation measures not required.
<b>Photo 42</b>	5390 Cedar Springs Road (Towards Western Extension)	Views of mixed vegetation on private property and roadside. Existing topography and vegetation provides full screening of potential views. 5390 at significantly lower grade than other side of the road.	None	-	-	Mitigation measures not required.
<b>Photo 43</b>	2129 & 2139 Colling Road (Towards Western Extension)	Relatively open views of the golf course. Rolling hills with some mixed vegetation. Photo taken between 2129 & 2139. Clear views anticipated. Extraction activities occurring close to public right of way.	High	Views of golf course will be removed. Almost all vegetation and golf course landscape will be removed. Long linear views of quarry will be present without mitigation.	Views of roadside wetland and planted grassland. Clear views of water feature and proposed islands.	Proposed 3.5 m noise berm will provide adequate screening.

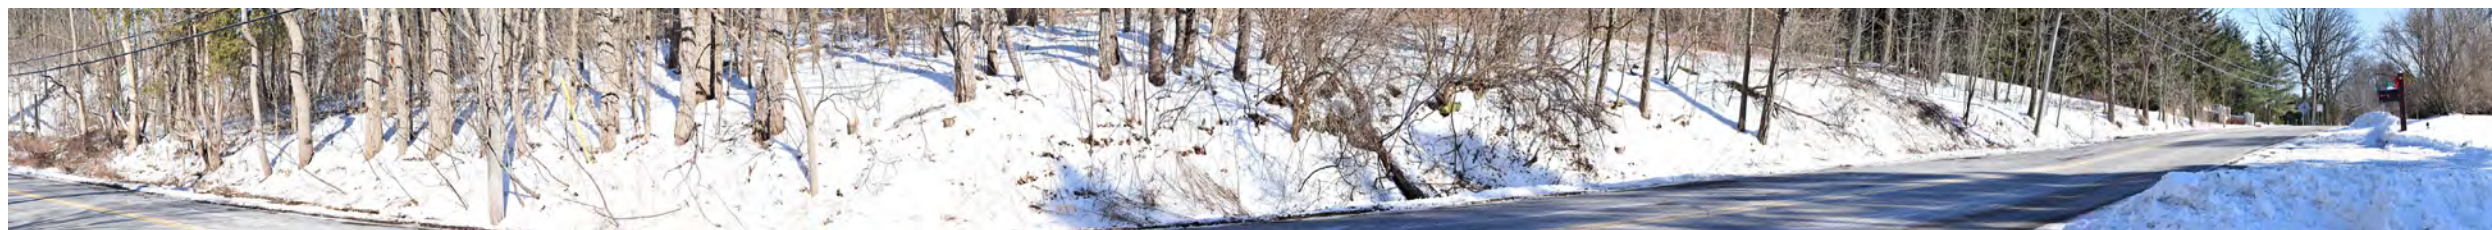
Photo 41: 5360, 5370, 5380 Cedar Springs Road. Taken Between 5360 and 5370, Facing Towards Proposed Western Extension.

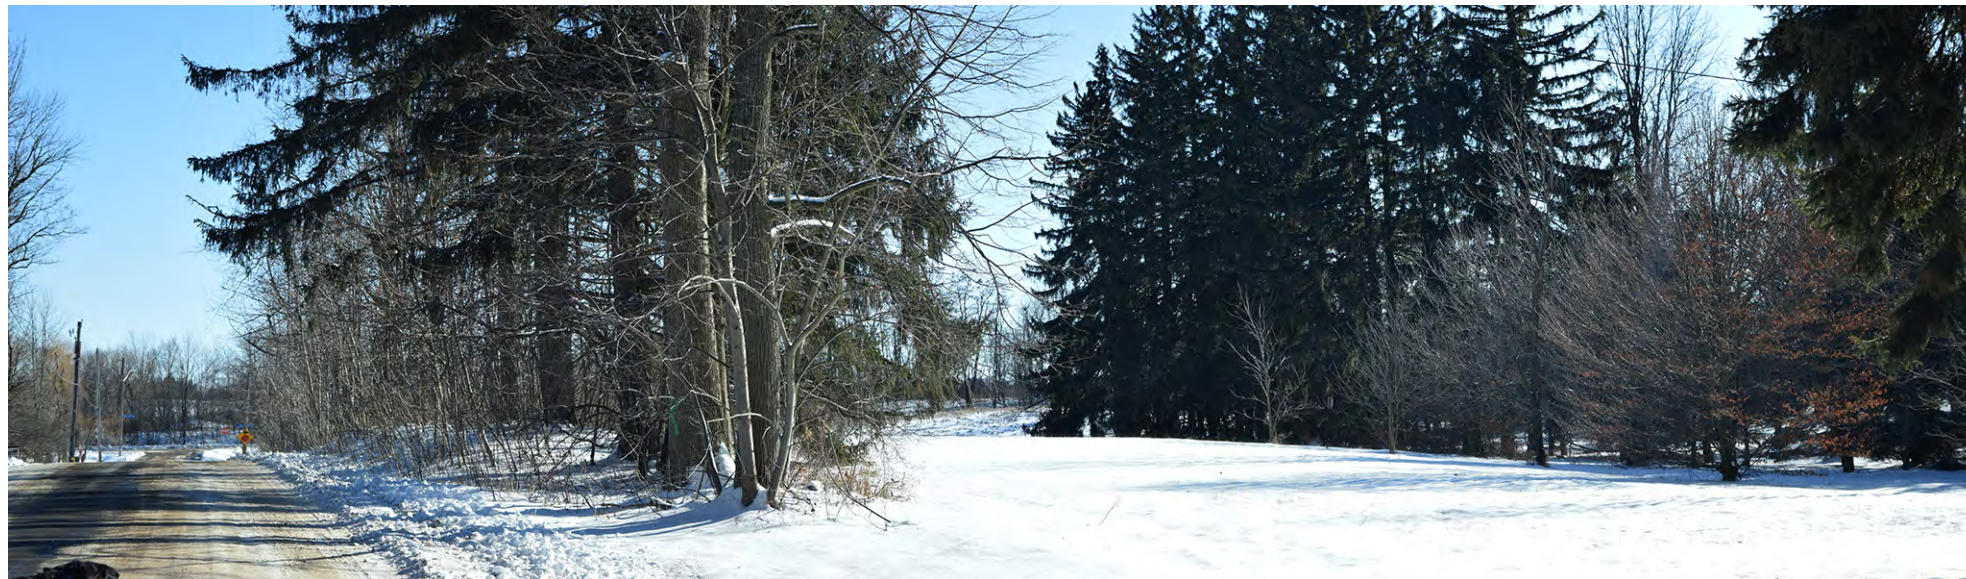
Photo 44: 5374 Blind Line. Taken at the Property Frontage Facing Towards Proposed Western Extension.

<b>Photo 44</b>	5374 Blind Line (Property Frontage) (Towards Western Extension)	Largely coniferous trees on private property. Existing topography, distance, and vegetation provides full screening of potential views.	None	-	-	Mitigation measures not required.
<b>Photo 45</b>	5374 Blind Line (Colling Road Frontage) (Towards	Views of deciduous trees along roadside adjacent to lands owned by the applicant and private property. Existing topography,	None	-	-	Mitigation measures not required.

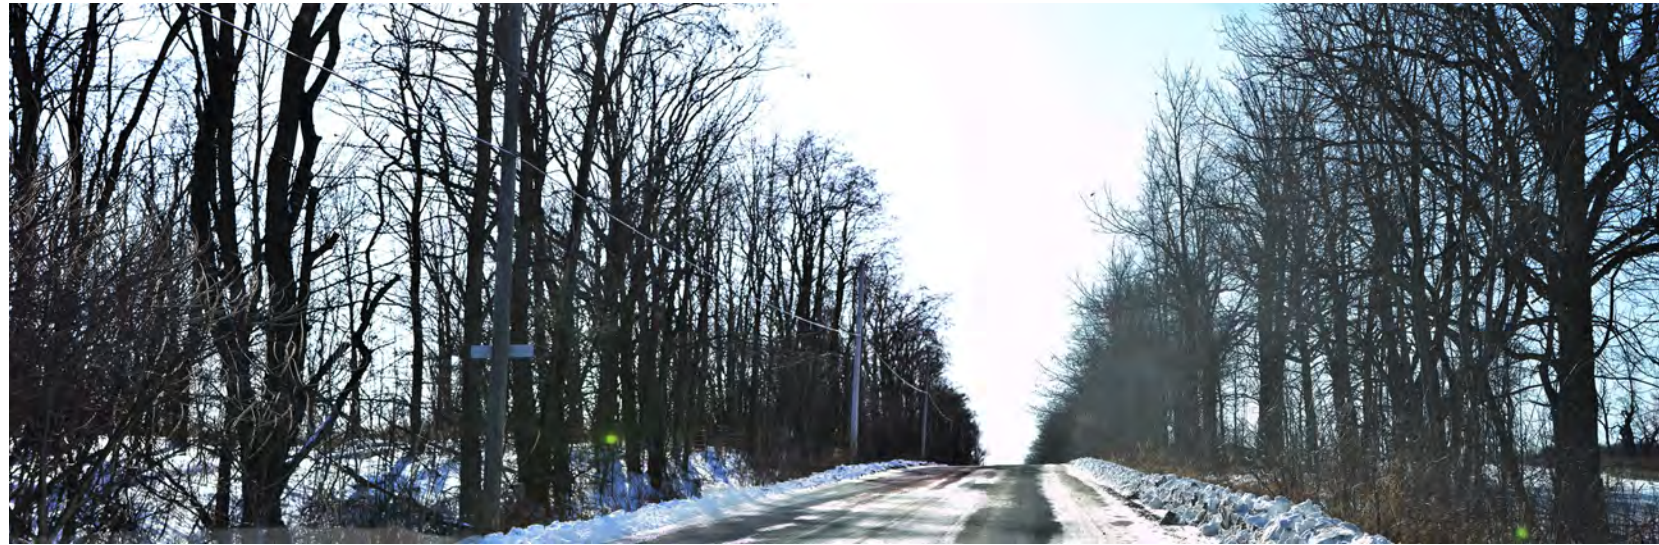
Photo 45: Taken at Colling Road and Blind Line Where the 5374 Blind Line Property Fronts onto Colling Road.

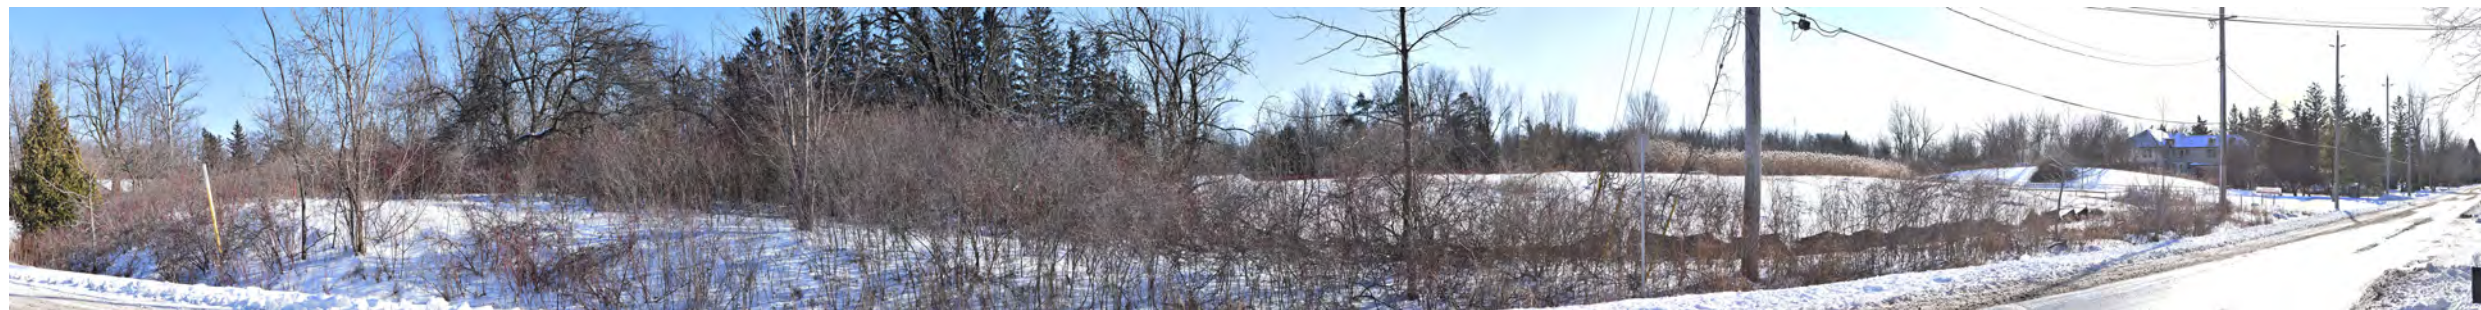
Photo 46: 2519 2 Side Road. Facing Towards Proposed Southern Extension.

Western Extension)	distance, and vegetation provides full screening of potential views.				
<b>Photo 46</b>	2519 2 Side Road. (Towards Southern Extension)	Topography and vegetation creates minimal opportunity for views.	None	-	-	Mitigation measures not required.
<b>Photo 47</b>	2509 & 2495 2 Side Road (Towards Southern Extension)	Photo taken between 2509 & 2495. Topography and vegetation creates minimal opportunity for views.	None	-	-	Mitigation measures not required.
<b>Photo 48</b>	2585 & 2479 2 Side Road (Towards Southern Extension)	Photo taken between 2585 & 2479. Topography and vegetation creates minimal opportunity for views.	None	-	-	Mitigation measures not required.
<b>Photo 49</b>	2473 2 Side Road (Towards Southern Extension)	Topography and vegetation creates minimal opportunity for views.	None	-	-	Mitigation measures not required.
<b>Photo 50</b>	Approx. 2322-2402 2 Side Road (Towards Southern Extension)	Open landscape character and views of agricultural fields. Views of surrounding mixed vegetation. Taken at the north east corner of the future Southern Extension.	High	Open views of agricultural lands to be removed. Removal of existing rural residential buildings owned by the applicant. Clear views of extraction activity will be present.	Views of proposed grassland and beaches. Views of proposed water getting progressively deeper. Further from the road.	Proposed 2.5m visual berm will prevent views into extraction area.

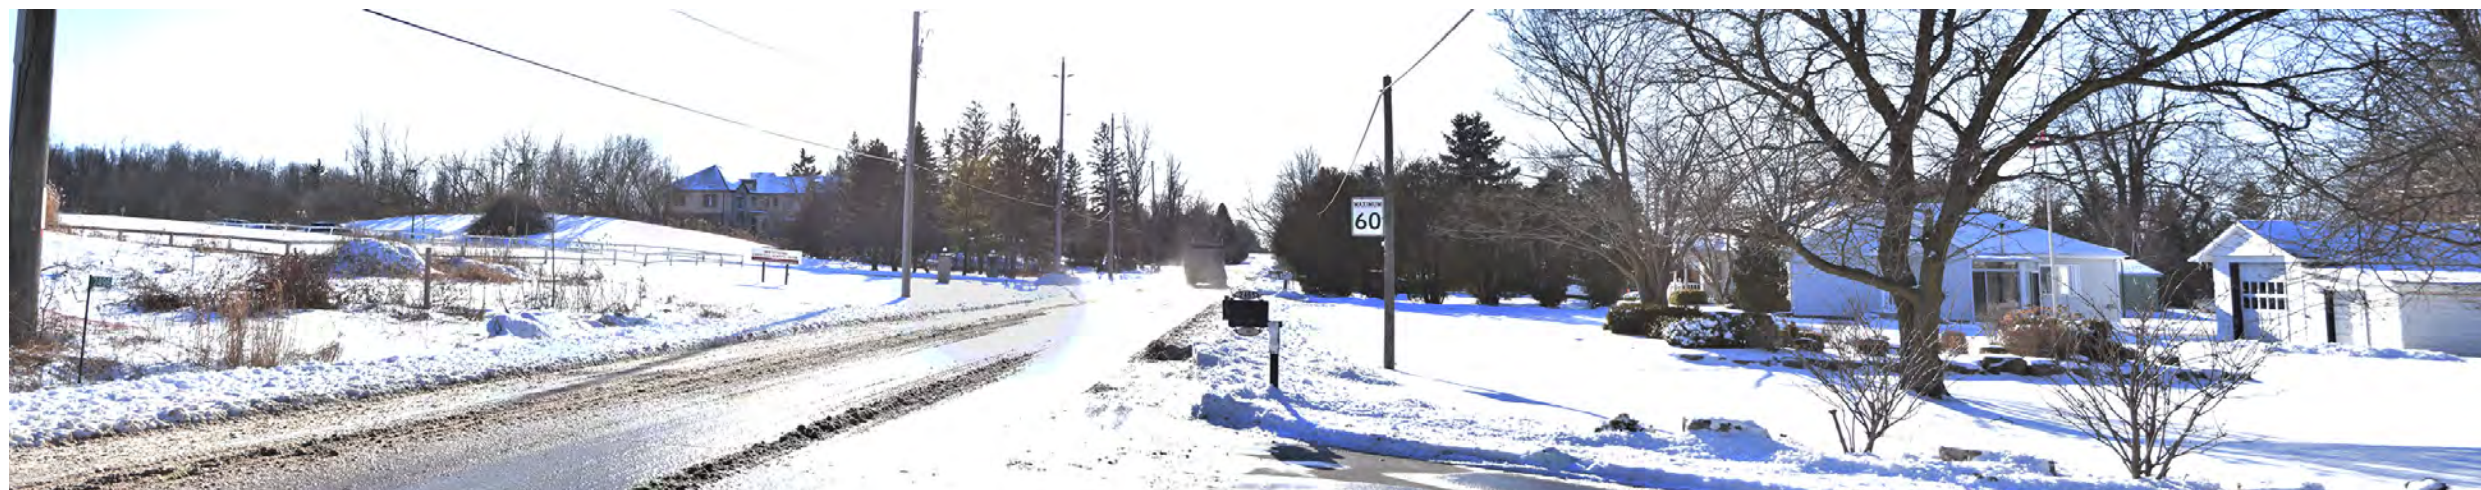
Photo 47: 2509, 2495 2 Side Road. Taken Between 2509 and 2495 Facing Towards Proposed Southern Extension.

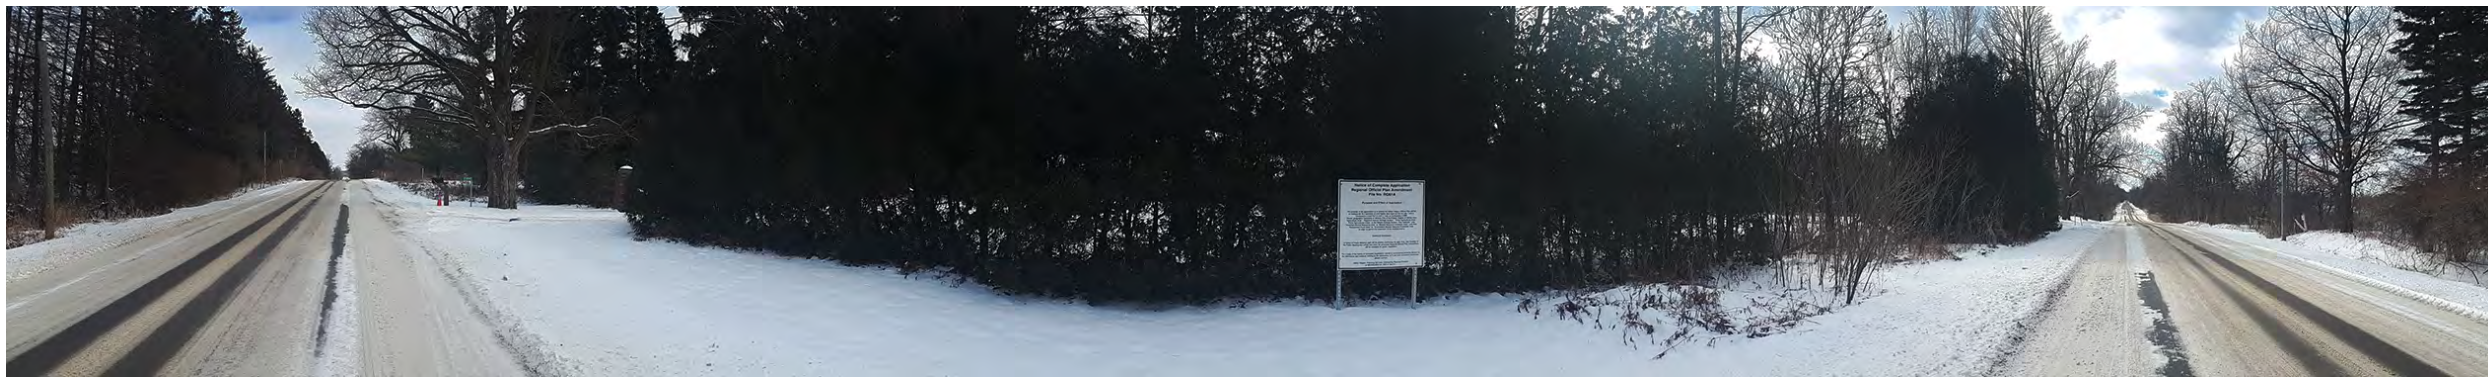
Photo 51: Approx. 2316 2 Side Road. Facing Towards Proposed Southern Extension.

<b>Photo 51</b>	Approx. 2316 2 Side Road (Towards Southern Extension)	Views of largely coniferous vegetation along road side and lands owned by applicant.	Low	Existing vegetation provides significant screening to the subject lands. This vegetation is outside the extraction zone and is expected to be retained. Likely views into site if vegetation were to decline.	Views of proposed grassland and beaches. Views of proposed water getting progressively deeper. Further from the road.	Proposed 2.5m visual berm will prevent views into extraction area. Where possible, retain existing vegetation.

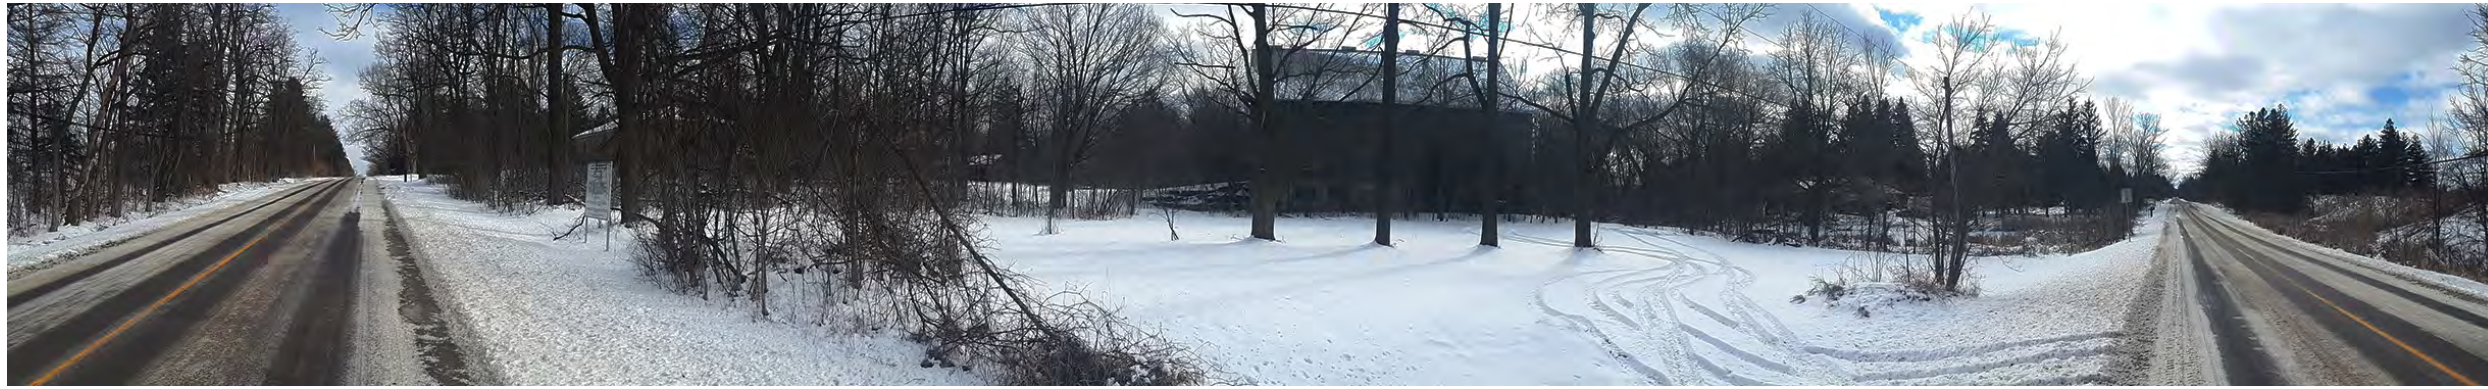
Photo 52: Approx. 2292 2 Side Road. Taken Between 2585 and 2479 Facing Towards Proposed Southern Extension.

<b>Photo 52</b>	Approx. 2292 2 Side Road (Towards Southern Extension)	Views of mixed vegetation along road side and lands owned by applicant. Views of barn and rural residential structure present.	Low	Existing vegetation provides significant screening to the subject lands. This vegetation is outside the extraction zone and is expected to be retained. Likely views into site if vegetation were to decline.	Views of proposed grassland and beaches. Views of proposed water getting progressively deeper. Further from the road.	Proposed 5.0m noise berm will prevent views into extraction area. Where possible, retain existing vegetation.
<b>Photo 53</b>	Approx. 1420 2 Side Road (Towards Western Extension)	Views of mixed vegetation on private property. Views of surrounding private residences. Existing vegetation provides some screening. Distance to extraction activities will reduce potential visual impact.	Low	The view of the golf course ancillary structure will be removed. Views of golf course will be removed. Possible views into extraction area without mitigation. Clear views of proposed pond will be present.	Views of existing vegetation that has been maintained. Possible views of infiltration pond, likely screened by pond berming and vegetation. Distant views of rehabilitated excavation area which included proposed trees and slopes.	Construction of 2.5m Visual berm will prevent views into the extraction zone.

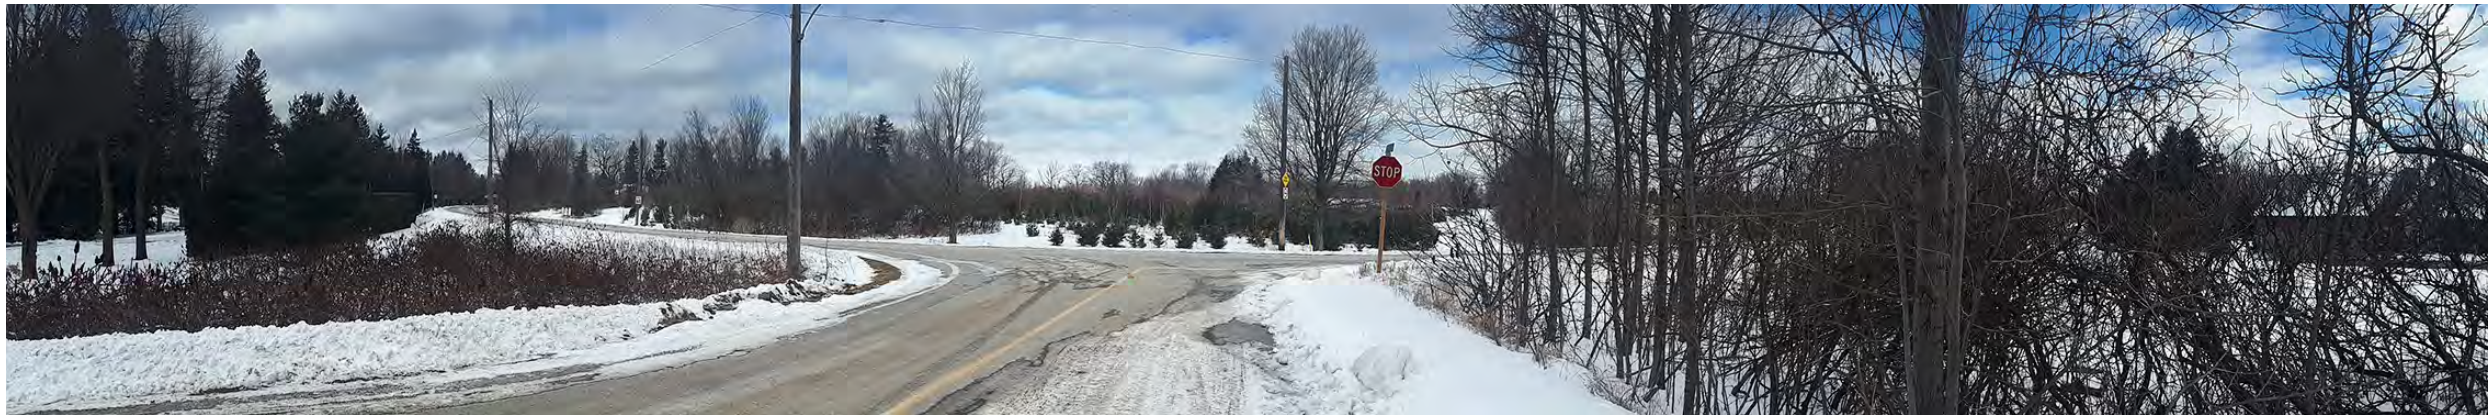
Photo 54: Cedar Springs Court. Facing Towards Proposed Western Extension.

<b>Photo 54</b>	Cedar Springs Court (Towards Western Extension)	Views of mixed vegetation. On private property and distance views of lands owned by the applicant. Filtered views probable. Existing vegetation provides some screening. Distance to extraction activities likely to reduce potential visual impact.	Low	Views of golf course will be removed. Distant Views of vegetation and rolling hills of golf course will be altered. Possible views of proposed pond.	Views of existing vegetation that has been maintained. Possible views of infiltration pond, likely screened by pond berming and vegetation. Distant views of rehabilitated excavation area which included proposed trees and slopes.	Construction of a 2.5 m visual berm. Retain existing vegetation where possible, including young coniferous plantation trees.
<b>Photo 55</b>	Approx. 5328 Cedar Springs Road (Towards Western Extension)	Views of mixed vegetation on private property. Some distant vegetation along the raised topography at the corner of the intersection is visible. Existing topography and vegetation provides full screening of potential views.	None	-	-	Mitigation measures not required.

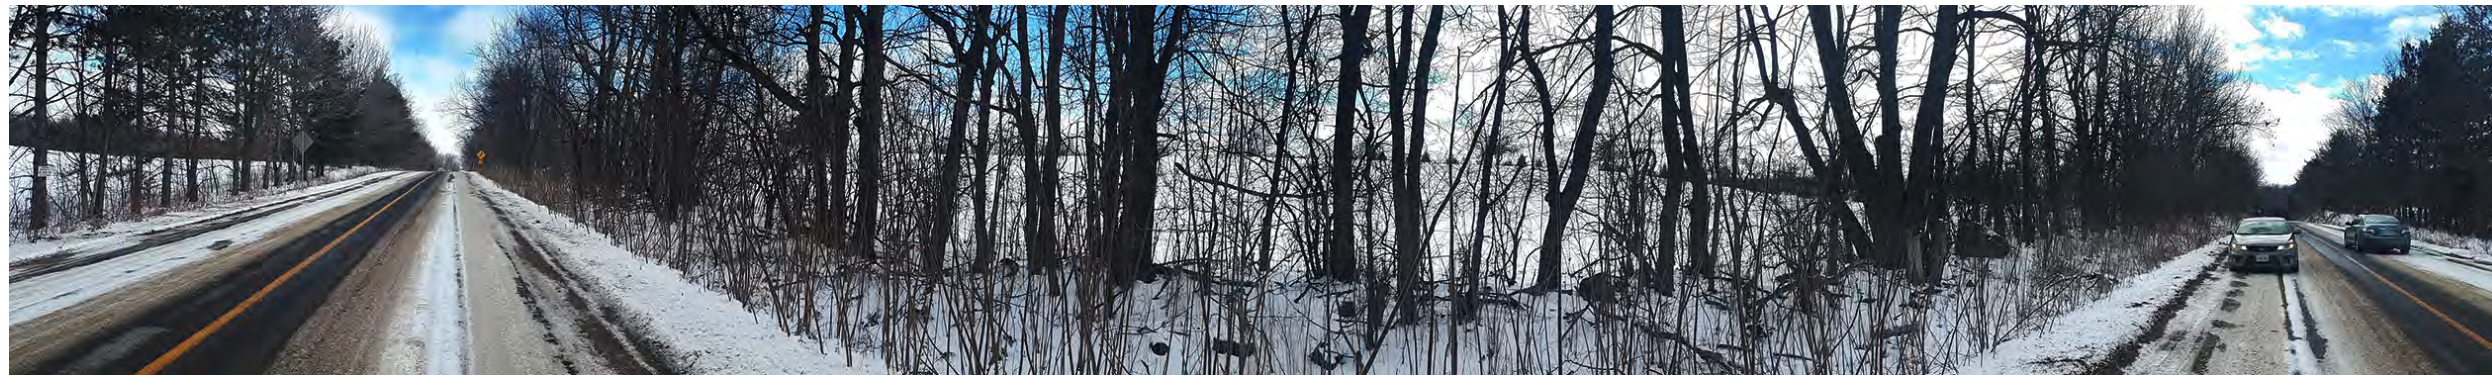
Photo 57: Approx. 2139-2129 Colling Road. Facing Towards Proposed Western Extension.

occurring close to public right of way.		removed. Views into the extraction area very unlikely.			
<b>Photo 57</b>	Approx. 2139-2129 Colling Road (Towards Western Extension)	Topography and vegetation creates minimal opportunity for views.	High	Views of golf course will be removed. Almost all vegetation and golf course landscape will be removed. Long linear views of quarry will be present without mitigation.		Clear views of water feature and proposed islands.	Proposed 3.0 m noise berm will provide adequate screening.
<b>Photo 58</b>	Approx. 2139-2129 Colling Road (Towards Western Extension)	Topography and vegetation creates minimal opportunity for views.	High	Views of golf course will be removed. Almost all vegetation and golf course landscape will be removed. Long linear views of quarry will be present without mitigation.		Views of roadside wetland and planted grassland. Clear views of water feature and proposed islands.	Proposed 3.5 m noise berm will provide adequate screening.
