## Proposed Burlington Quarry Expansion JART COMMENT SUMMARY TABLE – Visual Impact Assessment

**Proposed Burlington Quarry Expansion  
JART COMMENT SUMMARY TABLE – Visual Impact Assessment**

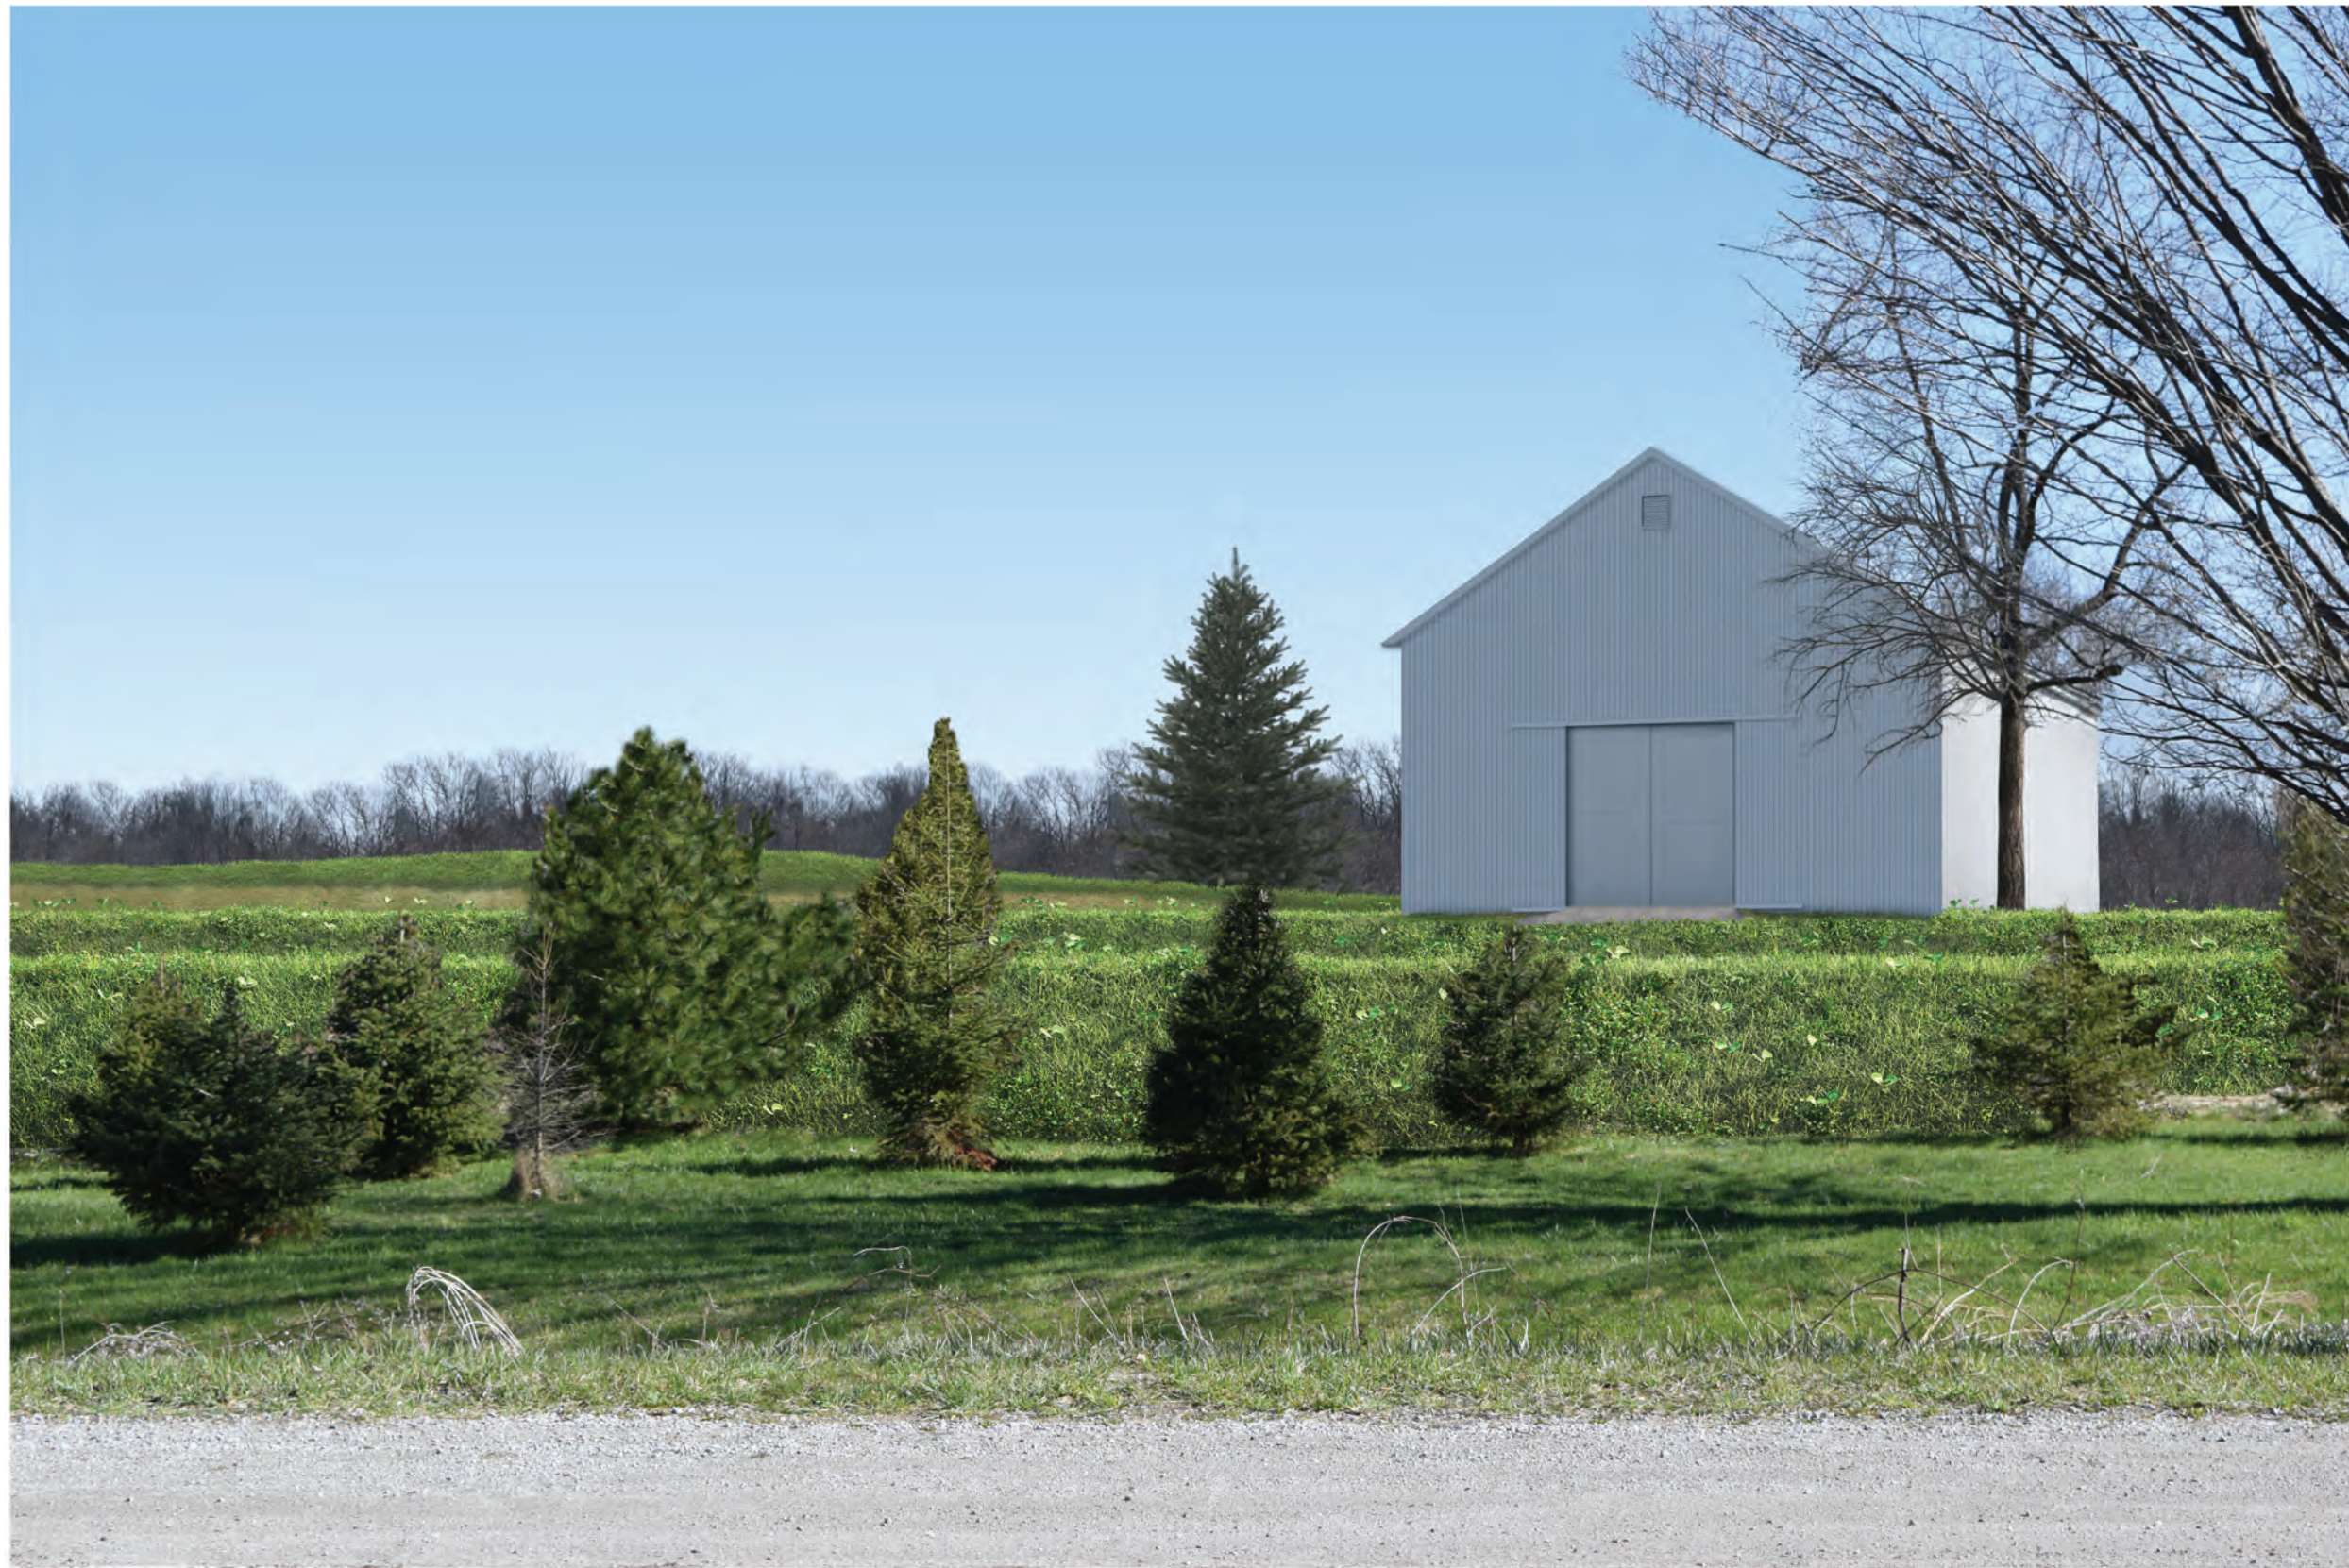
Figure 9A  
**Photo Simulation  
During Quarry Operations**

Photo Simulation During Quarry Operation - Viewpoint 22

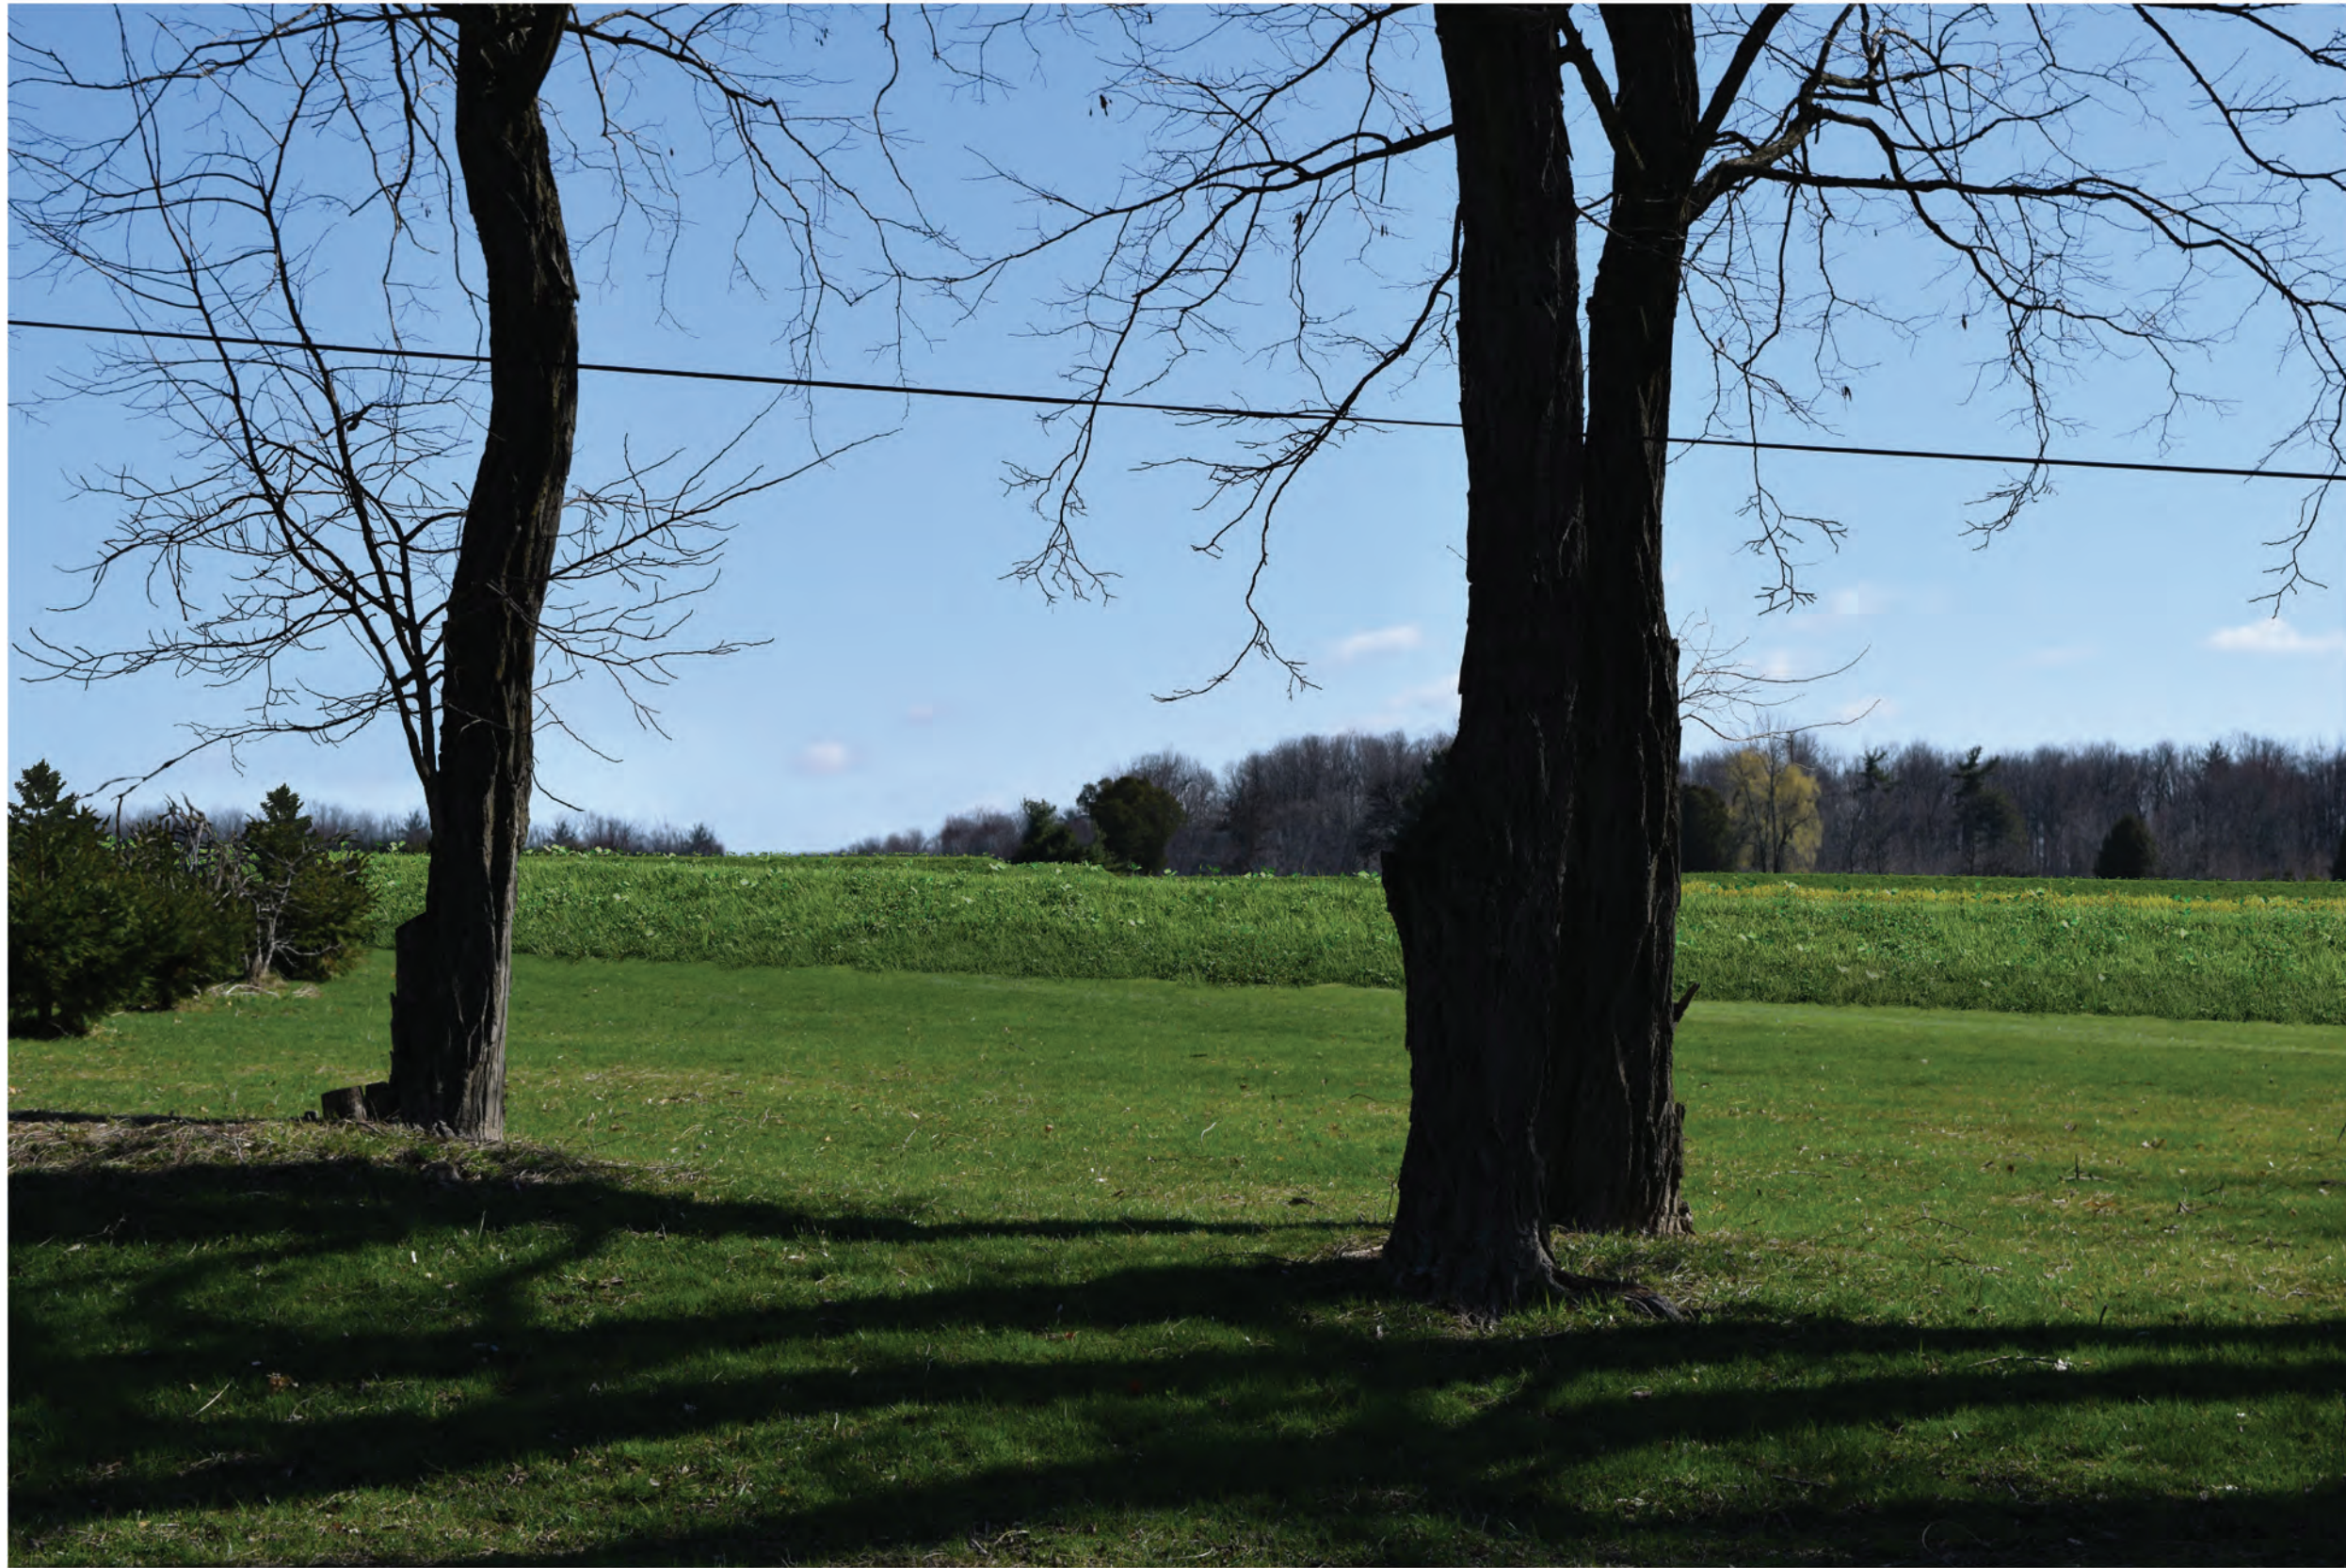
Figure 9B  
**Photo Simulation  
During Quarry Operations**

Photo Simulation During Quarry Operation - Viewpoint 32

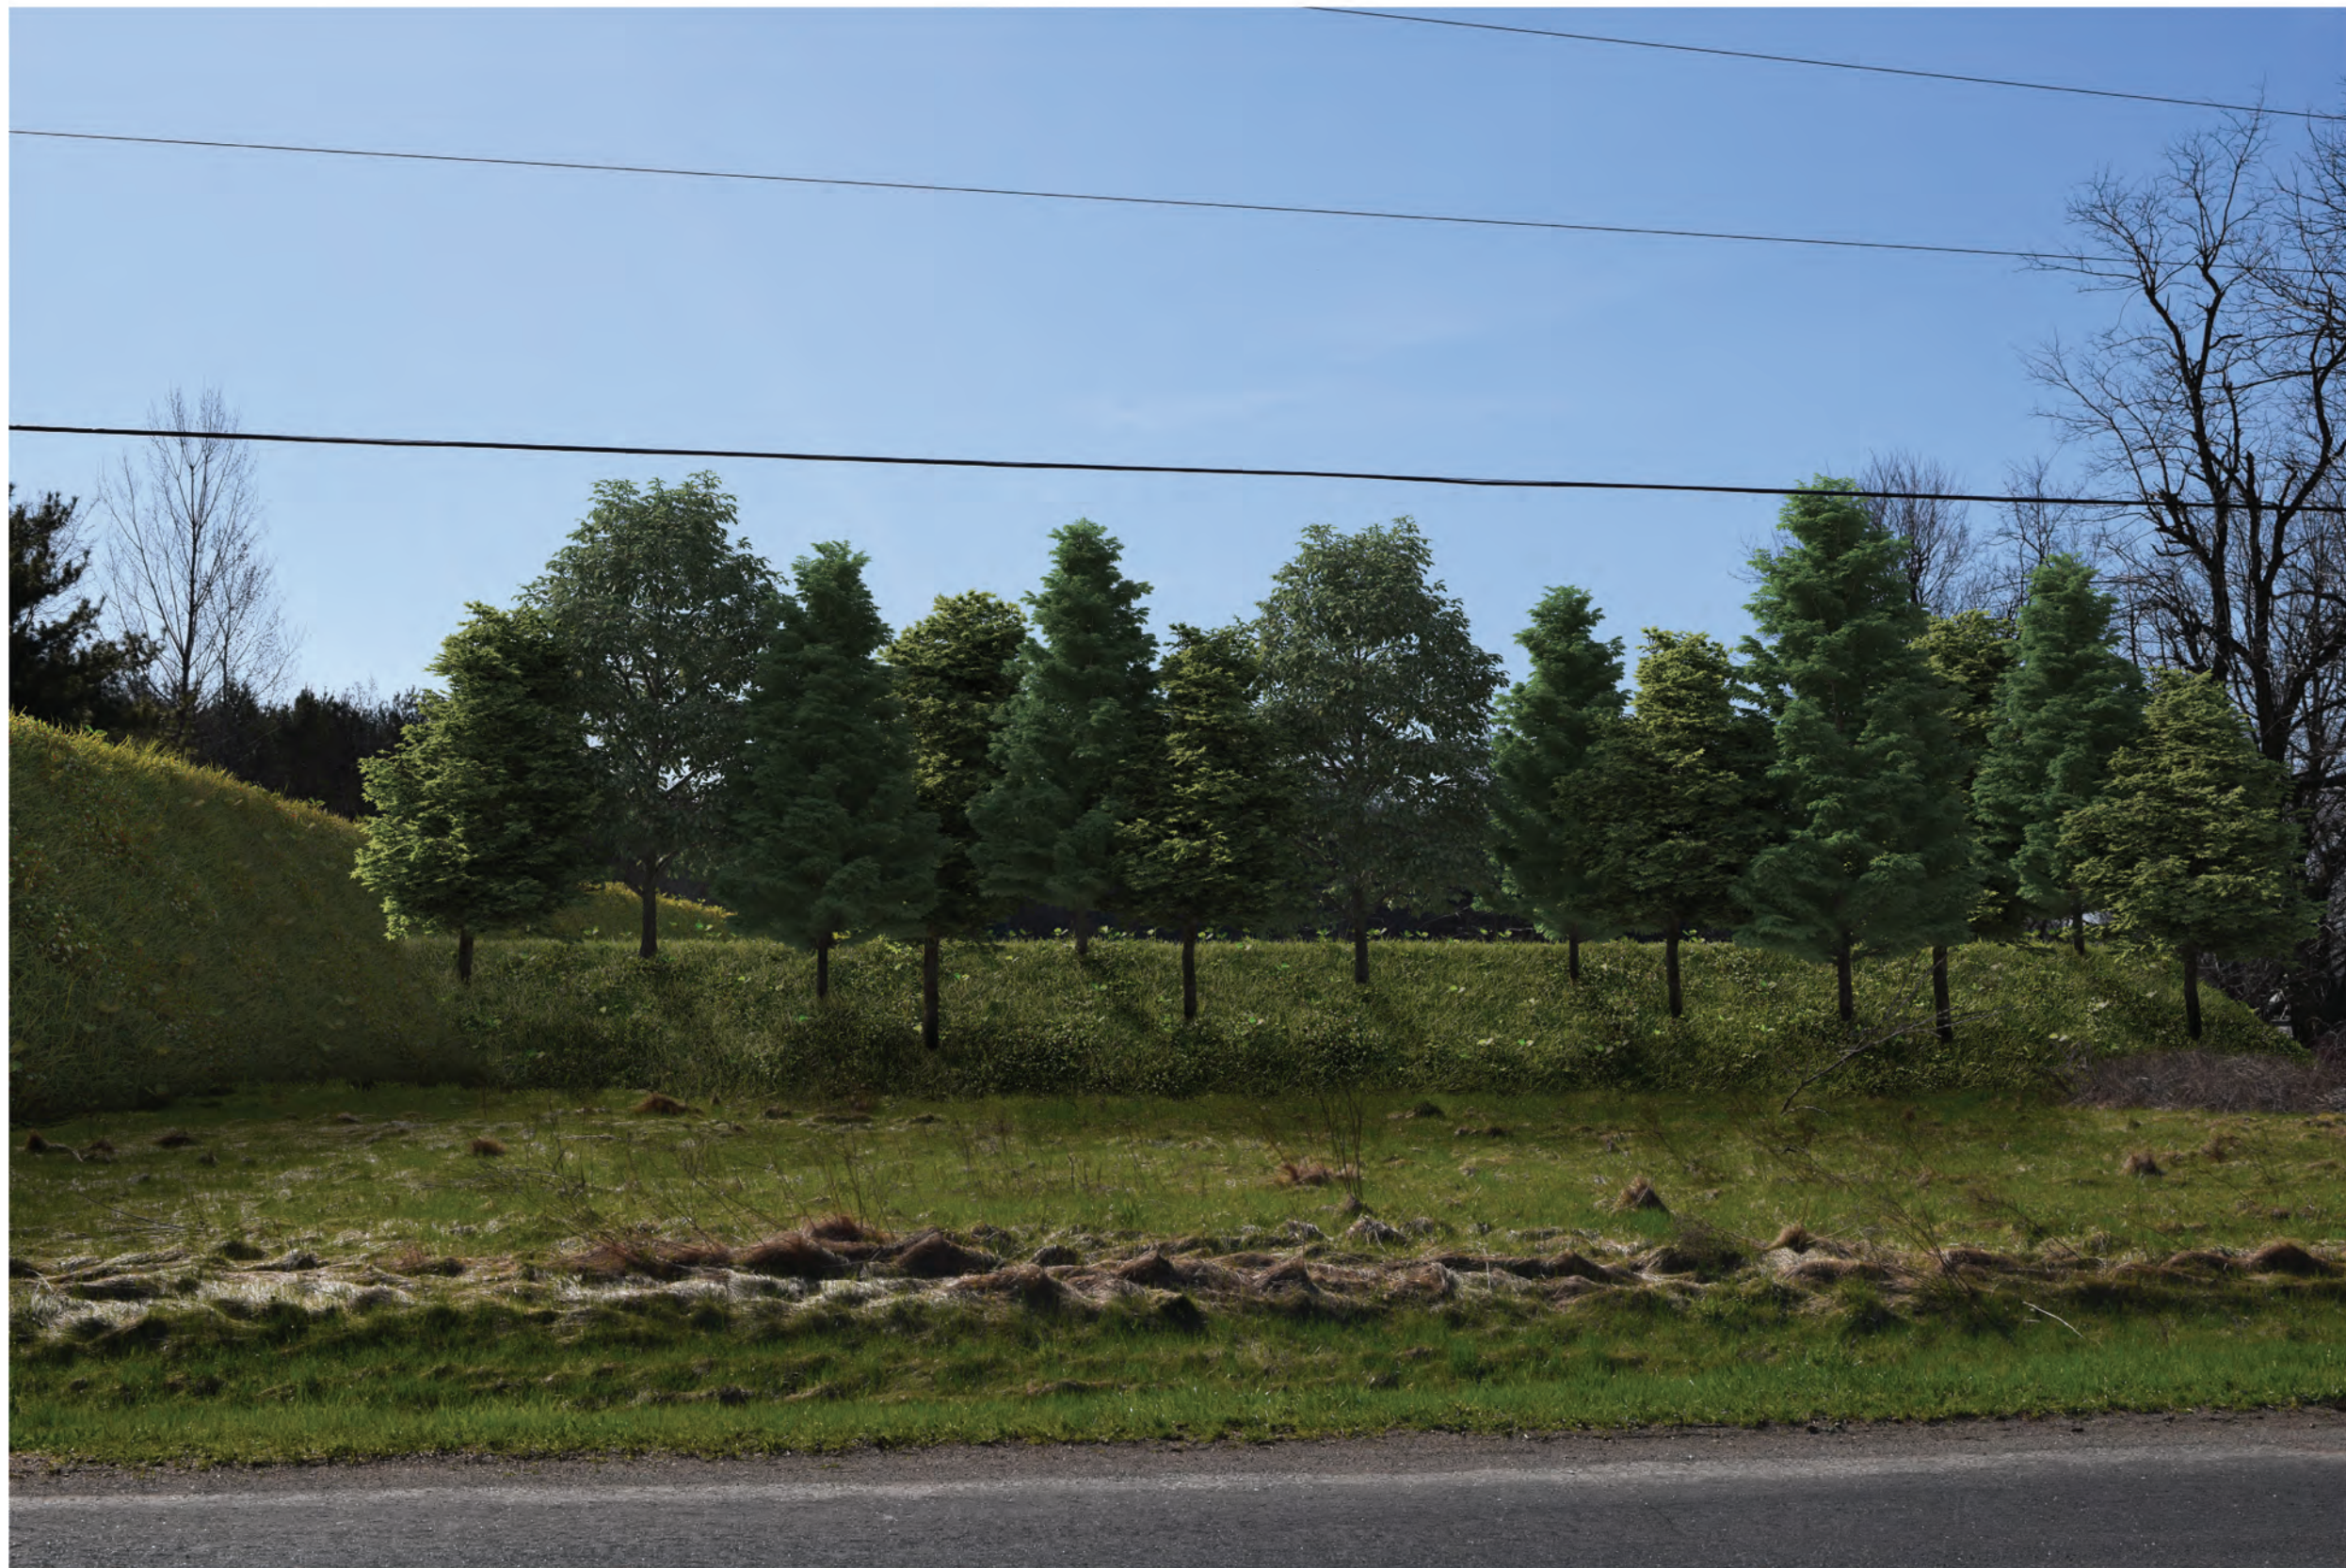
Figure 9D  
**Photo Simulation  
During Quarry Operations**

Photo Simulation During Quarry Operation - Viewpoint 50

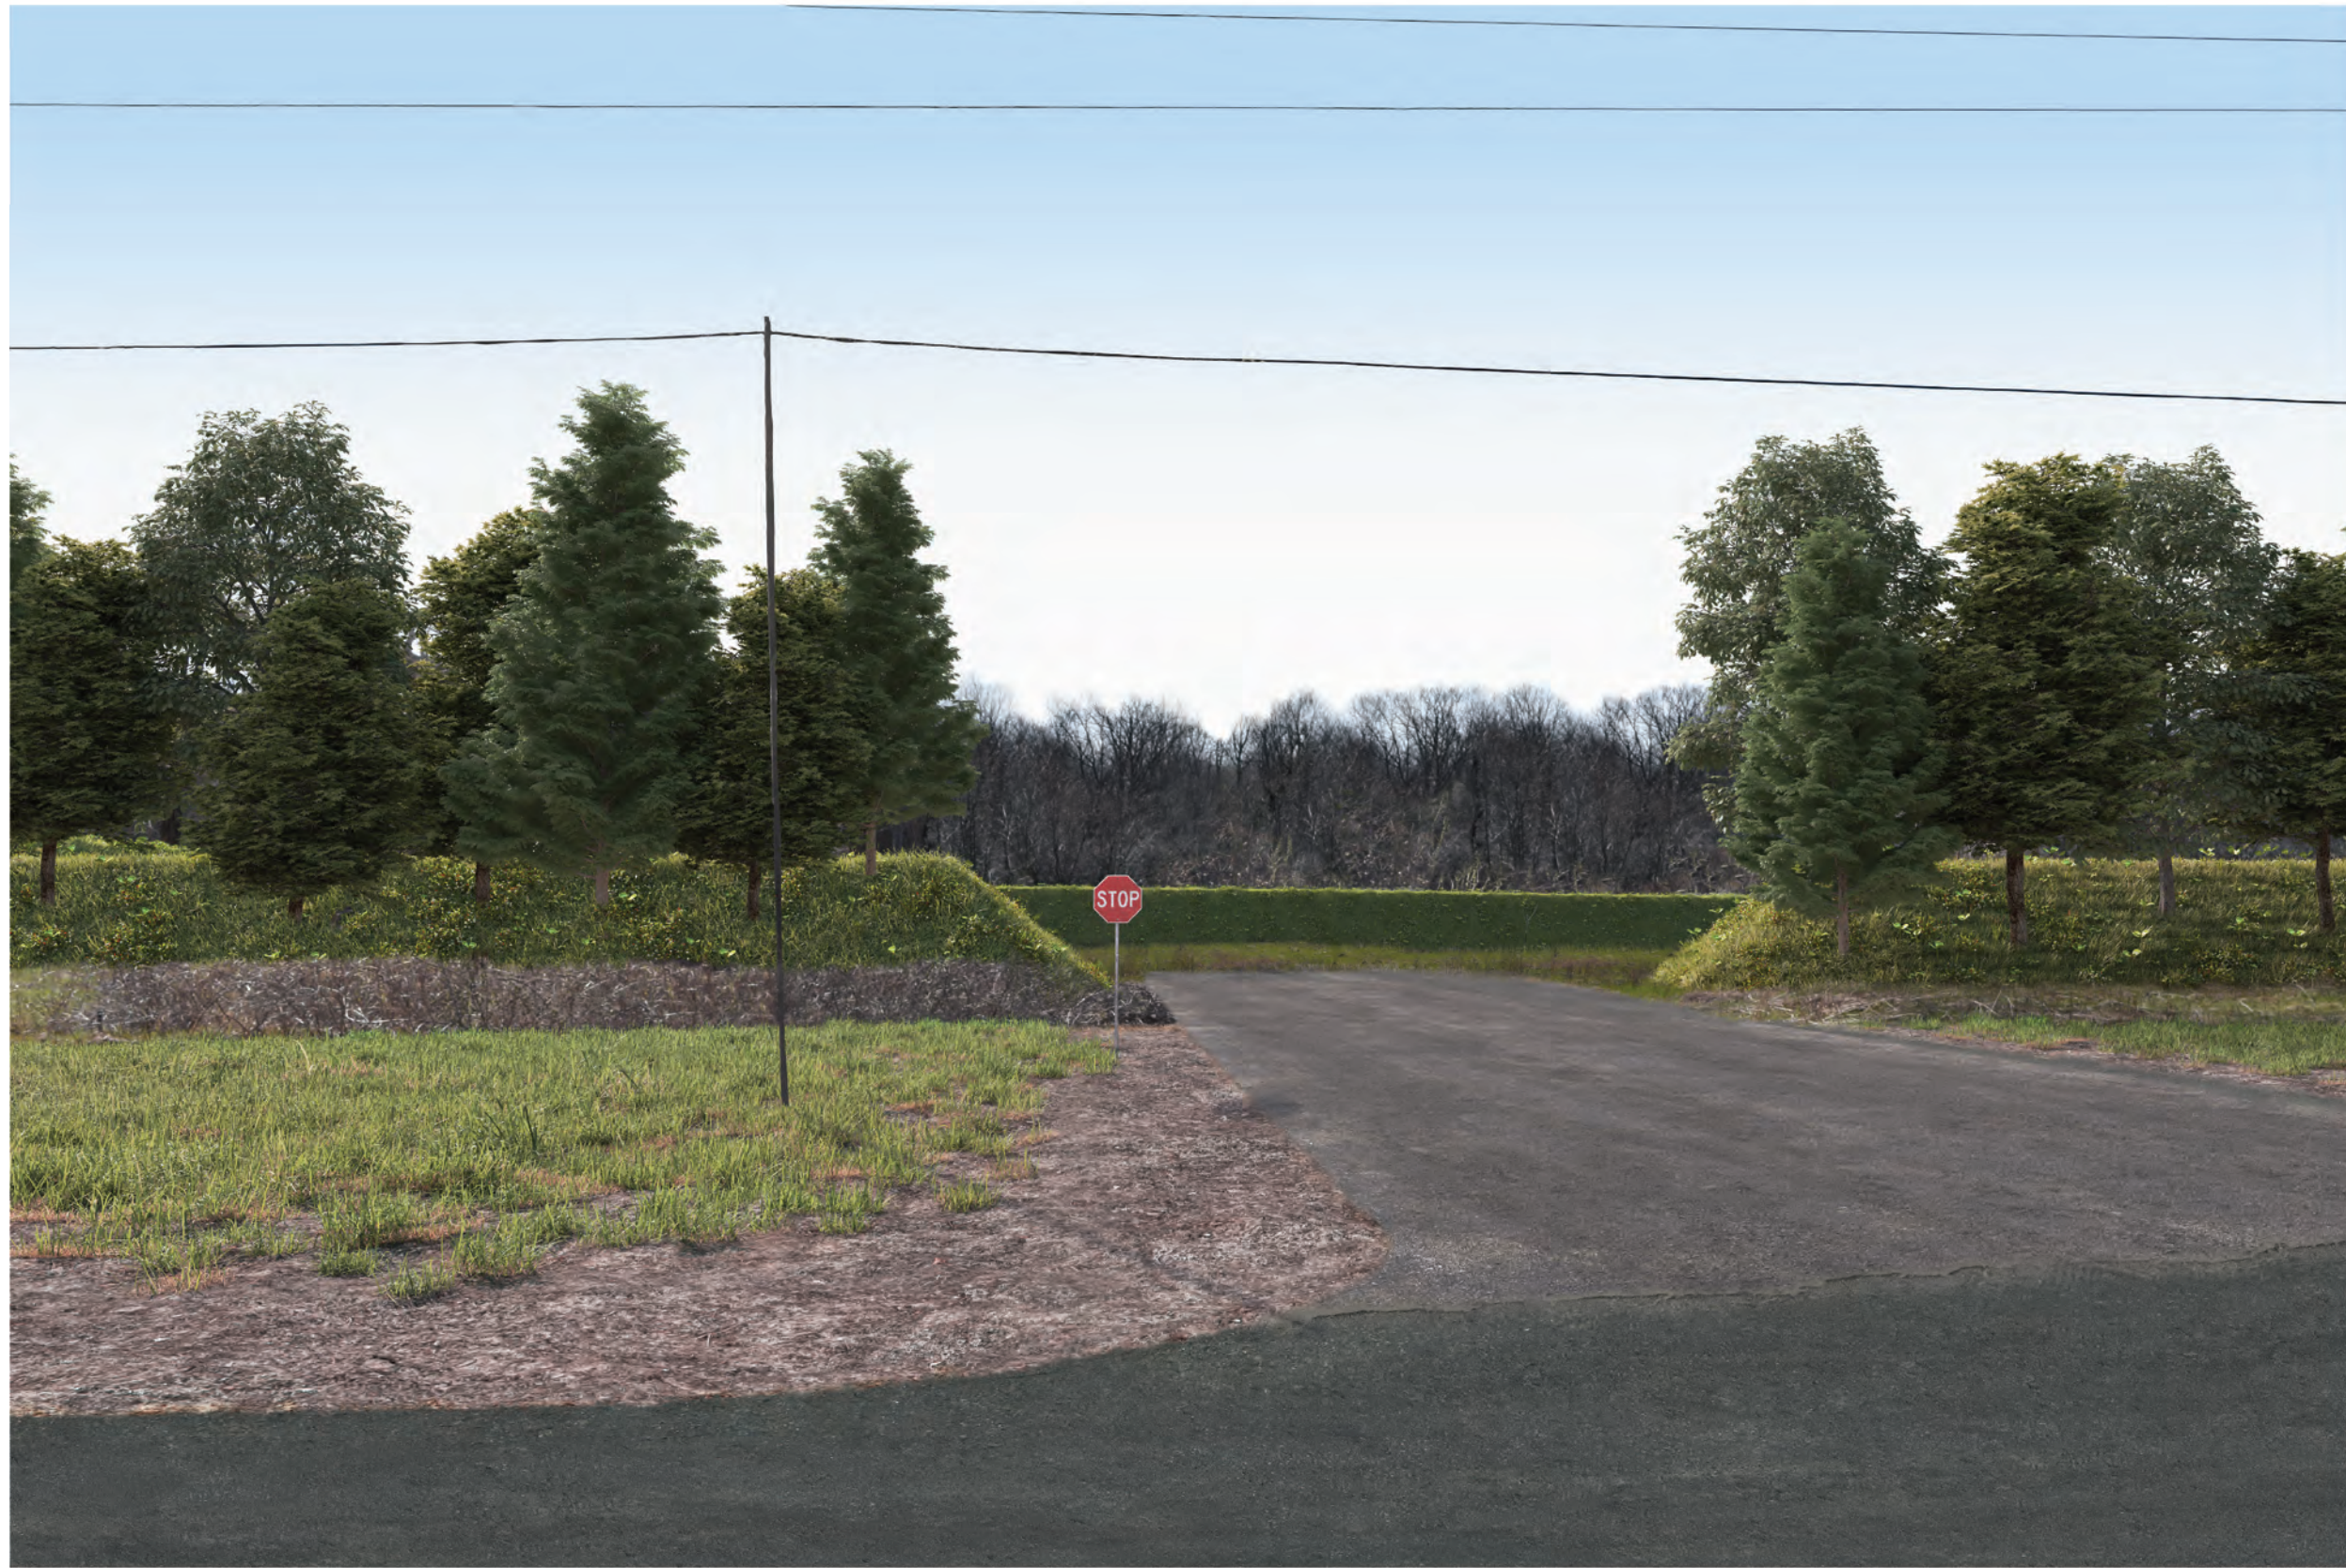
Figure 9E  
**Photo Simulation  
During Quarry Operations**

Photo Simulation During Quarry Operation - 2 Side Road Quarry Crossing Facing South

Photo simulations of the expected condition during quarry operations have been provided in **Figures 9E and 9F**.

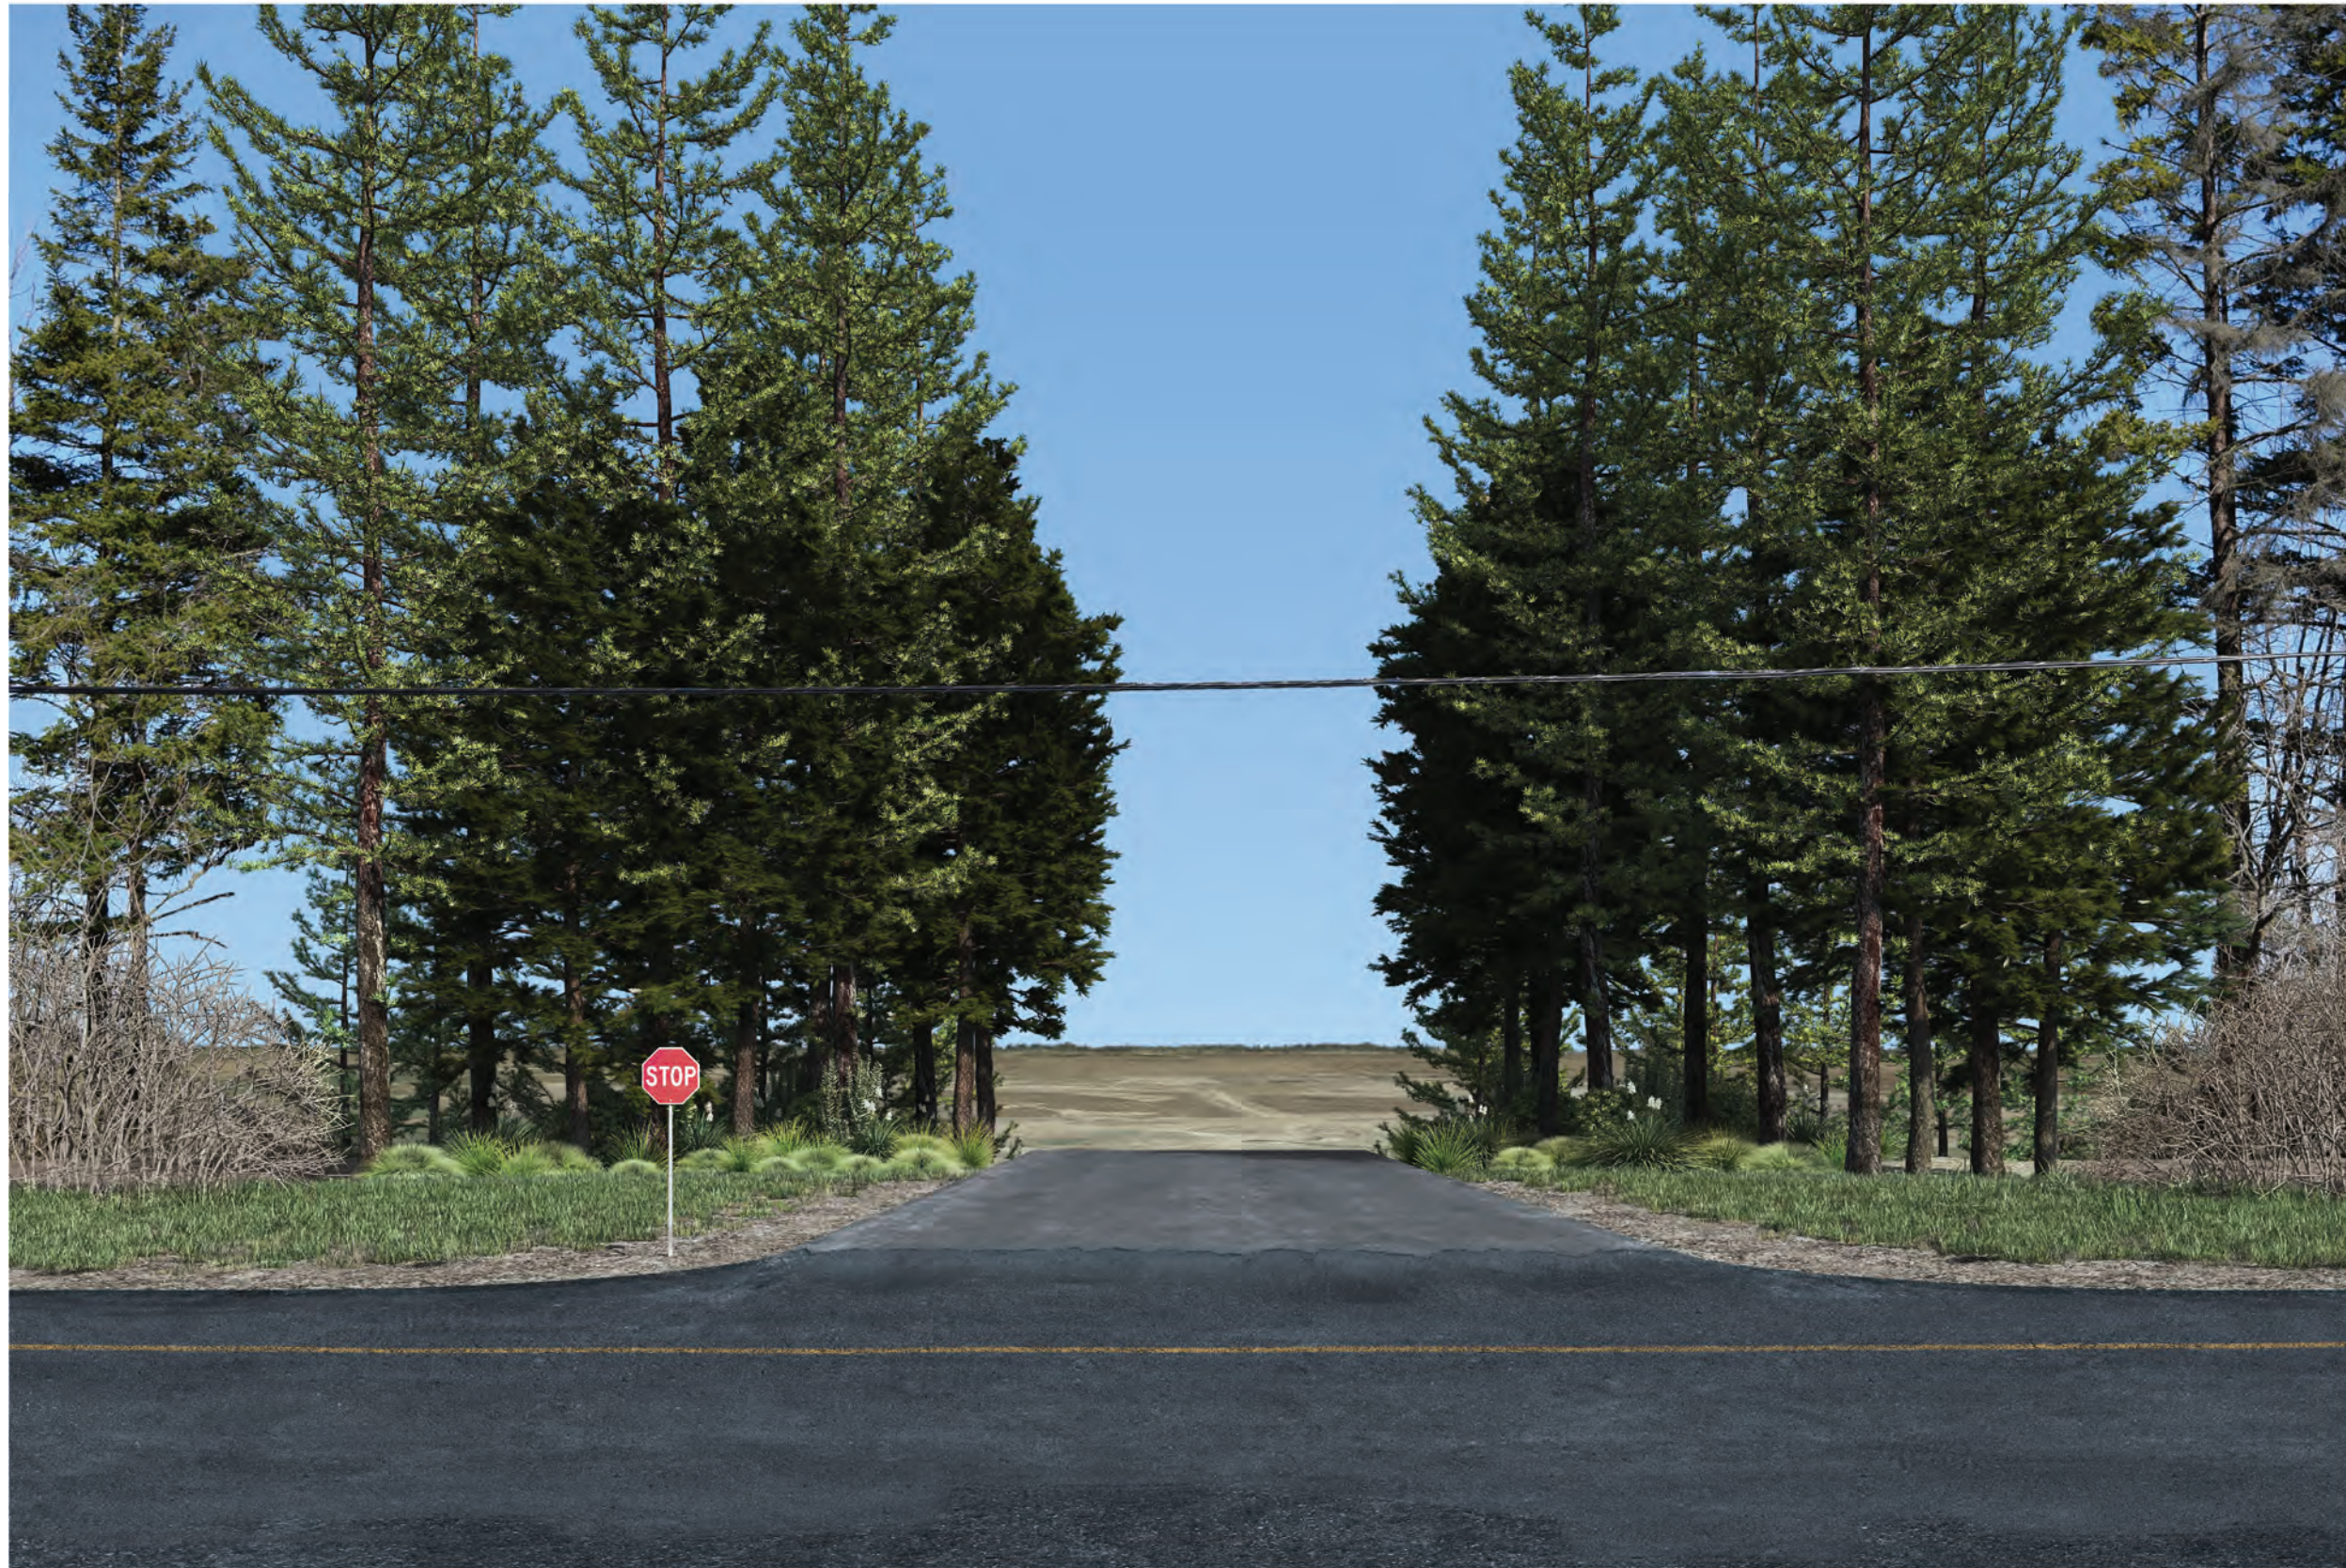
Figure 9F  
**Photo Simulation  
During Quarry Operations**

Photo Simulation During Quarry Operation - 2 Side Road Quarry Crossing Facing North

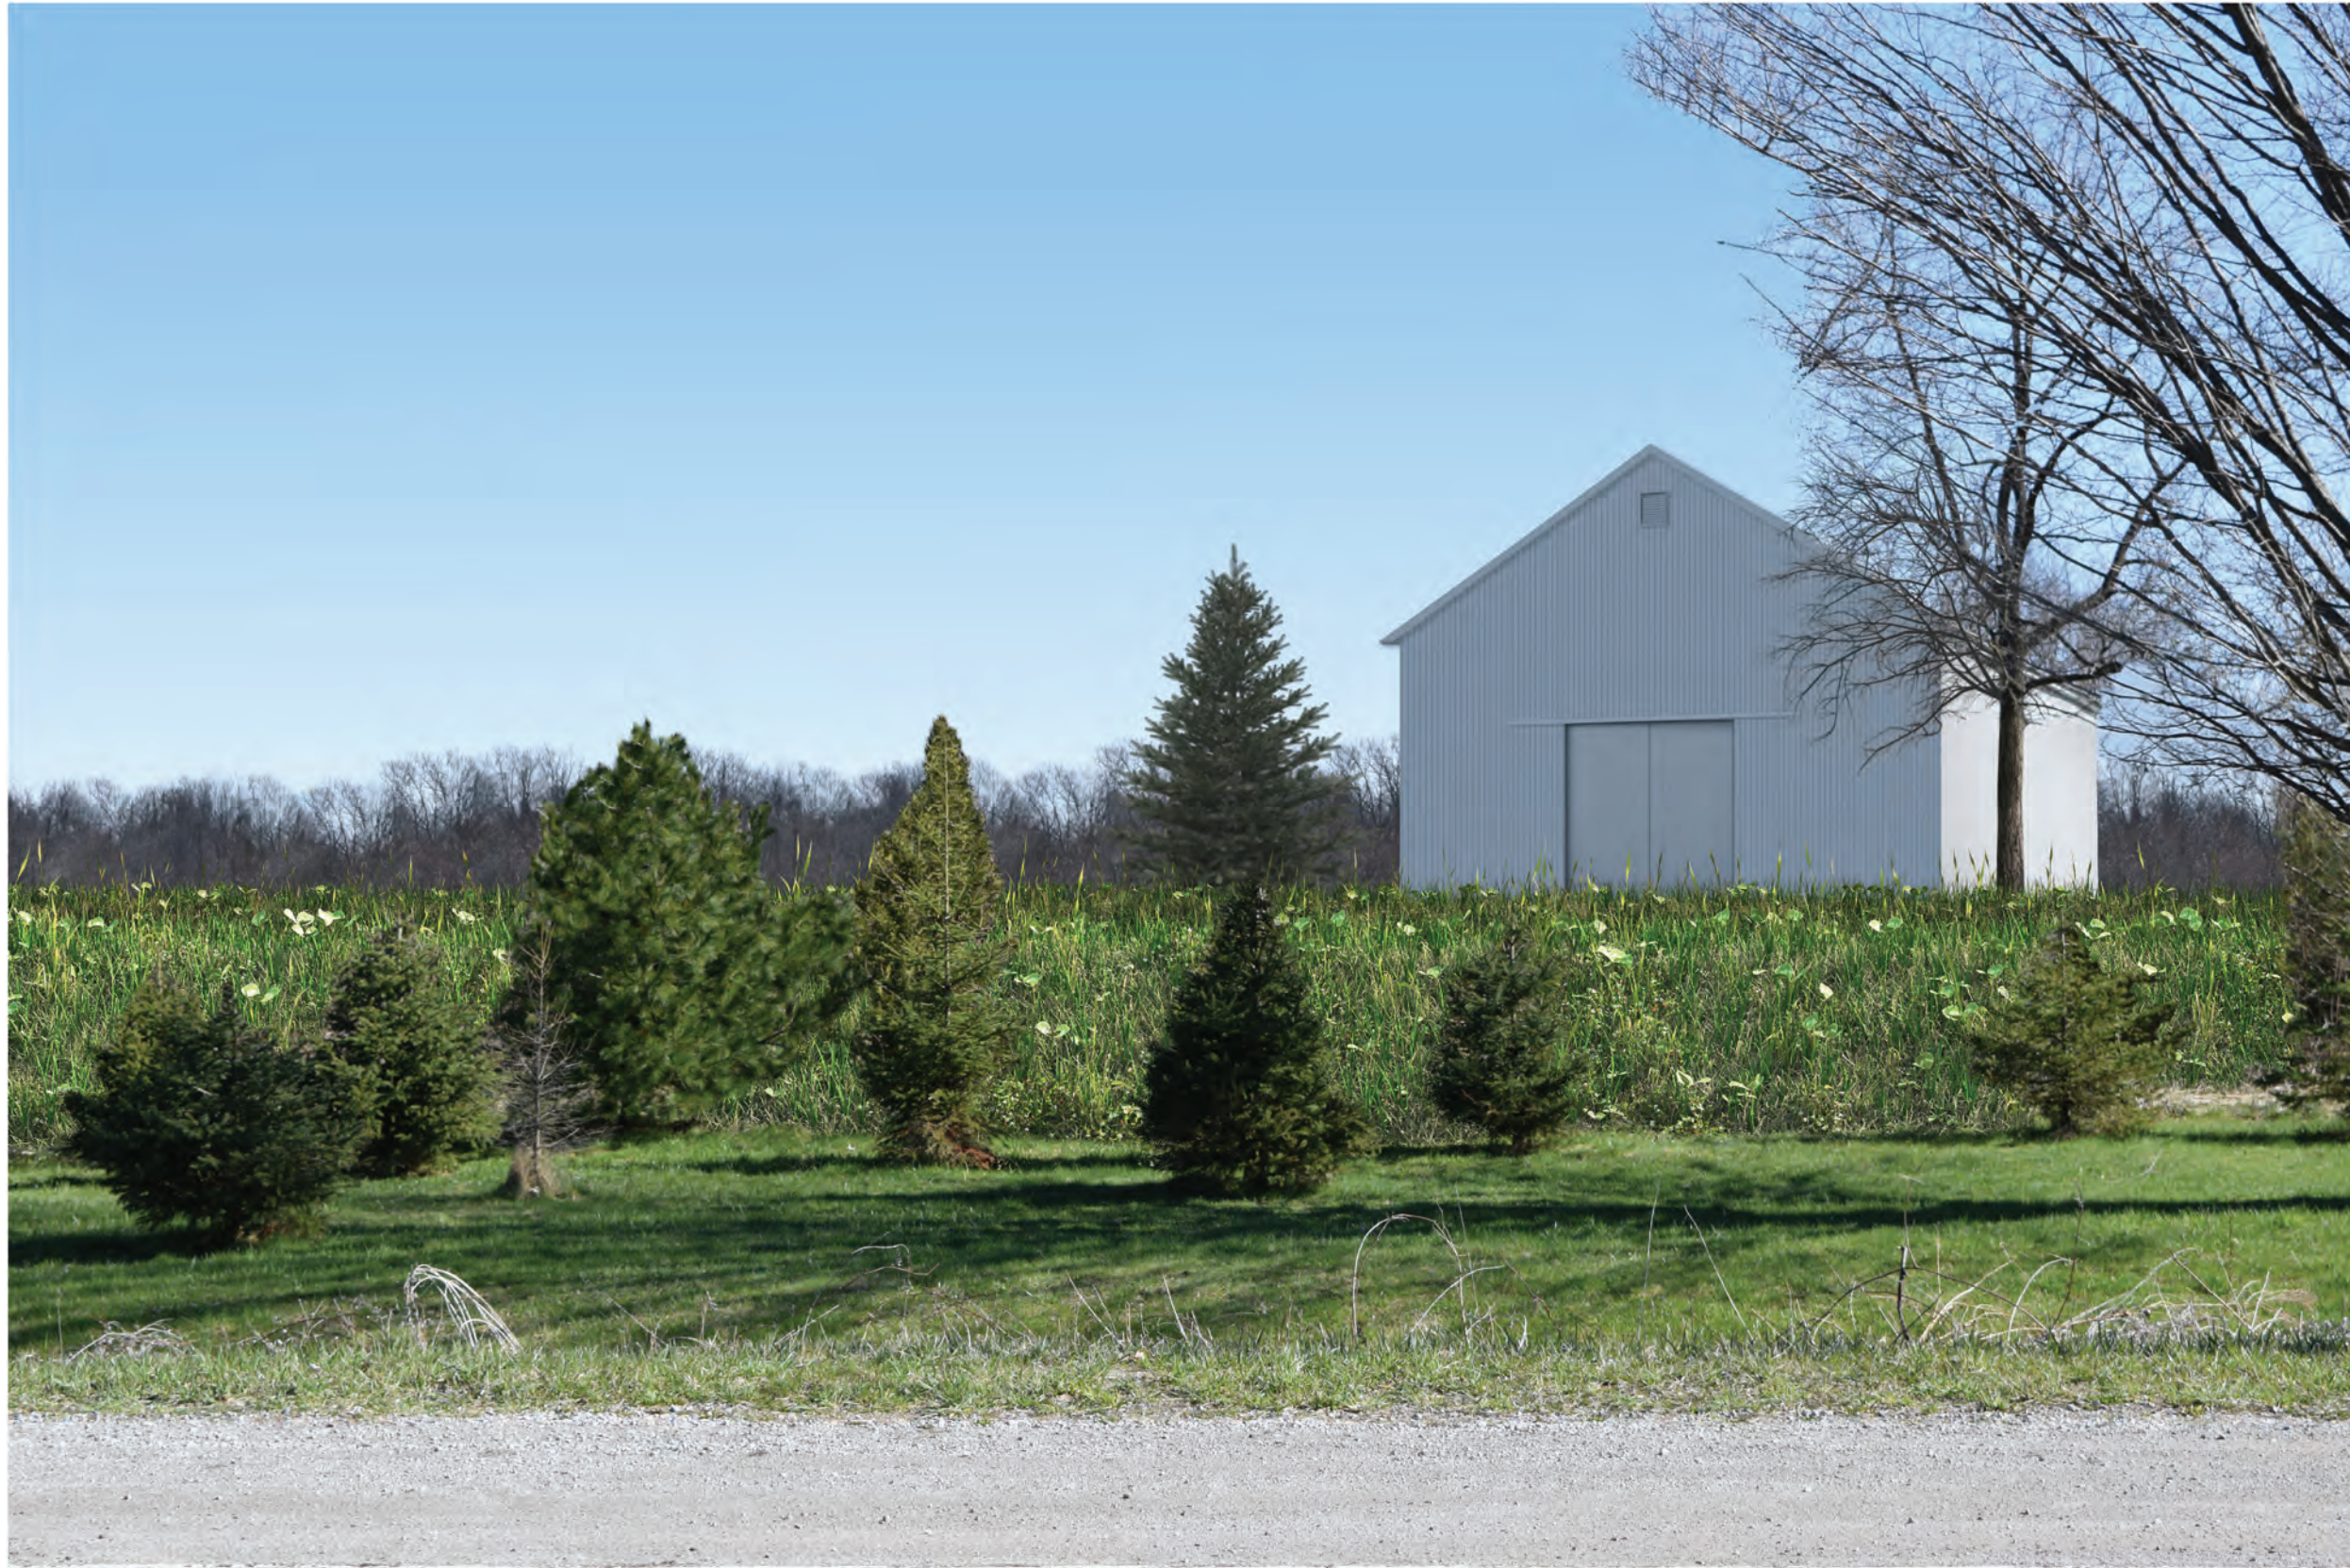
Figure 9G  
**Photo Simulation**  
**Post Quarry Operations**

Photo Simulation Post Quarry Operation - Viewpoint 22
