## Proposed Burlington Quarry Expansion JART COMMENT SUMMARY TABLE – Visual Impact Assessment

**Proposed Burlington Quarry Expansion  
JART COMMENT SUMMARY TABLE – Visual Impact Assessment**

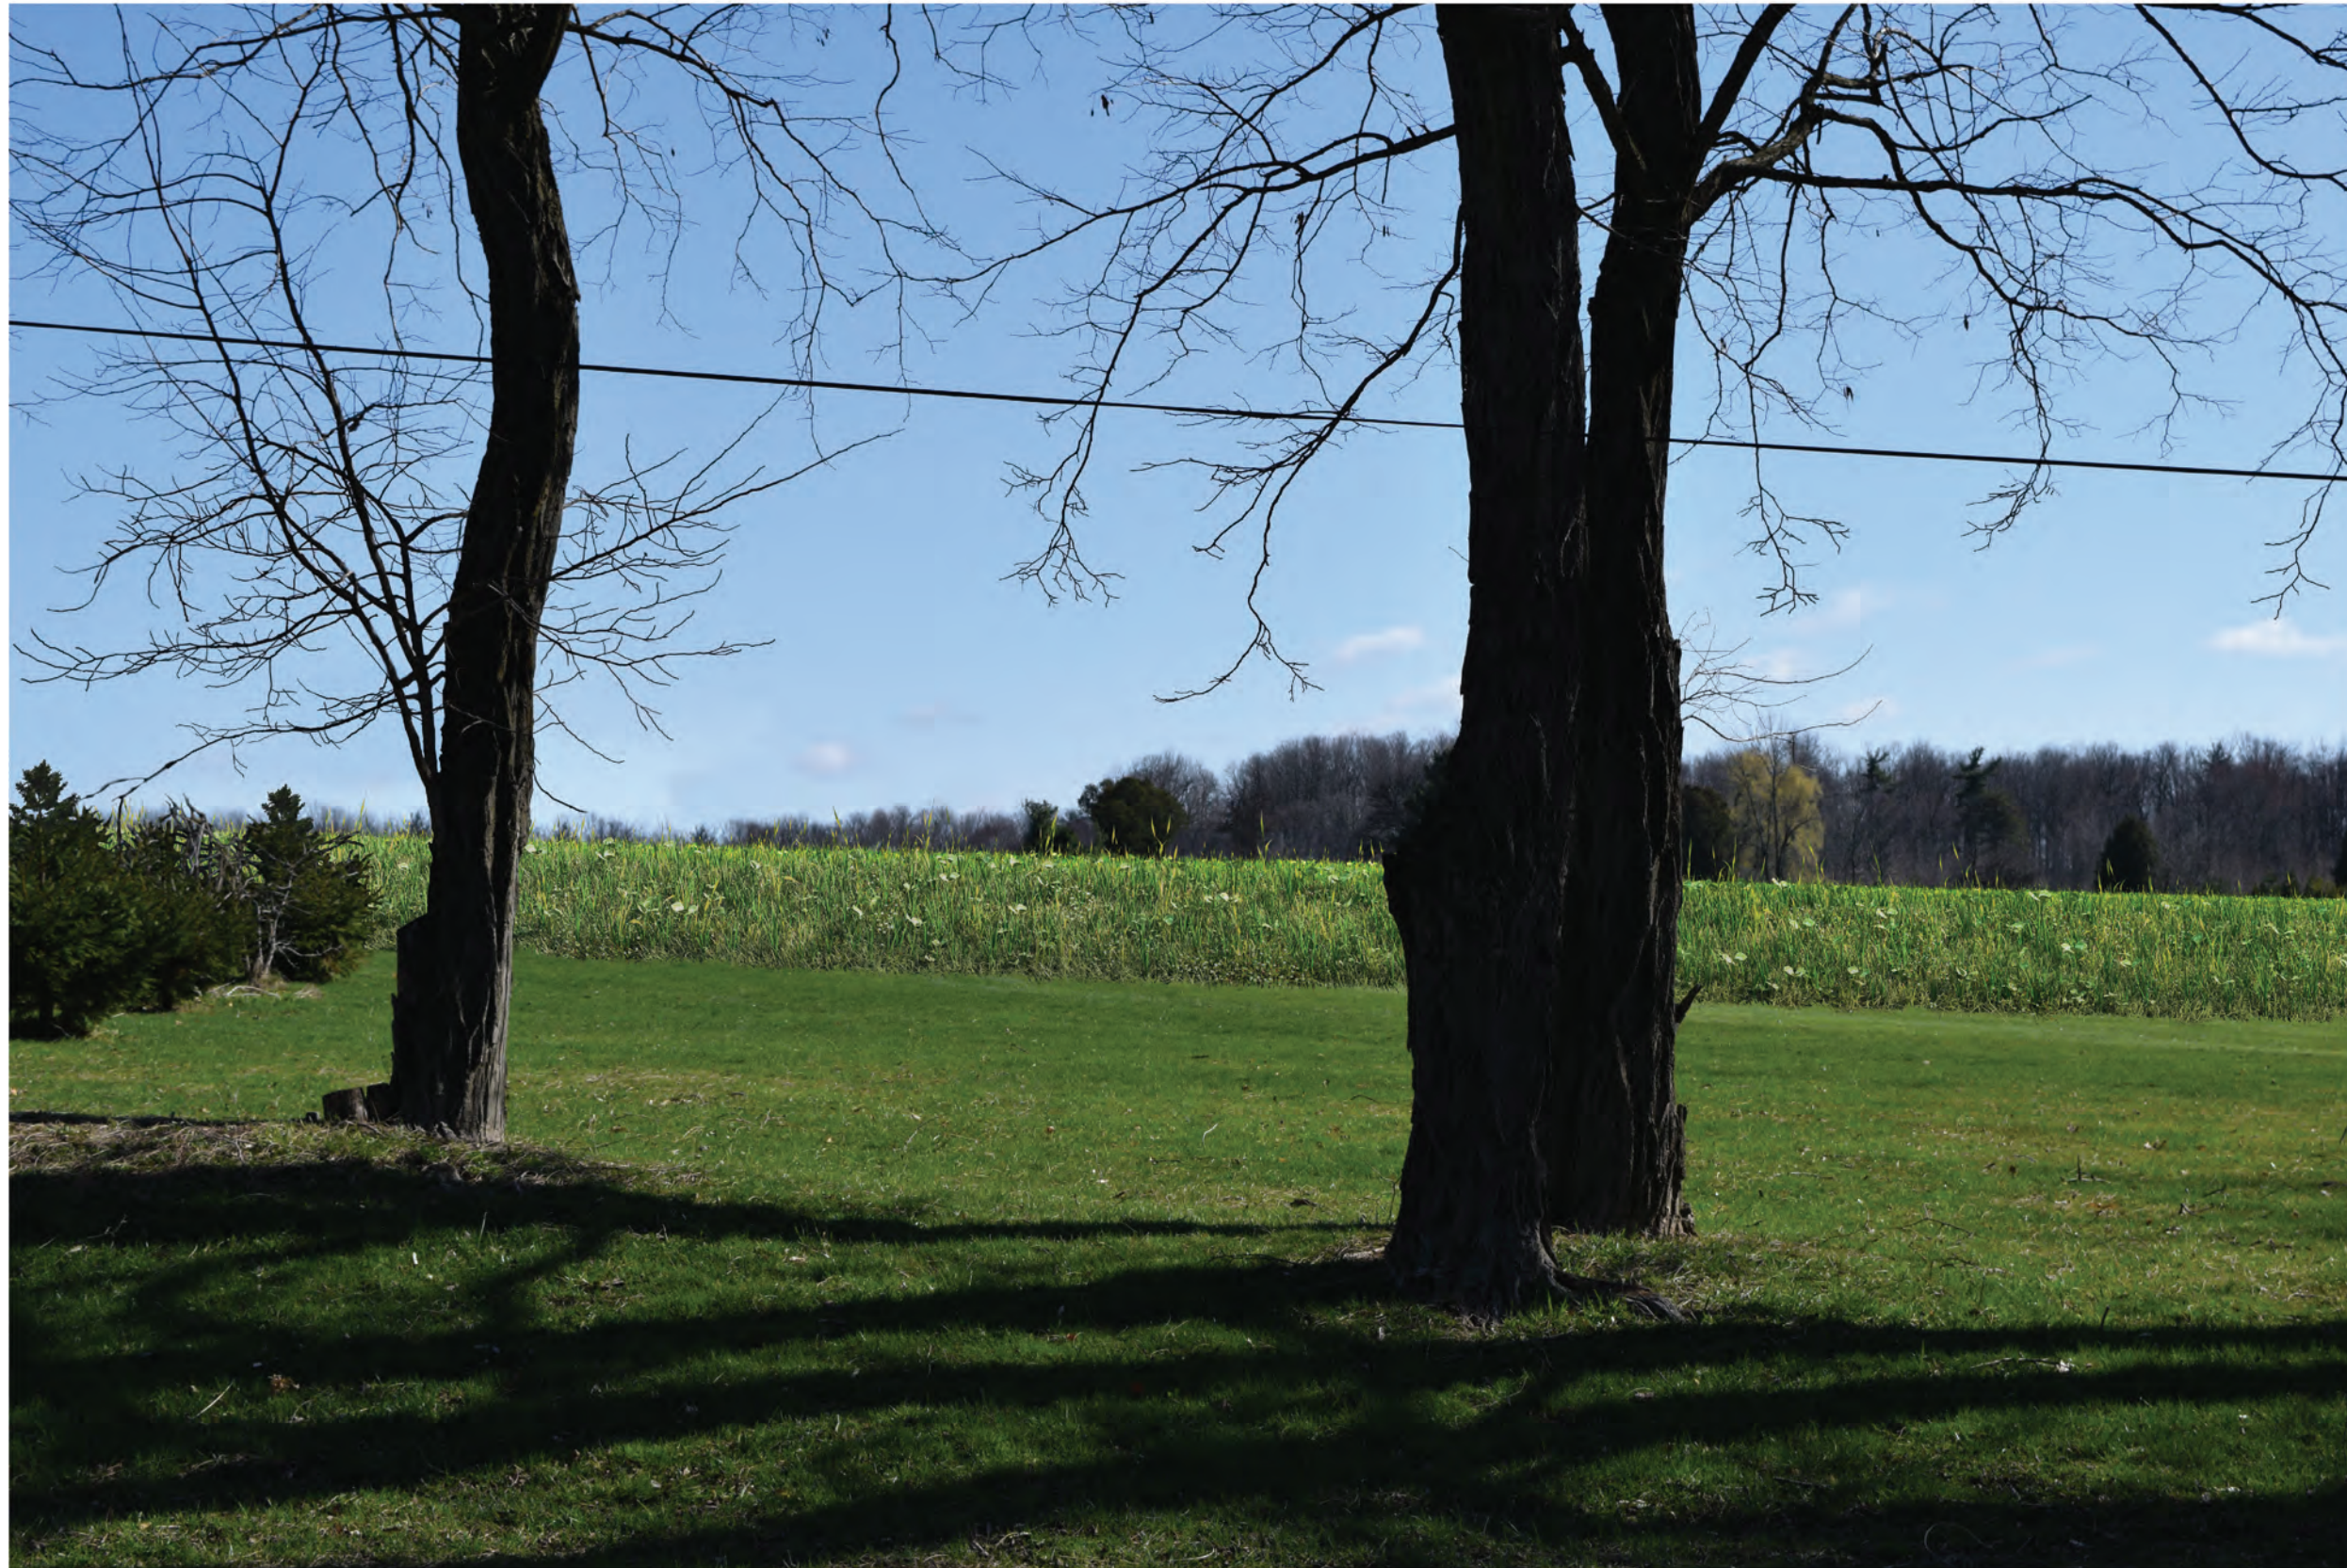
Figure 9H  
**Photo Simulation**  
**Post Quarry Operations**

Photo Simulation Post Quarry Operation - Viewpoint 32

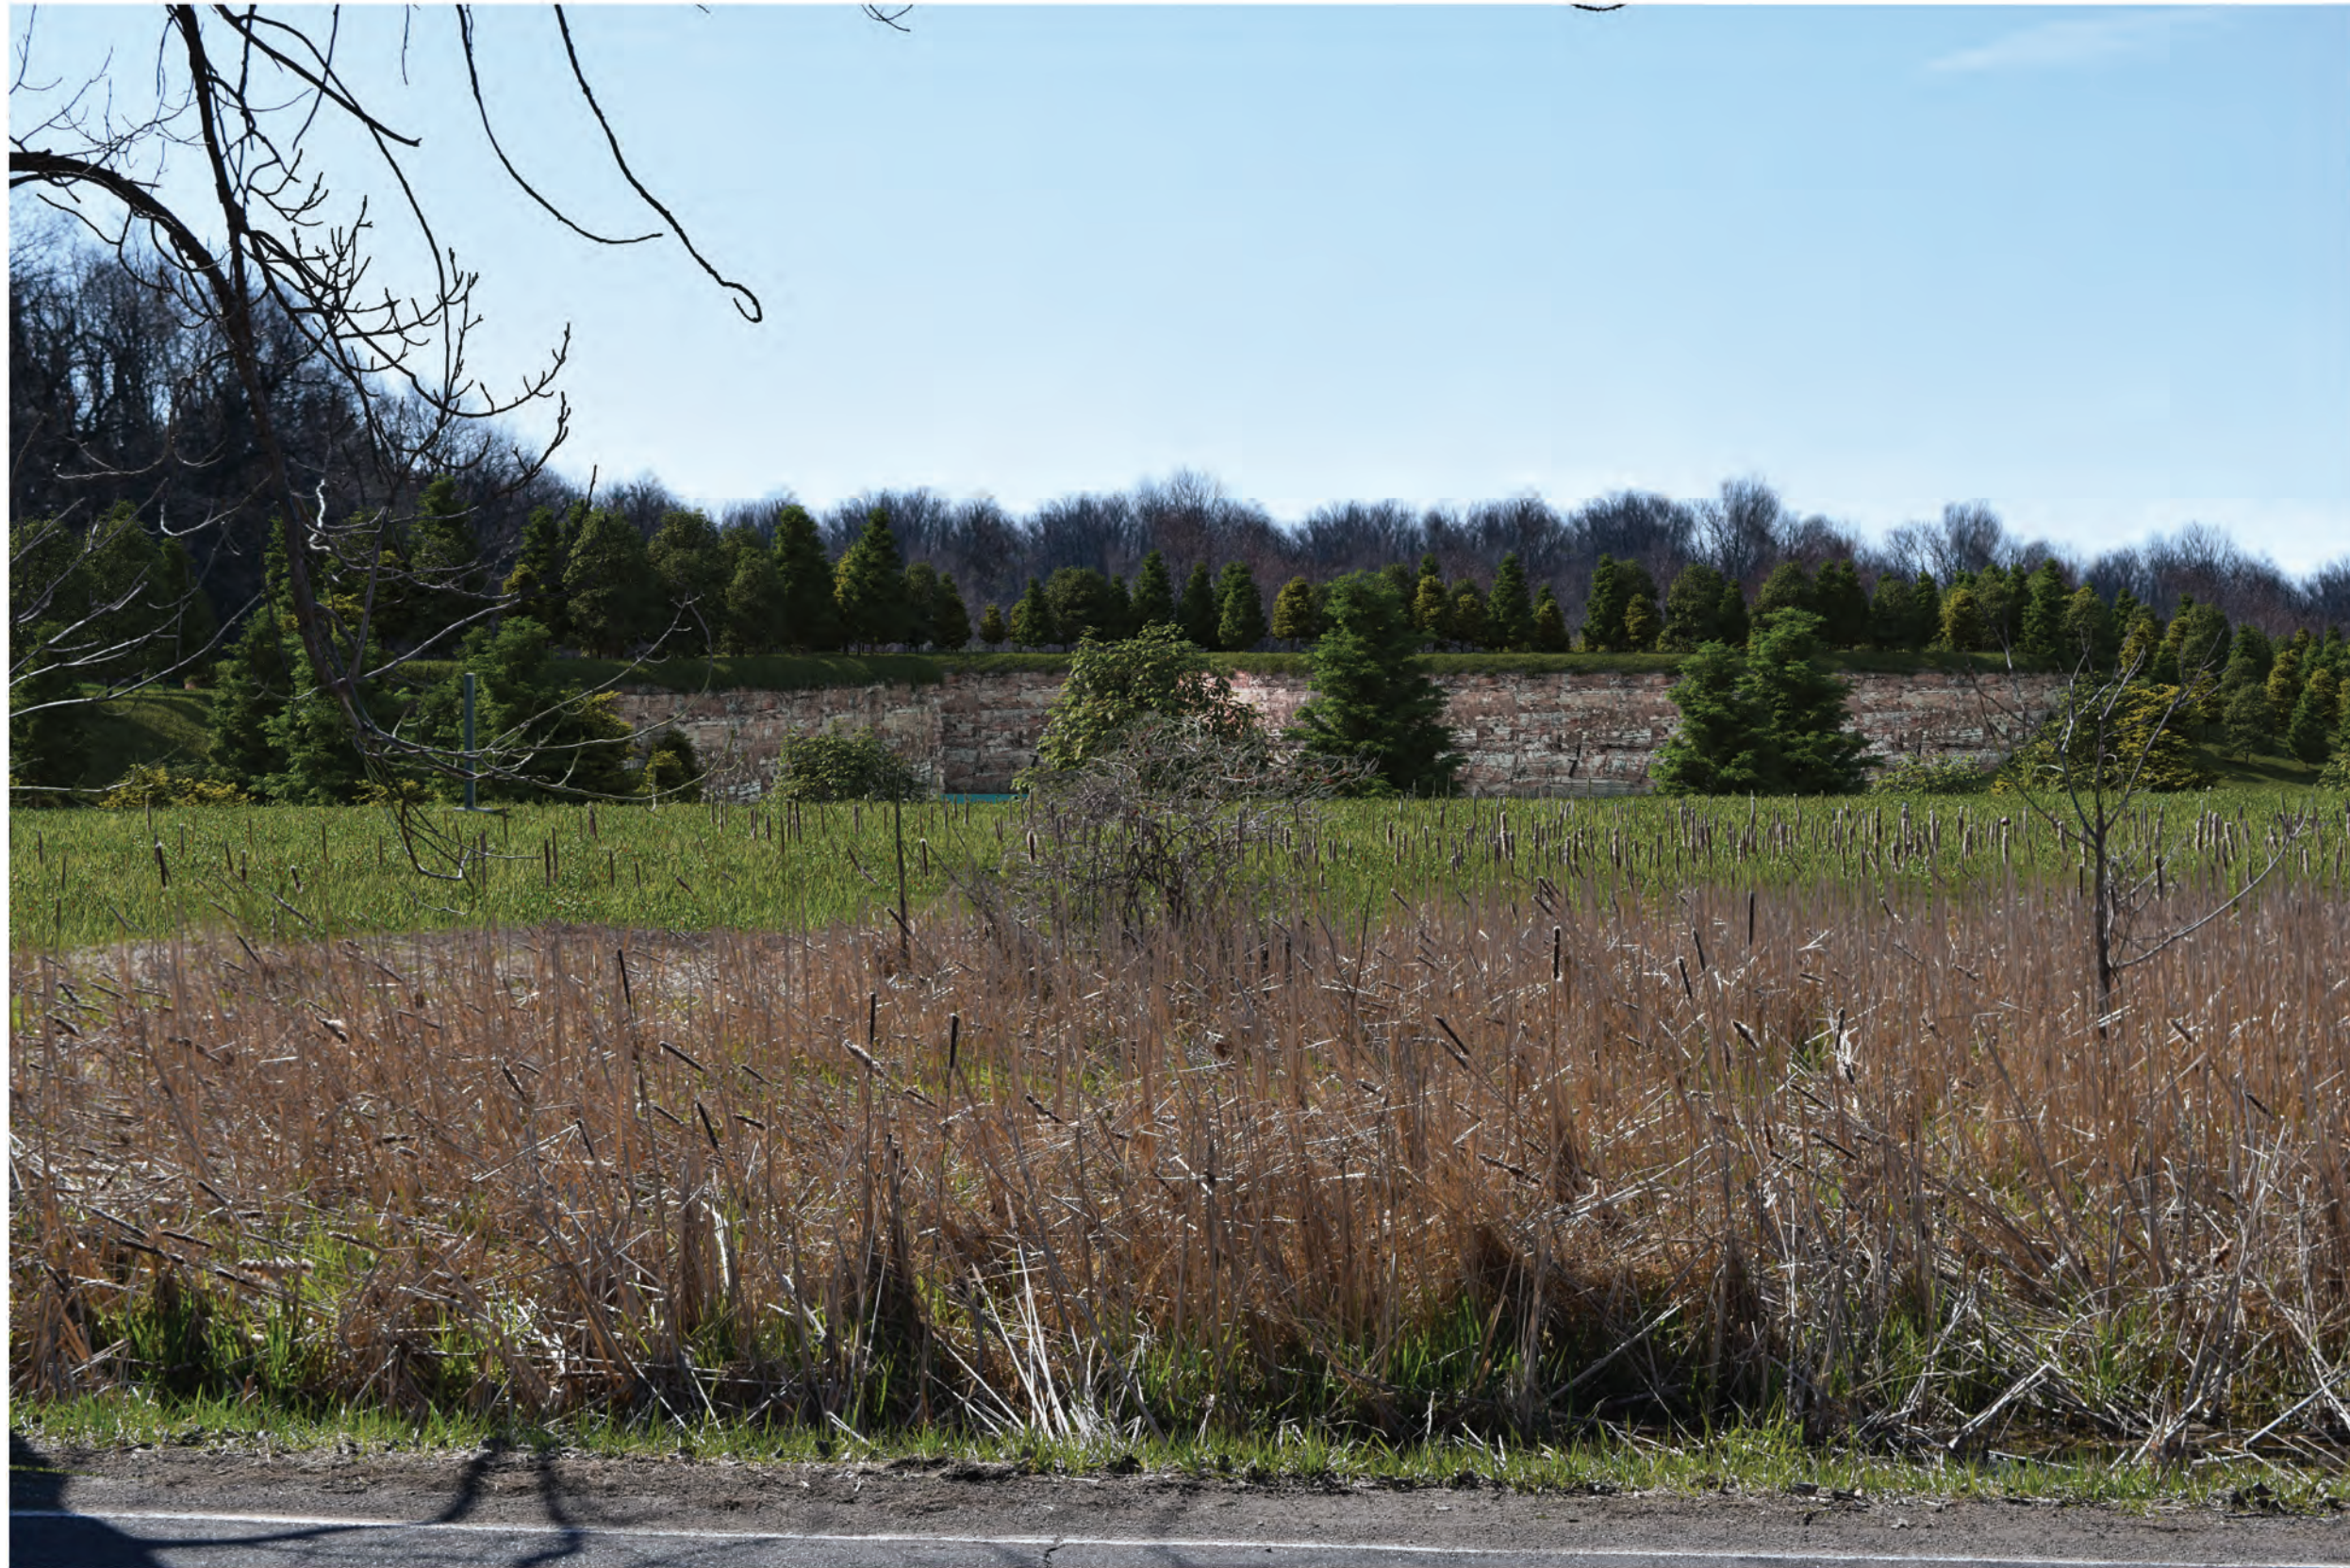
Figure 91  
**Photo Simulation**  
**Post Quarry Operations**

Photo Simulation Post Quarry Operation - Viewpoint 43

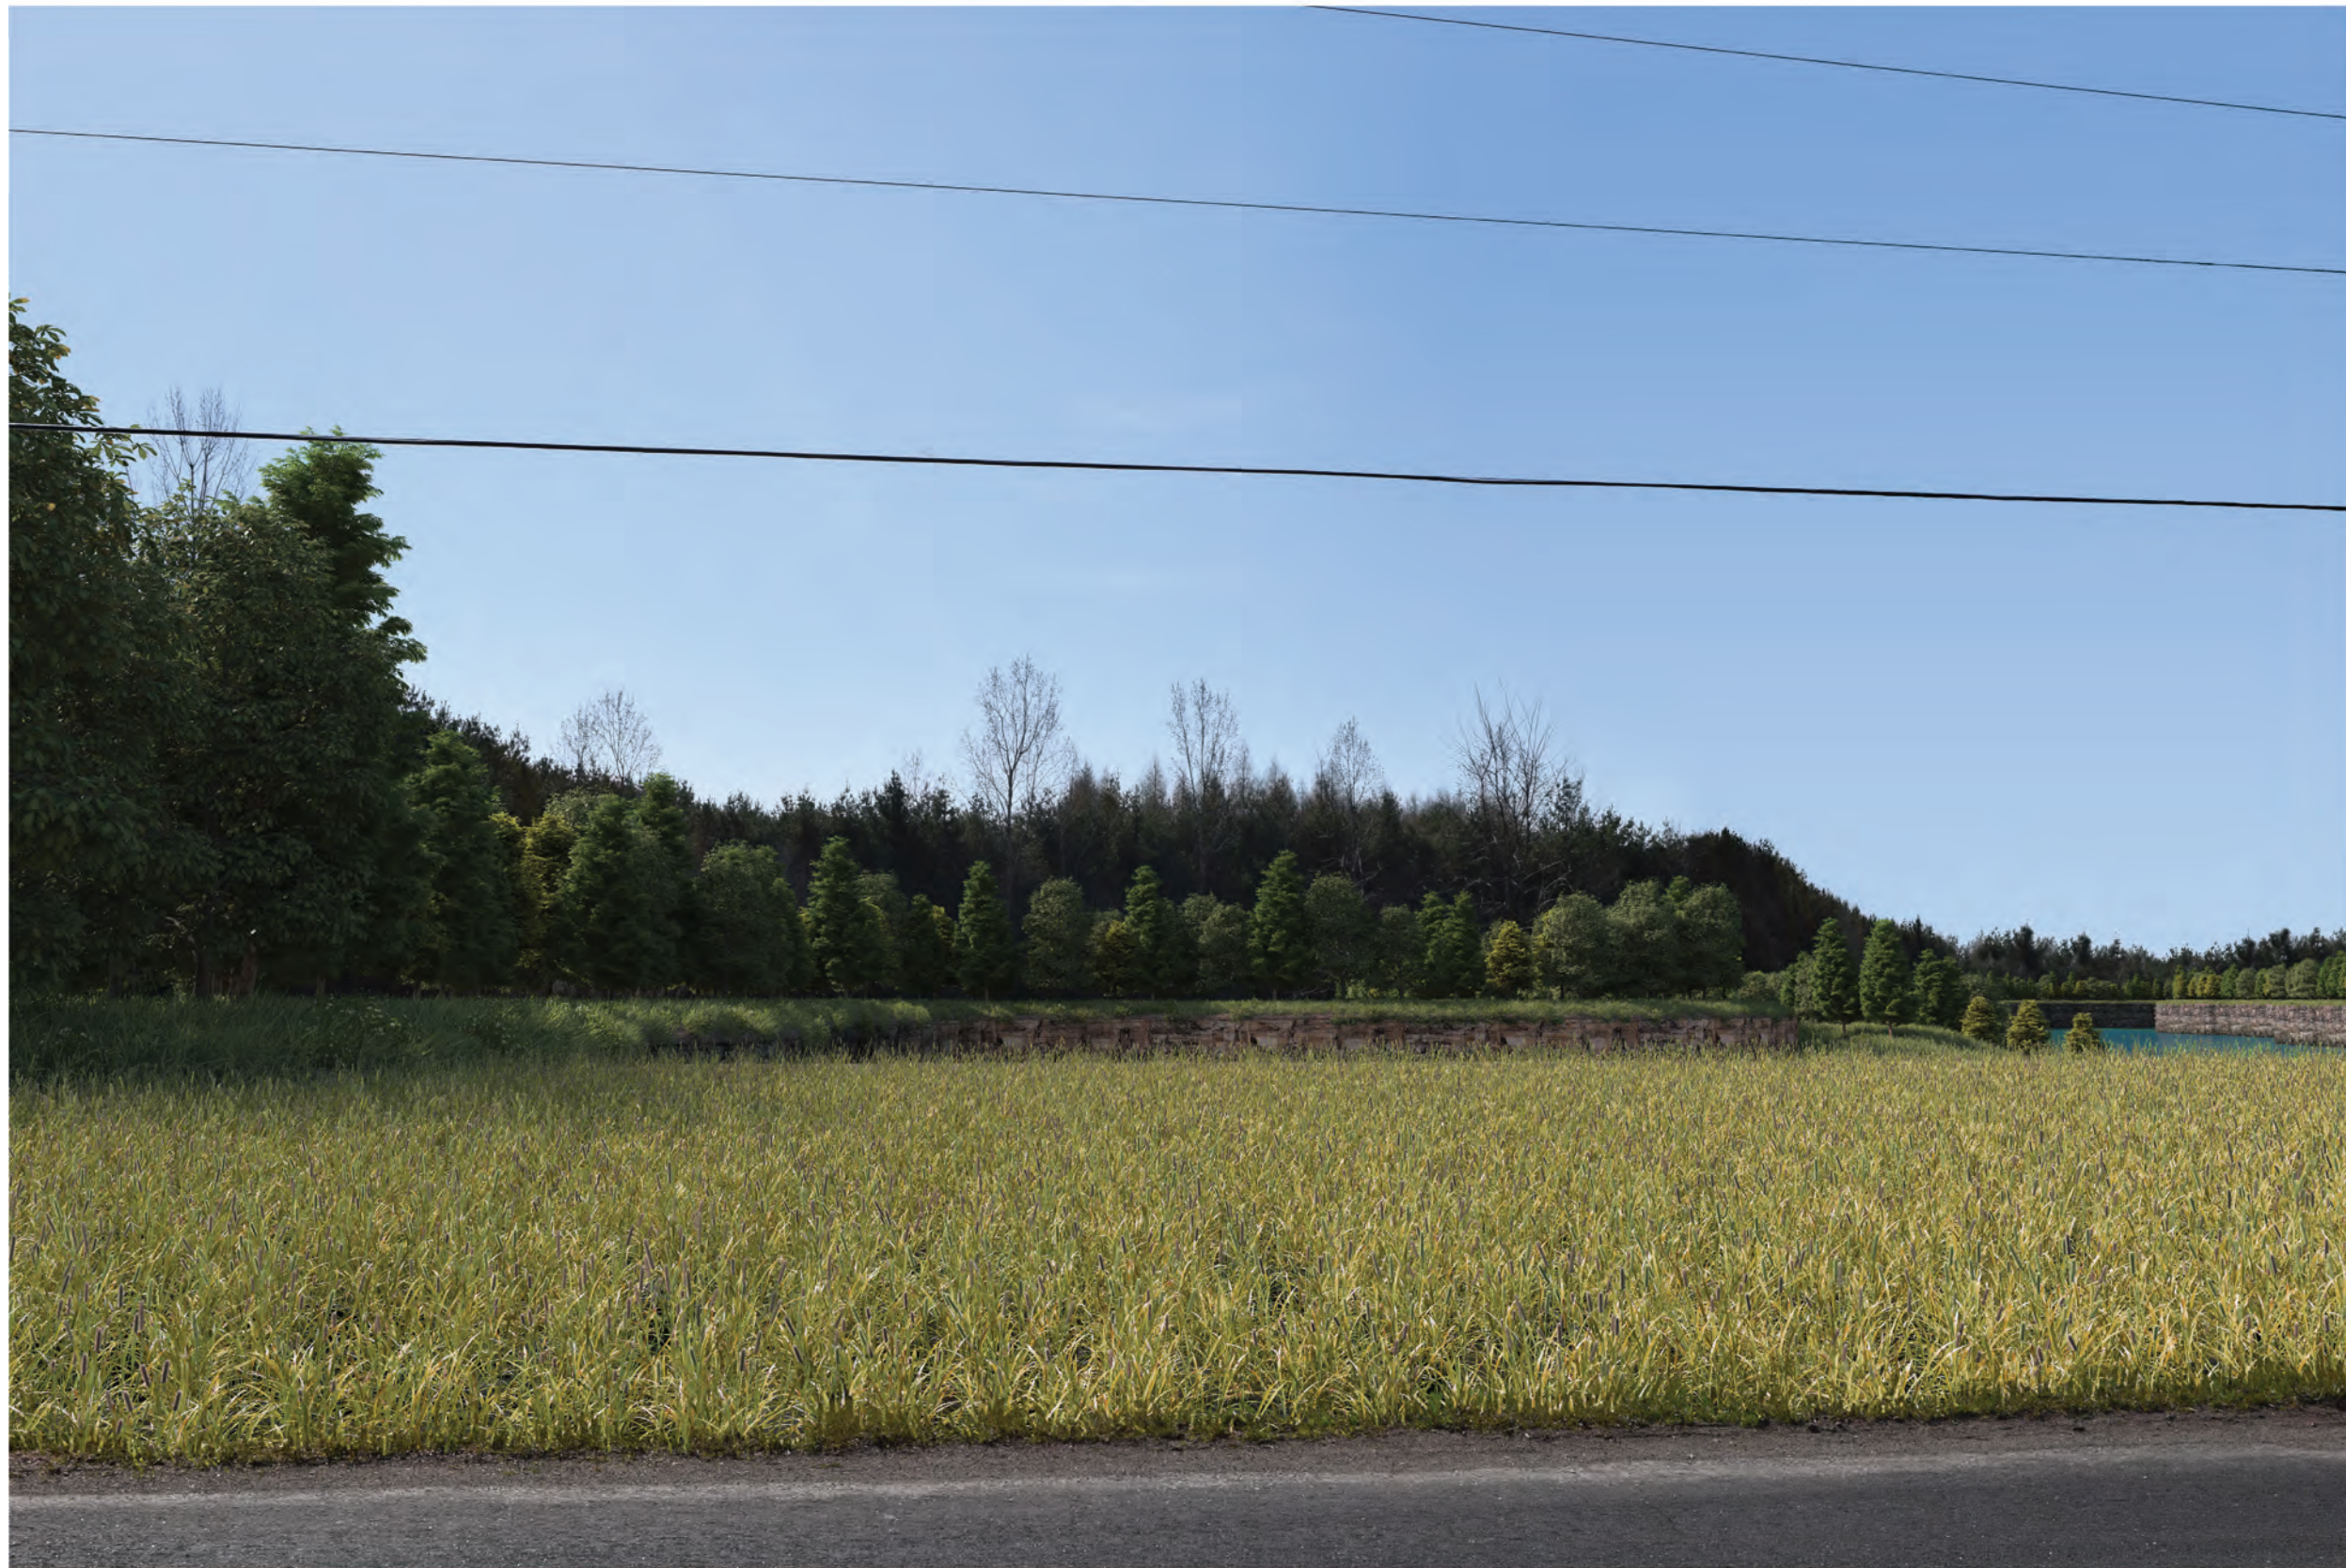
Figure 9J  
**Photo Simulation**  
**Post Quarry Operations**

Photo Simulation Post Quarry Operation - Viewpoint 50
