**APPENDIX F2**  
**CNR OVERHEAD BRIDGE DECK CONDITION SURVEY REPORT 2009**

September 2009

## Dundas Street - CNR Overhead Structure Site Number 010-0175

### Bridge Deck Condition Survey Report

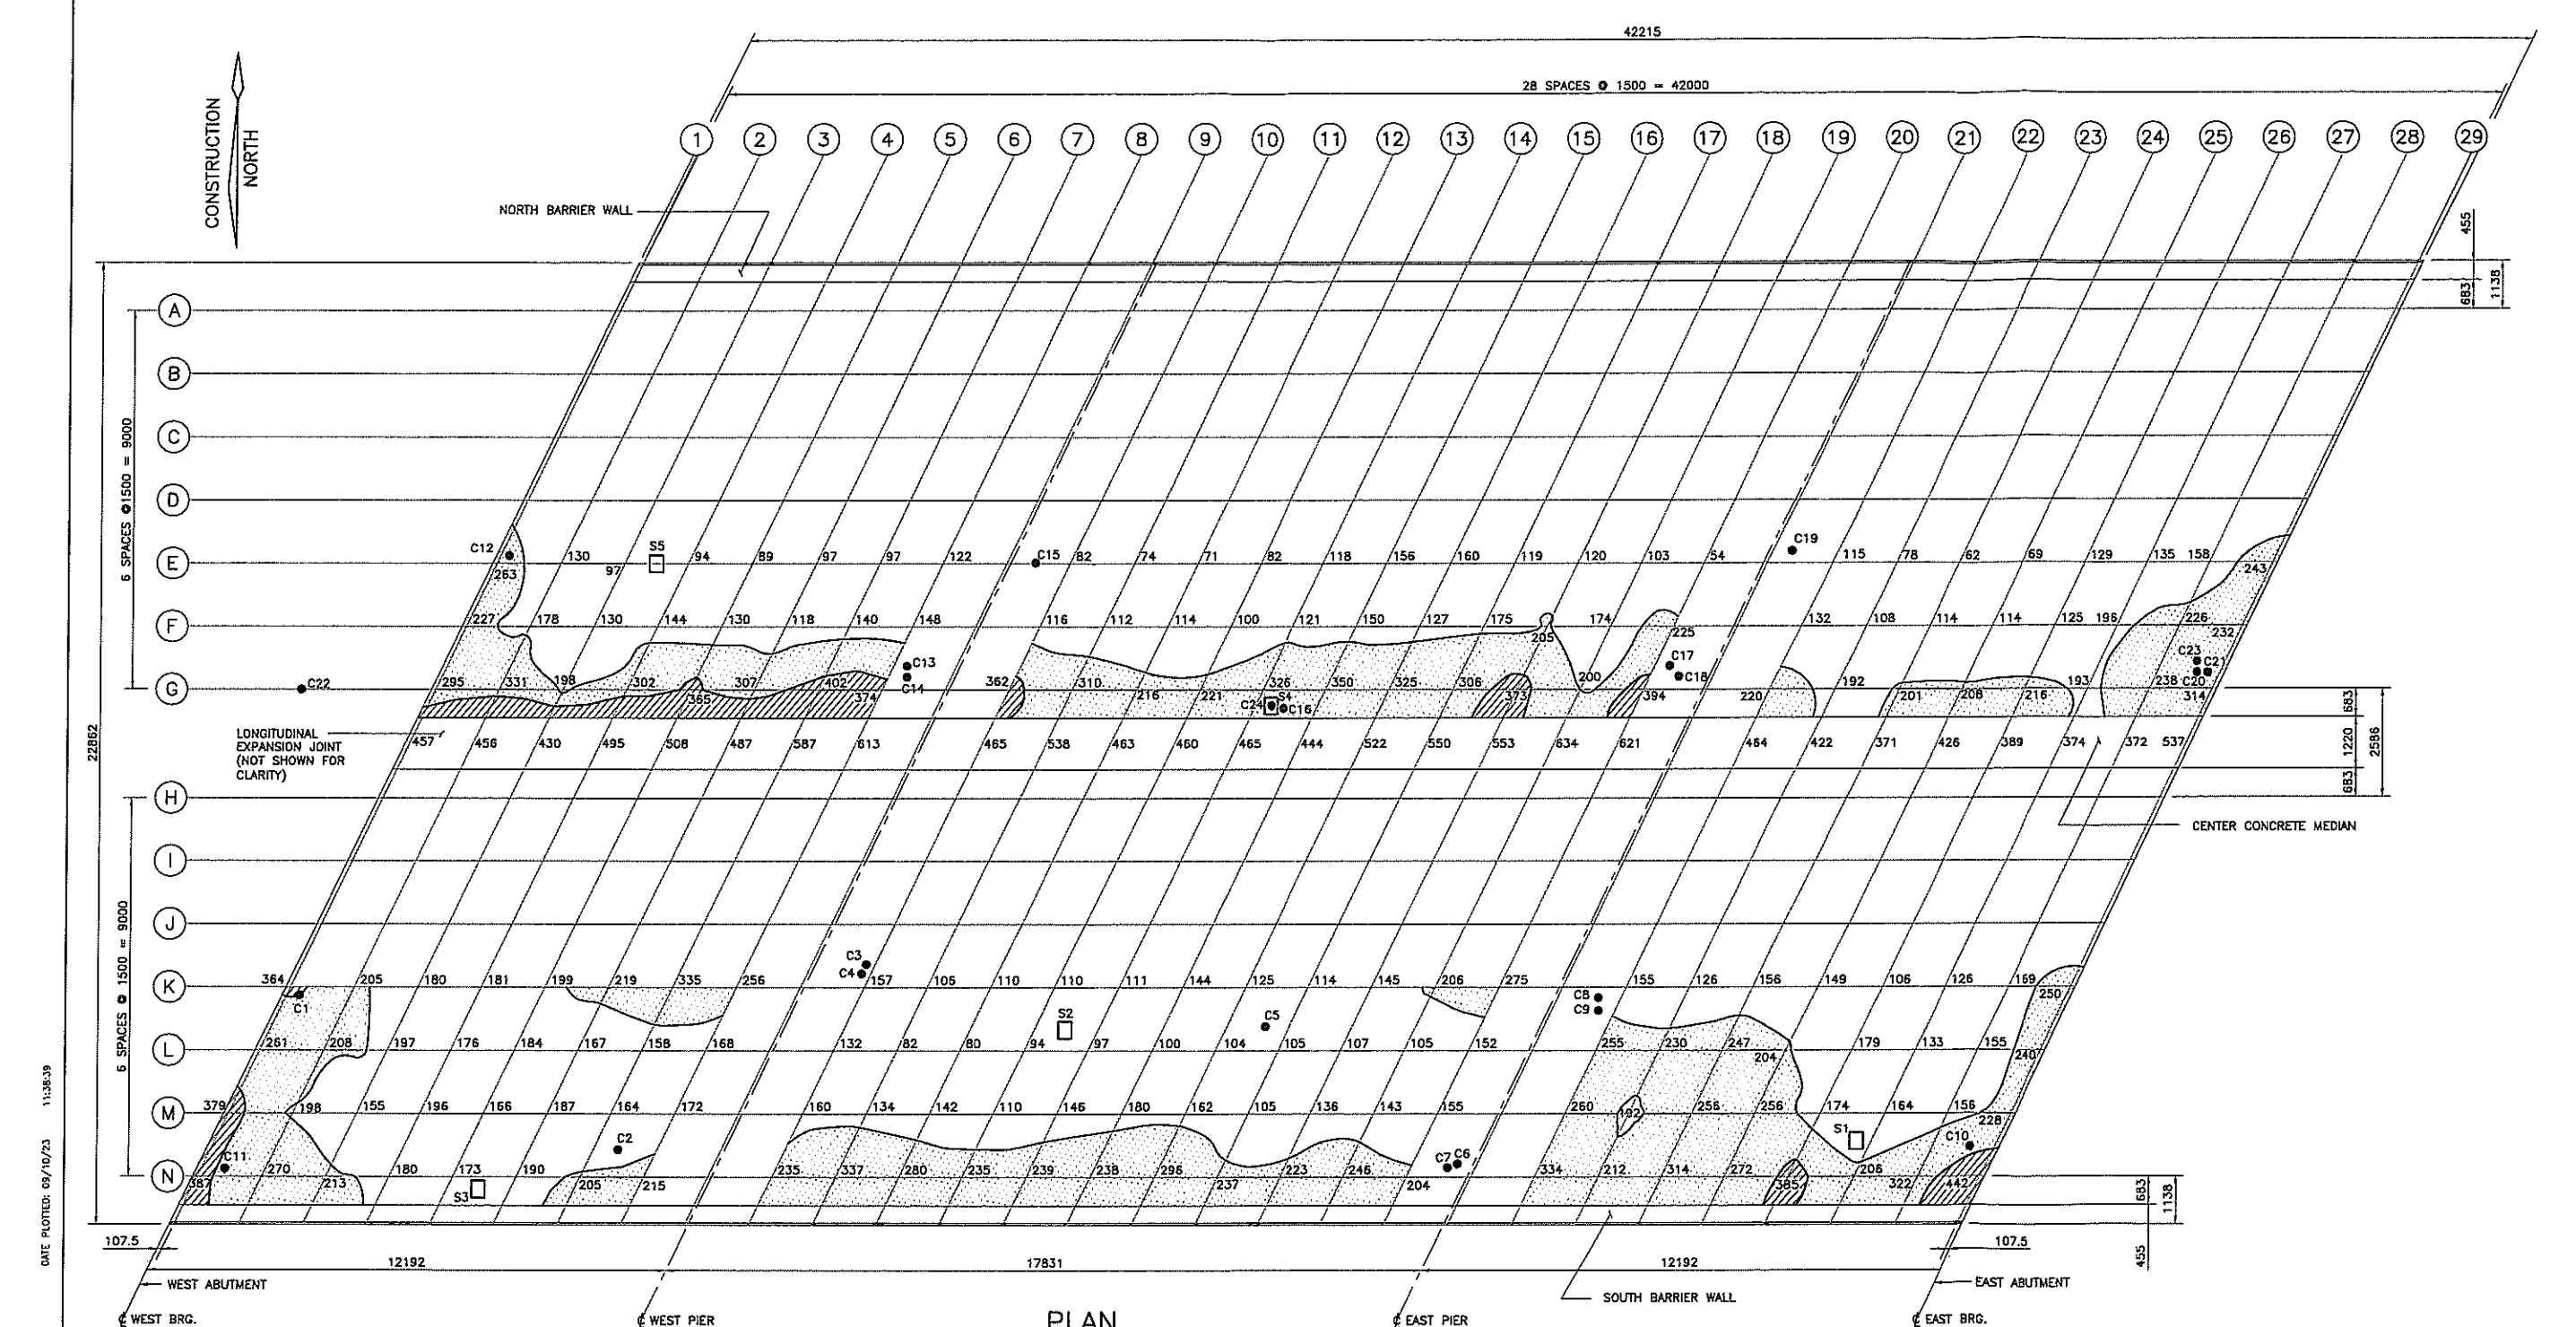
TITLE  
**GENERAL ARRANGEMENT  
DUNDAS STREET  
CNR OVERHEAD  
ASPHALT WEARING SURFACE CONDITION**

The asphalt wearing surface on the Dundas Street - CNR Bridge was partially replaced during the 2004 rehabilitation and appears to be in fair condition. There are several sealed and unsealed longitudinal and transverse cracks (see photograph 10). There are transverse sealed cracks spanning the width of the bridge at the edge of the east and west approach slabs. In total, approximately 60 m of longitudinal light and medium cracks were noted on the deck surface.

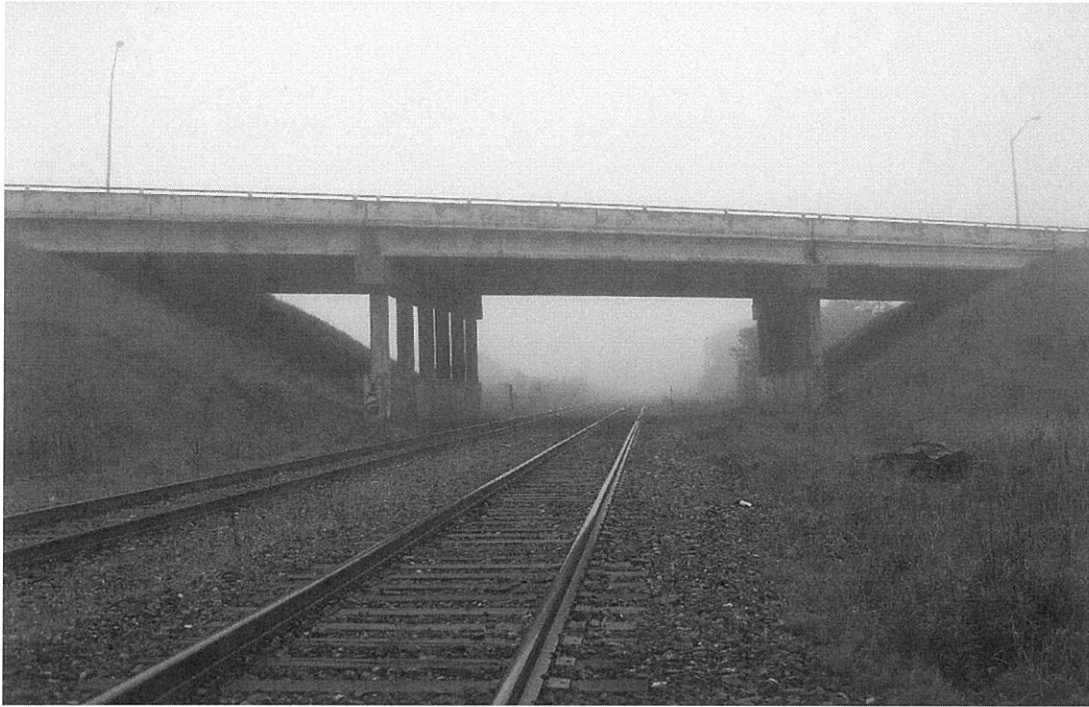
The bridge consists of a three (3) span (12.912m, 17.831m, 12.192m) reinforced concrete deck with ten (10) precast prestressed concrete girders in each span. The bridge was constructed at approximately 26° skew to the road alignment, which is on a horizontal curve (see photo 1 for general elevation of the bridge). As a result of the curve, the bridge is superelevated +4.1% to the north.

Photo 1 – South Elevation

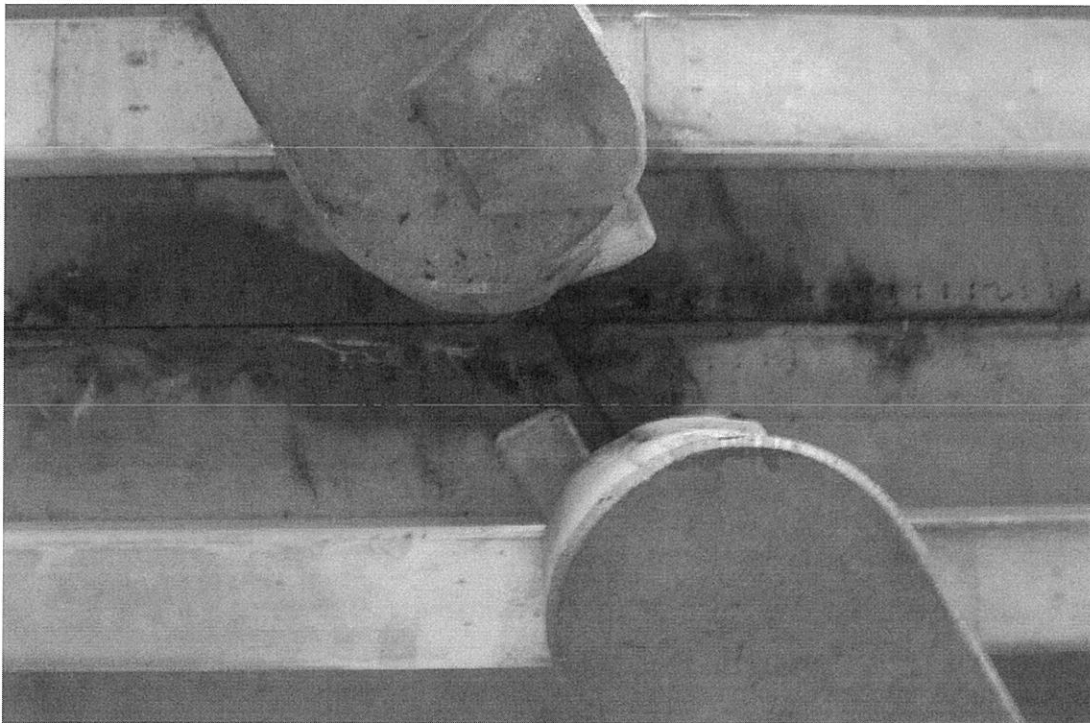
The deck soffit is generally in good condition except at the longitudinal expansion joint, where numerous isolated delaminations and spalls were observed. Several of these spalls have rust stains (see photo 2). On the day of the inspection it was raining and some leaks

Photo 2 – Longitudinal Expansion Joint at East Pier

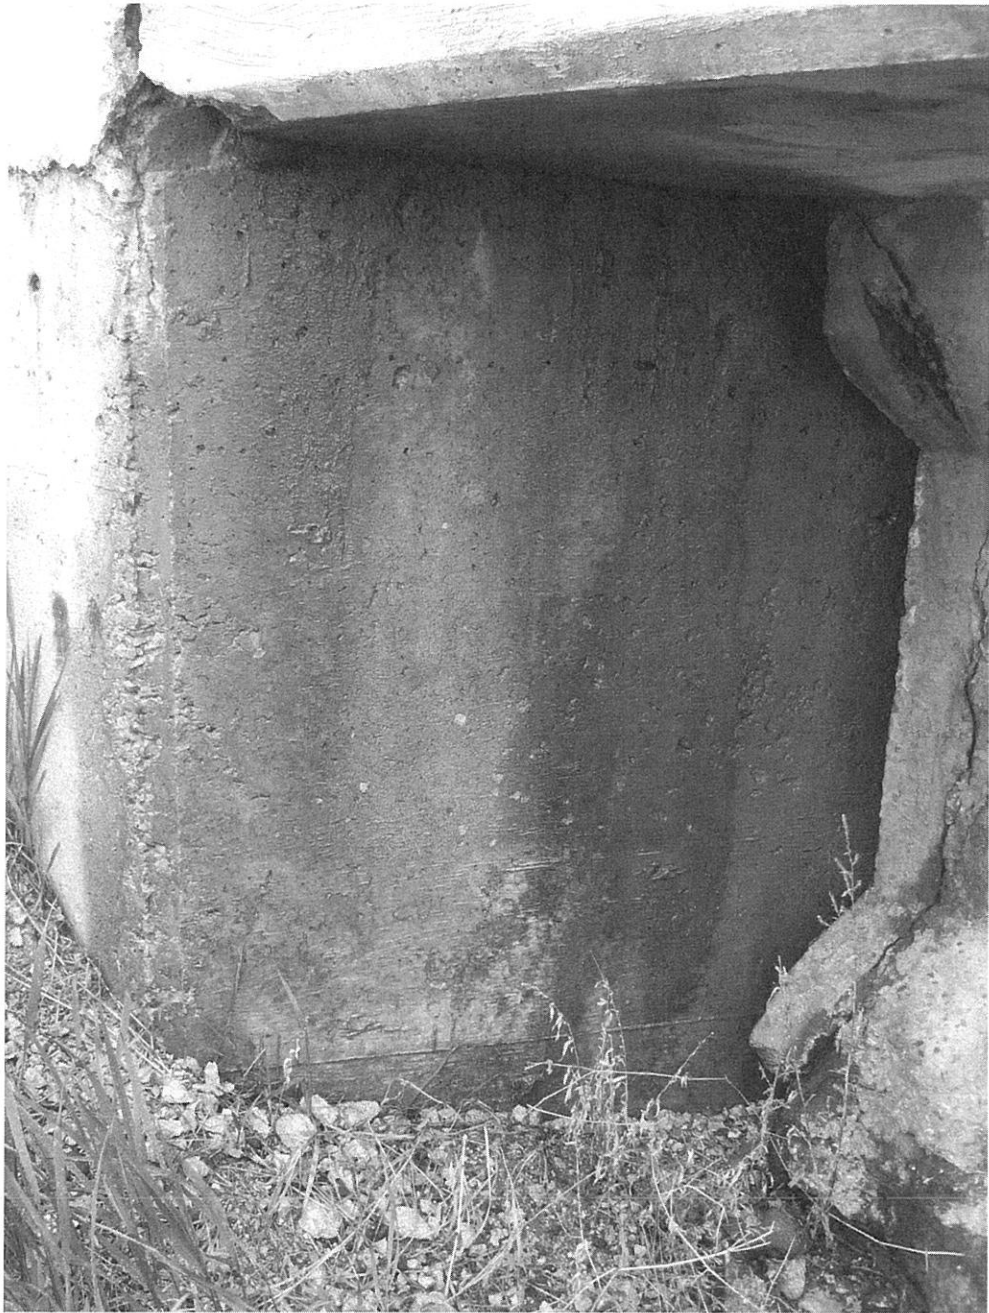
In general girders were in good condition, except at the ends of some of the girders at the abutments, which were typically delaminated (see photo 3). Delaminations were found at the ends of the following girders:

Photo 3 – South Girder at West Abutment

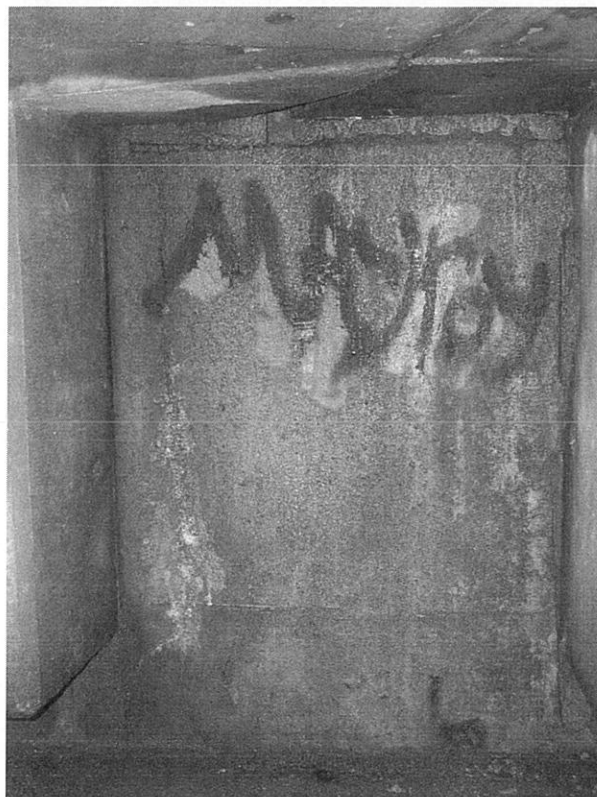
The diaphragms at the piers and abutments were generally in good condition. The unexposed faces of the diaphragms were not accessible for inspection but are probably in poorer condition than the exposed face due to the expansion joint leaks (see photo 5).

Photo 5 – East Abutment below the Longitudinal Expansion Joint

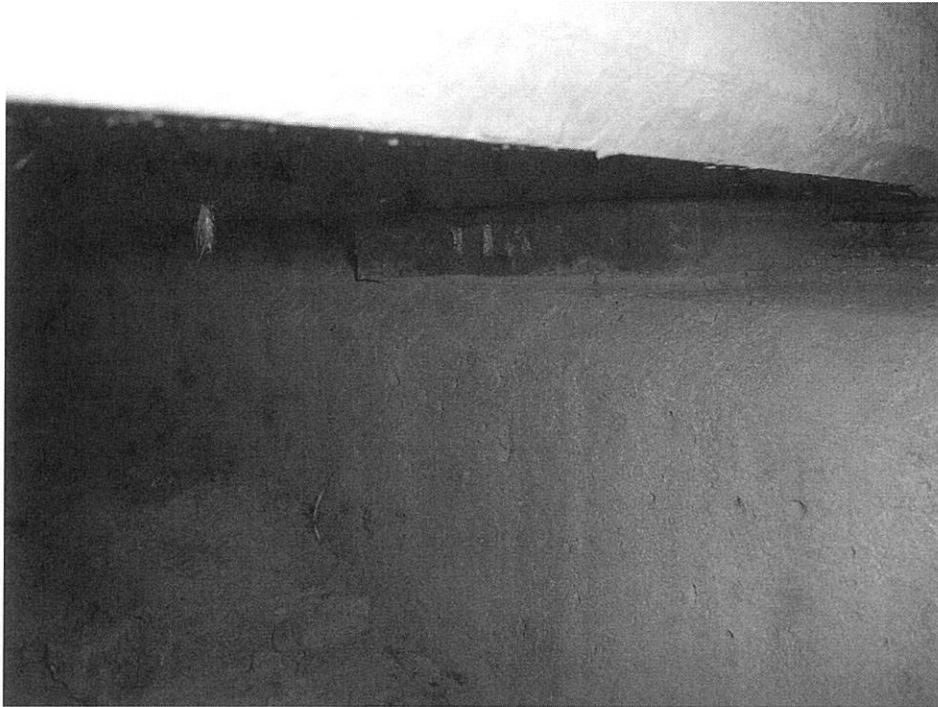
The bearings at the abutments are in good condition. Despite not having a bevel and shoe plate at the end of the girders to accommodate the prestress camber and vertical curve in the road, no signs of excessive deformation or uplift at the bearing was observed. Some of the bearings overhang the chamfer on the bearing seat. However the overhanging area is very small and structurally insignificant (see photo 6).

Photo 6 – Bearing at East Abutment
