To	Sheri Harmsworth	Page 1
Subject	Preliminary Evaluation of Integrating Trafalgar Road SWM with Pond 29 and Pond 30 (North Oakville Main-East Morrison Creek EIR/FSS)	
Prepared By	Janelle Wepler, B.Sc. (Env.), P.Eng., Water Resources Engineer	
Reviewed By	Glenn Farmer, Senior Environmental Technologist	
Date	November 4, 2013	Project Number 60119993

**Summary Action Report**  
**Structure 03-1182320 CU01 (MTO Site No. )**  
**Trafalgar Road**

Structure Number: **03-1182530 CU02**

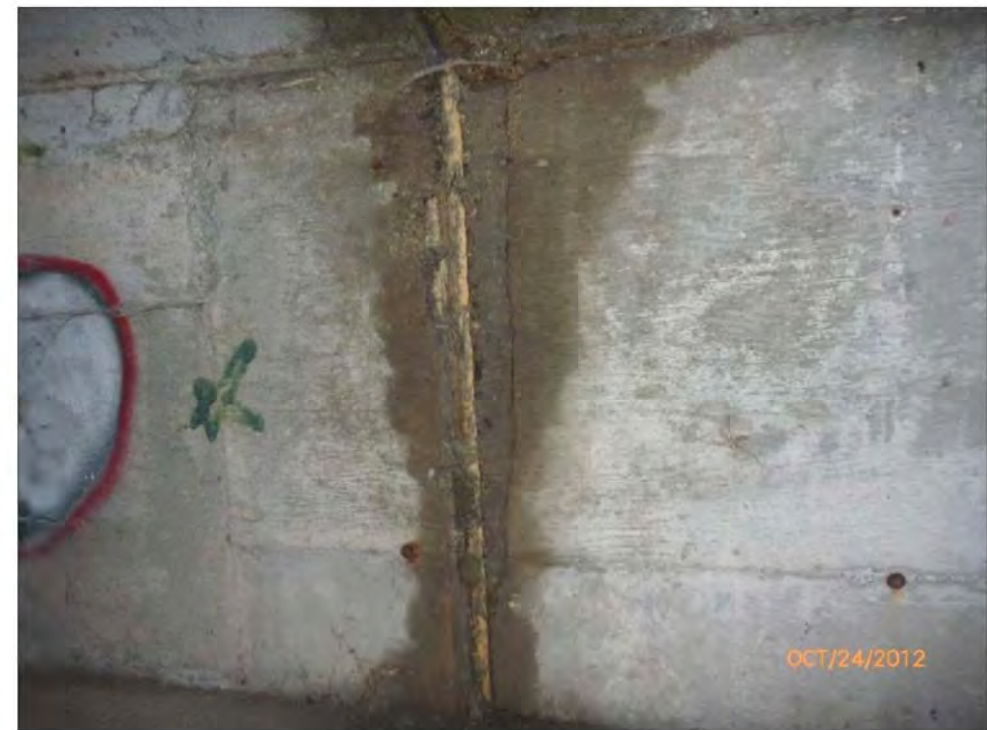
Delamination on Abutment Wall

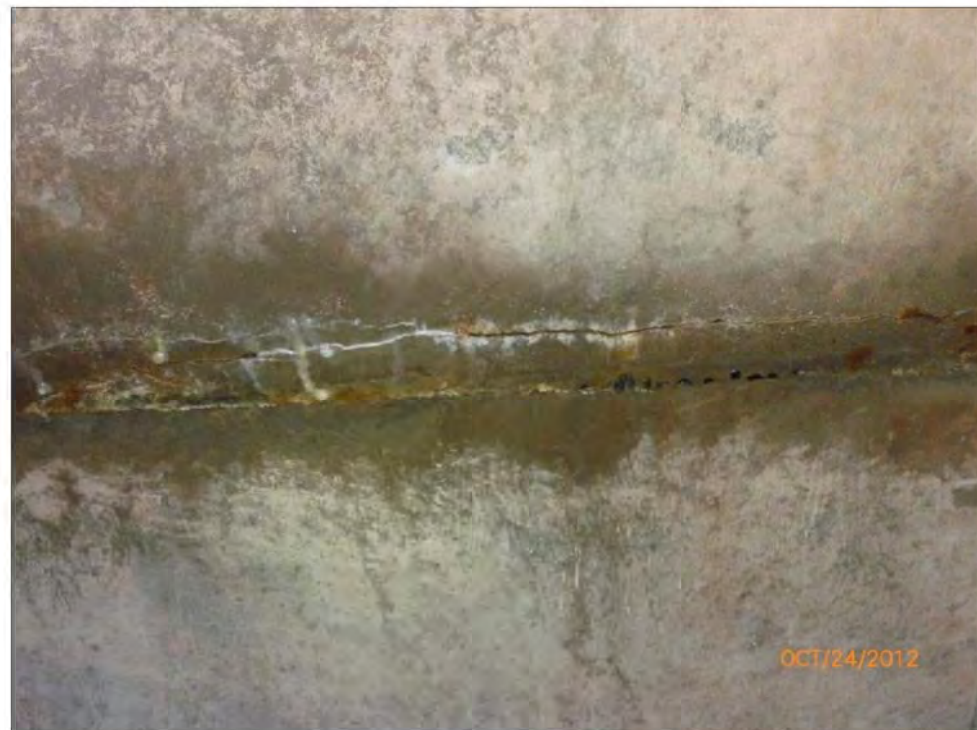
Delamination on Barrel Soffit

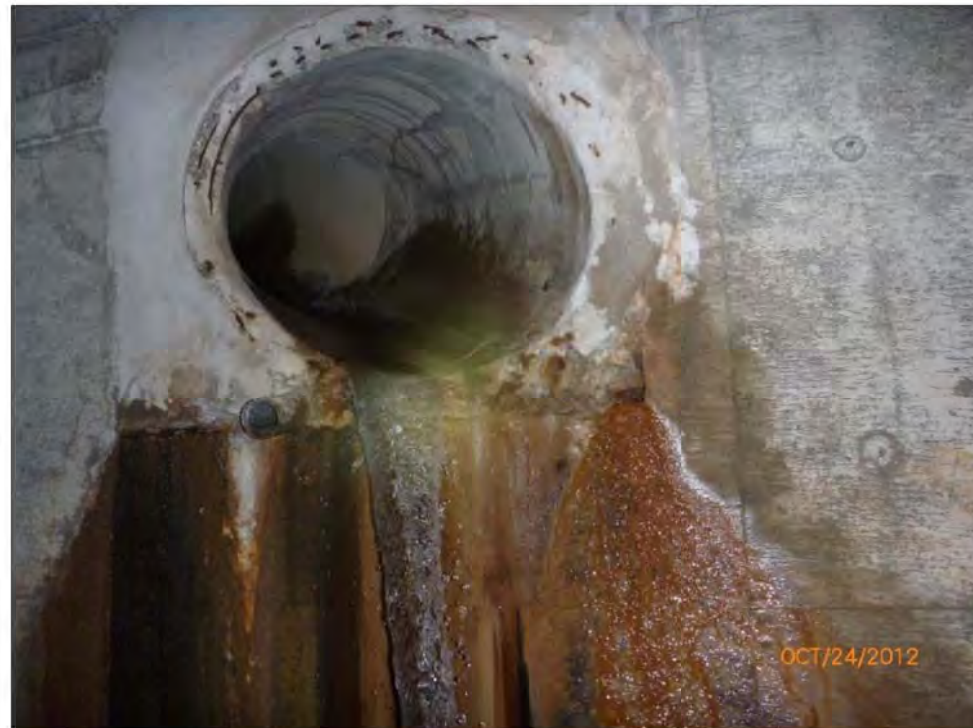
Severe Scaling Below Storm Sewer Outlet on Barrel Wall

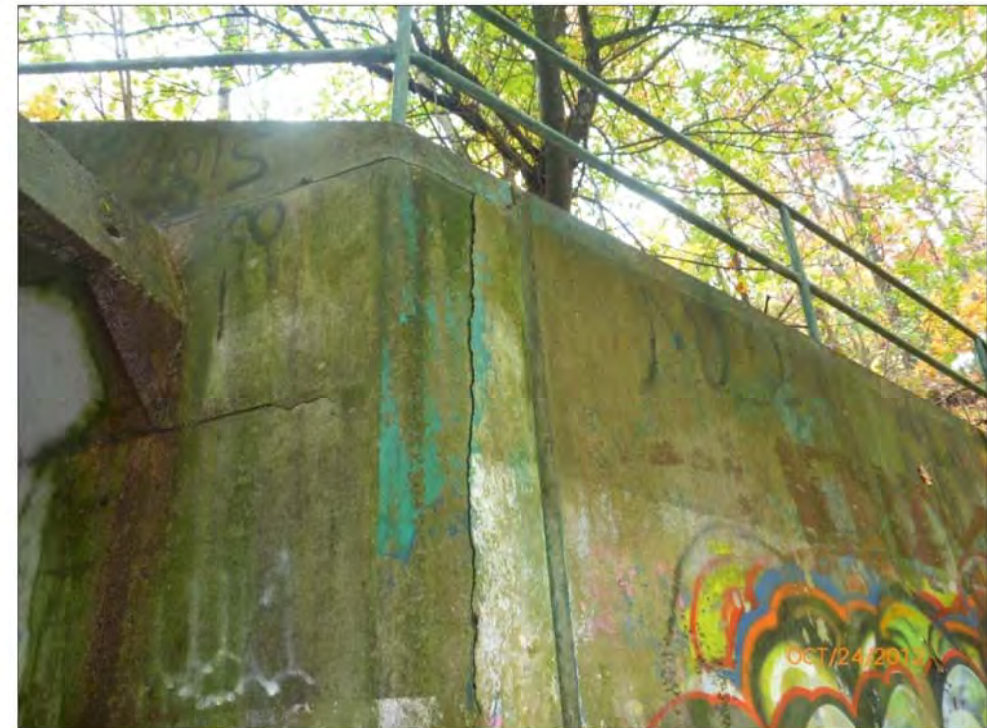
Delamination on Inlet Retaining Wall

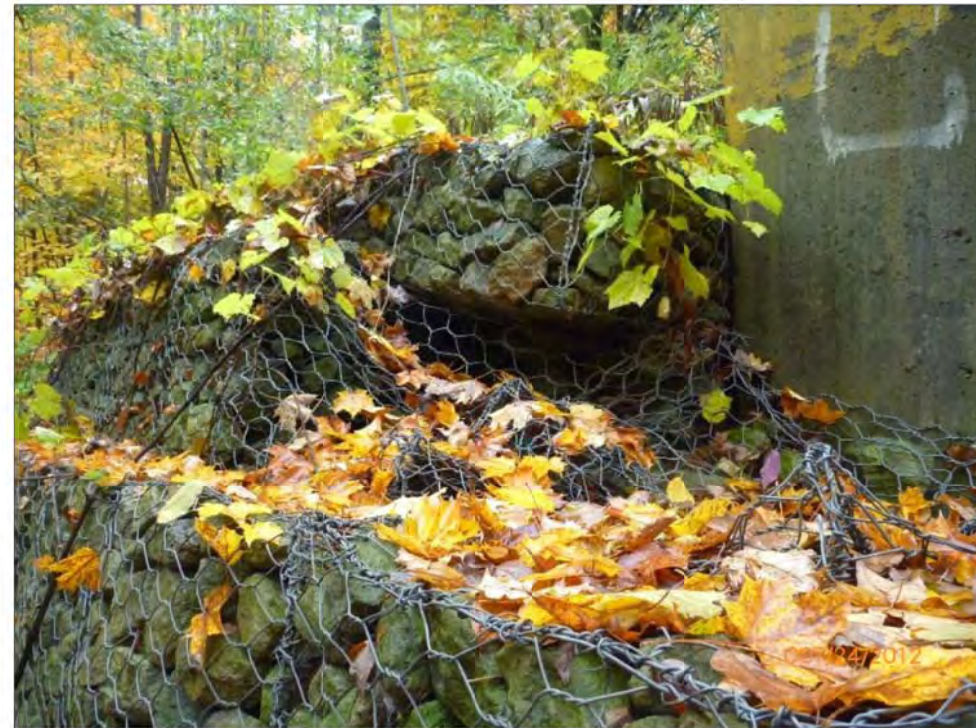
Loss of Rock at Inlet Gabion Basket

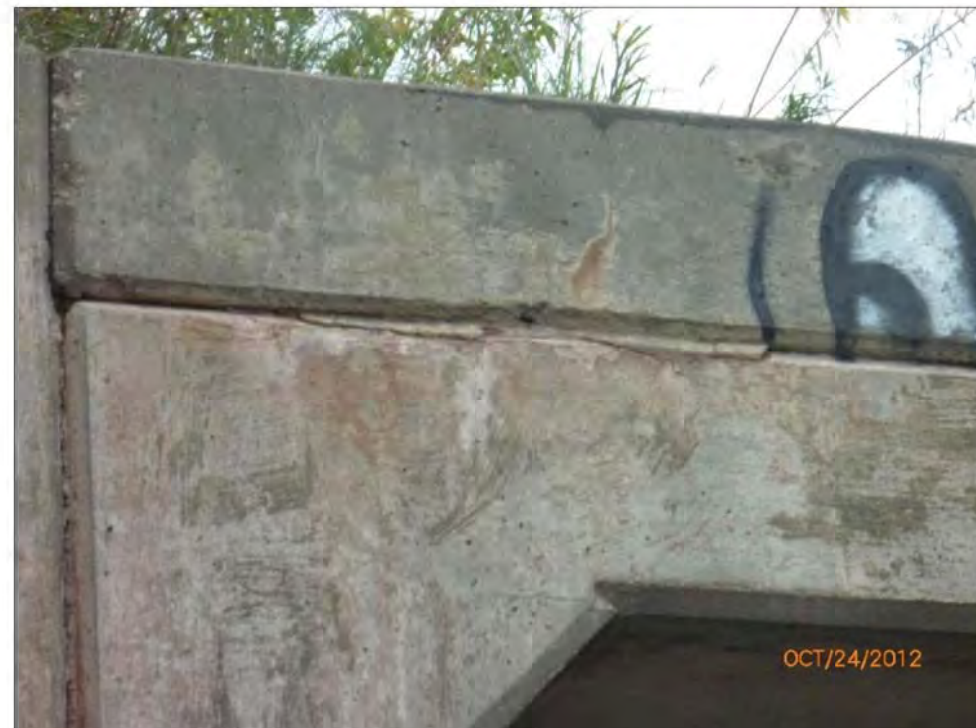
Delamination on Outlet Headwall

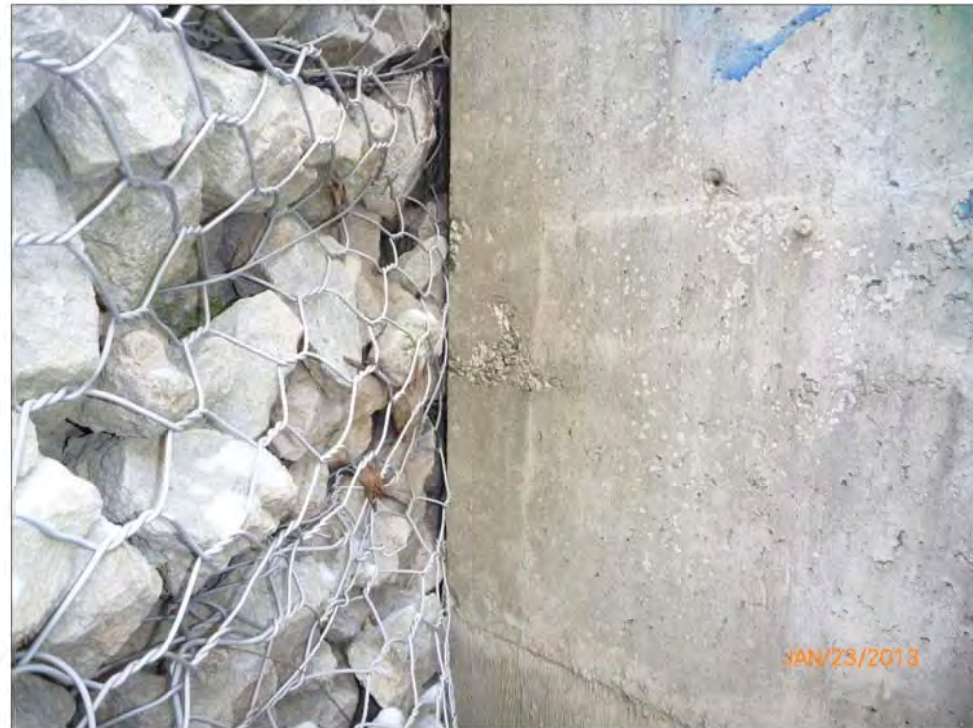
Light Honeycombing of Outlet Headwall

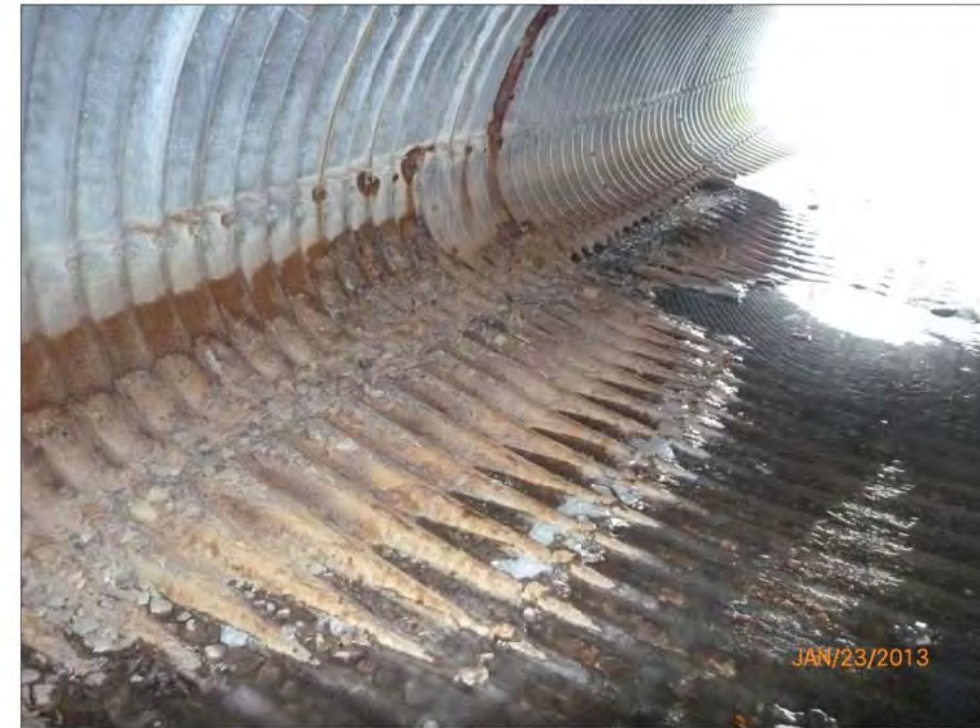
Comments  
Severe corrosion, perforations on barrel inverts, heaving of the barrel invert.

Heaving of Barrel Invert

Rehab/Repair Recommendations	Priority	Cost	Comments
Replace	Now	\$280,000	Replace culvert
