3. EXISTING AND FUTURE CONDITIONS

The study area focuses on Dundas Street from Brant Street to Bronte Road, and is located within the City of Burlington and the Town of Oakville in Halton Region. **Exhibit 1-3** provides a key plan of the study area. **Exhibit 3-1a** to **3-1c** are aerial mosaic of the study area identifying existing conditions and key features which are discussed in the following sections.

DUNDAS STREET CLASS EA STUDY
Brant Street to Bronte Road

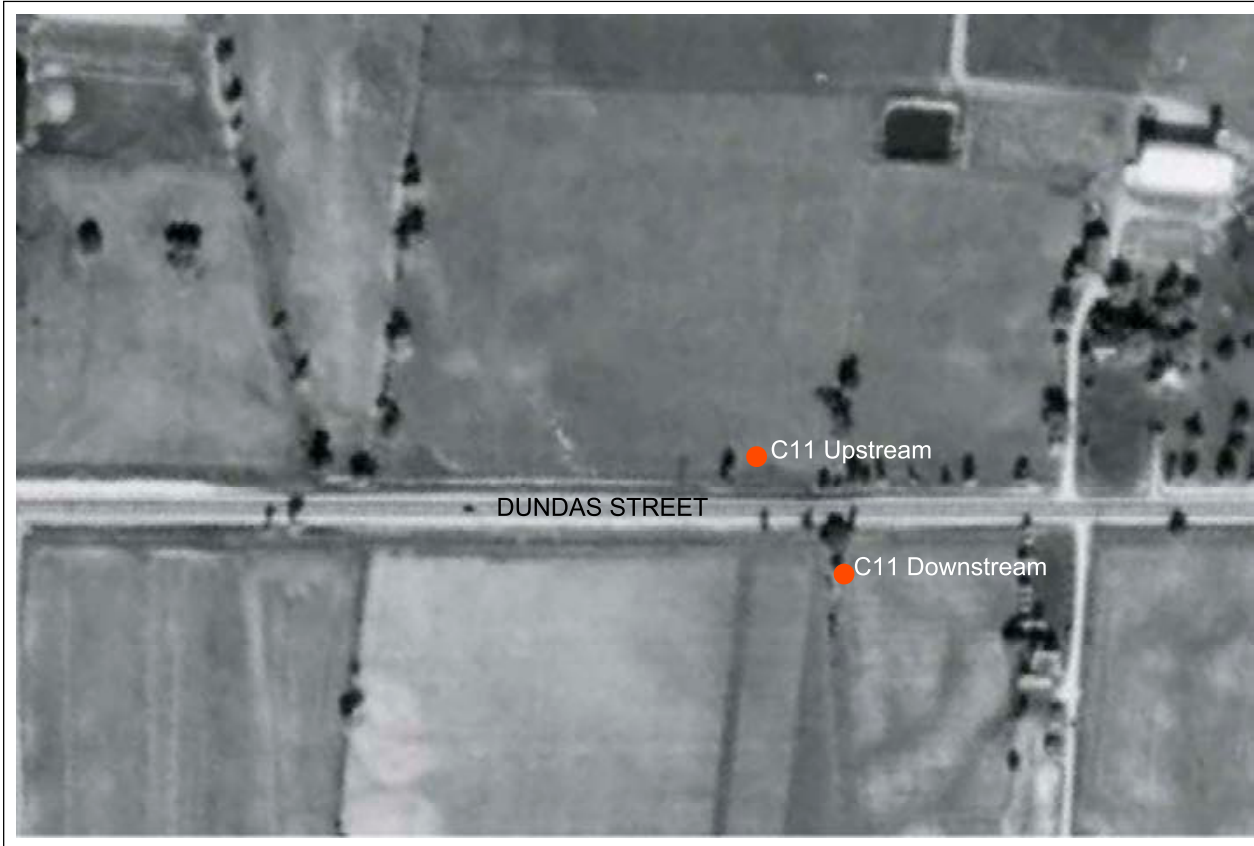
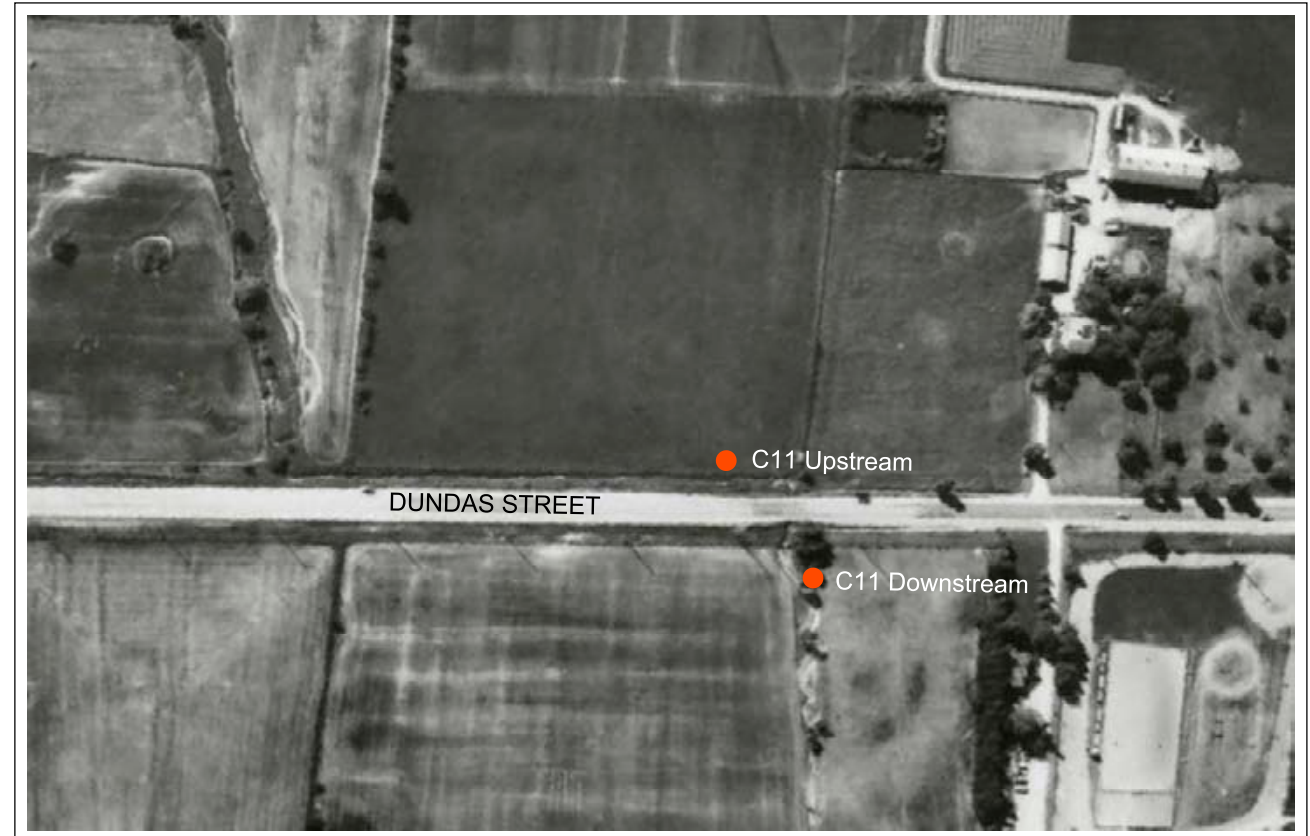
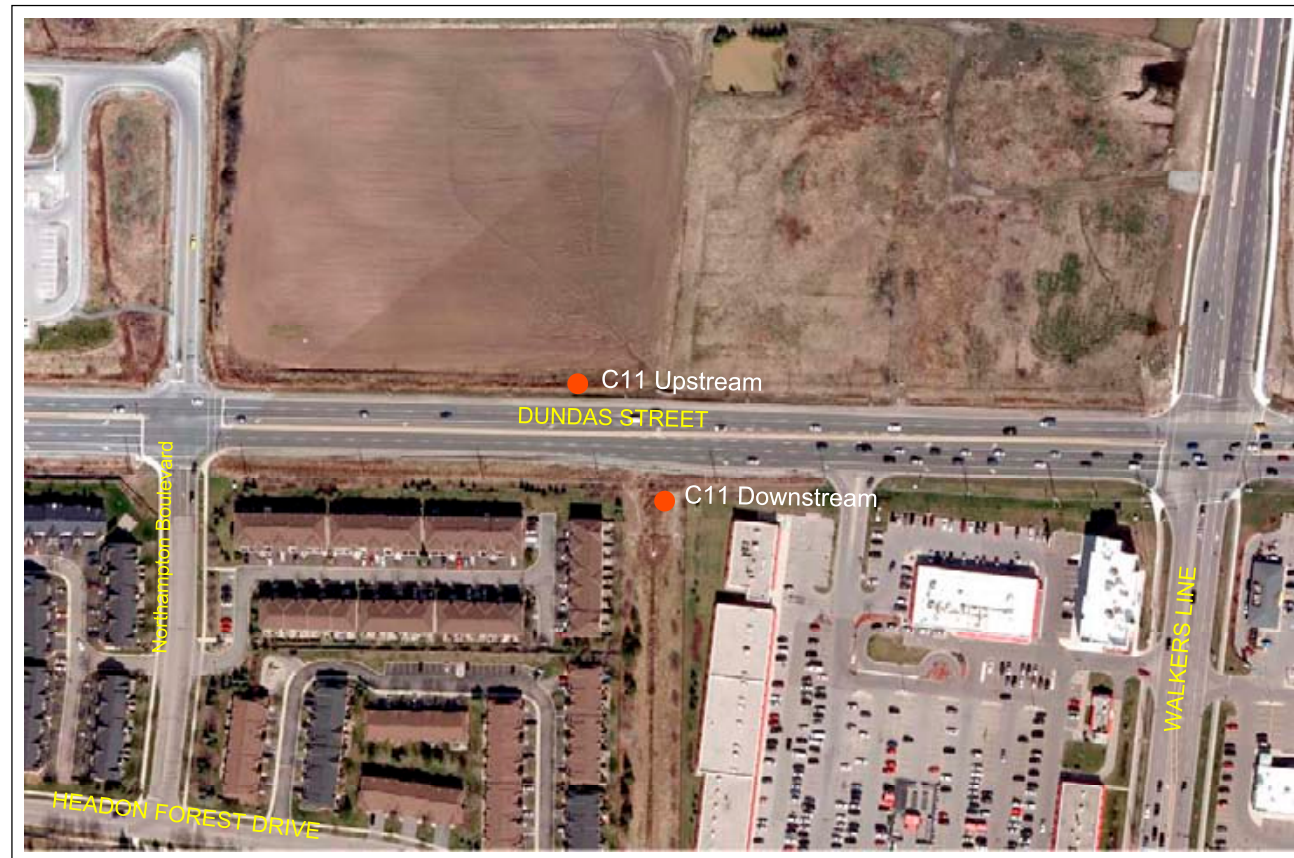
1954

1978

2011

Bronte Creek is situated within a steep valley which confines any lateral migration. There appears to have been more channel adjustment between 1954 and 1978 than between 1978 and 2006 (see **Exhibit 3-5**). Between the two earlier photographs the creek appears to have increased in sinuosity upstream and in the location of the Dundas Street crossing. There has also been a change in the amount of sediment stored within the system in this location. In particular, the frequency and size of mid-channel bars decreased significantly between 1954 and 2006 with most of the change occurring between 1954 and 1978. Along with this reduction in sediment load, it appears that the average channel width has narrowed. It should be noted that Hurricane Hazel was in October 1954 and this extreme event would have affected the changes observed. All of these channel adjustments are confined within the steep river valley.

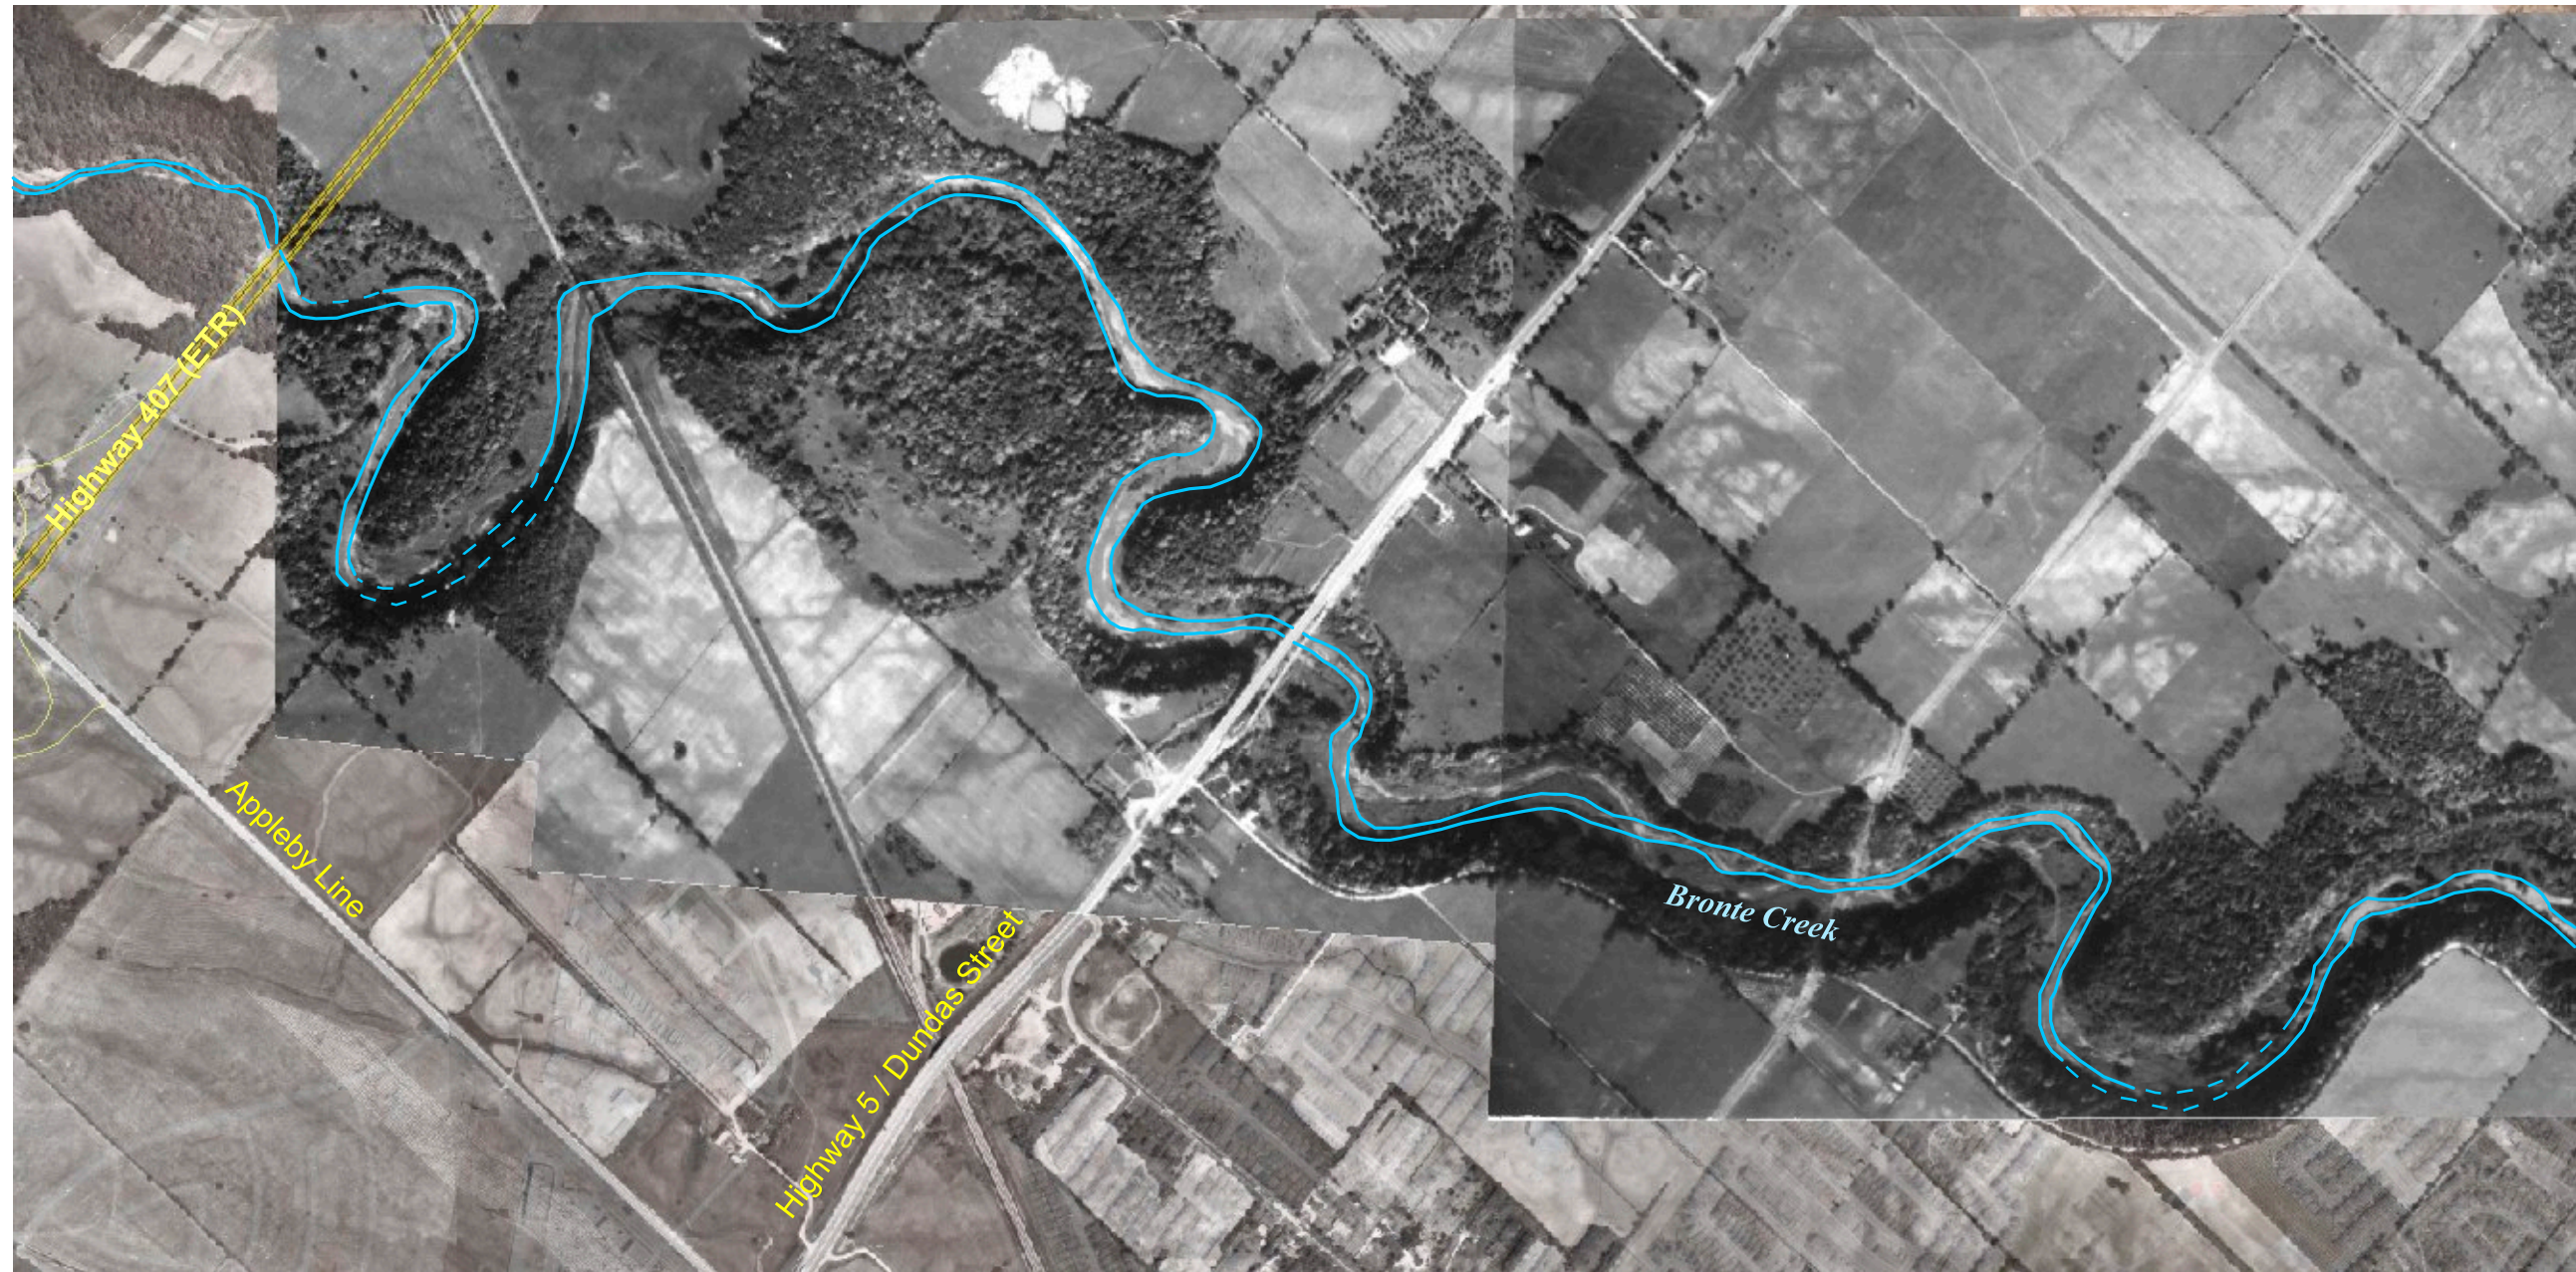
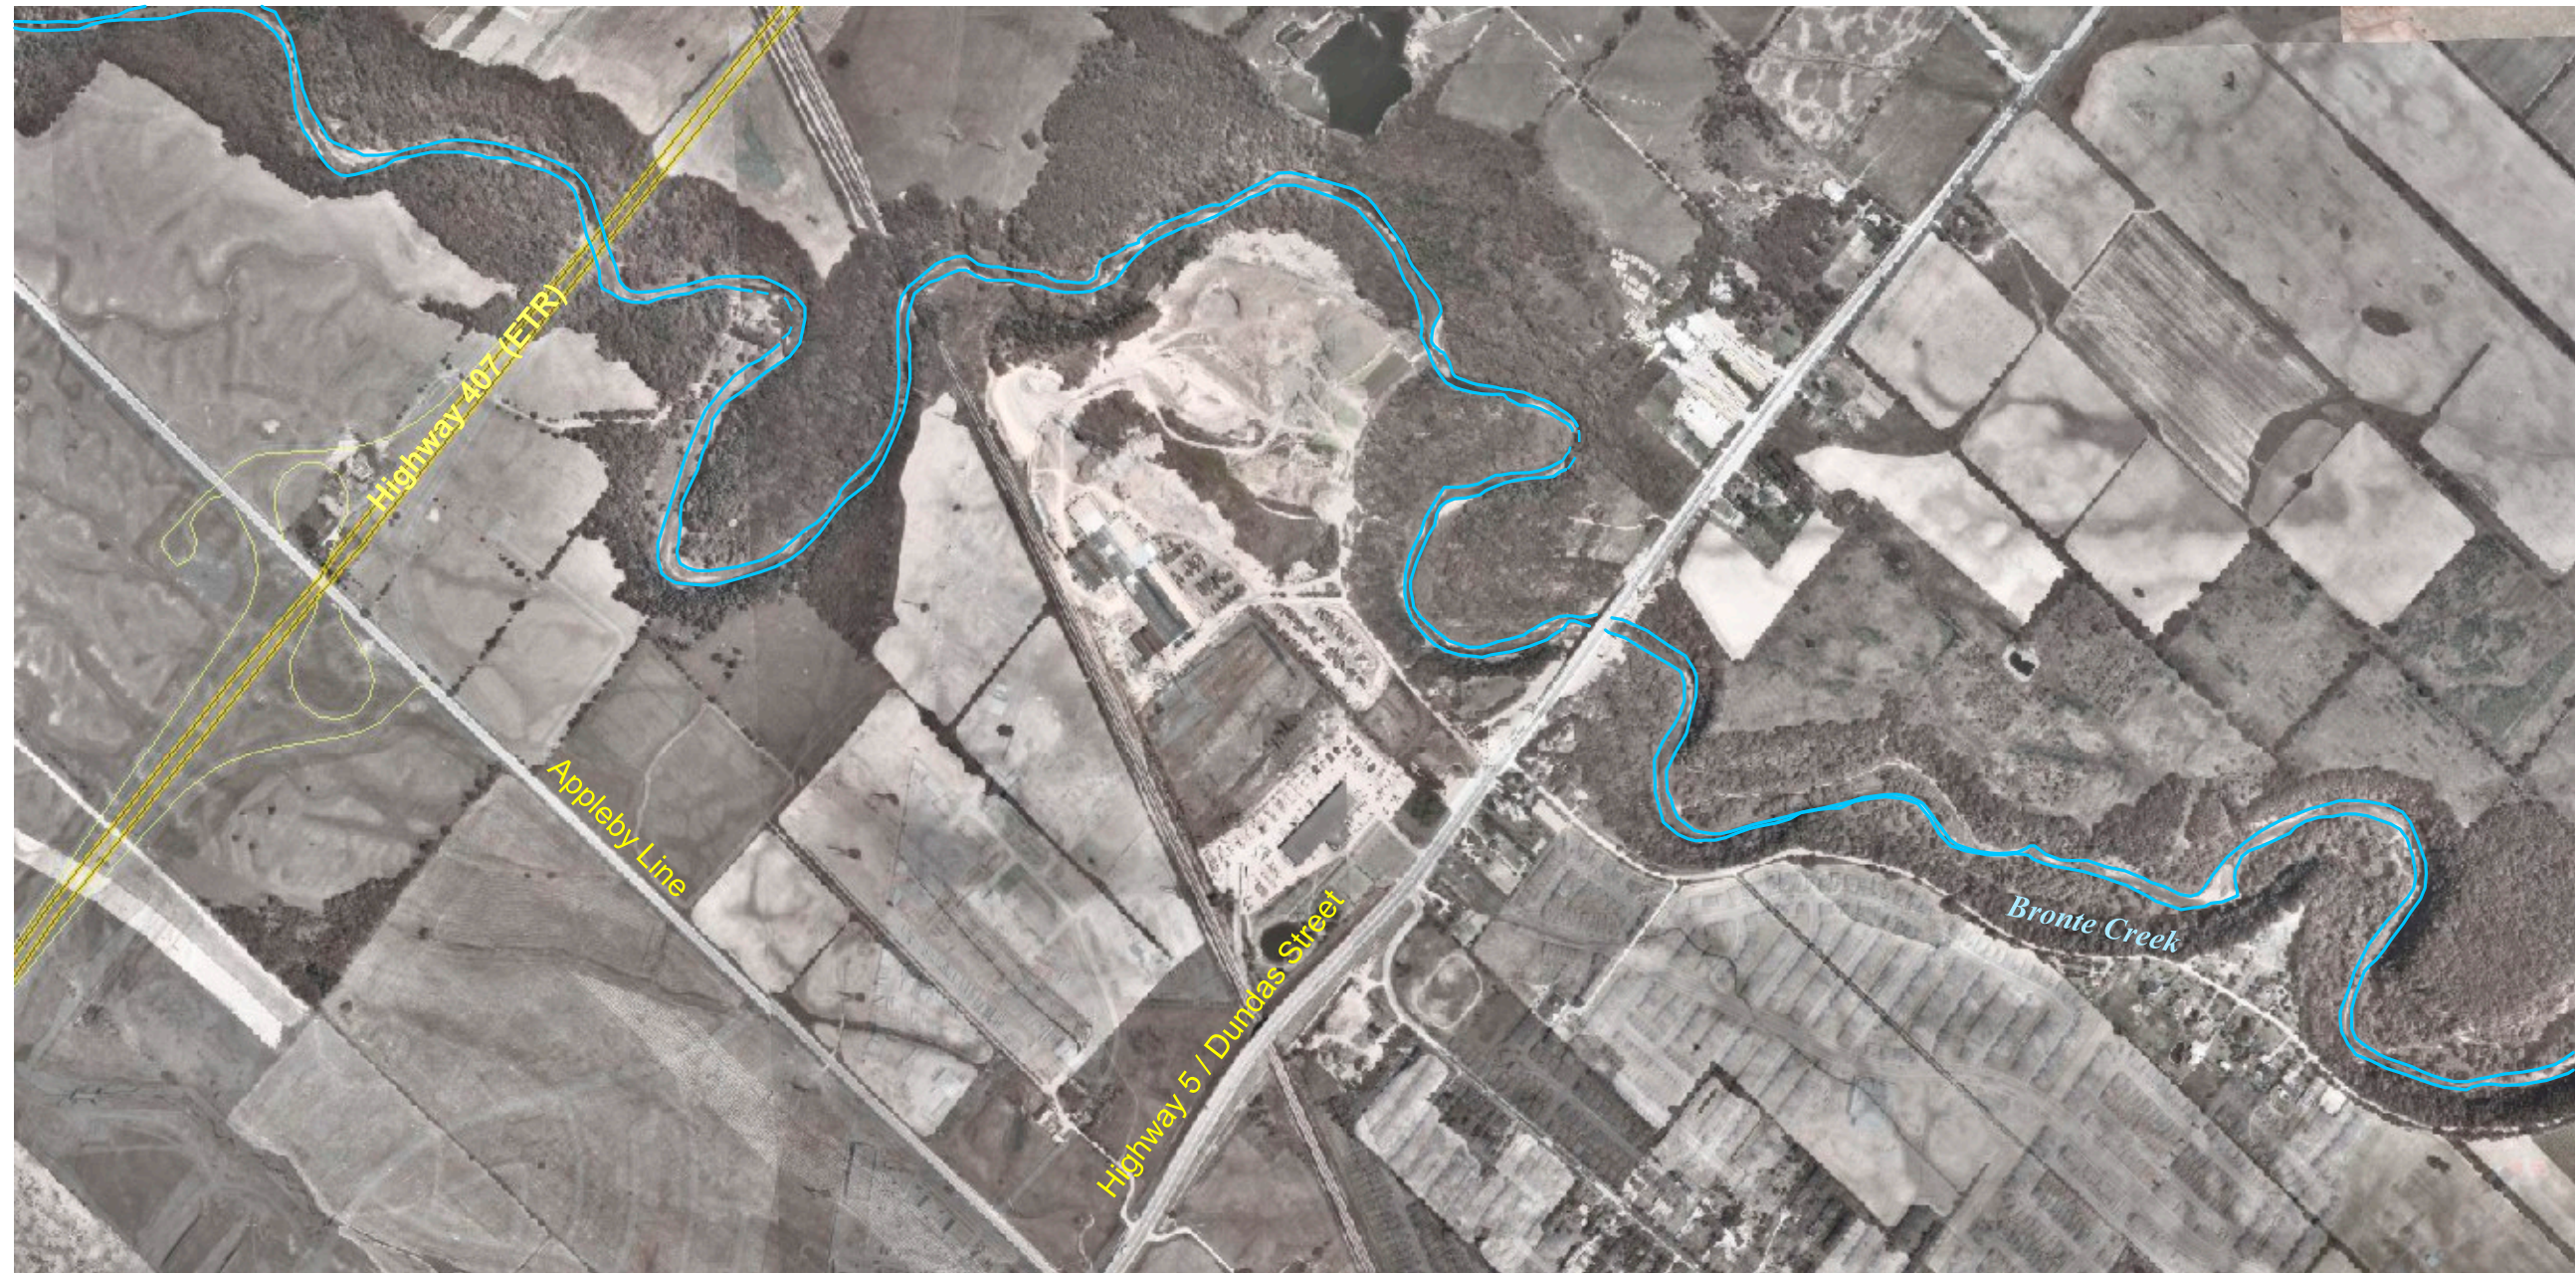
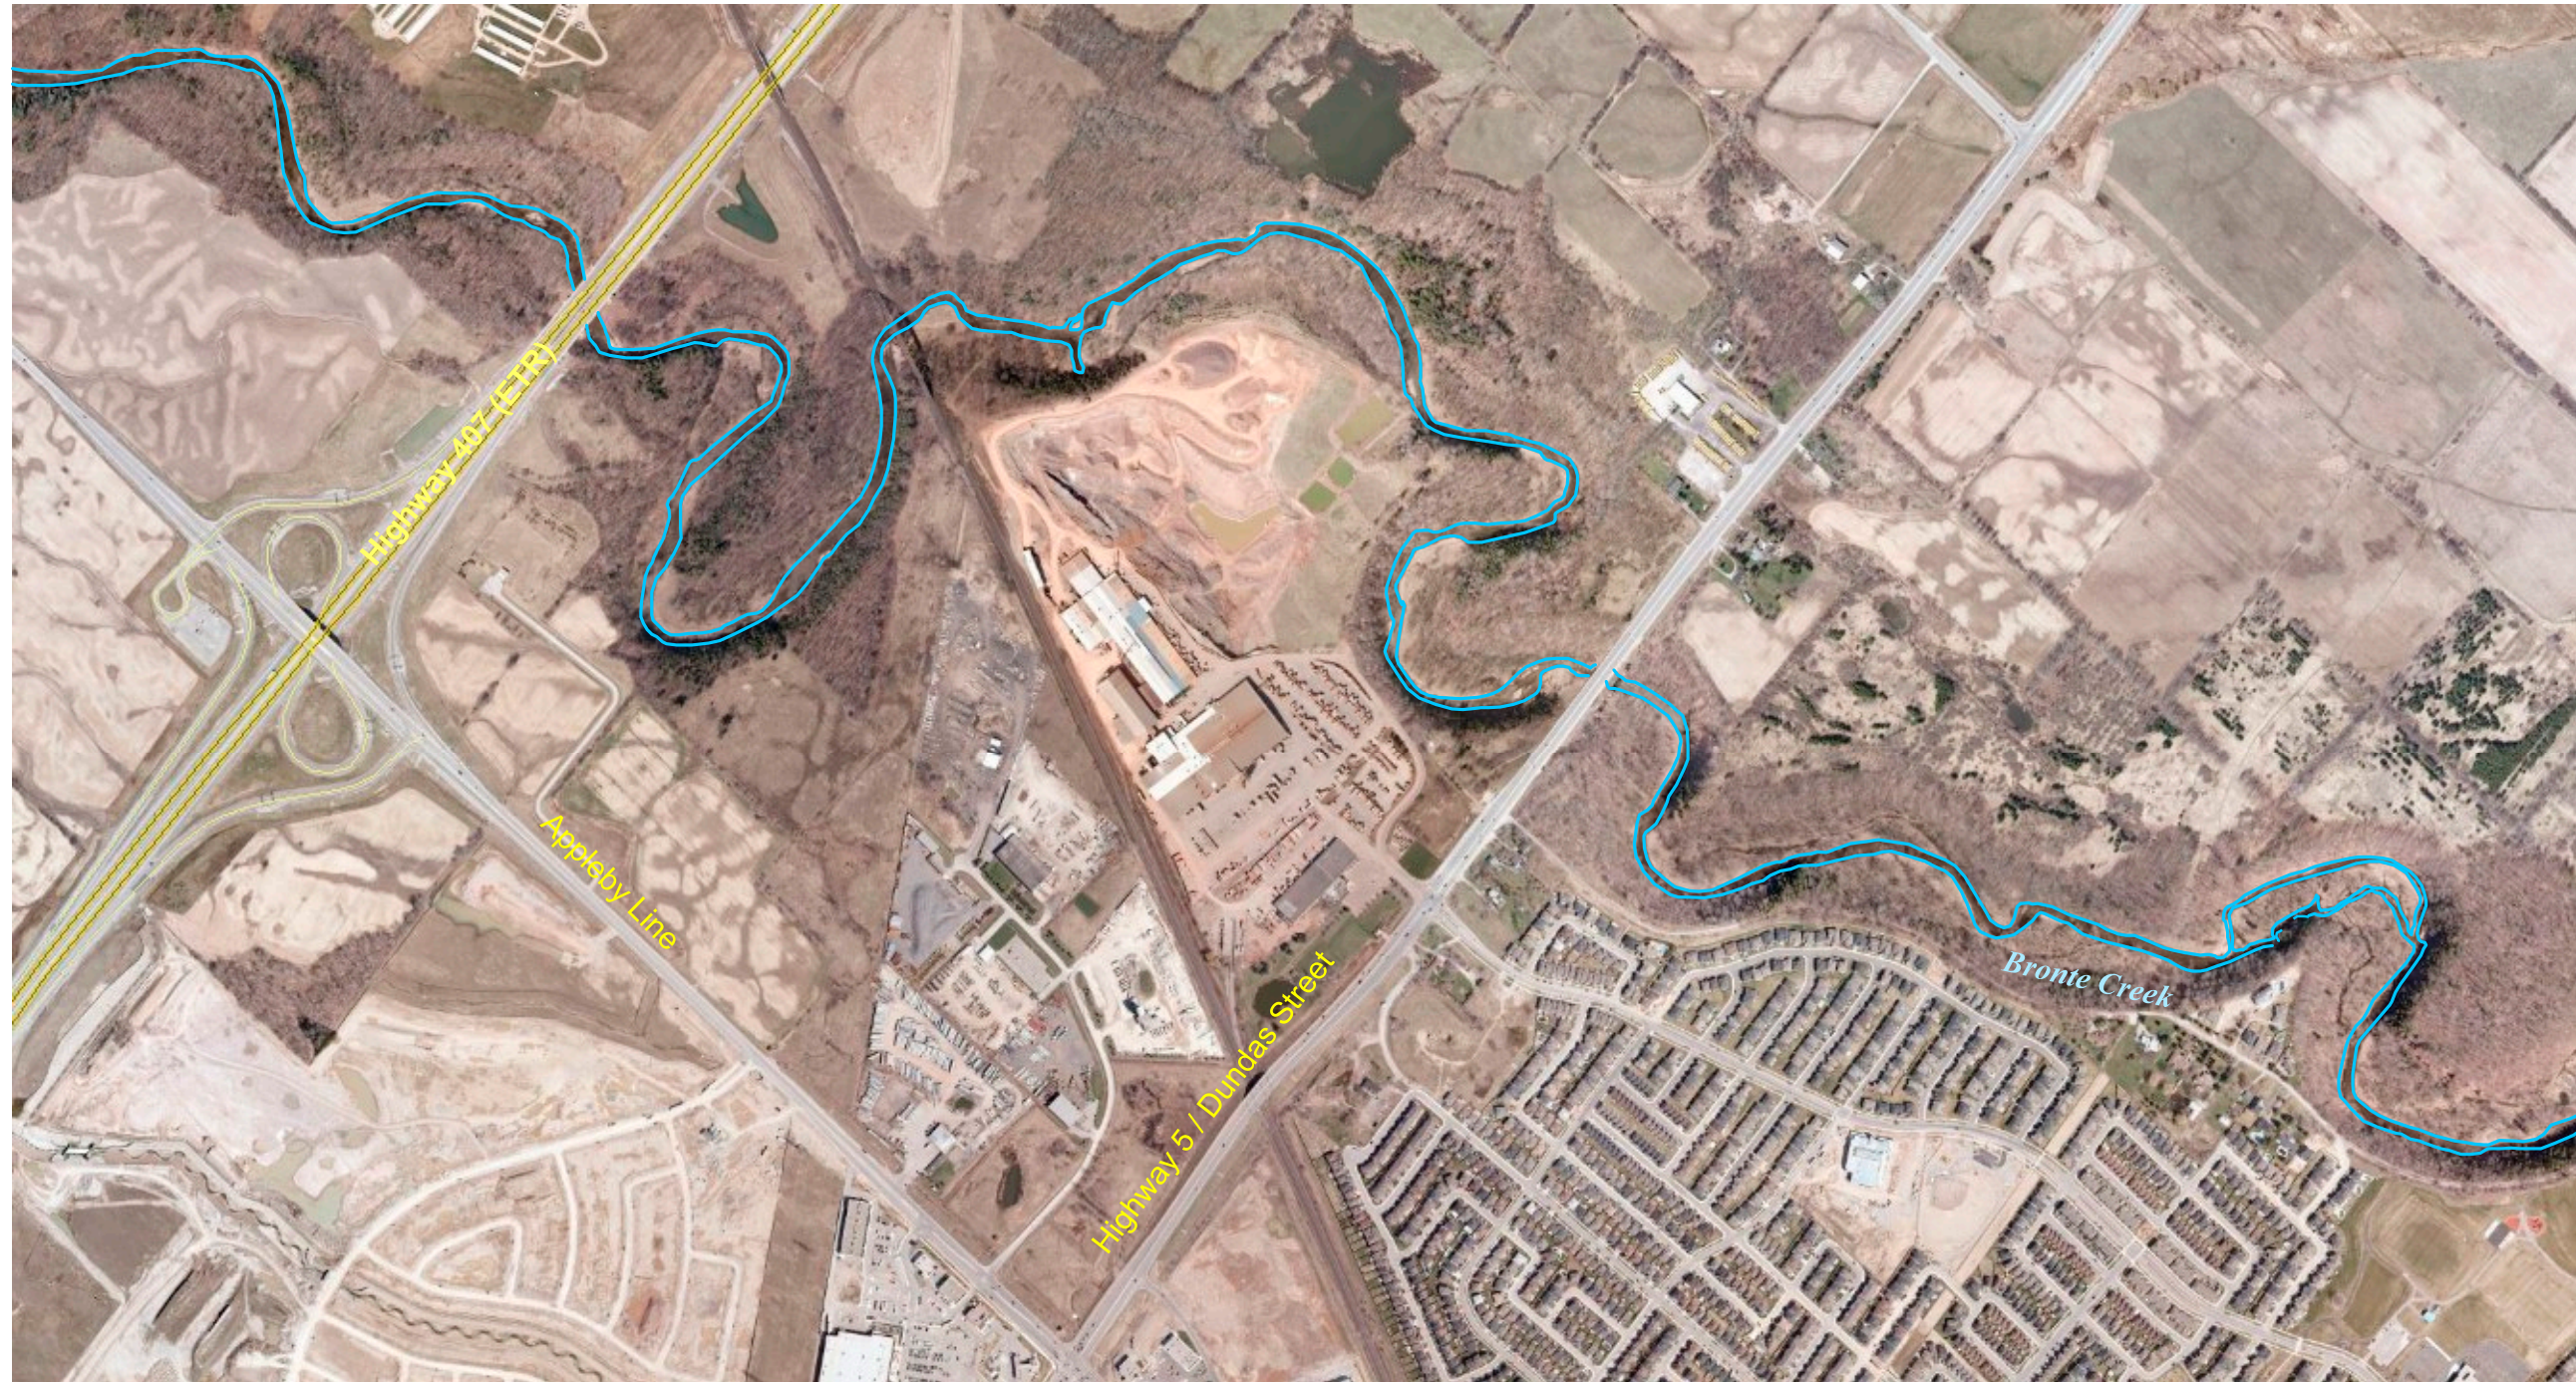
Field Investigation - Bronte Creek in the vicinity of Dundas Street is a semi-confined channel located within a deep valley. The channel meanders across the valley floor making contact with the toe of the valley slope in several locations. The Bronte Creek floodplain is often present on only one side of the channel, and where present it varies in width. The floodplain and valley slopes are generally well vegetated.

The channel is considered to be laterally migrating, however due to the confined nature of the valley lateral adjustment of the creek would be limited over time. The reach has pool-riffle morphology and a moderate slope. Bankfull width varies from 17 to 25 m with an average of 20 m. Bank heights range from 0.2 to 1.5 m where unconfined. A cut-off channel was observed on the eastern floodplain on the meander upstream of Dundas Street.

There is a large supply of sediment to the system both from upstream and colluvial sources within the study reach (notably the exposed shale valley slopes). Numerous depositional features have formed which include point bars, mid channel bars and side bars comprised of material ranging from fines to cobble. These depositional features appear to be quite mobile based on site observations made in 2011 and 2014; for instance, the point bar located upstream of Tansley Bridge appears to have lost material since 2011, and the shape and extent of the upstream riffle has changed. The sediment supply appears to be well-balanced with material leaving the system through transport and erosion. Bank erosion was observed on the outer banks of meanders as is typical of a meandering system. Overall the reach functions as an exchange for sediment.

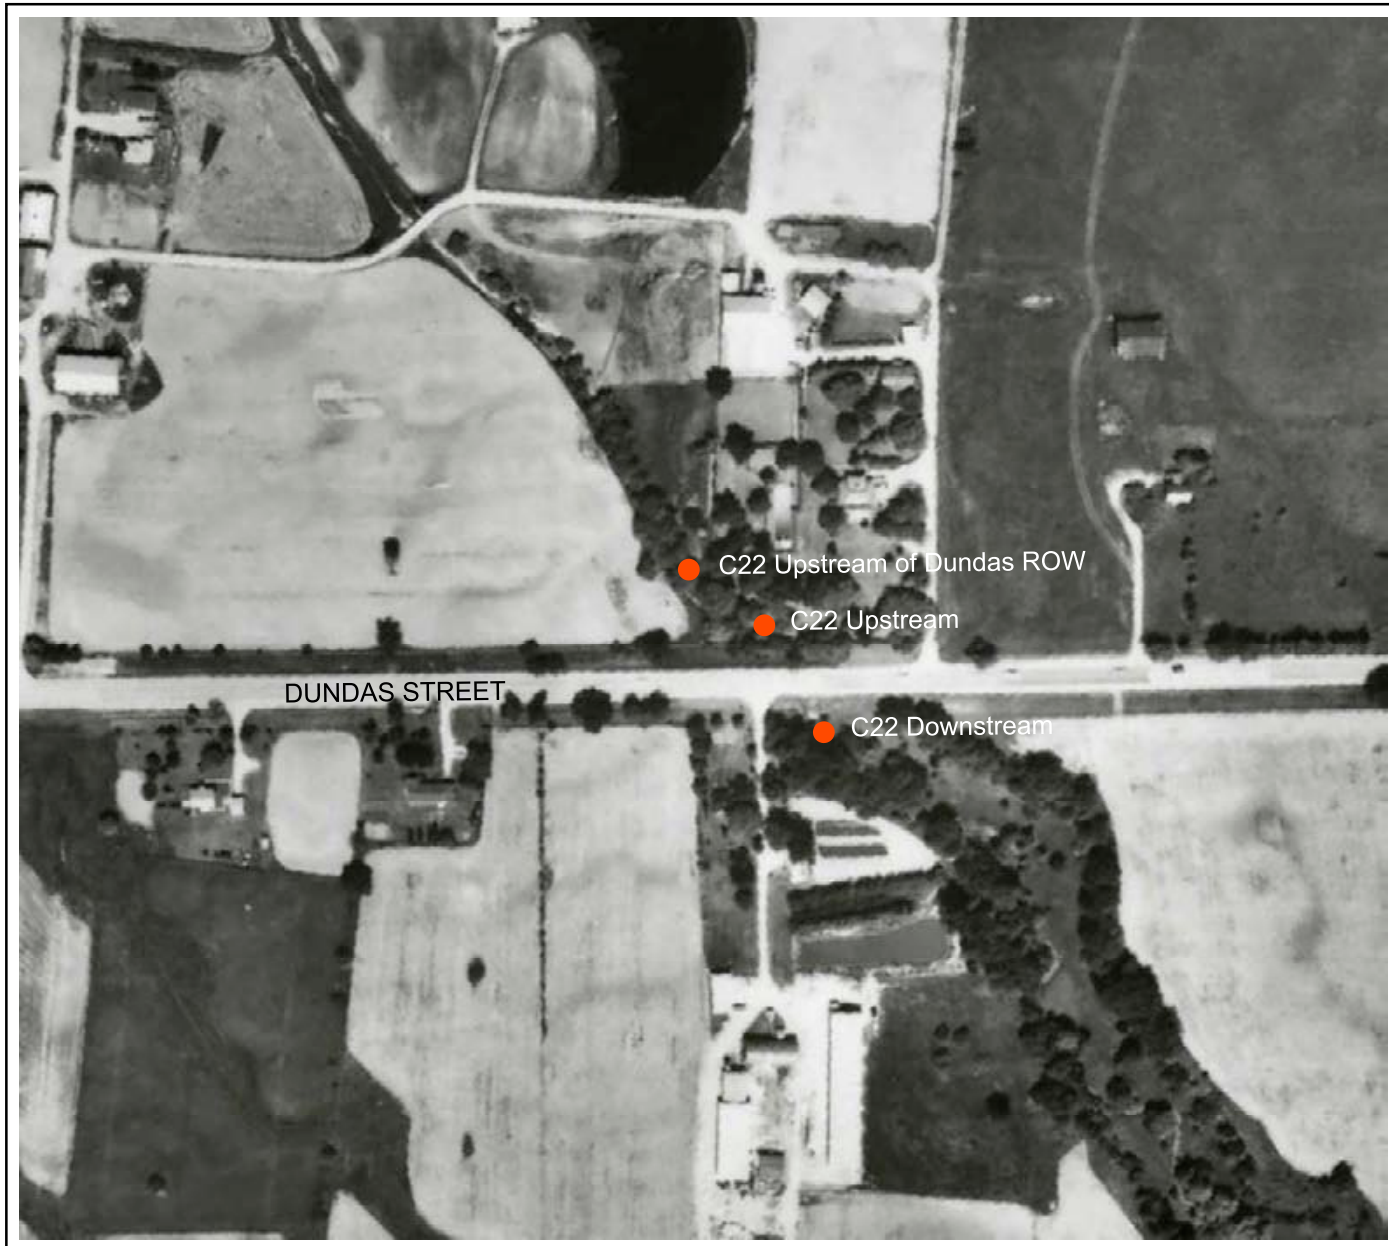
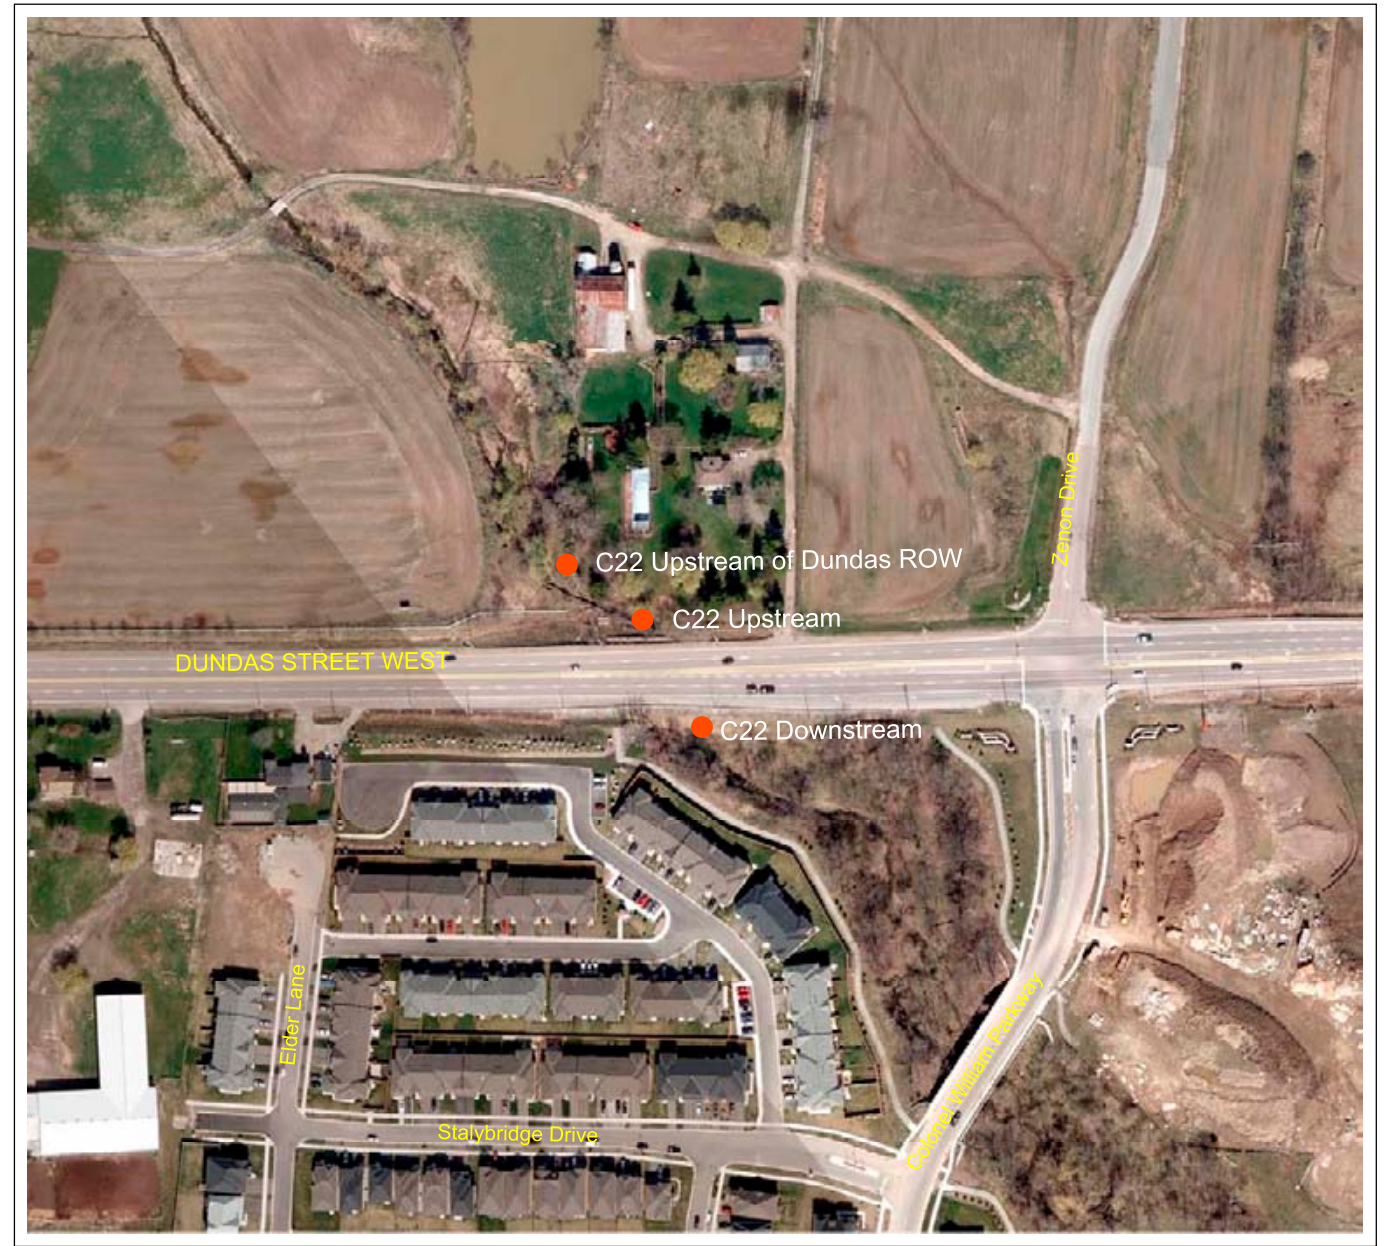
1978

2011

Historic Air Photography Interpretation - Historic photographs of the Fourteen Mile Creek West Tributary were only available for 1978 (**Exhibit 3-6**). No significant alterations to the catchment, floodplain or riparian zone have occurred in the upstream reaches since this time. Likewise there has been no notable change in the channel planform. By 1978, the concrete channel had been built immediately upstream of Dundas Street in Reach FW02.

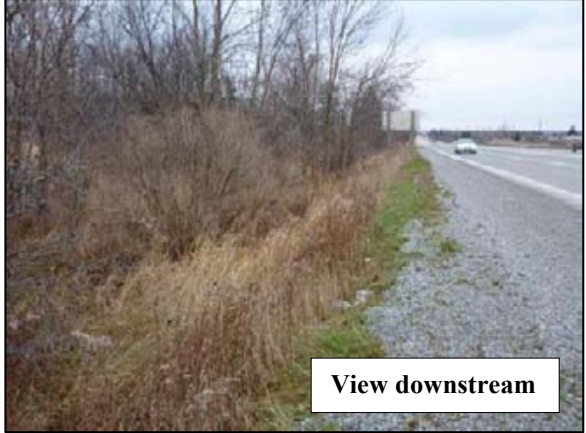
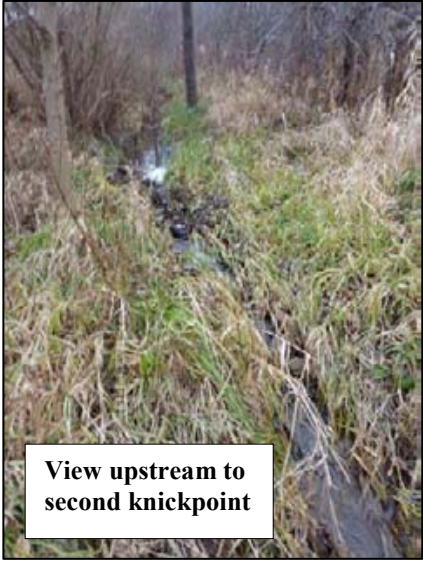
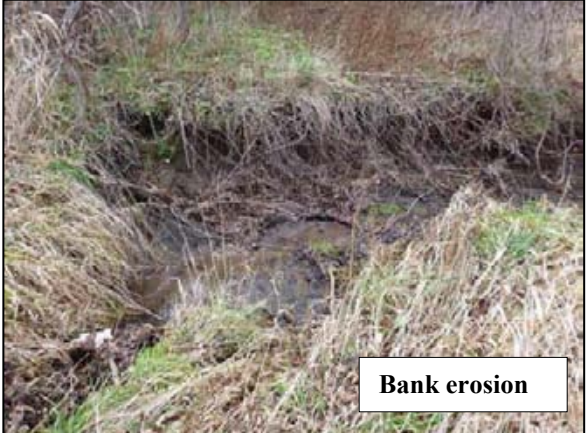
Watercourse	Tuck Creek Tributary	
Culvert ID	C1	
Location	Upstream	
Function	Source	
Process	Lateral adjustment with incision	
Stability Index	0.31	Transitional
Conservation status	3	
Bankfull width (m)	1.3	
Channel geometry	Straight	
<p>The channel runs parallel to the north side of Dundas Street from west of the 2111 Dundas Street driveway to the C1 inlet.</p> <p>The channel has a modified cross section, moderate to high gradient, straight planform and poor floodplain connectivity. The right channel bank is confined by the Dundas Street road embankment. Upstream of the 2111 Dundas Street driveway the channel is a grassy ditch which is not deeply entrenched. The driveway culvert is slightly perched. Downstream of the driveway is a 0.65 m high knickpoint which has been protected with riprap. A second knickpoint (0.55 m high) is located farther downstream.</p> <p>The channel gradually becomes more entrenched downstream and is recovering sinuosity through lateral adjustment. Bank erosion is extensive. Channel dimensions vary throughout the reach (bankfull width ranging from 0.6-1.6 m and depth 0.3-0.55 m). A more representative bankfull width of 1.3 m was measured in the lower portion of the reach where adjustment has occurred. The bed and banks are composed primarily of silt and clay.</p>

Erosion Risk	Moderate

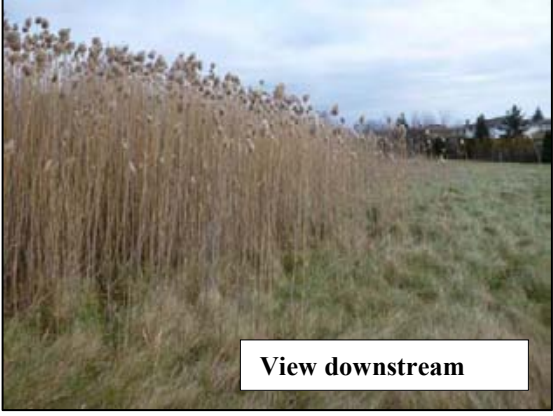
<p data-bbox="1073 569 1360 621" style="text-align: center;">View downstream</p>			
Function	Transfer				
Process	Stable				
Stability Index	N/A				
Conservation status	3				
Bankfull width (m)	1.0				
Channel geometry	Straight				
<p data-bbox="183 573 760 789">Downstream of Dundas Street is a short reach which traverses a grassy area and ends at a drop structure near a housing development. The outlet of C1 was submerged by ponded water at the time of survey.</p> <p data-bbox="183 831 743 1192">In the Dundas Street right-of-way, the tributary consists of a stable reed choked swale with no defined channel. Midway between Dundas Street and the drop structure is a riprap drop downstream of which is a defined channel with several knickpoints. Where defined the channel is 1.0 m wide and 0.2 m deep on a run, but channel dimensions appear to vary with slope.</p>

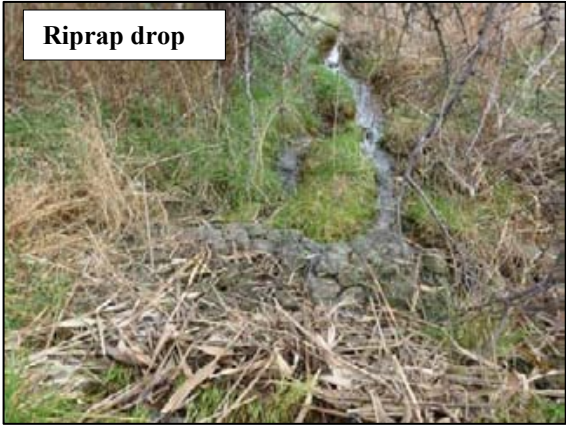
<p data-bbox="854 695 1052 741" style="text-align: center;">Riprap drop</p>

Erosion Risk	<p data-bbox="792 1346 1000 1377">Low-Moderate</p> <ul style="list-style-type: none"> <li data-bbox="792 1381 1333 1413">-Stable within Dundas Street right-of-way <li data-bbox="792 1417 1414 1520">-Disturbance of riprap grade control could allow knickpoint to migrate toward Dundas Street in the future

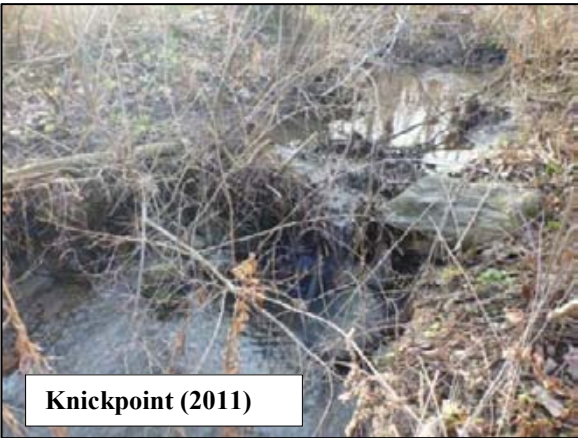
Knickpoint (2011)

Watercourse		Tuck Creek	
Culvert ID	C2		
Location	Upstream		
Function	Exchange		
Process	Lateral adjustment with incision		
Stability Index	0.11	In regime	
Conservation status	4		
Bankfull width (m)	2.5		
Channel geometry	Straight		
<p>The channel is modified and has a moderate gradient. The reach appears to be undergoing very gradual lateral adjustment but is stabilized by constraints such as imported stones, erosion-resistant banks and tree roots. The stream bed is composed of gravel and cobble. Bankfull width ranges from 2.2-2.7 m and is modified. Banks are generally well vegetated and are 0.7-1.0 m high. Some bank erosion was observed. A deciduous riparian strip (approximately 10 m wide) lines the creek.</p> <p>A knickpoint is located approximately 1 m upstream of the culvert inlet. Knickpoint migration appears to be checked by several imported stones (approximately 0.5 m in diameter). The culvert inlet is not perched.</p>

Erosion Risk		<p>Low-moderate</p> <ul style="list-style-type: none"> - Adjustment rate appears to be slow - Disturbing stones at knickpoint could lead to instability

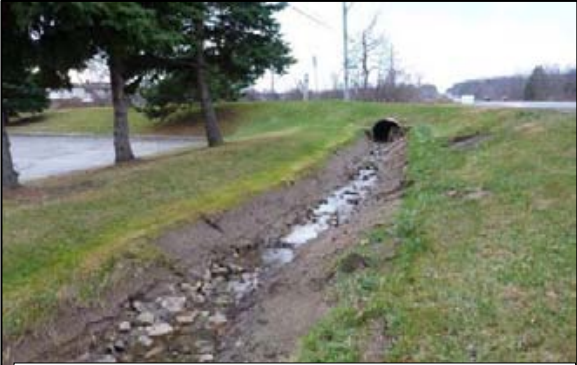
Watercourse	Tuck Creek	
Culvert ID	C2	
Location	Downstream	
Function	N/A	
Process	N/A	
Stability Index	N/A	
Conservation status	2	
Bankfull width (m)	1-3 (ditch width) 0.5 (previous adjusted width)	
Channel geometry	Straight	
<p>From the culvert outlet the creek turns east at a 90 degree angle to cross Eaglesfield Drive to run parallel to Dundas Street. Until the fall of 2014, the channel downstream of Eaglesfield Drive was recovering a sinuous planform through lateral adjustment. The channel had a narrow cross section with a bankfull width of approximately 0.5 m. Banks were vertical to undercut with some bank slumping, and the bed was composed of well-sorted gravel and cobble.</p> <p>As of the November 30 2014 site visit, this reach had been dug into a straight, entrenched ditch with bare silt and clay banks and a moderate slope. The ditch width is approximately 1-3 m. Scattered riprap lines the bed in areas. The channel is too recently modified for adjustment processes to have begun.</p>

<p>View looking upstream to Eaglesfield Drive, November 30 2014.</p>

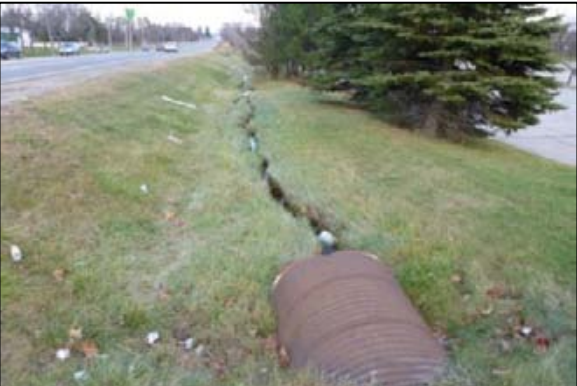
<p>Previous view looking downstream from Eaglesfield Drive</p>

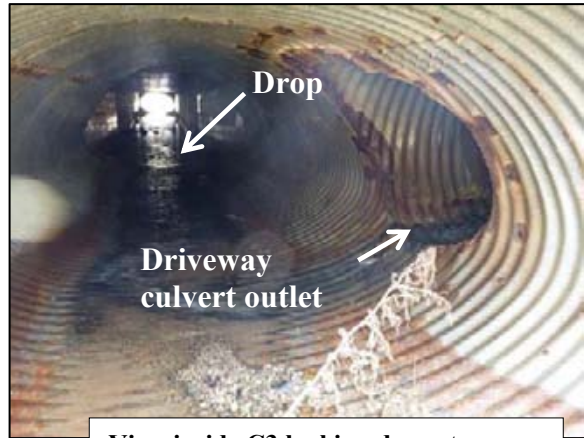
The inlet of the C3 culvert is connected to the driveway culvert to the west. There is a visible drop within the C3 culvert.

View inside C3 looking downstream

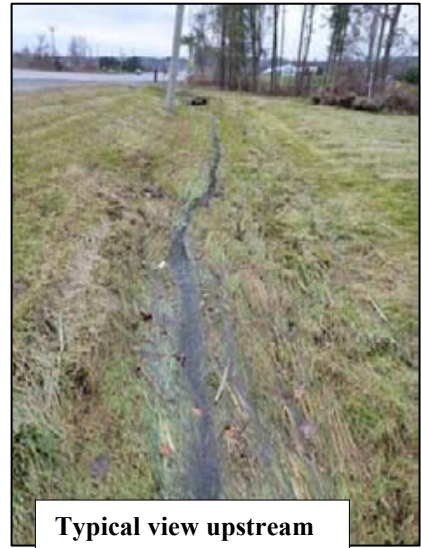
Typical view upstream

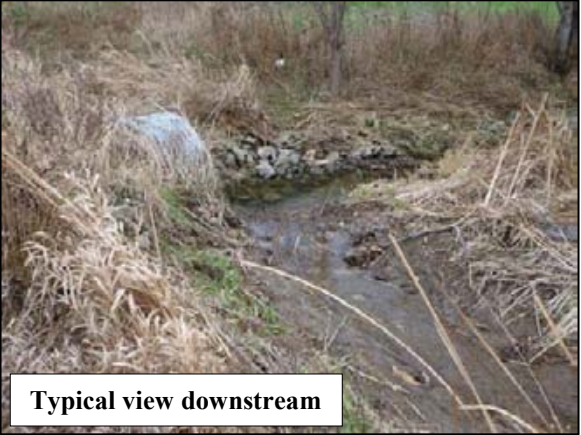
<p>Typical view downstream</p>
Culvert ID	C3	
Location	Downstream	
Function	Source	
Process	Incision	
Stability Index	N/A	
Conservation status	2	
Bankfull width (m)	No representative width Modified: 1.5-5.0	
Channel geometry	Straight	
<p>At the outlet of C3, the C2 channel joins the creek from the west. The reach ends at a drop structure near a housing development. The channel has a straight planform and an entrenched, modified cross section of approximately 1.5-5.0 m wide. The banks are 0.5-1.5 m high. The Rapid Geomorphic Assessment (RGA) was not completed as the channel bed and banks are lined with riprap. The channel has a high gradient. One knickpoint is located downstream of the Dundas Street right-of-way. The dominant process is incision which is slowed by the bed and bank protection.</p>		
Erosion Risk		<p>Low-moderate -Channel has been stabilized -Incision could occur if erosion protection is disturbed</p>
