3. EXISTING AND FUTURE CONDITIONS

The study area focuses on Dundas Street from Brant Street to Bronte Road, and is located within the City of Burlington and the Town of Oakville in Halton Region. **Exhibit 1-3** provides a key plan of the study area. **Exhibit 3-1a** to **3-1c** are aerial mosaic of the study area identifying existing conditions and key features which are discussed in the following sections.

DUNDAS STREET CLASS EA STUDY
Brant Street to Bronte Road

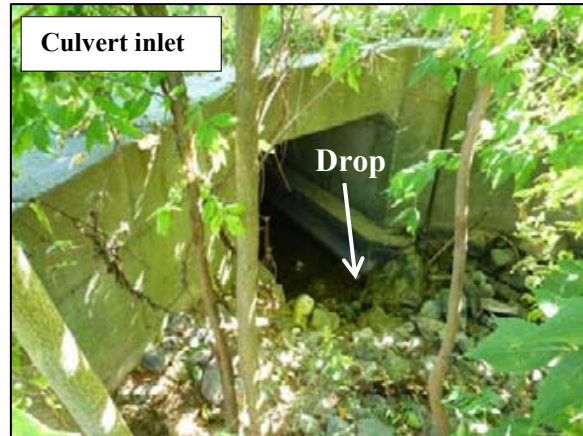
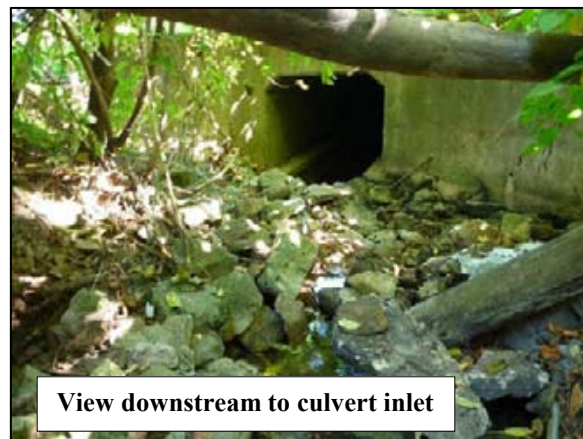
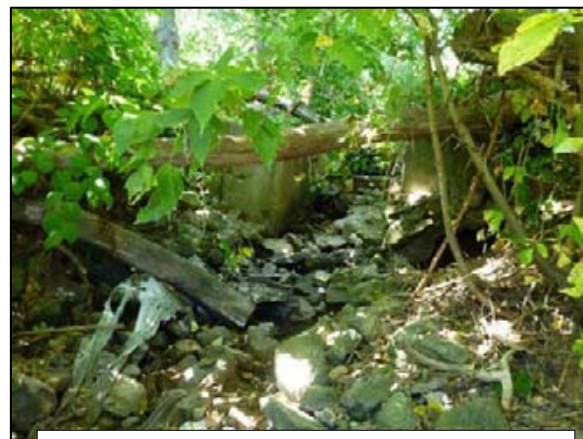
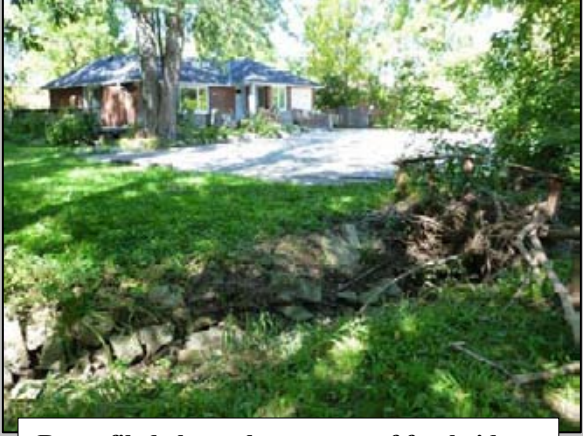
This reach is in very poor condition and has undergone several types of disturbance. On the property upstream of Dundas Street, the channel begins as a wide, shallow depression flowing through a forested riparian strip. This has been channelized midway along the property into a 2.7 m wide and 0.8 m deep trapezoidal channel which is protected with riprap. This appears connected to the floodplain based on the surrounding floodplain deposits. Near the existing parking lot the channelized section ends and a footbridge crosses the creek. The bridge footings are scoured and debris from a high flow event was caught in the railings at the time of the site visit.

Downstream of the bridge the creek flows through a failed concrete channel which appears to have originally acted as a drop structure. The channel is 1.6 m wide and 1.1 m deep. The concrete bed has failed, with a 0.5 m drop to the natural bed below.

The structure ends approximately 6 m upstream of the Dundas Street culvert inlet. Between the structure and the culvert wingwalls both banks are badly eroded. Riprap has piled up on the bed which is likely failed bank protection. This forms a 0.6 m drop in bed elevation at the culvert inlet.

<p style="text-align: center;">Reprofiled channel upstream of footbridge</p>
<p>Erosion Risk</p>	<p>High</p> <ul style="list-style-type: none"> -Significant scour at inlet -Failed bank and bed protection of several types -Evidence of flashy flows

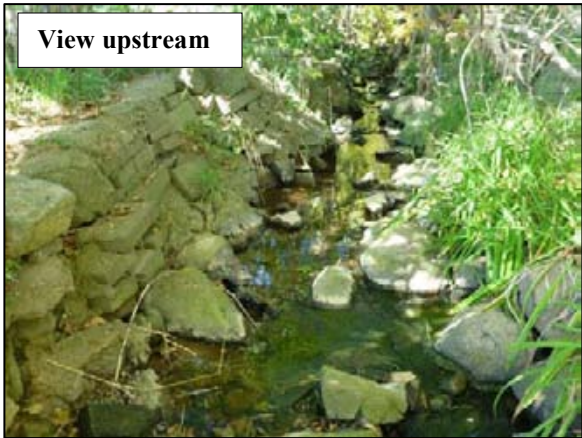
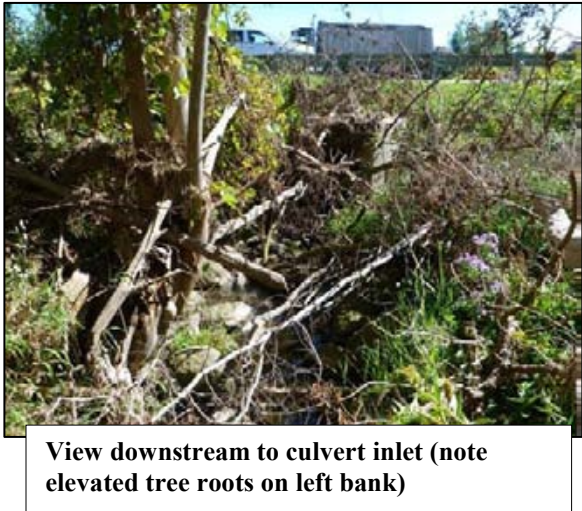
Watercourse	Tuck Creek Tributary	
Culvert ID	C8	
Location	Upstream	
Function	Exchange	
Process	Lateral adjustment	
Stability Index	0.33	Transitional
Conservation status	2	
Bankfull width (m)	1.5 (modified)	
Channel geometry	Straight	
<p>The reach runs along the edge of a residential property north of Dundas Street. A drainage ditch joins the channel from the west at the culvert inlet. The culvert is skewed to the left bank of the channel.</p> <p>The channel is straightened and has a high gradient. The channel is 1.5 m wide within an estimated 3 m wide embanked corridor. The banks are protected by riprap and brick walls, and the bed is composed of riprap with deposited gravel. Debris jams partially obscured the culvert inlet at the time of survey. These indicate that the channel is subject to high flows.</p> <p>The reach appears to have undergone historic incision based on the presence of knickpoints and elevated tree roots (set 0.7 m above the current bed). The incision was likely caused by channel straightening and steepening. The incision appears to be historic because the Dundas Street culvert foot matches the incised bed elevation.</p> <p>The channel is beginning to laterally adjust, although it retains a straight planform overall.</p>

<p>Erosion Risk</p>	<p>High</p> <ul style="list-style-type: none"> -Reach subject to historic incision -High gradient channel -Could become susceptible to ongoing incision if erosion protection is disturbed - Angle of culvert is not aligned with channel

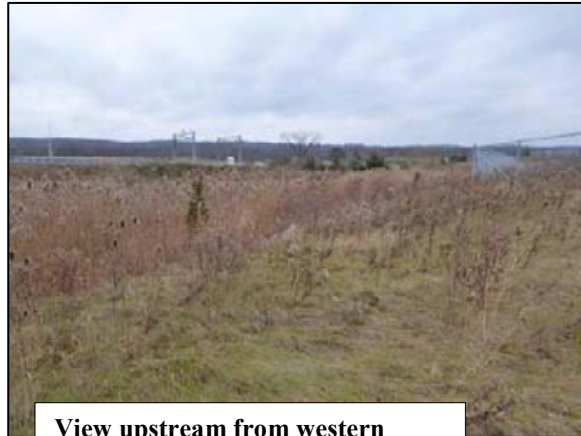
Watercourse	Shoreacres Creek	
Culvert ID	C9	
Location	Upstream	
Function	Sink	
Process	Aggrading	
Stability Index	0.14	In Regime
Conservation status	3	
Bankfull width (m)	2.0-2.5 (realigned) 0.6 (adjusted)	
Channel geometry	Regular meandering	
<p>C9 crosses Dundas Street near the onramp of 407 ETR. The reach is located between berms to the east and west. The channel is lined by a buffer strip of reeds.</p> <p>The reach has a sinuous realigned planform. The reach is acting as a sediment sink as it aggrades. Within the upper portion of the reach, the channel has narrowed to 0.6 m bankfull width. The aggraded channel is poorly defined and is very well connected to the floodplain. Near the C9 inlet, the channel is still in the process of aggrading and the realigned channel cross section is in place. The realigned channel width is 2.0-2.5 m and was ponded at the time of survey.</p> <p>Scour has occurred at the culvert inlet. Organic debris has deposited on top of the culvert, which is indicative of high flows.</p>

View upstream from western

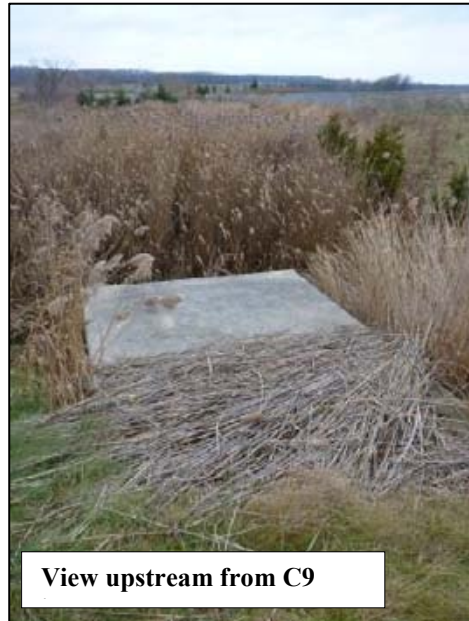
View upstream from C9

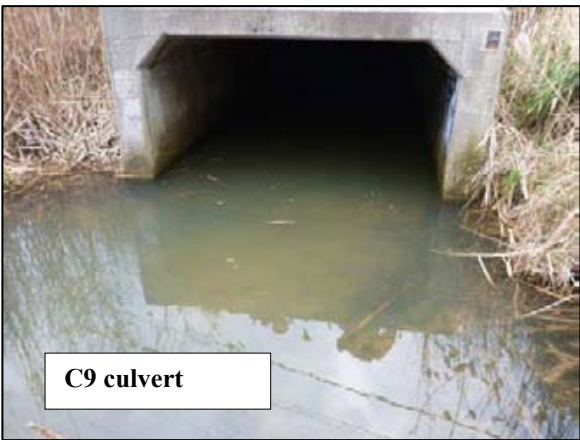
Watercourse		Shoreacres Creek	
Culvert ID	C9		
Location	Downstream		
Function	Exchange		
Process	Lateral adjustment		
Stability Index	0.18	In regime	
Conservation status	4		
Bankfull width (m)	2.0		
Channel geometry	Regular meandering		
<p>C9 outlets to a scour pool partially lined with riprap. The culvert walls have been outflanked by 1.0 m and 1.4 m. The channel flows through a shallow valley with graded valley slopes. Riparian vegetation includes semi-continuous deciduous riparian strip and tall reeds and grasses.</p> <p>The channel has a sinuous planform with a moderate slope. Representative bankfull width is 2.0 m and bankfull depth is 0.5 m. The dominant process is lateral adjustment, and bank erosion is limited to the outside of bends. Overbank flow paths have developed within the floodplain vegetation indicating good floodplain connectivity.</p>			
Erosion Risk		<p>Low -Channel is in phase, some scour at existing culvert outlet</p>

C9 culvert

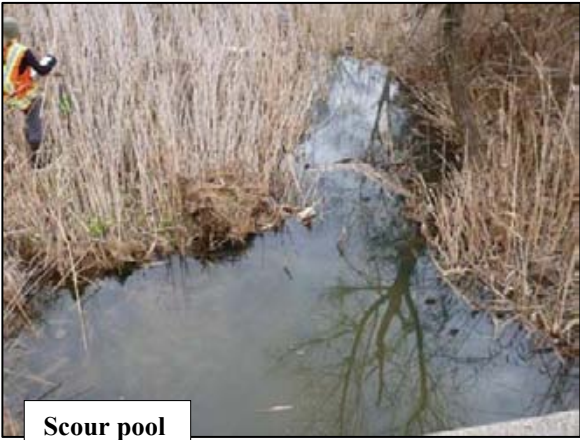
Scour pool

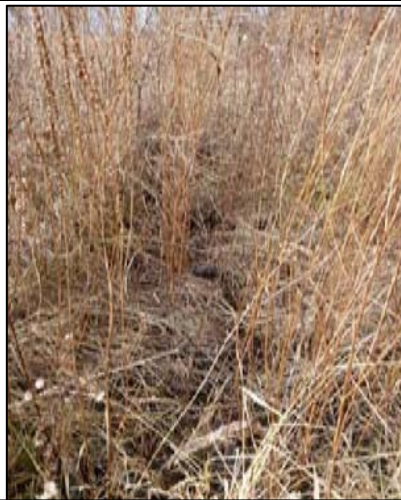
Watercourse		Shoreacres Creek	
Culvert ID	C10 Ditch		
Location	Upstream		
Function	Source		
Process	Incision (where defined)		
Stability Index	0.37	In regime	
Conservation status	3		
Bankfull width (m)	0.9 (where defined)		
Channel geometry	Straight		
<p>This reach is a secondary channel east of the main C10 channel. Upstream of the Dundas Street right-of-way the feature appears to be a former farm ditch. In this area the channel is poorly defined, has stable, vegetated bed and banks, a straight planform and flows through a forested riparian area. The reach turns west to run parallel to Dundas Street. Along most of this length the channel is a stable, reed-choked swale with a modified bankfull width of 1.5 m. Flows appear to be frequently diverted over the floodplain and large reed accumulations indicate these flowpaths.</p> <p>Approaching the culvert inlet, the channel becomes defined. The bankfull channel is 0.9 m wide and 0.25 m deep and has a moderate slope. Several knickpoints are present which have been checked by riprap bed protection; these indicate that the reach is incising. The eastern culvert wall has been outflanked by 1.5 m where this reach joins the main C10 channel.</p>

Poorly defined channel

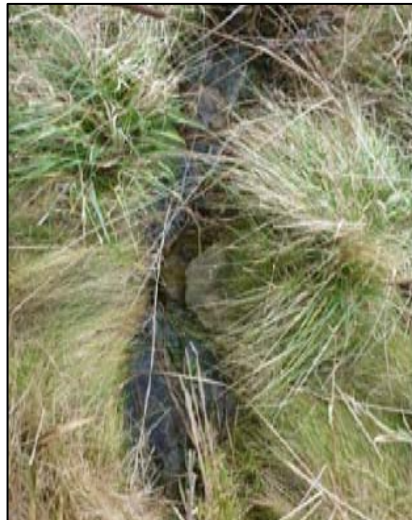
Defined channel near C10 inlet

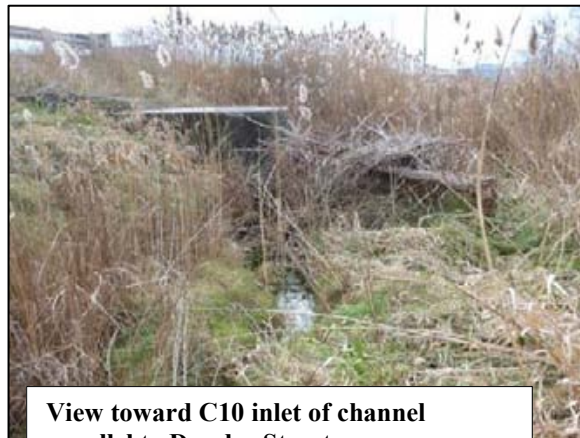
View toward C10 inlet of channel parallel to Dundas Street

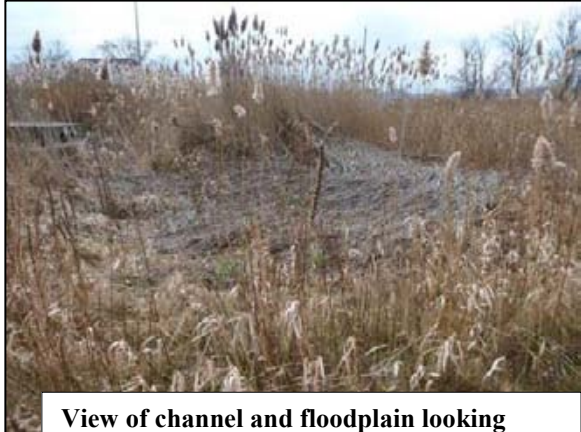
Watercourse	Shoreacres Creek	
Culvert ID	C10	
Location	Upstream	
Function	Sink	
Process	Aggrading	
Stability Index	0.17	In regime
Conservation status	3	
Bankfull width (m)	0.5	
Channel geometry	Regular meandering	
<p>The creek flows south toward Dundas Street between two berms. The channel has a regularly meandering planform which has been previously realigned. Riparian vegetation includes tall herbs, grasses and reeds with scattered trees.</p> <p>The channel is reed-choked and in the process of aggrading. In the upper portion of the reach the channel retains its realigned cross section which is approximately 1.0 m wide and 0.25 m deep. In this area the channel is reed-choked and contains loose silt deposits. Near the right-of-way the channel has narrowed to 0.5 m wide and 0.1 m deep with gentle, poorly defined banks and less in-channel silt deposition. Here, the channel functions as a wetland with water out of bank under low flows.</p> <p>A 0.5 m high knickpoint is located approximately 5 m upstream of the C10 inlet. This is likely from construction rather than fluvial process as the reach is aggrading rather than downcutting and it is protected by riprap to act as a grade control. At the culvert inlet, the right bank has eroded and both culvert walls have been outflanked. The culvert foot is slightly scoured. Elevated reed accumulations on top of the culvert and on the floodplain indicate high floodplain flows.</p>

View of channel and floodplain looking west. Note floodplain reed deposits.

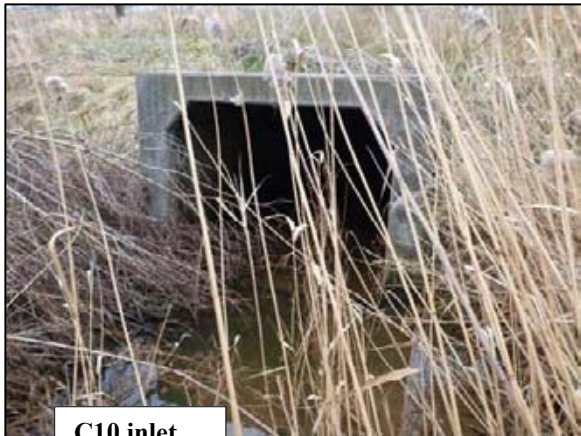
C10 inlet

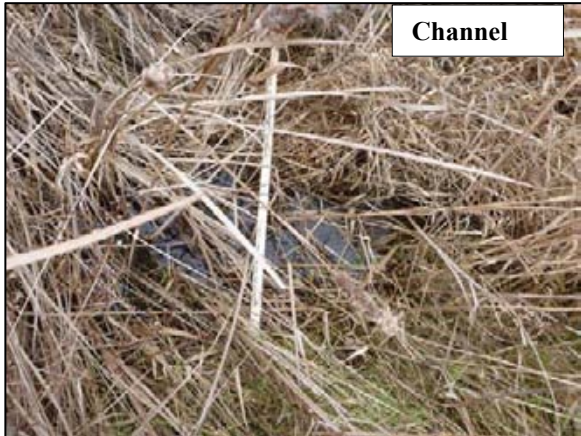
Channel

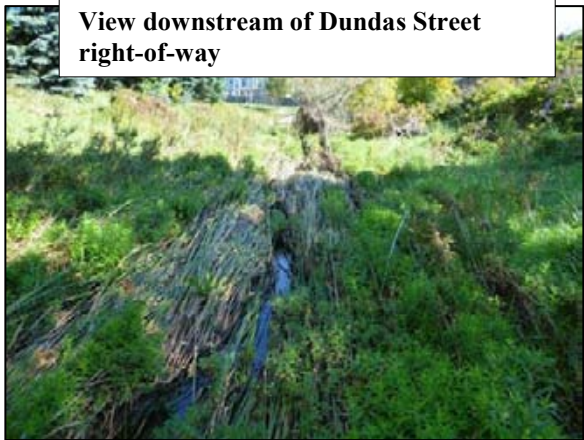
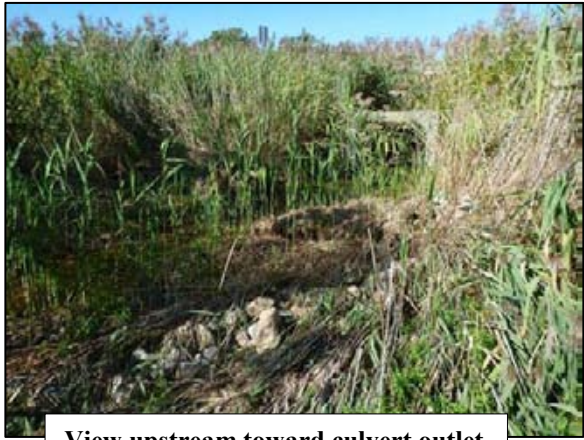
Watercourse		Shoreacres Creek	
Culvert ID	C10		
Location	Downstream		
Function	Stable		
Process	Transfer		
Stability Index	0.07	In Regime	
Conservation status	4		
Bankfull width (m)	3		
Channel geometry	Straight		
<p>The culvert outlets to an artificial scour pool (approximately 4 m wide). Within the Dundas Street right-of-way, the valley floor is protected by a concrete apron. This is overlain by riprap, soil and reeds. The apron forms a 0.5 m drop at its downstream extent. Beyond the apron the reach has been realigned and embanked on both sides. The channel has a two stage cross section including a narrow low flow channel and a wider vegetated bankfull channel. The realigned channel section appears to be well adjusted to the flow regime as no erosion was noted and the low flow channel is clear of reeds and silt deposits.</p>			
Erosion Risk		<p>Low -Stable channel with erosion protection near C10</p>

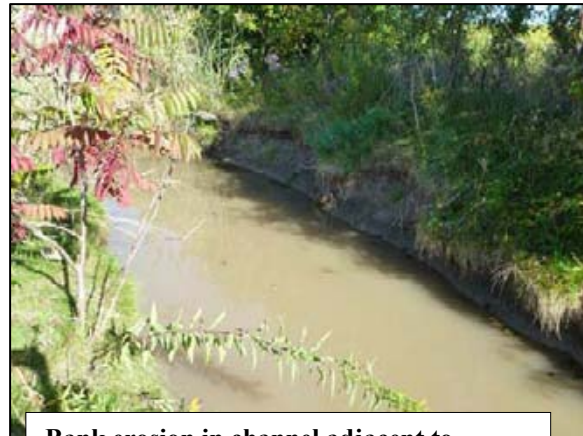
The channel has been realigned along the eastern edge of the parking lot driveway, turning 90° at Dundas Street to runs parallel to the road. These realignments have lengthened the channel, reducing the channel gradient and in-channel velocities. This has resulted in siltation and infilling by reeds in the channel along Dundas Street. Local bank erosion has occurred in the channel adjacent to the carpool lot access which may indicate flashy flows. Within the Dundas Street right-of-way, the channel was obscured by vegetation but the channel appears stable. No erosion protection was observed. The channel has not recovered a more natural cross section or planform since realignment.

Bank erosion in channel adjacent to carpool lot driveway

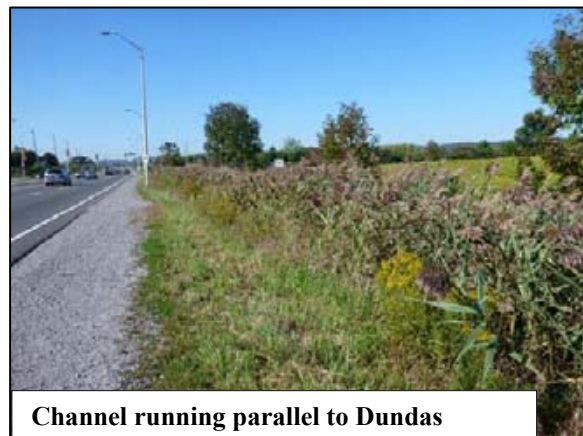
Channel running parallel to Dundas Street (looking west)

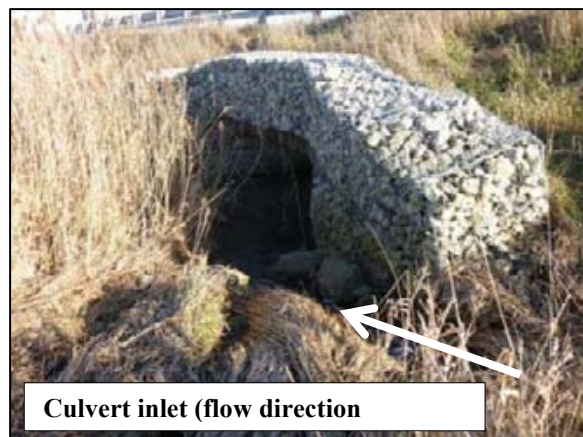
The culvert inlet is skewed to the channel by over 90°. A secondary channel flowing south through the northern farm field also flows through the culvert. There is no evidence of erosion at the inlet.

Culvert inlet (flow direction)

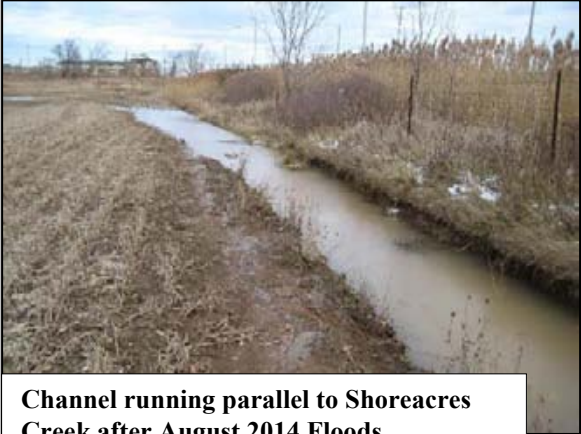
During the August 2014 floods, overland flows appear to have created a channel that runs parallel to Shoreacres Creek for part of the length between the parking lot driveway and the C11 inlet.

<p data-bbox="824 569 1344 646">Channel running parallel to Shoreacres Creek after August 2014 Floods</p>
Erosion Risk	Low -Channel stable within realignment area parallel to Dundas Street

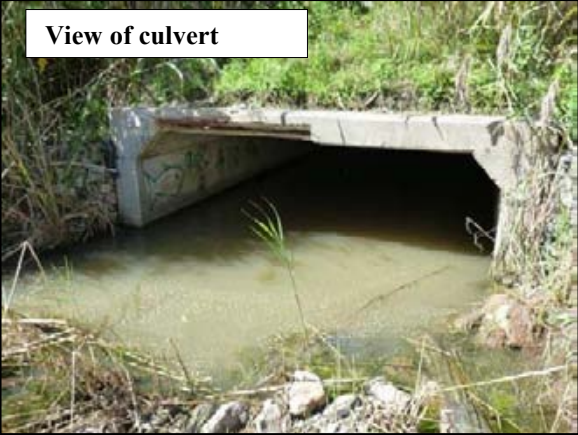
Watercourse	Shoreacres Creek	
Culvert ID	C11	
Location	Downstream	
Function	Transfer	
Process	Stable	
Stability Index	0.00	In regime
Conservation Status	3	
Bankfull width (m)	1.0-2.0 (where defined)	
Channel Geometry	Straight	
<p>The channel flows through a shallow regarded valley. The culvert outlets to a short artificial scour pool. A concrete apron extends approximately 20 m downstream from the culvert. Sedimentation has occurred on the concrete apron, and a 1.0-2.0 m wide and 0.4 m deep channel has developed which has a concrete bed and silty banks.</p> <p>The channel is reedy and less defined downstream of the concrete apron. Both the bank and bed materials are predominantly composed of silt and the channel is densely vegetated. This reach has few natural features or active fluvial processes and appears to be stable.</p>

<p>A photograph showing a concrete culvert structure with water flowing through it. The surrounding area is overgrown with grass and weeds.</p>

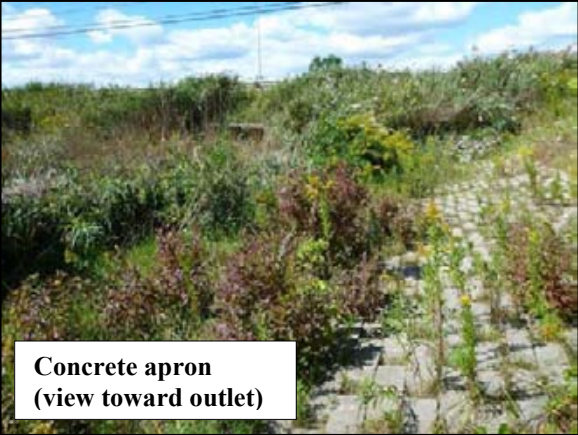
<p>A photograph showing a concrete apron extending downstream from the culvert. The apron is partially covered with sediment and surrounded by dense vegetation.</p>

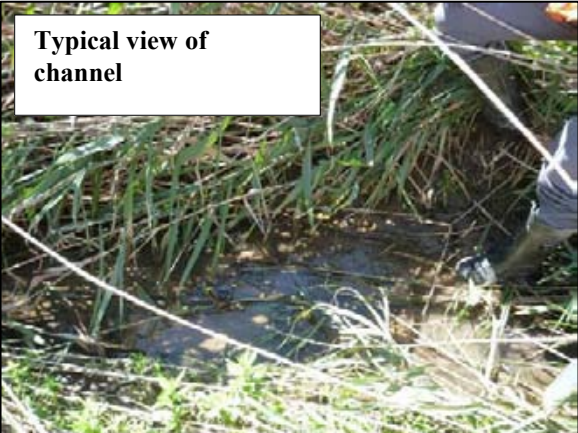
<p>A photograph showing a typical view of the channel downstream, characterized by dense, tall grasses and reeds growing in the water.</p>		
Erosion Risk	<p>Low -Stable channel with erosion protection near C10</p>

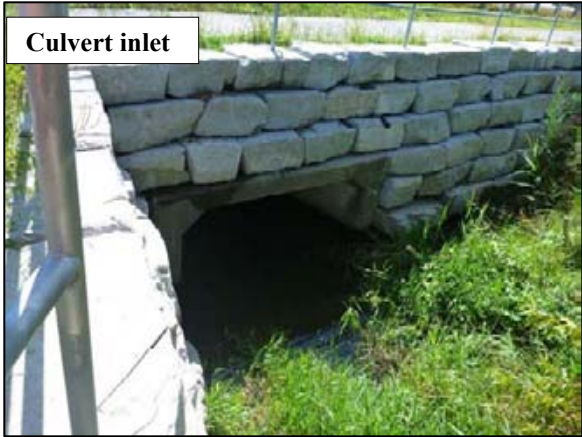
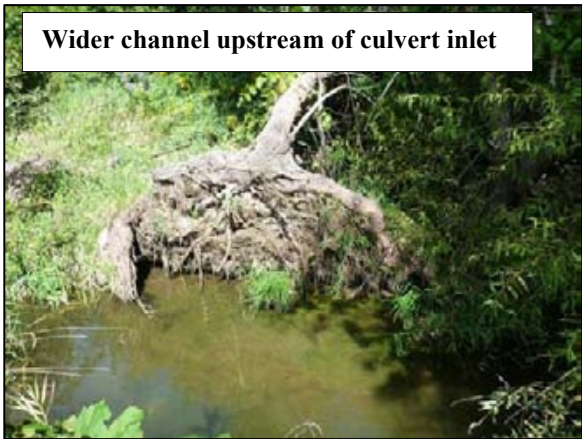
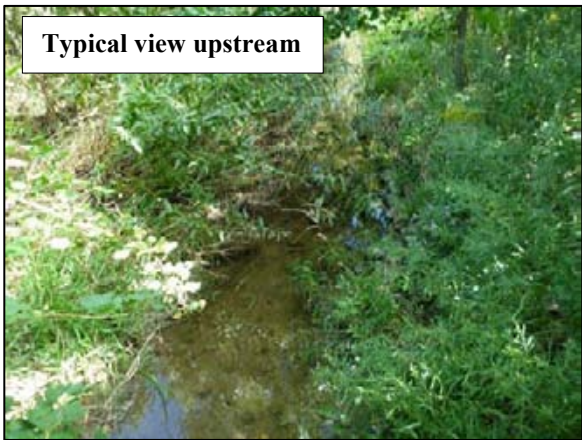
Watercourse		Appleby Creek	
Culvert ID	C12		
Location	Upstream		
Function	Transfer		
Process	Stable		
Stability Index	0.07	In regime	
Conservation Status	4		
Bankfull width (m)	1.5		
Channel geometry	Straight		
<p>The straight planform and riparian trees of uniform age indicate that this reach was historically realigned. In adjusted sections the bankfull width is approximately 1.5 m but the channel is locally overwidened to 3.6 m near the inlet. Banks are 0.5 m high.</p> <p>The channel appears to be stable in general. The reach has a low gradient. Bank erosion is minimal and the banks are generally vegetated. The bed is composed of cobble and silt with moderate sorting, and deeper silt deposits are found in pools. Flow was sluggish during both site visits.</p> <p>The culvert inlet is well aligned with the channel and is not scoured or outflanked. A SWM pond outfall joins channel upstream of the Dundas Street right-of-way.</p>

Erosion Risk		<p>Low-moderate -Channel is stable with minimal bank erosion</p>

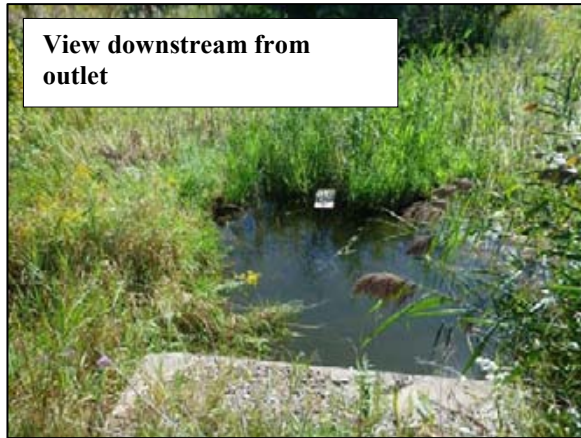
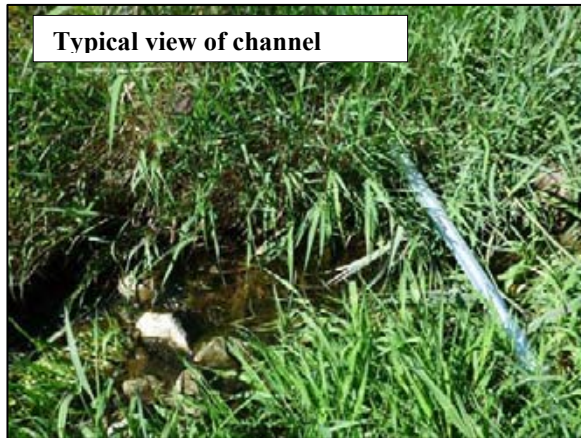
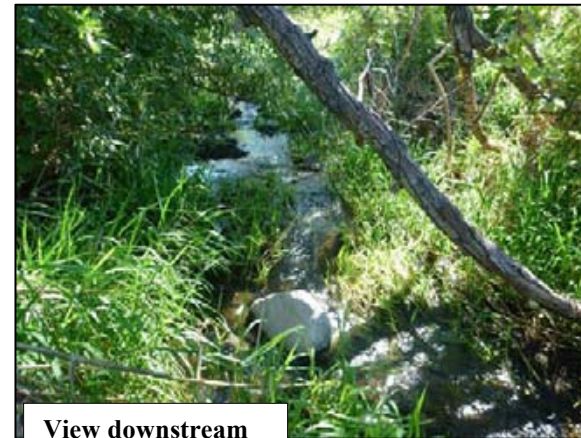
Watercourse		Appleby Creek	
Culvert ID	C12		
Location	Downstream		
Function	Transfer		
Process	Stable		
Stability Index	0.00	In regime	
Conservation Status	4		
Bankfull width (m)	1.0 (near Dundas) 3.5 (downstream)		
Channel geometry	Straight		
<p>The Dundas Street culvert outlets to a stone-lined scour pool that is 4 m wide and 4 m long. Within the Dundas Street right-of-way, the floodplain is protected with riprap and the channel is 1.0 m wide, 0.2 m deep and straight.</p> <p>Downstream, the channel widens to more natural cross section with variable width and bank height (1.5-3.5 m and 0.5-1.0 m respectively) and a cobble bed. The stream gradient is moderate and floodplain connectivity is good. Local erosion is present but overall the channel appears to be stable.</p>			
Erosion Risk		<p>Low -Channel is stable overall</p>

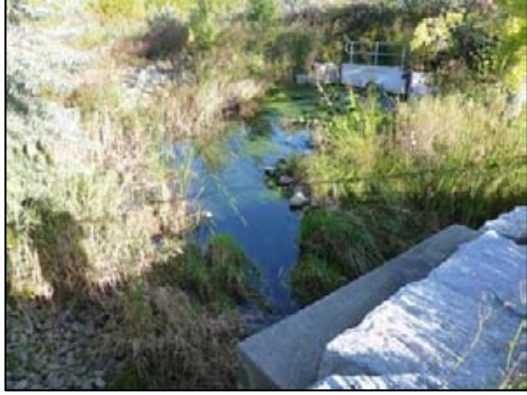
Watercourse	Sheldon Creek

Culvert ID	C13	
Location	Upstream	
Bankfull width (m)	N/A	
SE01 is a short segment of modified channel which connects the SWM pond outlet to the Dundas Street crossing. The channel is stable. Banks are protected with rounded river stone and both bed and banks are vegetated. No evidence of erosion was observed.		
Erosion Risk	Low -Stable channel with erosion protection

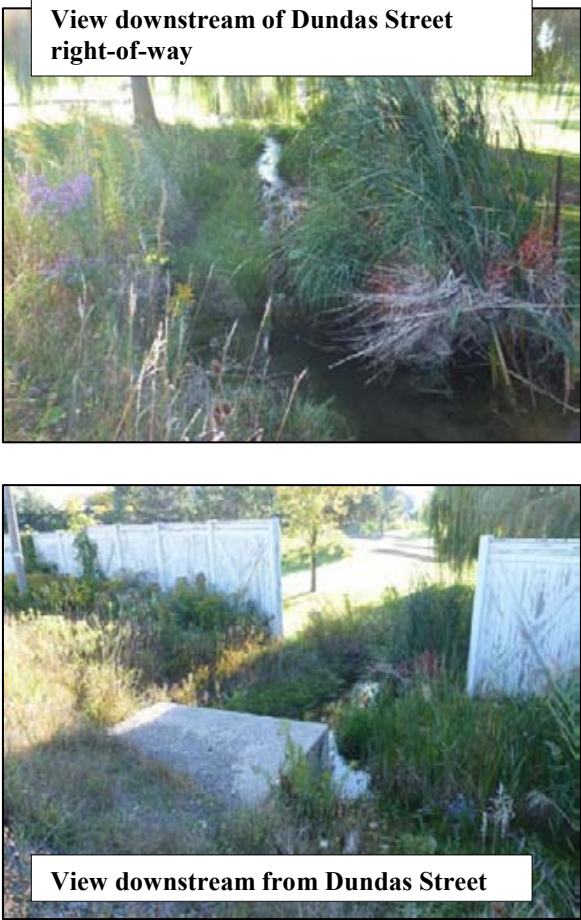
Watercourse	Sheldon Creek

Culvert ID	C13		
Location	Downstream		
Function	Transfer		
Process	Stable		
Stability Index	0.04	In regime	
Conservation Status	5		
Bankfull width (m)	1.5 (adjusted)		
Channel geometry	Straight		
The existing culvert outlets to a modified road right-of-way past a wooden fence and into a golf course. The channel is locally over-widened at the culvert outlet to 2.5 m. This area has stable banks lined with rounded river stone and deposition is occurring on the bed. The culvert is well aligned with channel.			
Downstream of the fence line the planform has been straightened, but small-scale sinuosity is developing as the channel adjusts. The channel has pool-riffle morphology. The bankfull width is 1.2-1.7 m which appears to have narrowed since the realignment. Banks are 0.25 m high and have a gentle slope. The bed is composed of gravel and the banks are gravel and earth. Currently, the reach appears to be stable.

Erosion Risk	Low -Stable channel with erosion protection

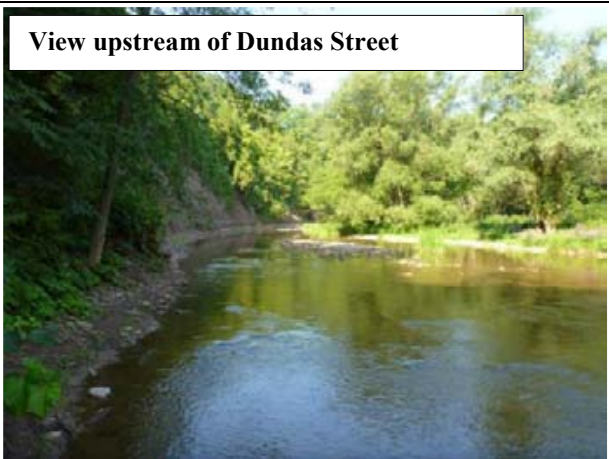
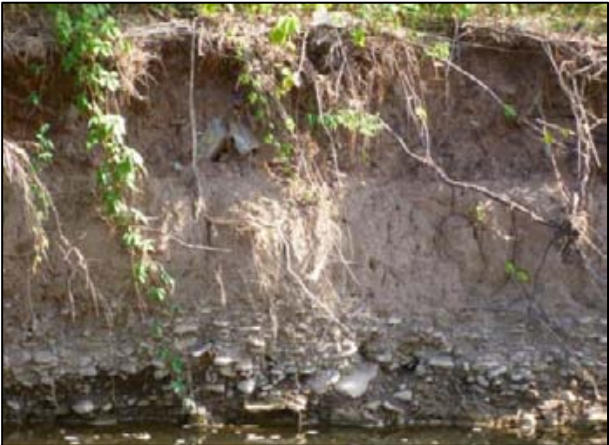
There is a high supply of sediment to the system both from upstream and colluvial sources within the study reach. There are numerous depositional features in the vicinity of Dundas Street. These include point bars, mid channel bars and side bars comprised of material ranging from fines to cobble size. These depositional features are semi-permanent in nature, they are typically partly vegetated and the larger gravel to cobble sized material is made cohesive with fine material. Due to the confined nature of the valley lateral adjustment of the creek would be limited over time, however, immediately upstream of the existing road crossing the bank is actively eroding. The existing bridge structure has minimal impact on the system. There is scour

Eroding bank comprised of glacial till and clay layers

<p>present around the pier of the watermain bridge.</p> <div data-bbox="191 306 792 359" style="border: 1px solid black; padding: 2px;"> <p>View downstream of Dundas Stream</p> </div>

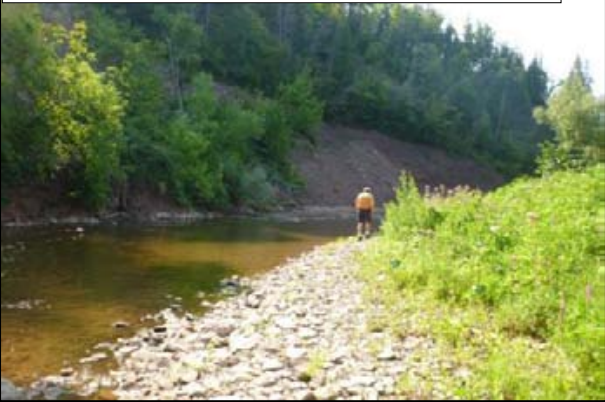
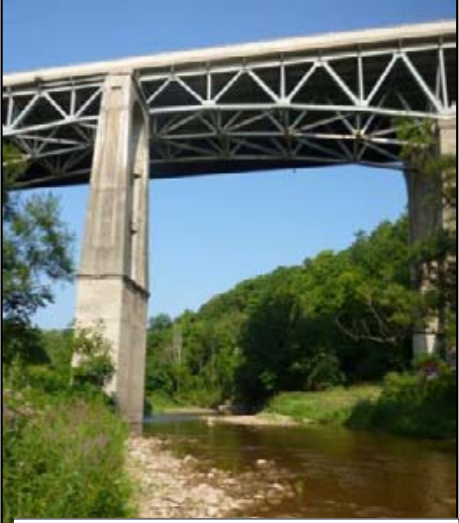
<div data-bbox="911 716 1354 793" style="border: 1px solid black; padding: 2px;"> <p>View upstream to Dundas Street crossing</p> </div>
<p>Erosion Risk</p>	<p>Moderate -Actively eroding bank immediately upstream of existing Dundas Street crossing - Not high risk as is located in confined valley</p>

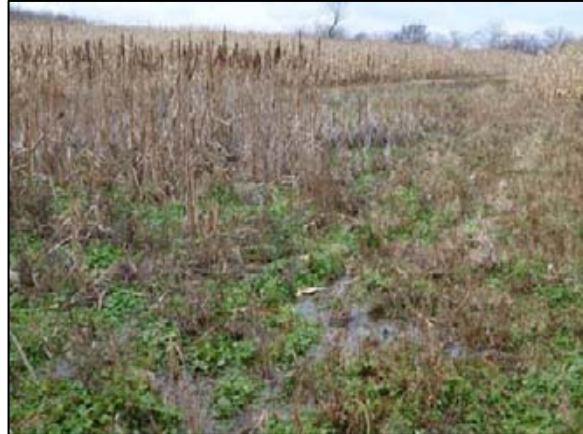
Watercourse	Tributary to Fourteen Mile Creek	
Culvert ID	C20	
Location	Upstream	
Function	N/A	
Process		
Stability Index		
Conservation Status		
Bankfull width (m)		
Channel geometry		
This reach is a swale with no formal channel.		
Erosion Risk	Low

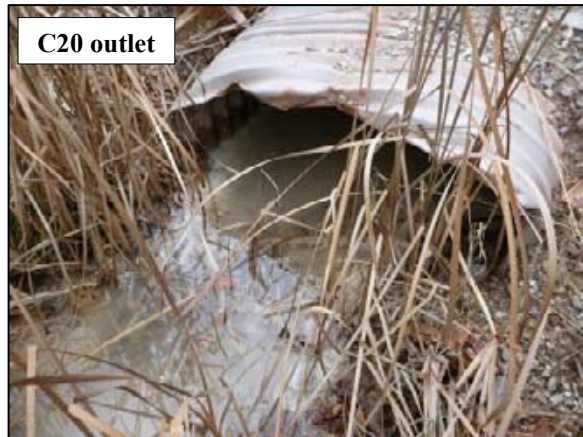
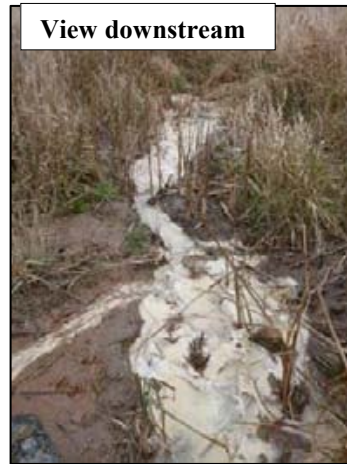
Watercourse	Tributary to Fourteen Mile Creek	
Culvert ID	C20	
Location	Downstream	
Function	Transfer	
Process	Stable	
Stability Index	0.07	In regime
Conservation Status	2	
Bankfull width (m)	1.5	
Channel geometry	Straight	
Downstream of C20 is a poorly defined channel partially choked with reeds. The channel is 1.5 m wide and 0.15 m deep, with gentle banks composed of silt and clay. The reach is stable. At the time of survey, the water contained yellow algae although it was not stagnant.		
Erosion Risk	Low

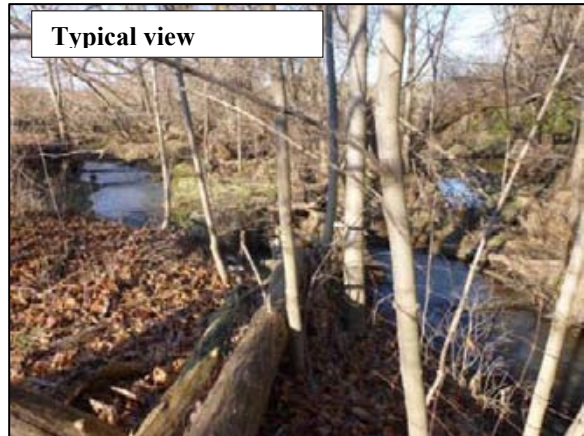
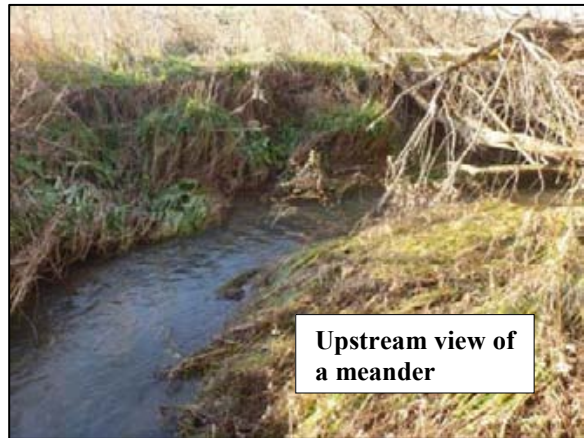
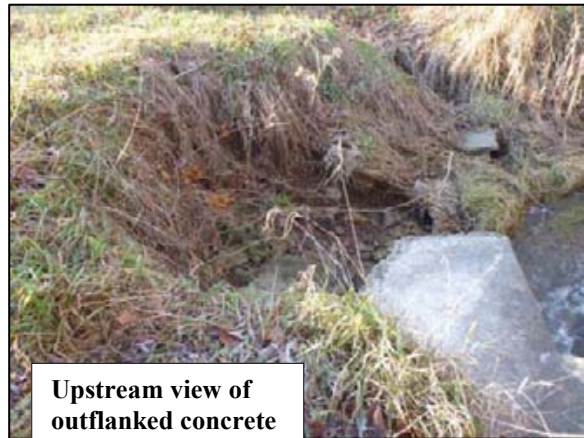
Watercourse	Fourteen Mile Creek West Tributary	
Culvert ID	C22	
Location	Upstream of Dundas ROW	
Function	Exchange	
Process	Lateral adjustment	
Stability Index	0.24	Transitional
Conservation Status	7	
Bankfull width (m)	3.0	
Channel geometry	Irregularly meandering	
<p>Located immediately approximately 50 m upstream of Dundas Street (upstream of the reach adjacent to the C22 inlet) this reach retains many natural features and fluvial processes.</p> <p>The channel has an irregularly meandering planform and is well connected to the floodplain, particularly on the left bank where a back water channel has developed. The reach is located in a shallow V-shaped valley and has a well-established riparian corridor with large woody debris and overhanging vegetation. The stream gradient is moderate.</p> <p>The reach has pool-riffle morphology and is laterally adjusting. The channel bed is composed of gravel and cobbles while banks are composed of shale, cobble and clay. The cross section of the channel varies with planform; on the inside of bends banks are gentle (bank height is 0.4 m) while the on the outside of the bend banks are steep (bank height is 0.8 m). This reach would be a suitable reference reach for the reach adjacent to the C22 inlet.</p> <p>At the downstream extent of the reach the channel has outflanked the start of the concrete wall bank protection by approximately 2 m. The natural bank materials include fine-grained till with fragments of weathered shale. The outflanking has occurred on the outside of a</p>

meander and therefore is in keeping with the natural fluvial processes upstream.	
Erosion Risk	Moderate - Reach is laterally adjusting but is upstream of the proposed works

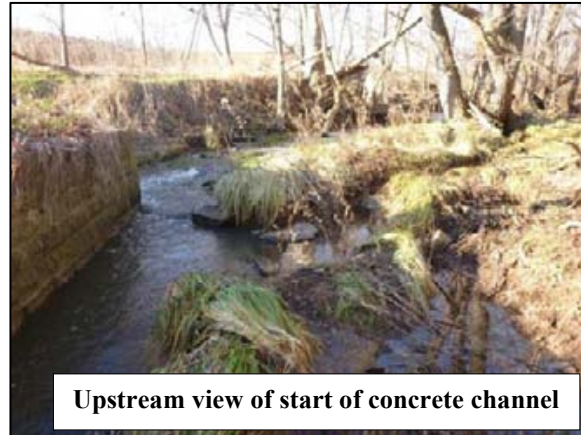
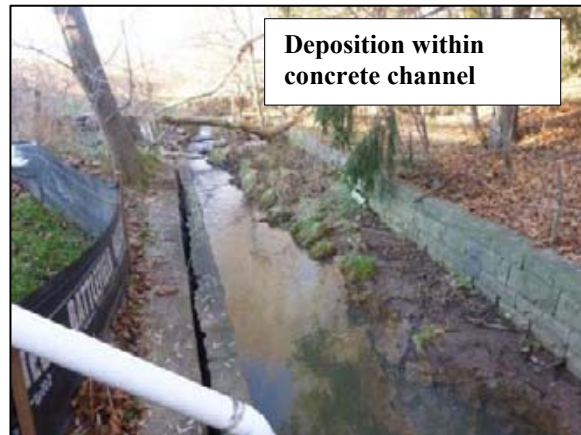
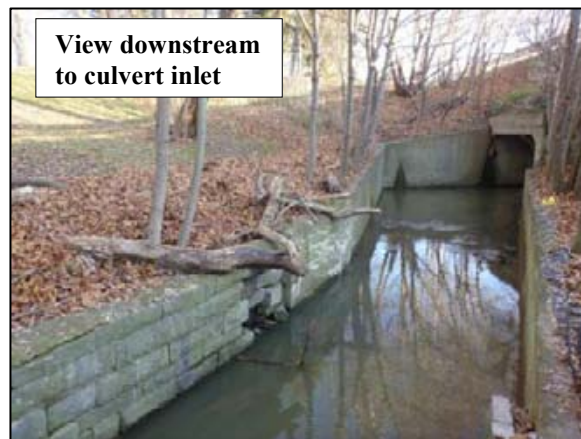
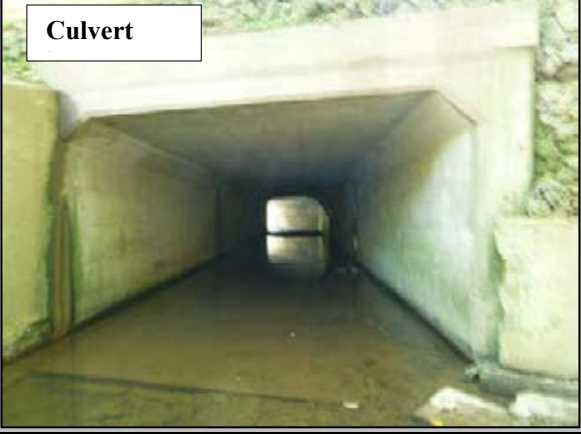
This reach is located immediately upstream of Dundas Street. The channel has been realigned into a straight concrete channel. Several concrete blocks are missing and both walls show signs of losing structural integrity. At the upstream extent of the reach, the concrete wall lining the right bank has been outflanked. Concrete bank height varies from approximately 1.0 m at the upstream extent to 1.8 m near the culvert due to change in the elevation of the stream bed (the channel gradient is fairly high). The bed is lined with concrete and partially covered with deposited sediment.

A 20 m long partly vegetated bar has developed along the left (east) bank in the concrete channel. This deposit appears to be semi-permanent indicating that the concrete channel is likely over wide for the flow and sediment regime. The concrete channel is over-wide compared to the natural channel upstream. In the larger context of the meander pattern this deposit would be a point bar. Along the right bank, which is the natural direction of lateral migration, the stream bed is scoured and the wall is undercut by over 0.2 m. As such the reach is attempting to adjust laterally through

<p>deposition on the left bank and erosion on the right bank. Due to the hard bed and bank this process is very slow. The depositional bar feature has created a narrower low flow channel.</p> <p>The existing culvert angle is out of alignment with the channel's course and the channel turns abruptly south to flow under Dundas Street.</p>

<p>Erosion Risk</p>	<p>High -Possibility of outflanking/ undercutting new structures</p>

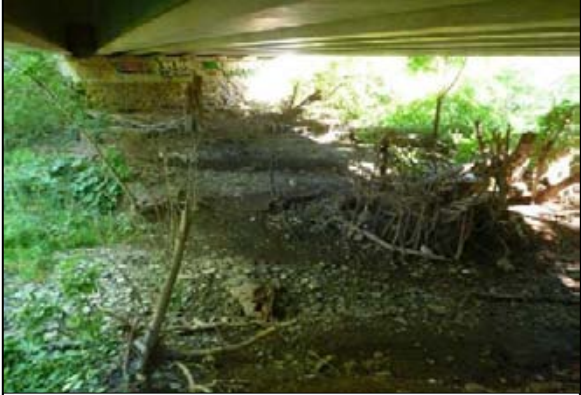
Watercourse	Fourteen Mile Creek Tributary West	
Culvert ID	C22	
Location	Downstream	
Function	Exchange	
Process	Lateral adjustment	
Stability Index	0.18	In regime
Conservation Status	4	
Bankfull width (m)	6.0 (modified) 3.0 (representative)	
Channel geometry	Straight with developing sinuosity	
<p>This reach extends from Dundas Street to the Colonel William Parkway bridge. The channel lies within a steep, asymmetric forested valley and is constrained by a very steep right bank and a moderately steep left bank near Dundas Street. Near the Colonel William Parkway bridge, the channel has better floodplain connectivity on the left bank. The channel has been realigned.</p> <p>The culvert outlet is perched by approximately 0.3 m. Near Dundas Street, the channel appears to have been widened (up to 6 m wide) and straightened and has yet to recover a more natural planform and cross section. Near the bridge the channel contains vegetated mid-channel bars and silt deposits and appears to be narrowing. Beneath the bridge flow is split. The main channel, where present, is 2.5-3.5 m wide. It is actively adjusting and has a meandering planform, undercut banks and a moderate gradient. The substrate includes gravel, silt and shale fragments.</p>

<p>View beneath Colonel Williams Parkway</p>

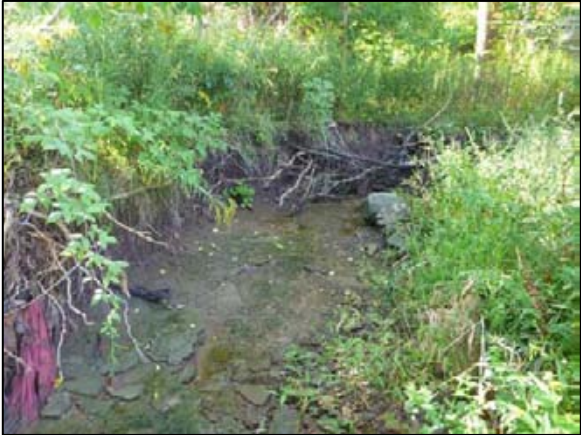
<p>View downstream from C22 outlet</p>		
Erosion Risk	Moderate

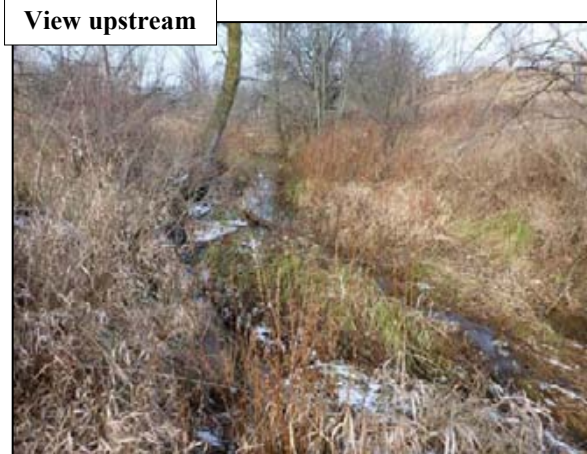
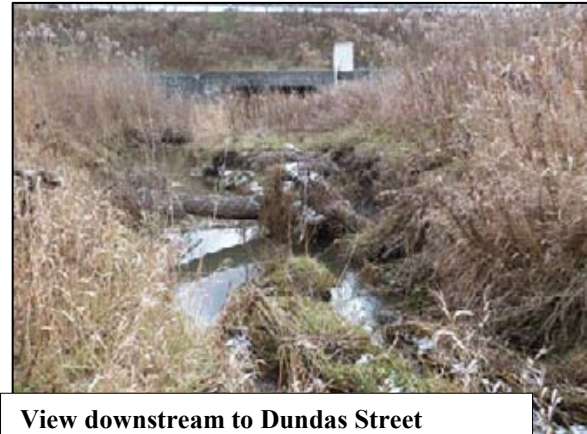
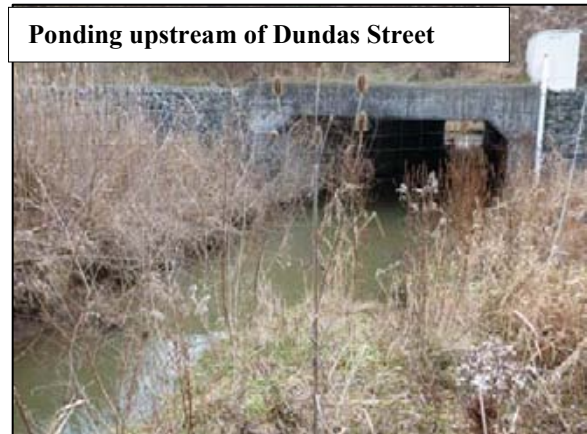
Watercourse	Fourteen Mile Creek	
Culvert ID	C23	
Location	Upstream	
Function	Source	
Process	Incision and widening	
Stability Index	0.49	Adjusting
Conservation Status	5	
Bankfull width (m)	1.8	
Channel Geometry	Irregular meandering	
<p>The channel is not in dynamic equilibrium, it is adjusting to modifications including changes in hydrology. Downcutting and widening are the predominant fluvial processes with frequent bank slumping as a result. This has led to spilt flow in some locations. Typically the channel pattern varies from narrow steeper sections (often with slumped banks) to wide pools. Banks are often undercut and are composed of clay. The bed is a mixture of gravel, sand and silt. Several knickpoints are present through the reach.</p> <p>The riparian corridor is fragmented with scattered trees lining the channel. In places large woody debris is influencing fluvial processes and pools are present as a result. The channel is generally confined, especially on the left bank.</p> <p>The existing Dundas Street culvert is influencing the channel. It is causing ponding upstream. There is no low flow channel through the culvert.</p>

Erosion Risk	<p>Low – moderate -The channel is adjusting and erosion is present, however, immediately upstream of the culvert the channel is ponded</p>

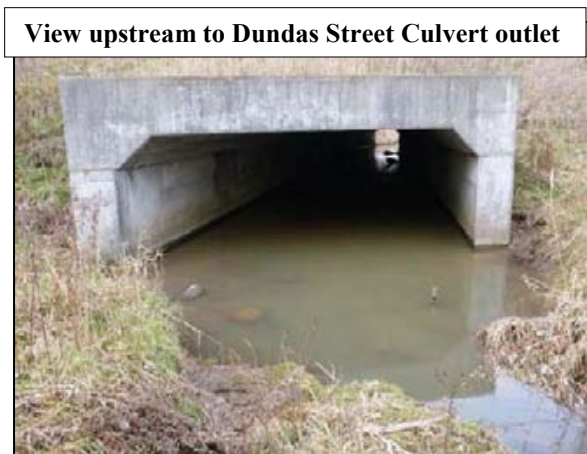
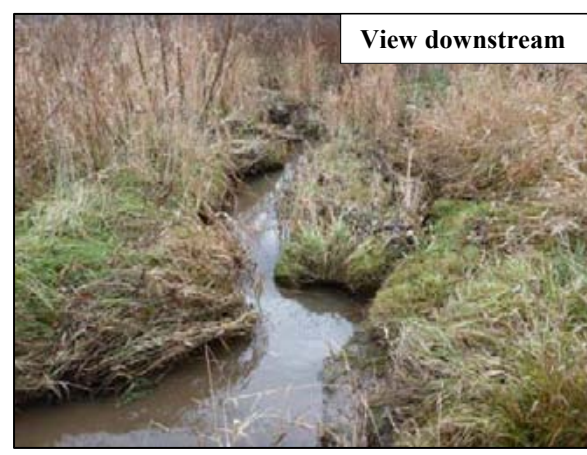
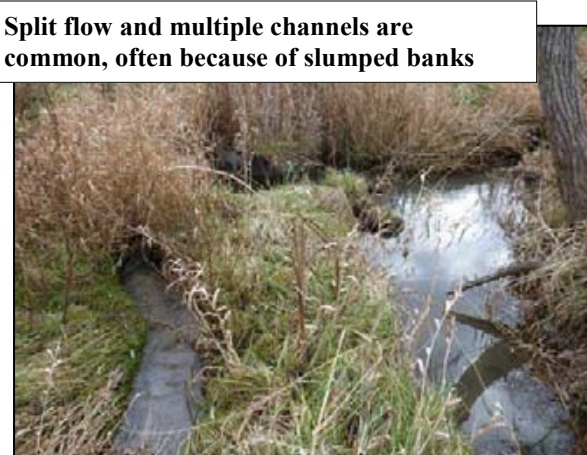
Watercourse	Fourteen Mile Creek	
Culvert ID	C23	
Location	Downstream	
Function	Source	
Process	Lateral adjustment	
Stability Index	0.39	Transitional
Conservation Status	5	
Bankfull width (m)	1.8	
Channel geometry	Regular meandering	
<p>Downstream of the culvert a scour pool has formed and the culvert is outflanked by approximately 0.5 m on both banks. It appears that the stone protection placed in the scour pool is mobile.</p> <p>The channel is transitional and areas of split flow are frequent. Bank material is predominantly clay with some silt. Bank slumps occur throughout the reach and banks are often held together by grass roots. Bed material is a mixture of gravels, cobble and sand.</p> <p>The channel is well connected to the floodplain and evidence of overbank flows was observed throughout the reach. The riparian corridor is fragmentary with very few trees.</p>		
Erosion Risk	<p>Low – Moderate -Erosion is frequent but channel is well connected to the floodplain</p>
