3. EXISTING AND FUTURE CONDITIONS

The study area focuses on Dundas Street from Brant Street to Bronte Road, and is located within the City of Burlington and the Town of Oakville in Halton Region. **Exhibit 1-3** provides a key plan of the study area. **Exhibit 3-1a** to **3-1c** are aerial mosaic of the study area identifying existing conditions and key features which are discussed in the following sections.

DUNDAS STREET CLASS EA STUDY
Brant Street to Bronte Road

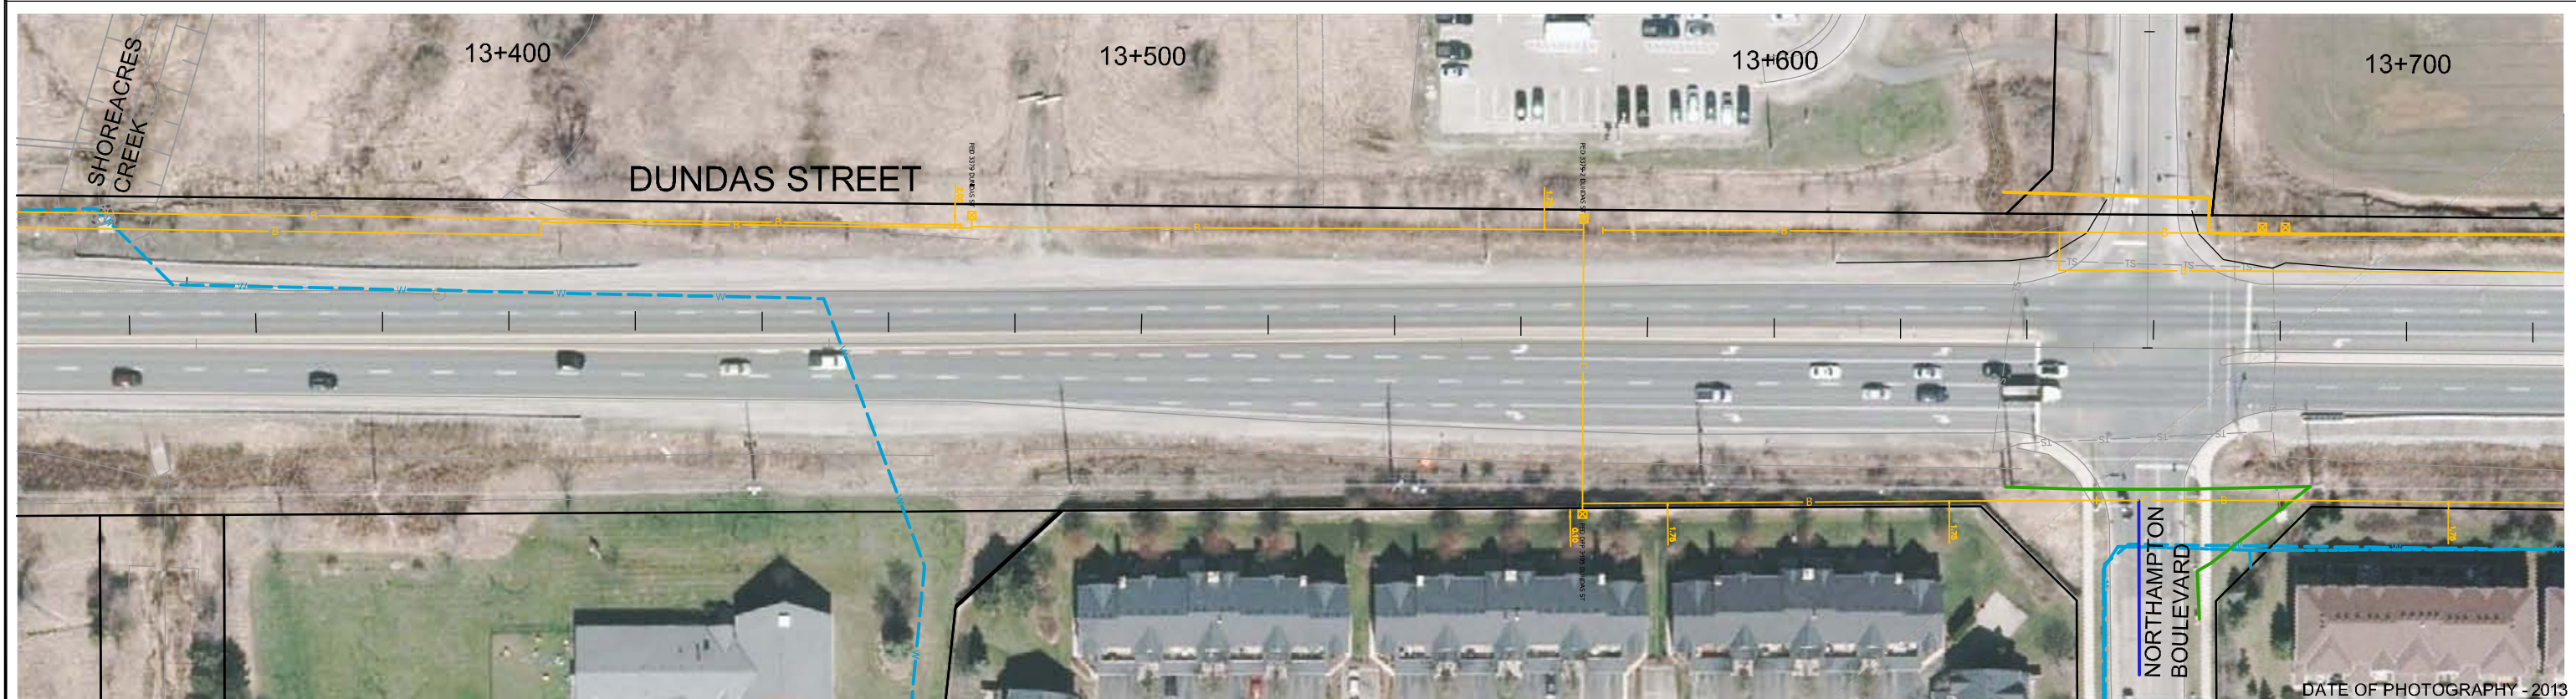
PLATE
3-7e

**DUNDAS STREET - UTILITY PLAN
FROM STA. 12+960 TO STA. 13+720**

Existing utilities are shown in **Exhibits 3-7a to 3-7n**.

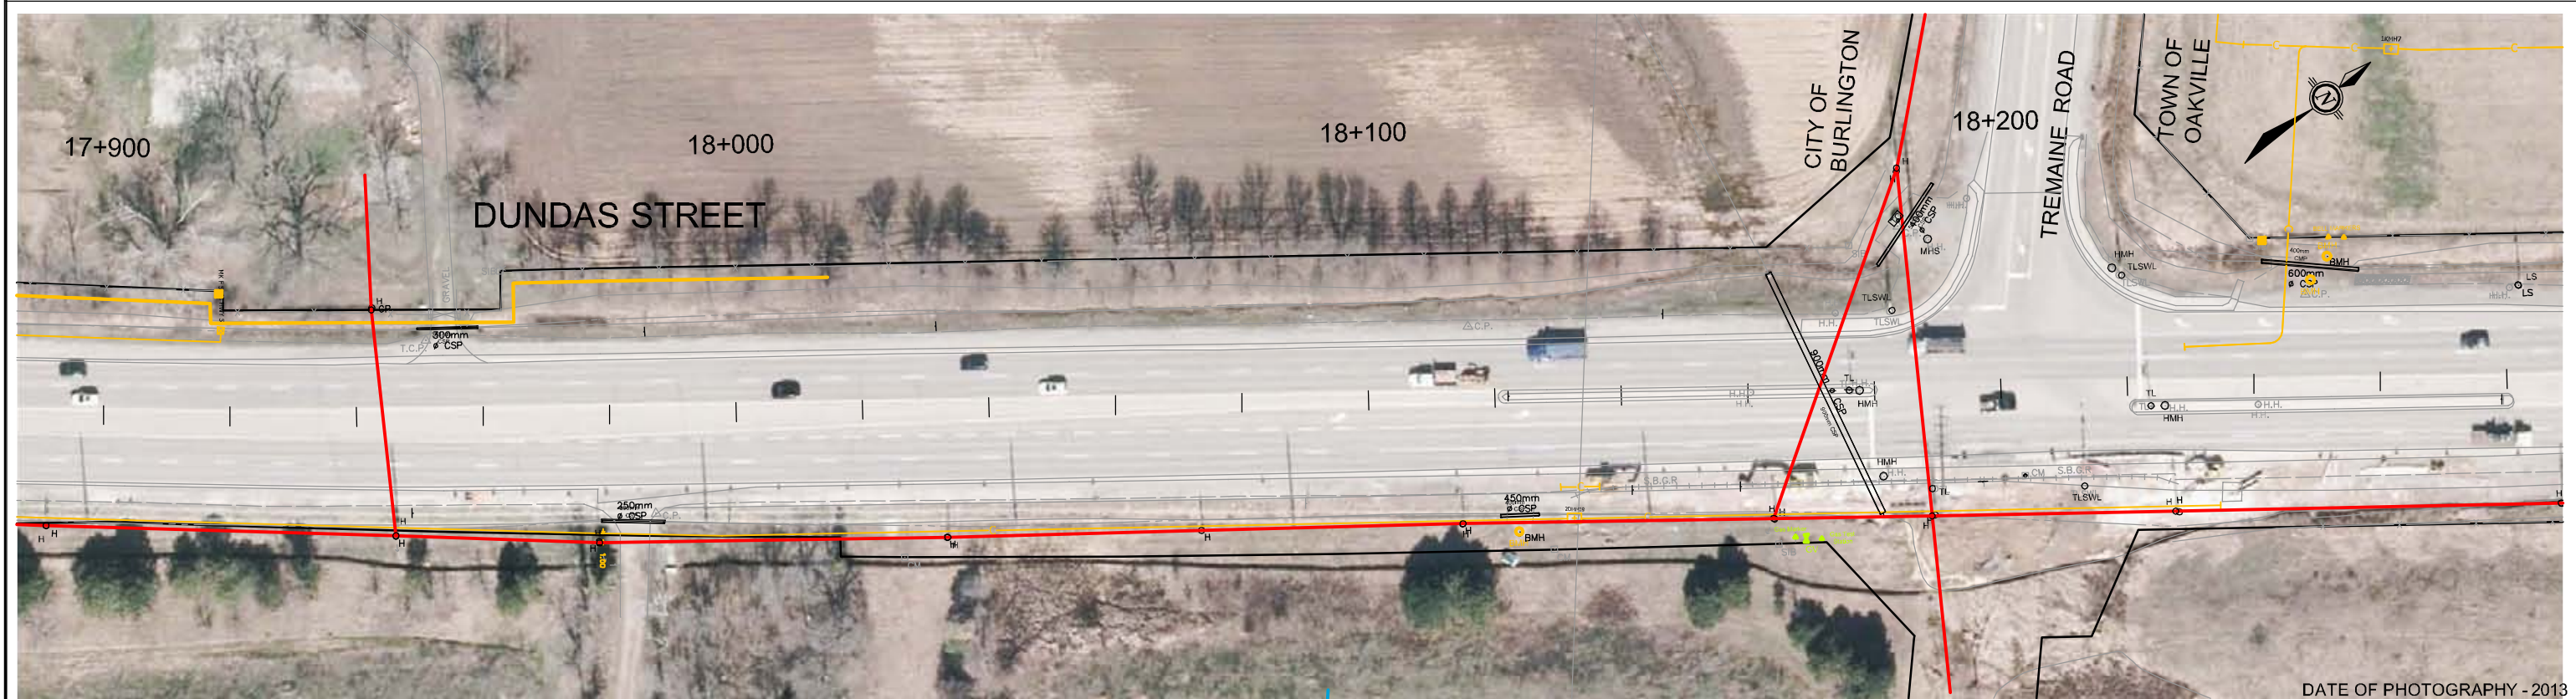
PLATE
3-7j

DUNDAS STREET - UTILITY PLAN
FROM STA. 17+520 TO STA. 18+280
