Project No. 04-1111-052

April 23, 2009

SITE RECONNAISSANCE FOR PROPOSED NEW NORTH OAKVILLE TRANSPORTATION CORRIDOR ENVIRONMENTAL ASSESSMENT NEW BURNHAMTHORPE ROAD OVER SIXTEEN MILE CREEK OAKVILLE, ONTARIO

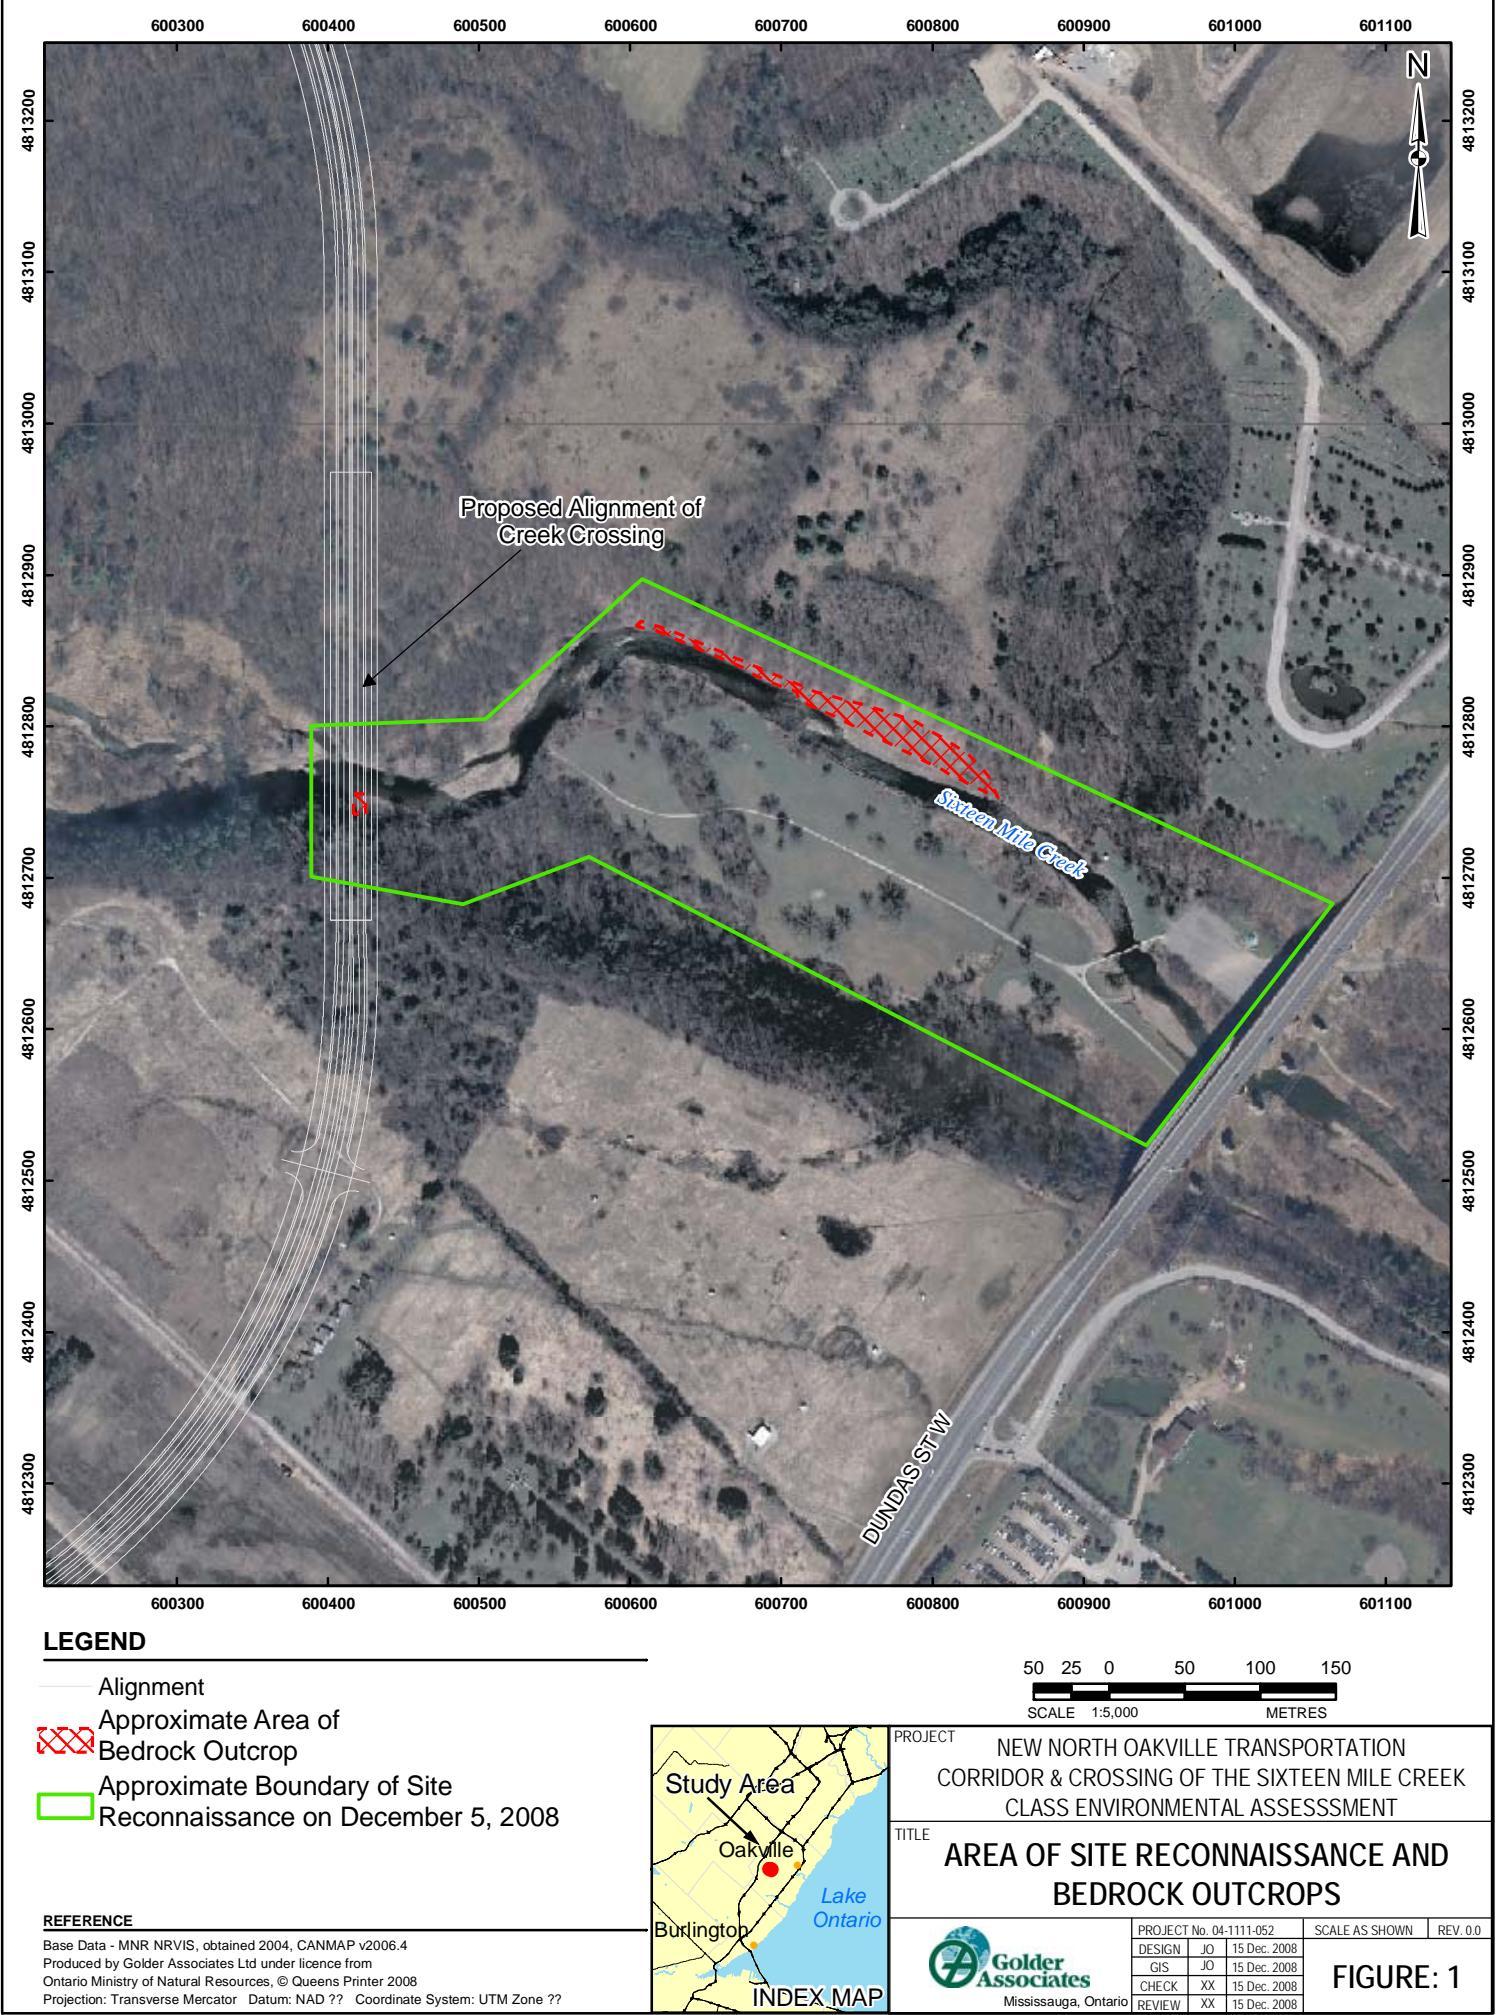
The approximate boundary of site reconnaissance completed on December 5, 2008 is shown on Figure 1. Both side slopes of the Sixteen Mile Creek valley are generally densely vegetated in the Lions Valley Park. Based on the available overburden in the valley generally consists of unsorted, unstratified heterogeneous mixtures of clayey silts, sands and gravels of glacial till origin. The overburden varies in thickness at different areas but is typically less than a few metres.

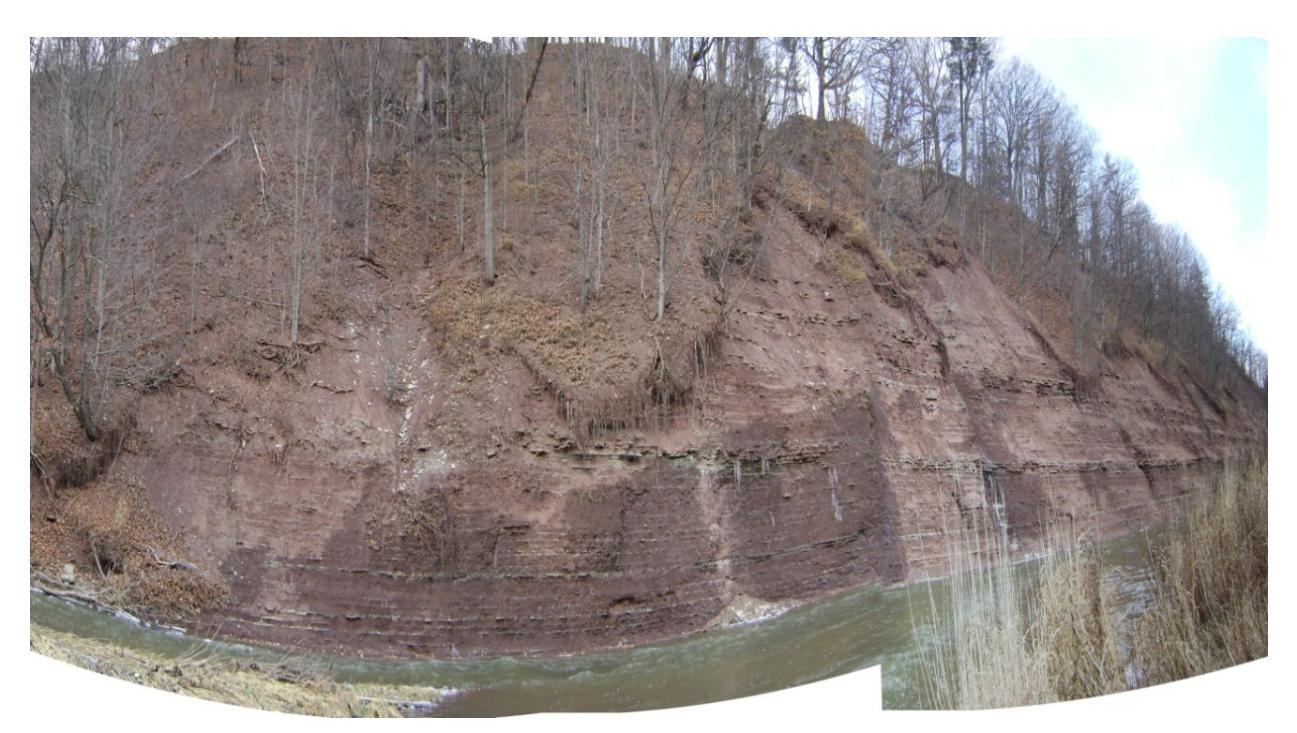
Photo 1 Bedrock Outcrop 1: North Valley Wall of Sixteen Mile Creek within the North Park

As shown on Photo 1, there is an approximately 260 m long stretch of the east/north creek valley slope within the Lions Valley Park, to the east of the proposed alignment, where the red-brown shale containing limestone/siltstone interbeds of the Queenston Formation is exposed. In the upper portion of the slope, surficial topsoil and shallow overburden overlies the shale bedrock. The lower 3 m to 5 m of the exposed bedrock slope is standing almost vertical; there are significant erosion channels formed on the slope surface.

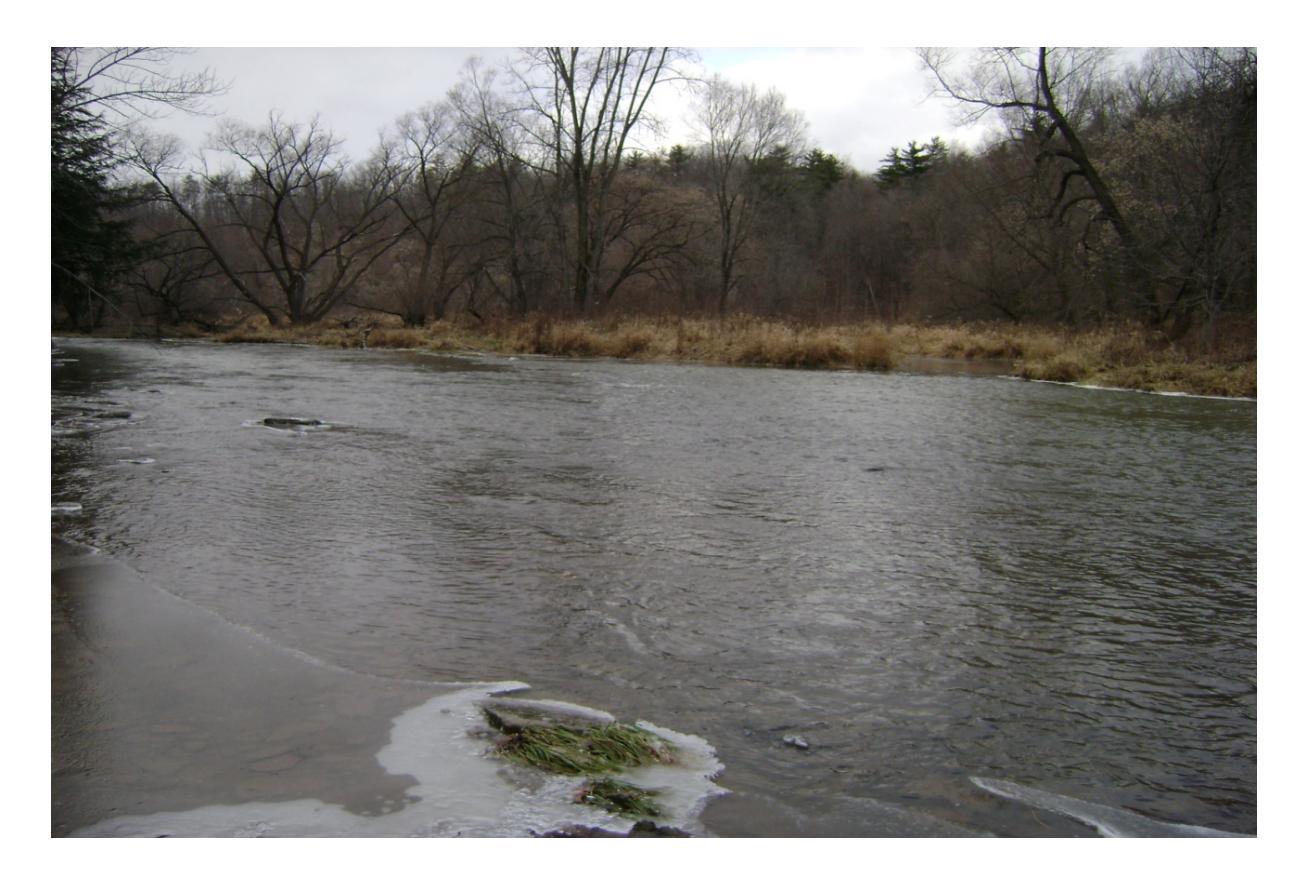
Photo 2 Dense Vegetation on North Side of Sixteen Mile Creek at the Proposed Bridge Crossing

The proposed bridge crossing Sixteen Mile Creek is located between approximately Station 13+120 and 13+420 near the point where a tributary flows into the main creek channel. The total length of the proposed four-span bridge is 280 m. The slope on the north side of the creek at the proposed creek crossing is densely vegetated as shown on Photo 2.

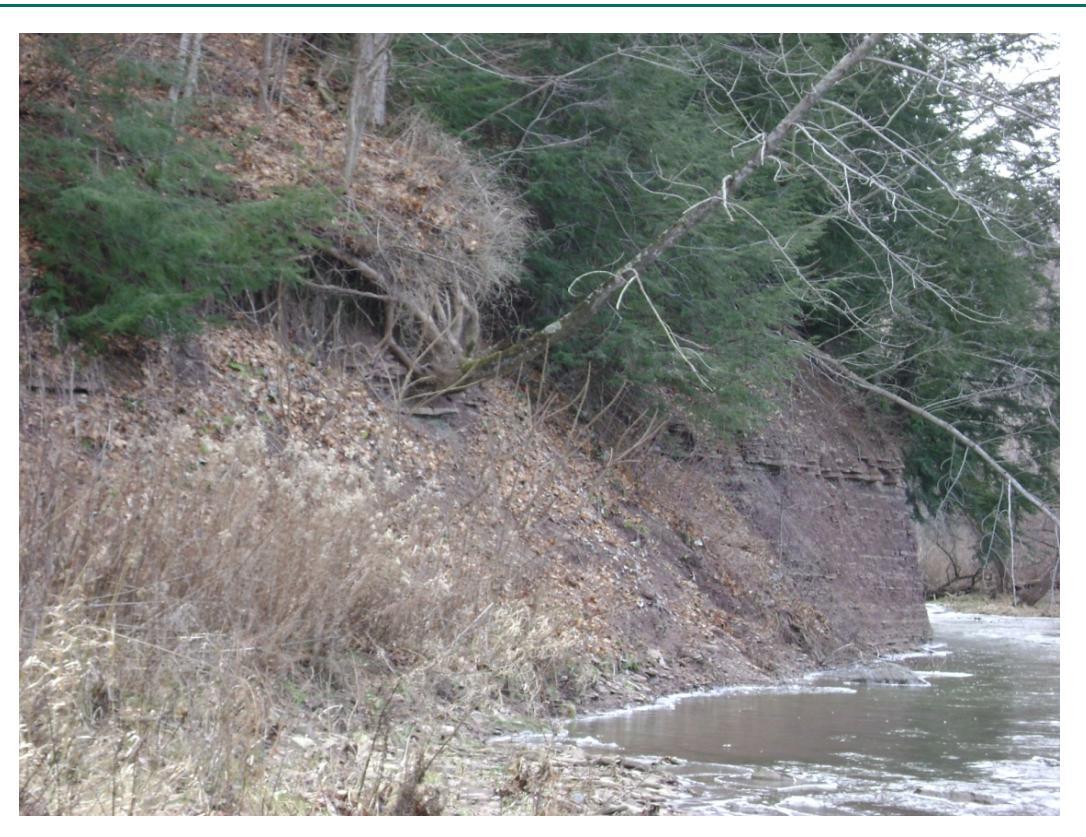
Photo 3 Exposed Bedrock at the Toe of the South Valley Wall at the Proposed Creek Crossing

The south creek valley slope at the proposed bridge crossing is also densely vegetated. The slopes are at inclinations generally ranging from 27 degrees to 32 degrees; however, there is a near vertical bedrock outcrop at the slope toe (see Figure 1 and Photo 3) where red-brown shale containing limestone/siltstone interbeds is exposed. The adjacent slopes are at inclinations of 50 degrees or steeper. Above the exposed bedrock, at heights ranging from 1.5 m to 2 m above the creek level, the overburden consist of clayey silt till underlying surficial topsoil; however, the thickness of the overburden is not known. Soils mixed with gravel, cobble, boulder and rock fragments are present at some locations in the creek bed; bedrock was not visible in the creek bed.
