RE: Burlington Quarry Extension – Nelson Response to JART’s Comments on the Visual Impact Assessment
OUR FILE 9135D

**Proposed Burlington Quarry Expansion
JART COMMENT SUMMARY TABLE – Visual Impact Assessment**

VISUAL IMPACT ASSESSMENT

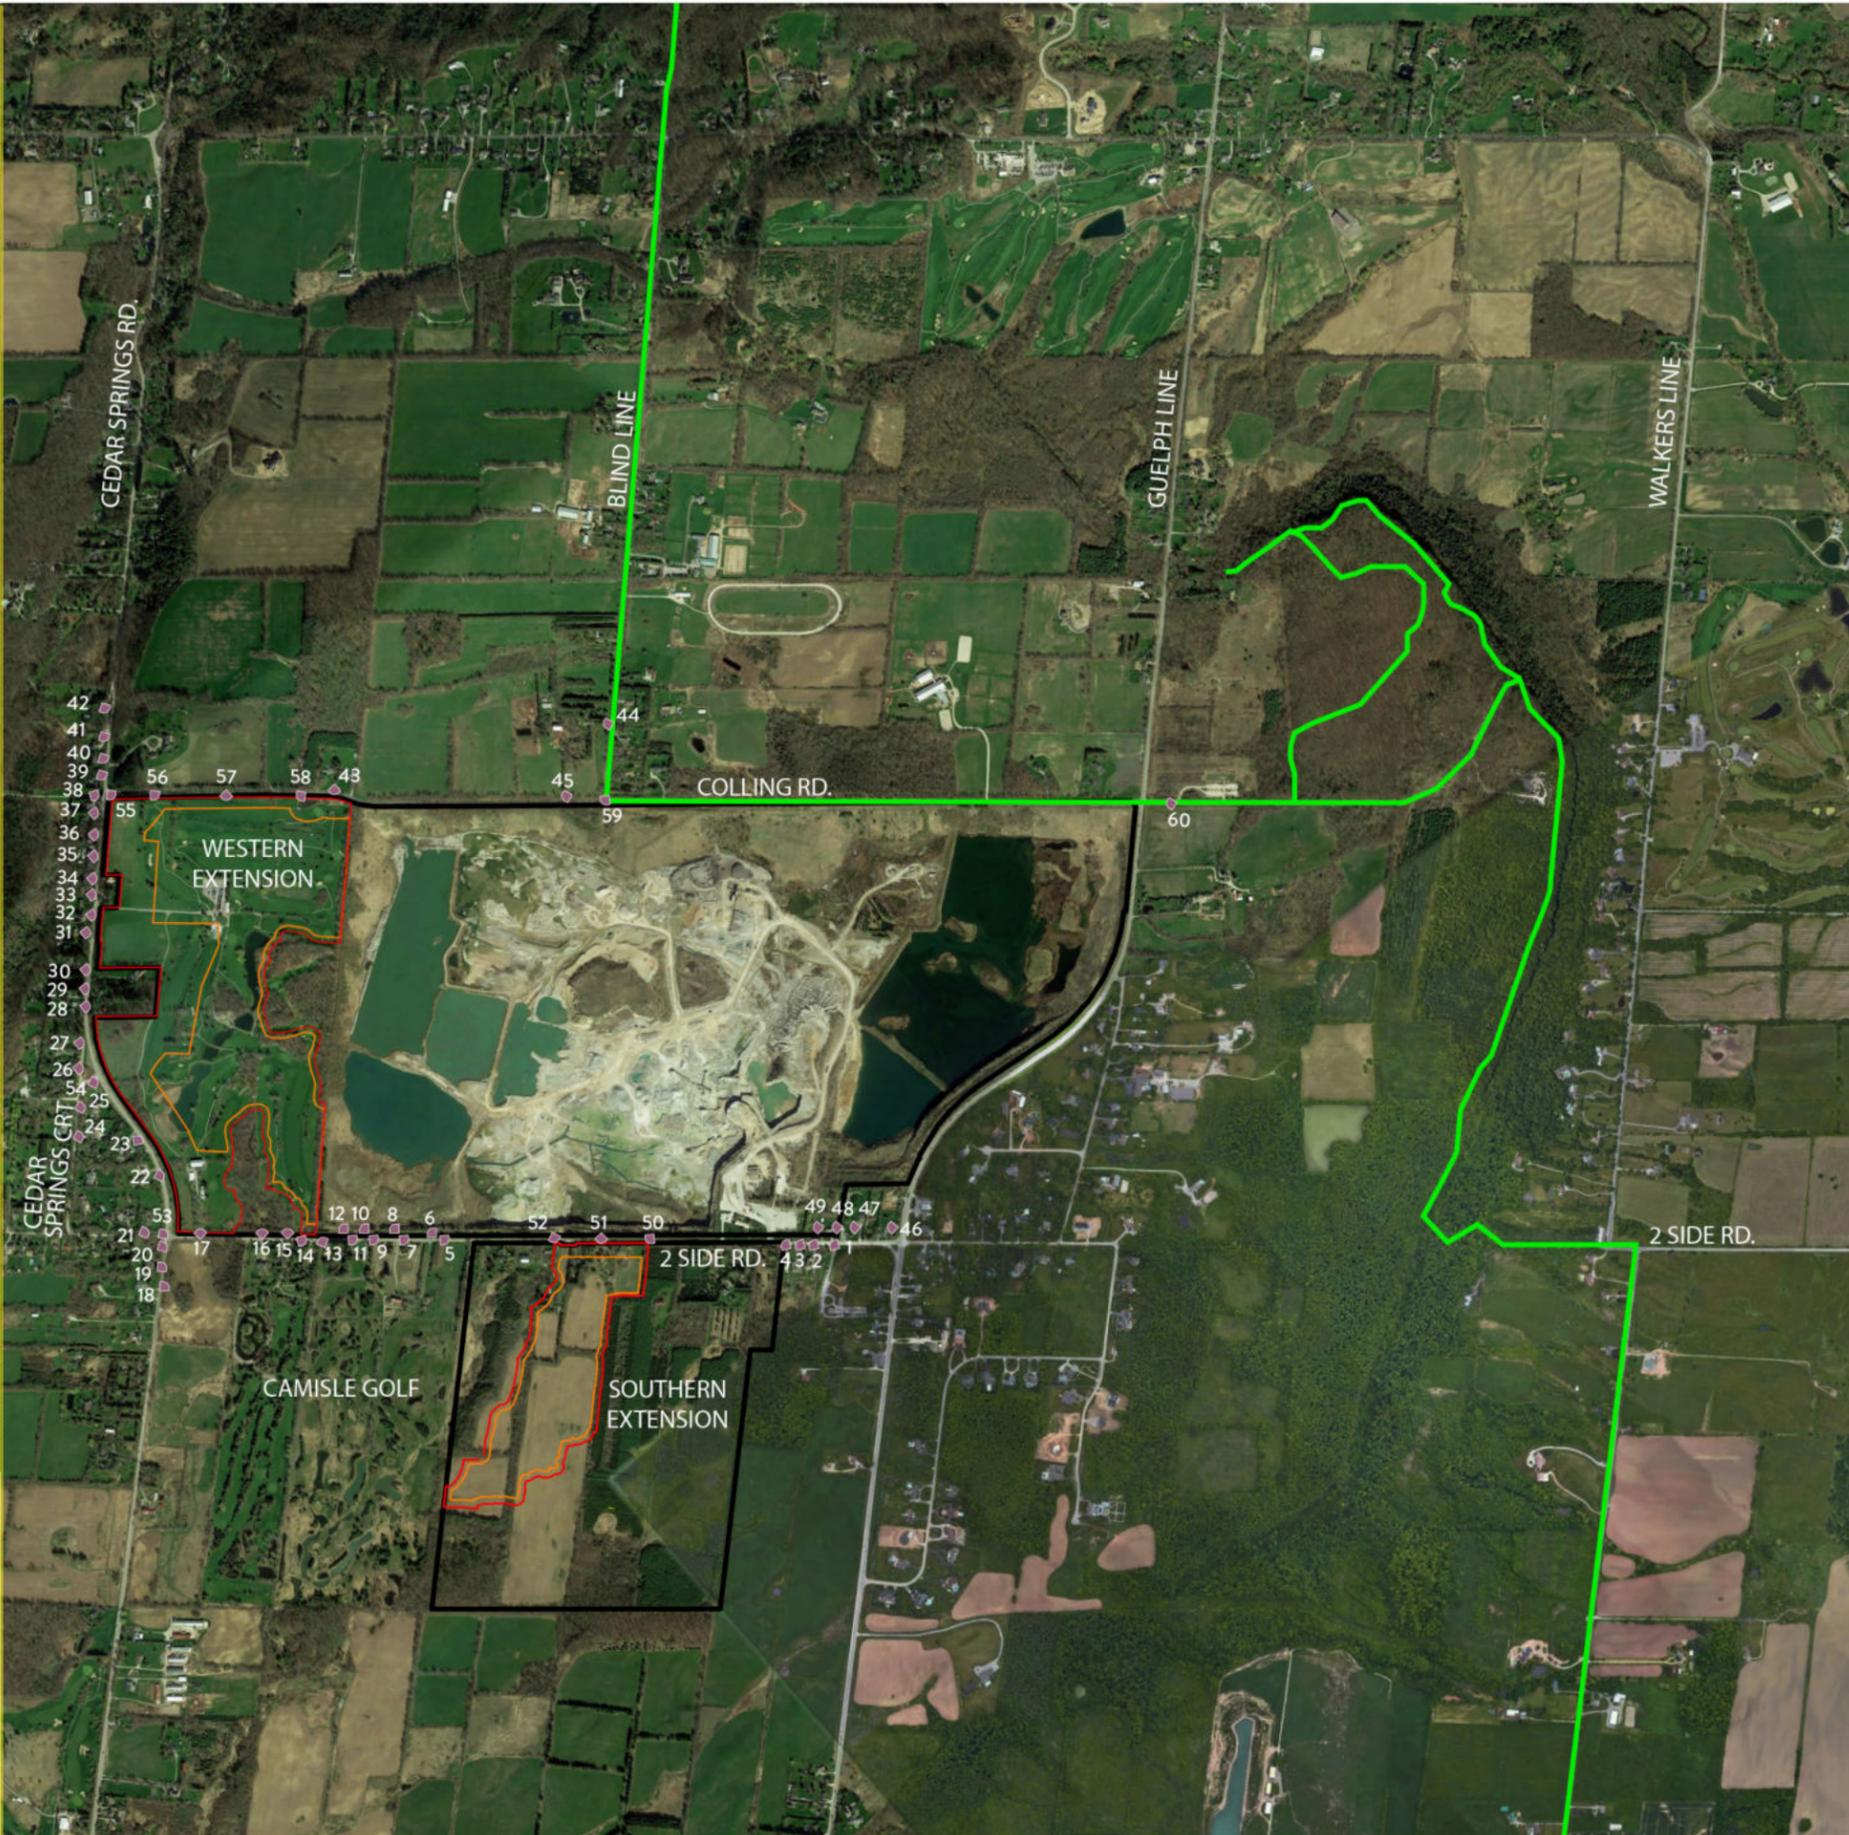
Figure 4
Assessed Views Photo Location Map

Site reviews were undertaken in Winter 2020 and Winter of 2021 during leaf-off condition to illustrate worst case scenario. The analysis and location of the 49 studied viewpoints are included in this chapter and are identified on **Figure 4 (Assessed Views Photo Location Plan), and 4A to 4P (Photo Records of Assessed Views)**. The site reviews included evaluation of potential receptors and views within 1 km of the proposed extensions and were chosen specifically in locations where visual impacts could potentially be expected. Refer to **Table 1** for a summary of the locations and associated evaluations of the identified potential receptors along the mentioned public roadways.

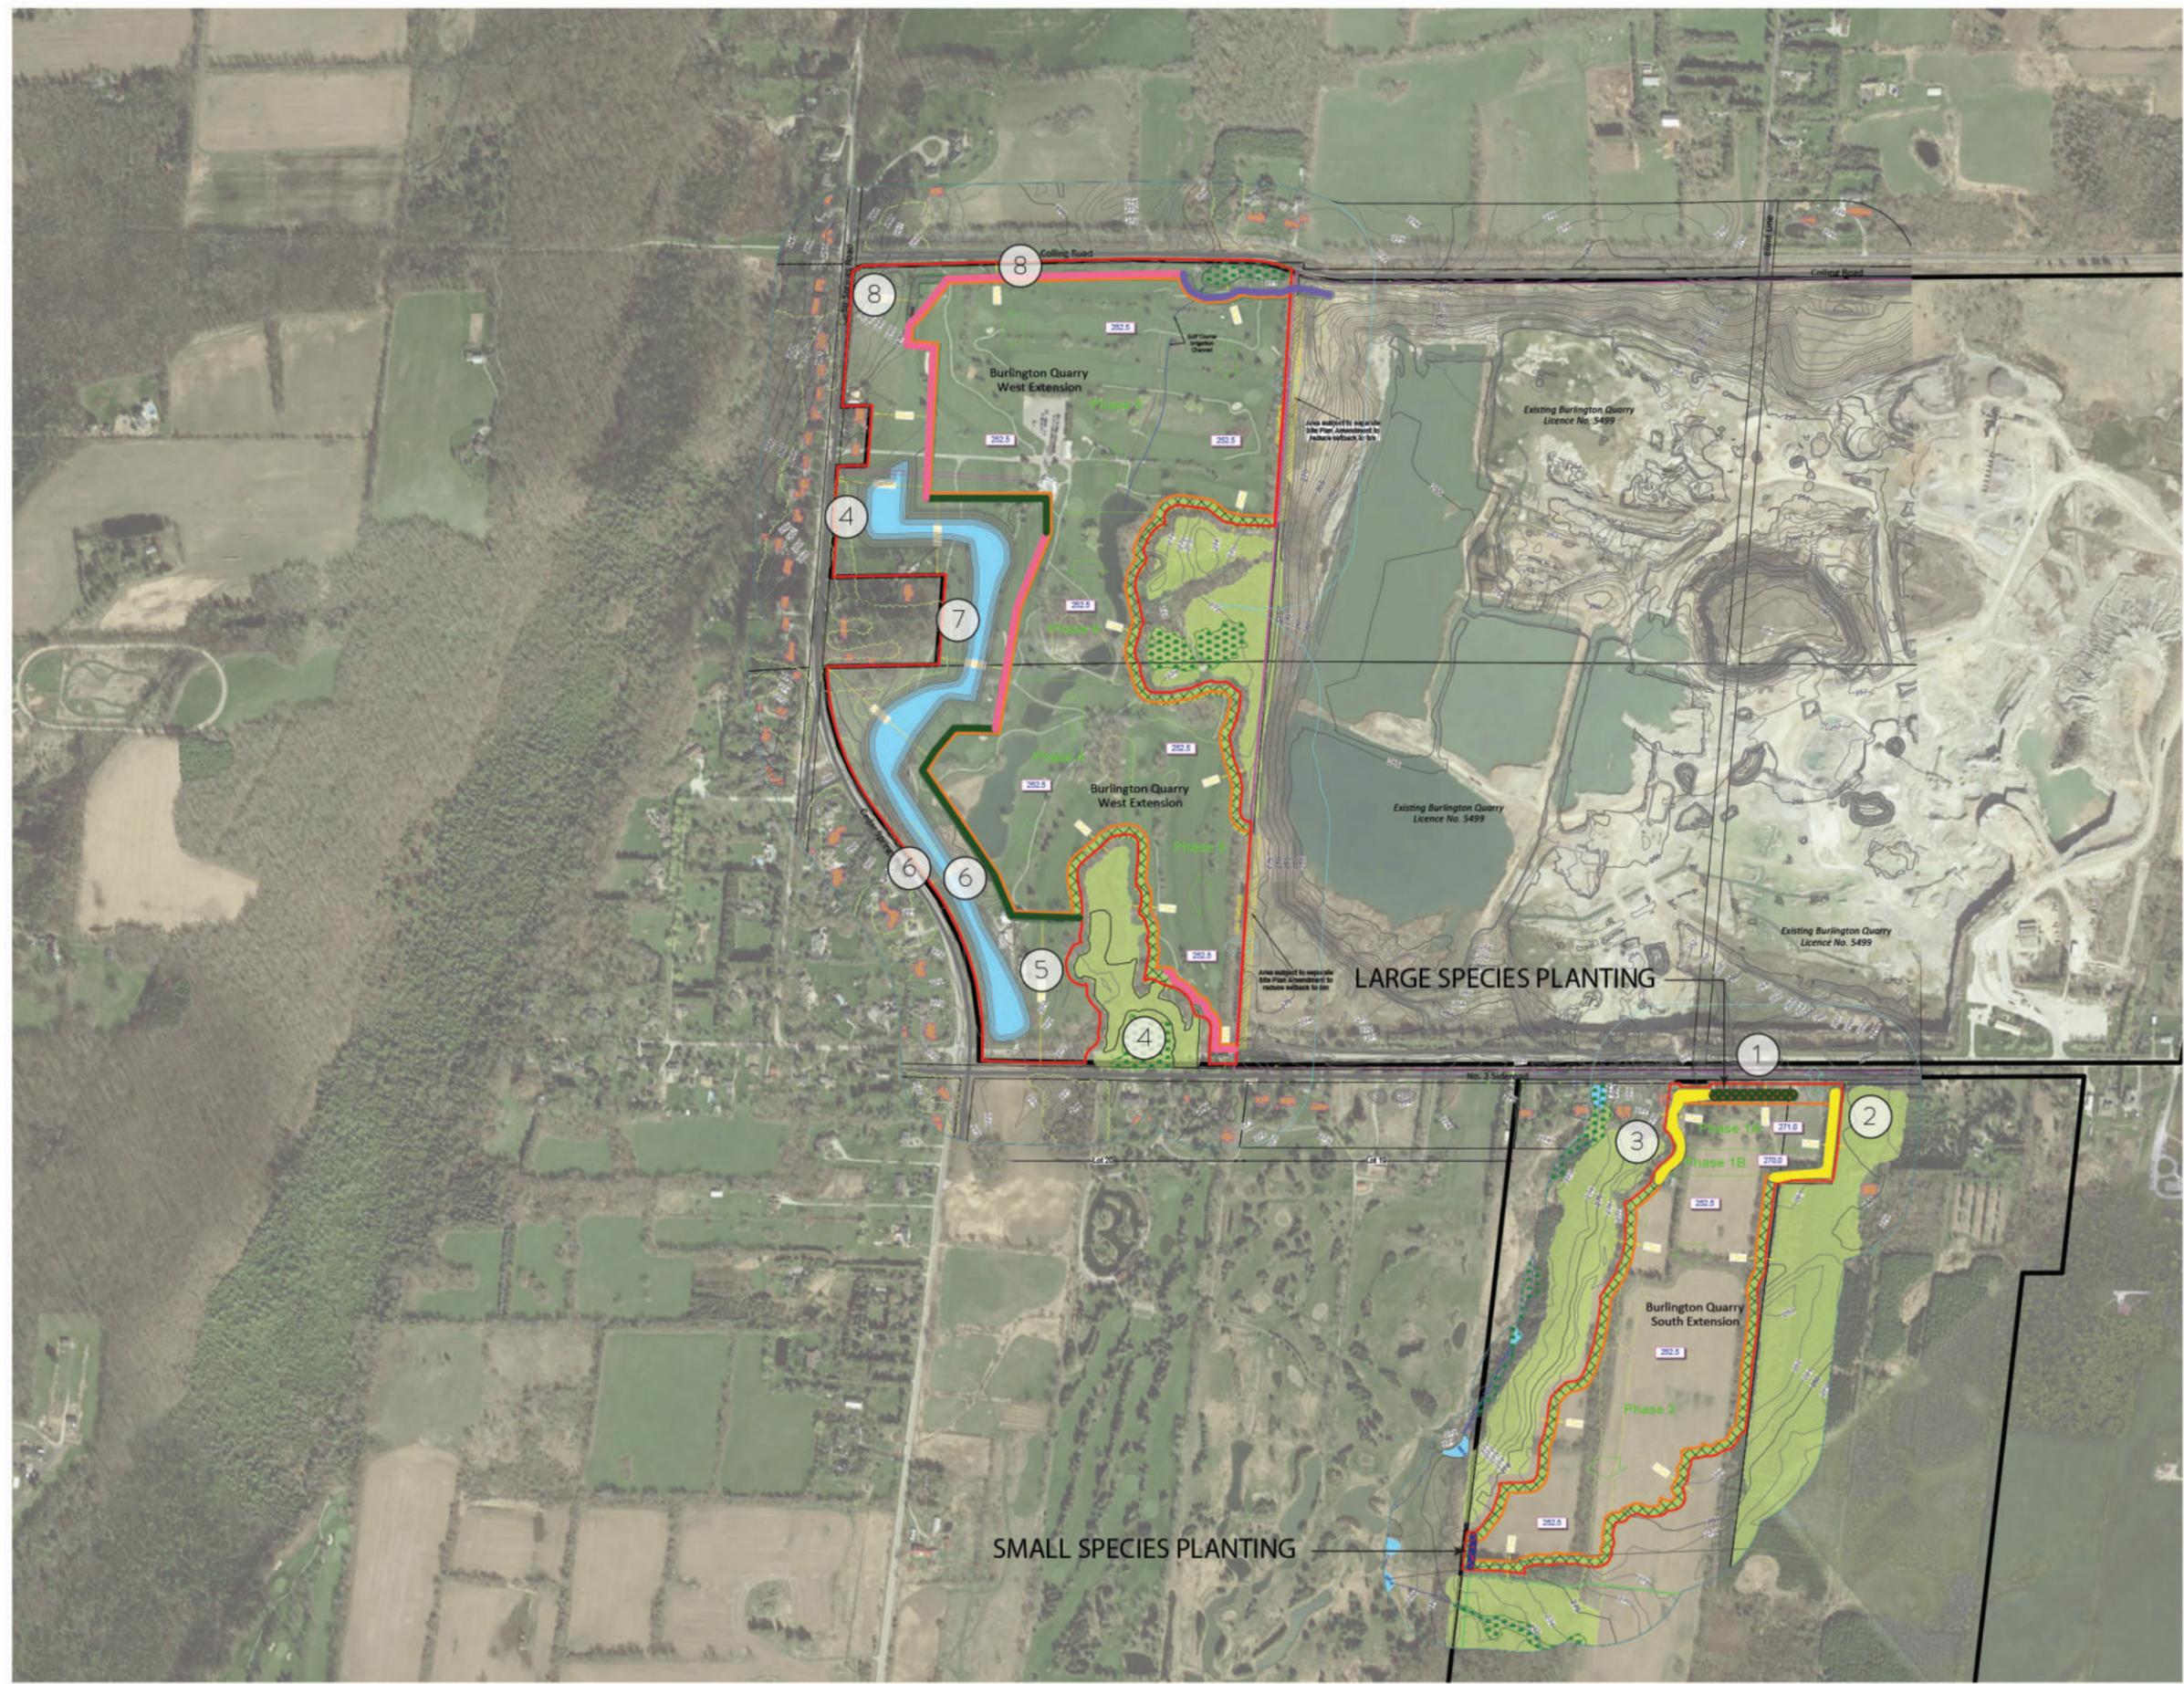
Figure 5
Mitigation Plan
 Project Sideways - Quarry Expansion
 Part Lot 1 & 2, Conc. 2 and Part Lot 17 & 18, Conc. 2,
 Town of Burlington
 Halton Region

- Subject Lands
- Extraction Limit
- Additional Lands Owned by Applicant
- Visual Berm 2.0 m
- Visual Berm 2.5 m
- Noise Berm 3 m
- Noise Berm 3.5 m
- Noise Berm 5 m
- Berm Planting (Large Species)
- Berm Planting (Small Species)
- Significant Woodland
- Woodland
- Forested Setback - During Operation
- Wetland

- b) Visual berms are to be installed as per the berm elevation detail and berm requirements as outlined in the noise report and as noted on the Mitigation Plan (**See Figure 5**).

- c) Visual berms are to be installed as outlined in this report and as noted on the Operations Plan (**See Figure 8**).
- d) Where berms are deemed to be required, they are to only be constructed where proposed (**See Figure 5**). Berms are to be constructed in a smooth, rolling manner with varying highpoints (respecting minimum height requirements), and variations along the berm frontage to create a more natural appearance. Berms should be seeded with a naturalizing mix of wildflowers and grasses to stabilize slopes and minimize mowing and maintenance.

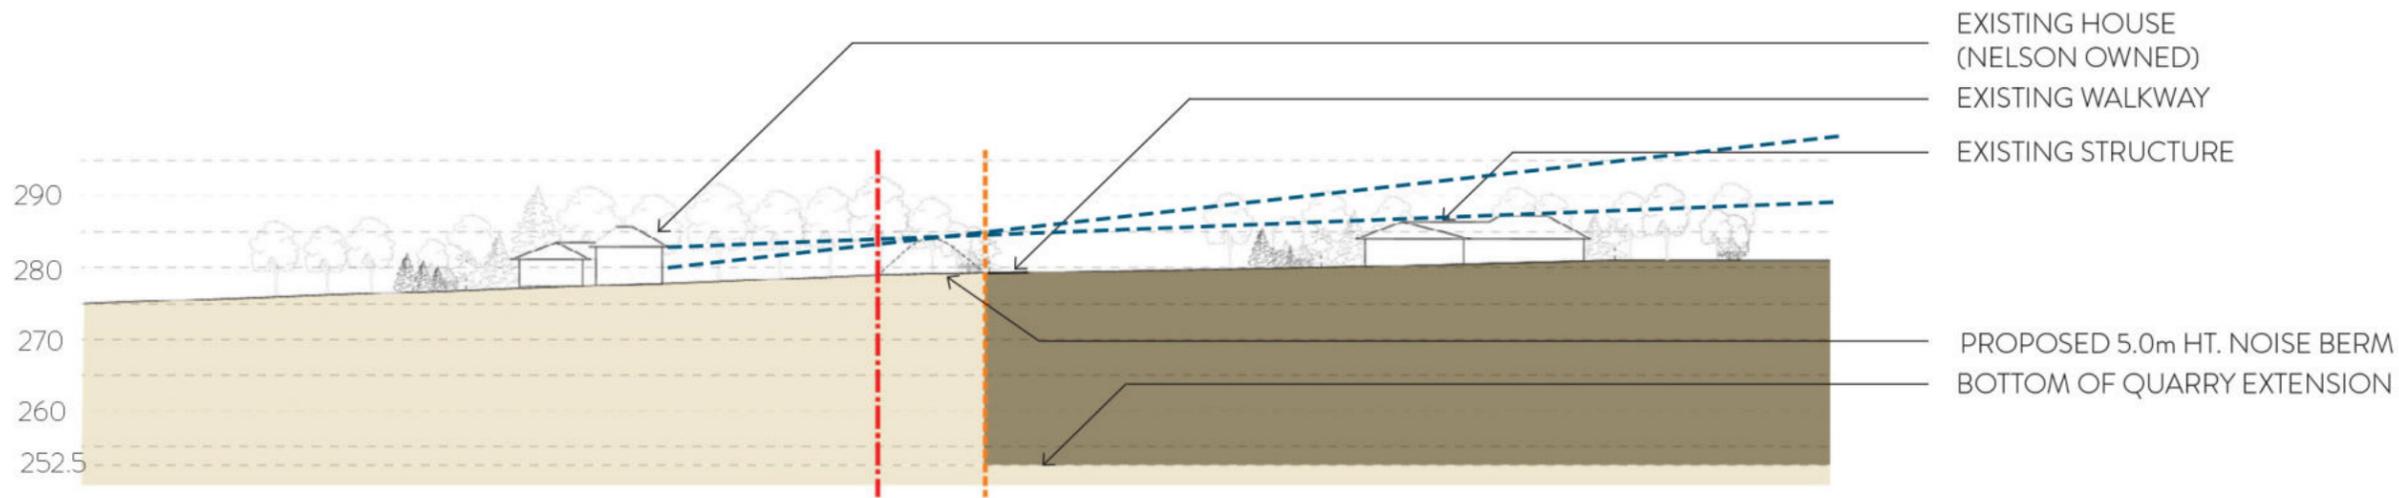
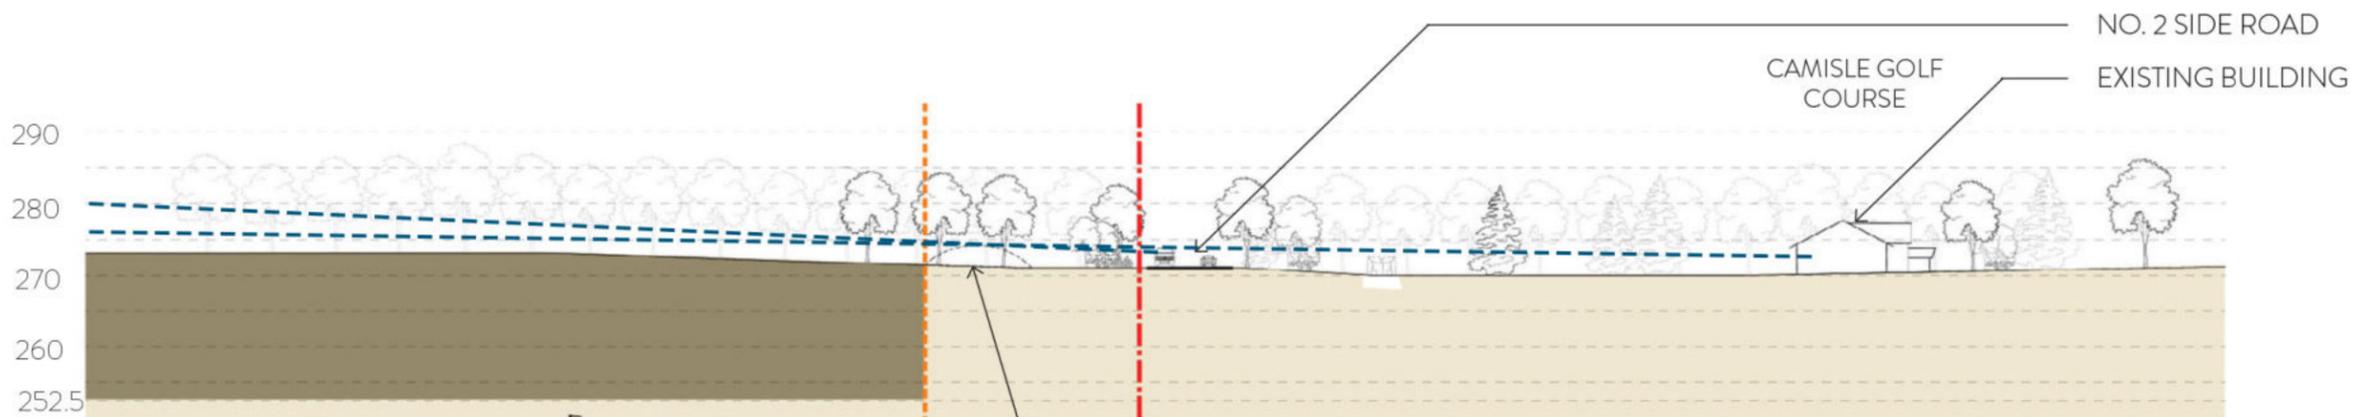
Figure 6 A, B, C

SECTION - A
SOUTHWEST - NORTHEAST

SECTION - B
SOUTHWEST - NORTHEAST

SECTION - C
NORTHWEST - SOUTHEAST

The visual impacts were assessed based on extraction occurring to the maximum proposed extent of 252.5 to 255.6 masl at the West Extension, and 270.0 – 271.0 masl at the South Extension. Cross sections at key vantage points were drawn in order to assess the existence of any visual impacts, and to inform mitigation recommendations these where visual impacts could exist **(See Figures 6A to 6K)**.

Cross-sections are included in **Figures 6A to 6K**, which illustrate the views relative to the subject lands. The sections illustrate that the location, topography and existing conditions around the majority of the subject lands are conducive to effectively screened quarry operations. There are some areas, however, where sparse vegetation and relatively flat topography create the opportunity for views into the site and visual mitigation is proposed in these areas (**See Figure 5, Mitigation Plan**). Mitigation strategies outlined in the table above are also shown on the post-mitigation sections, which show how the proposed strategies provide an effective screening from quarry operations.

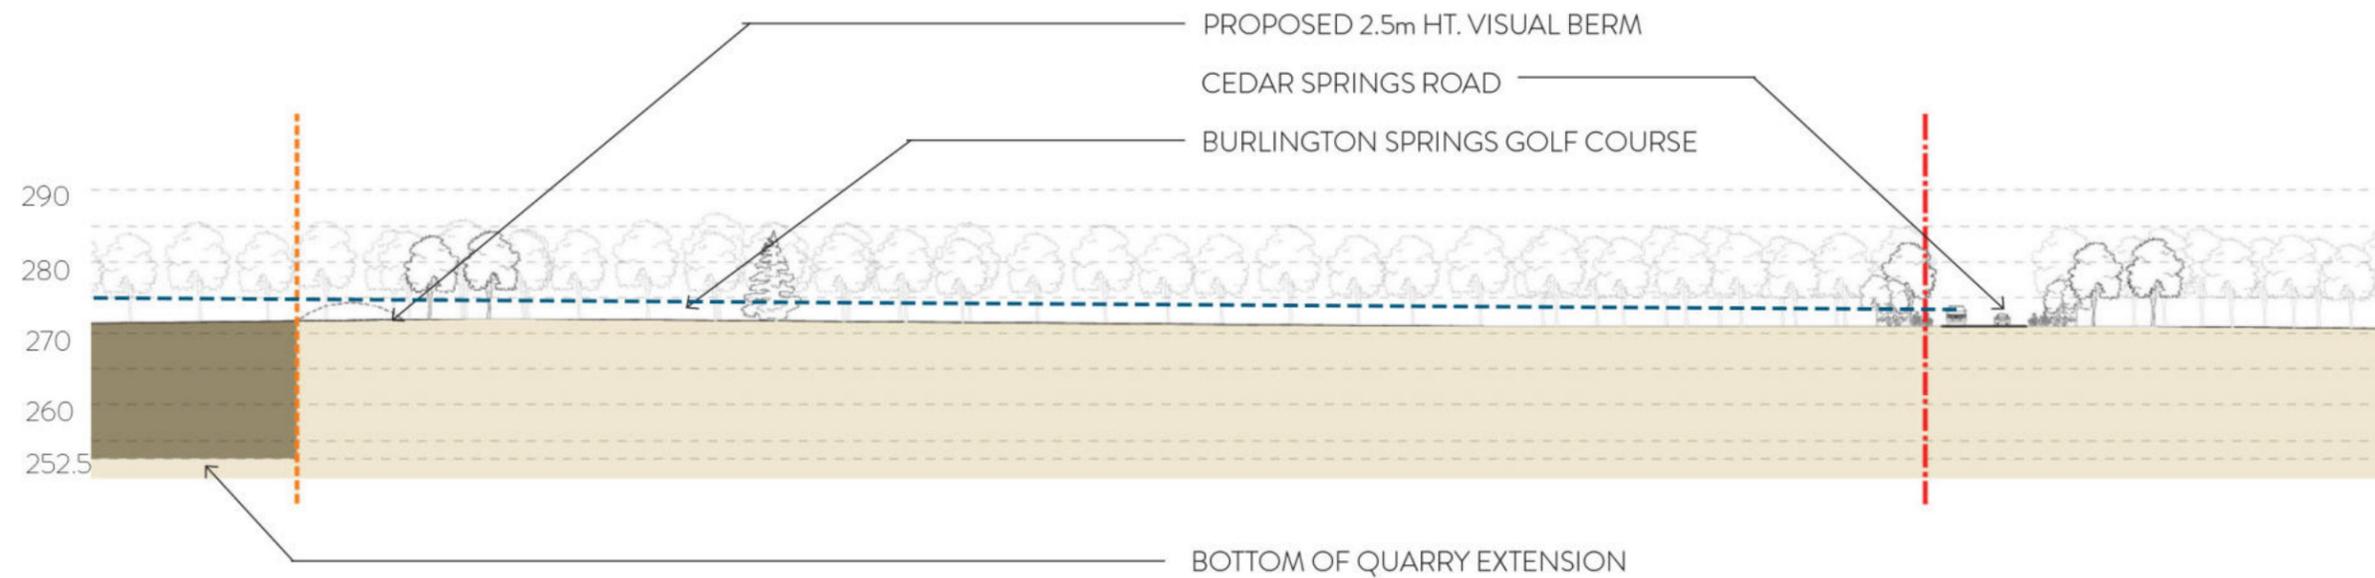
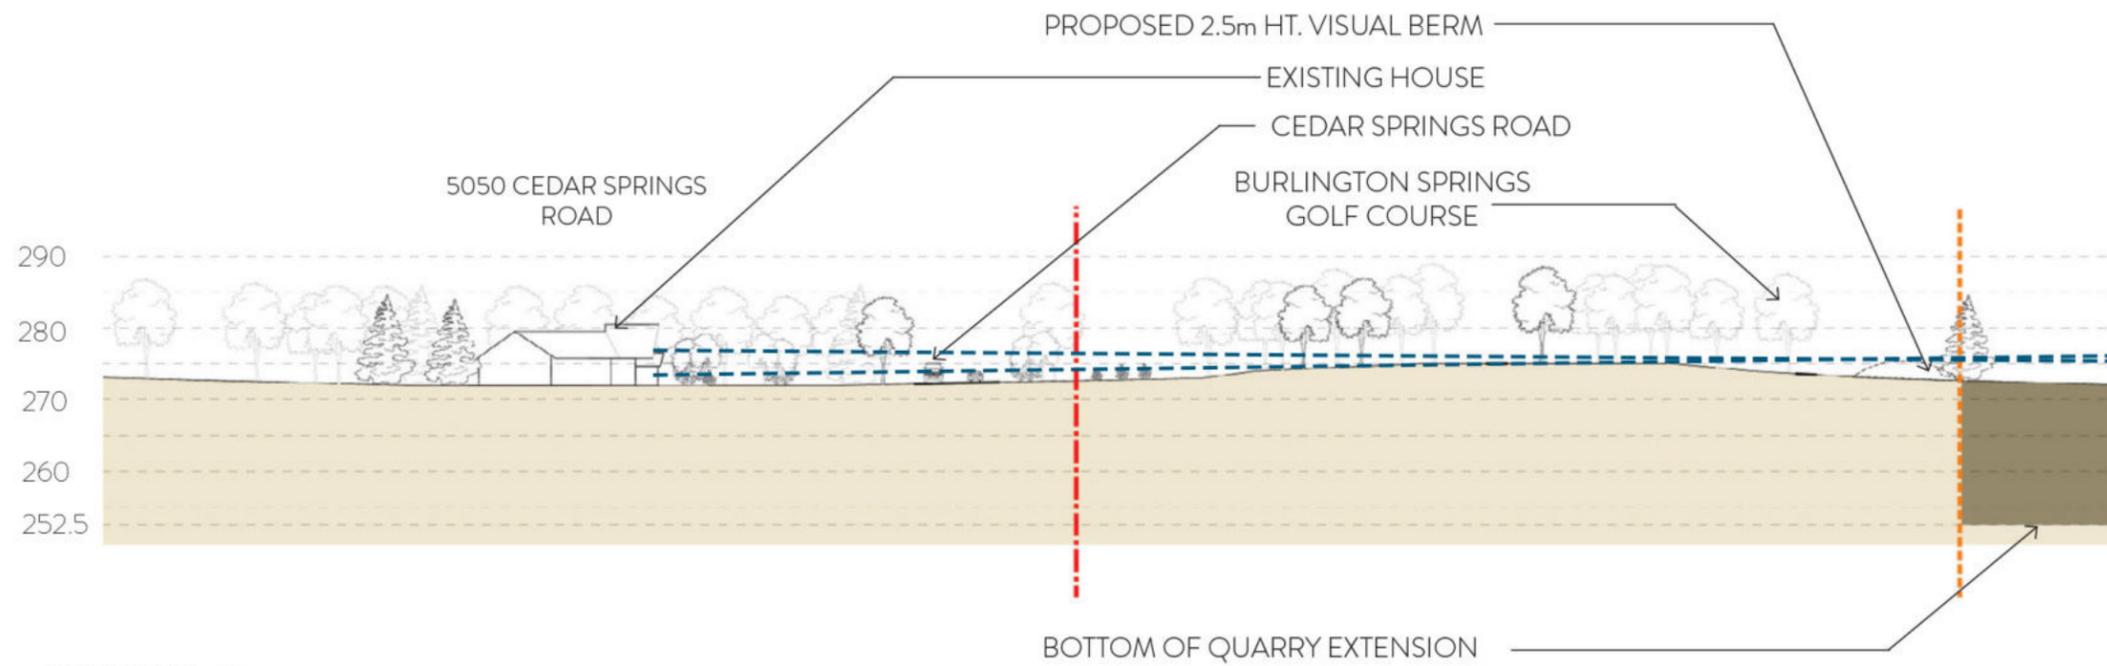
Cross Sections D & E

SECTION - D
NORTHWEST - SOUTHEAST

SECTION - E
SOUTH - NORTH

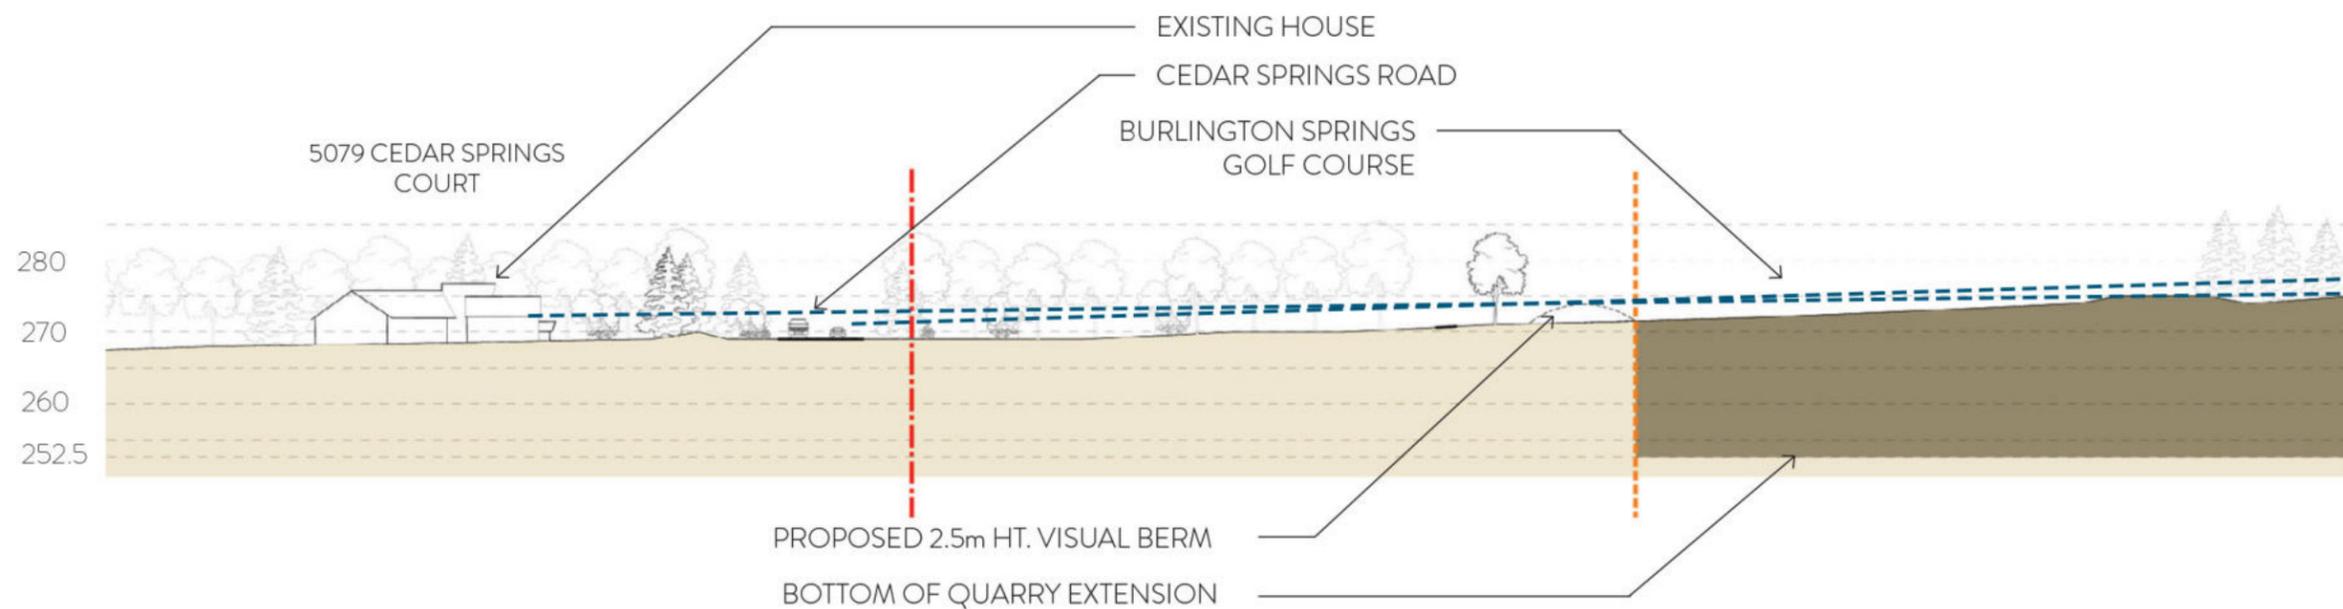
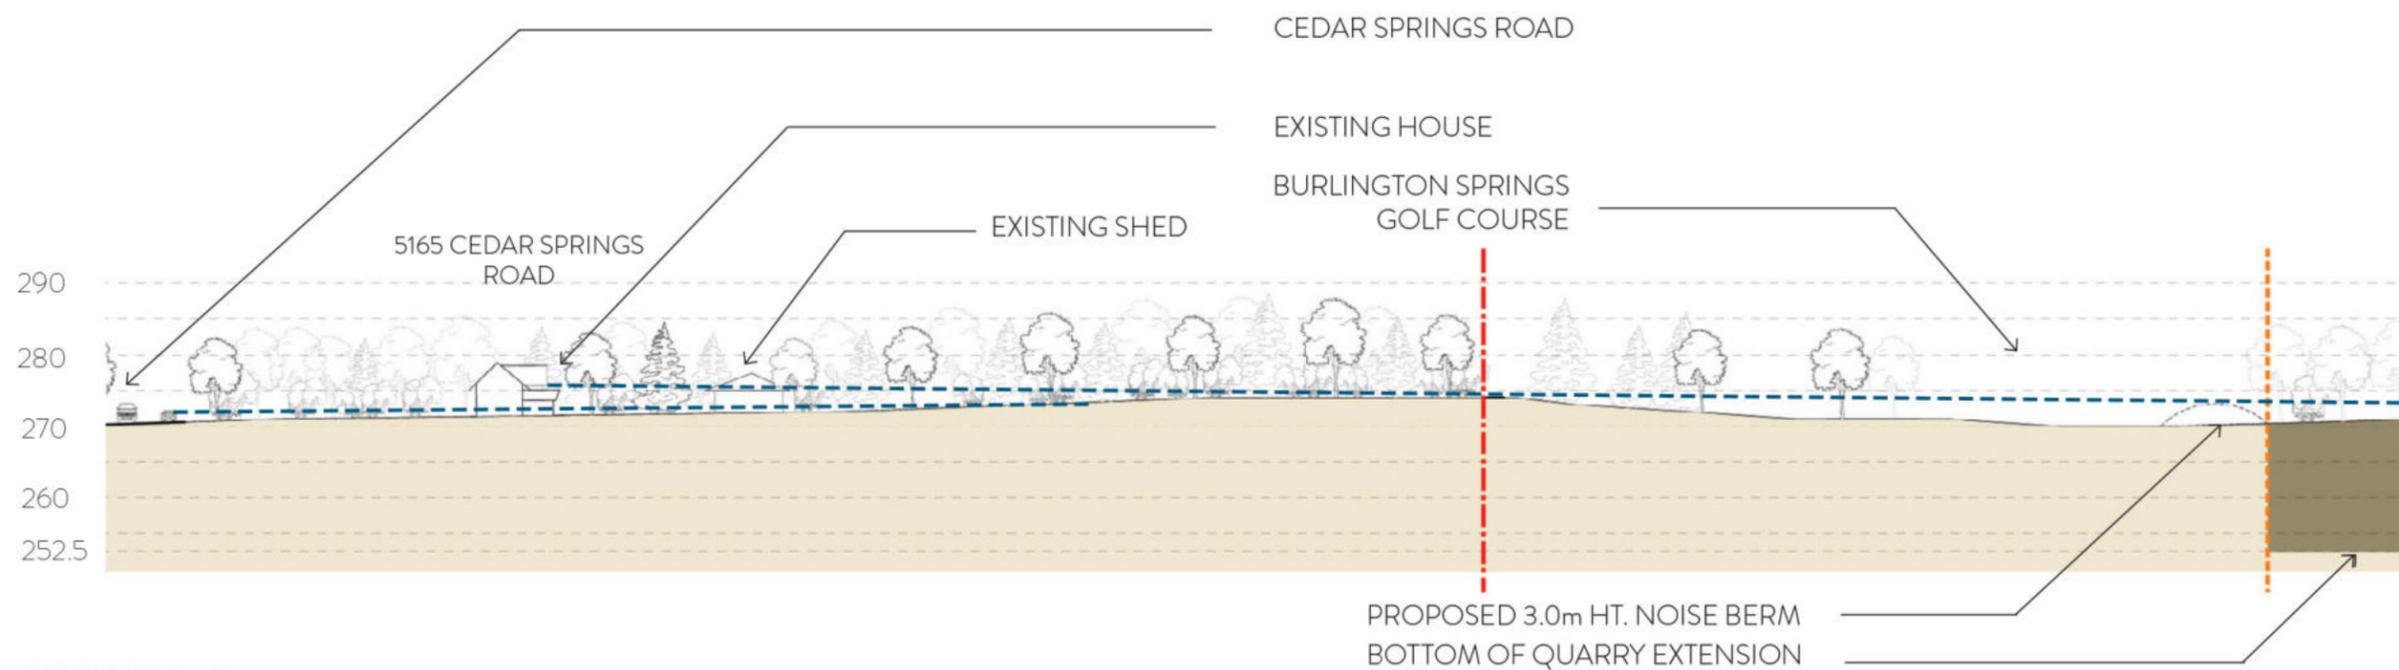
SECTION - F
SOUTH - NORTH

SECTION - G
SOUTHWEST - NORTHEAST

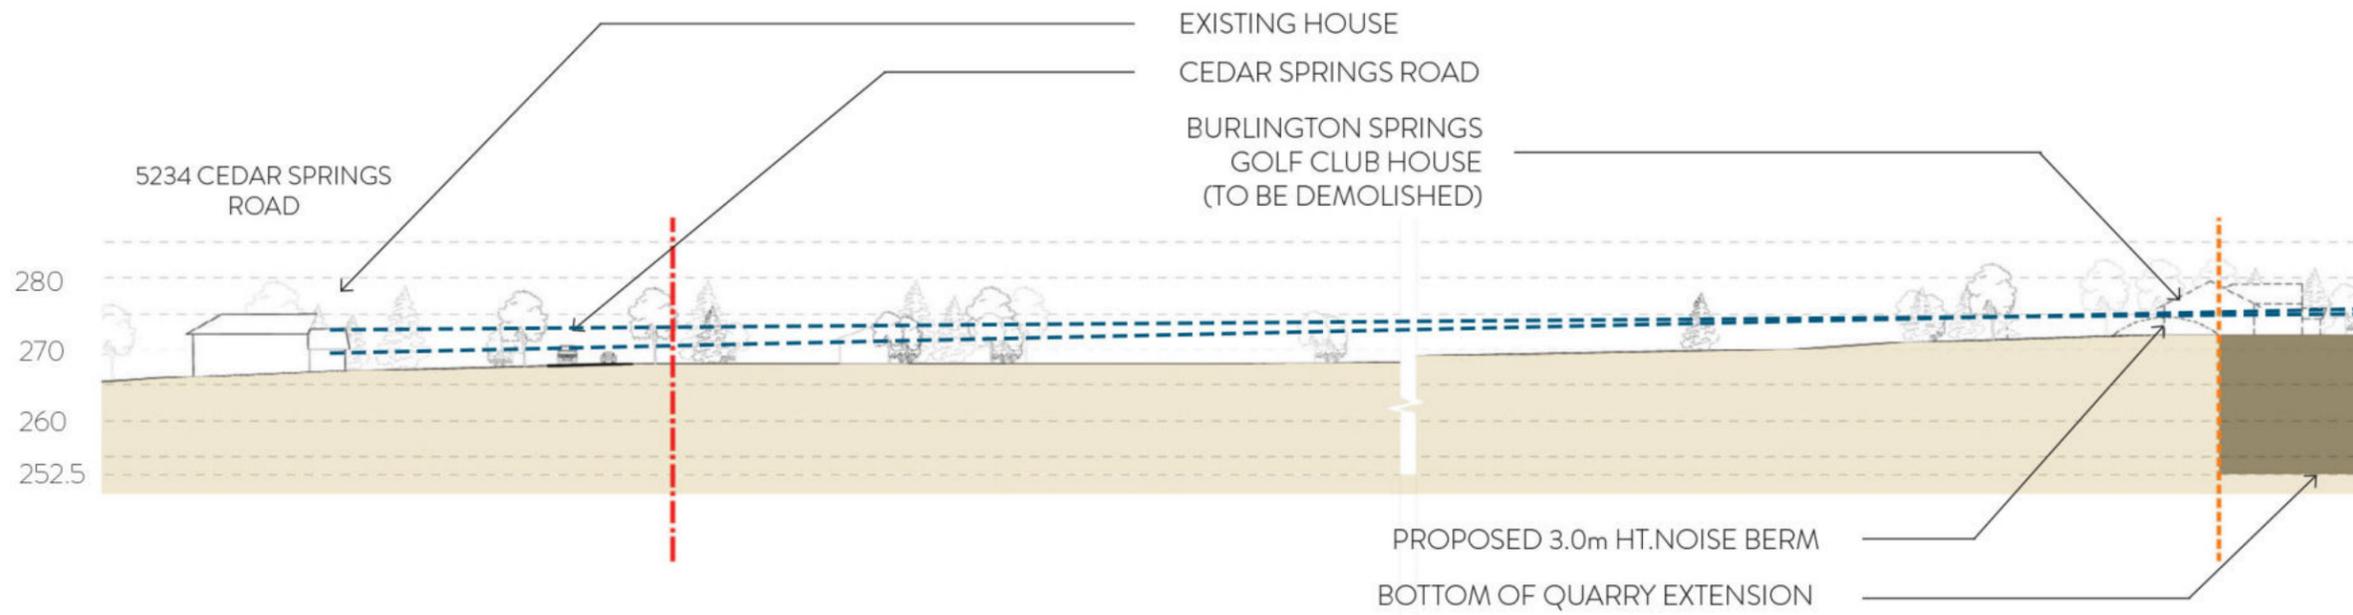
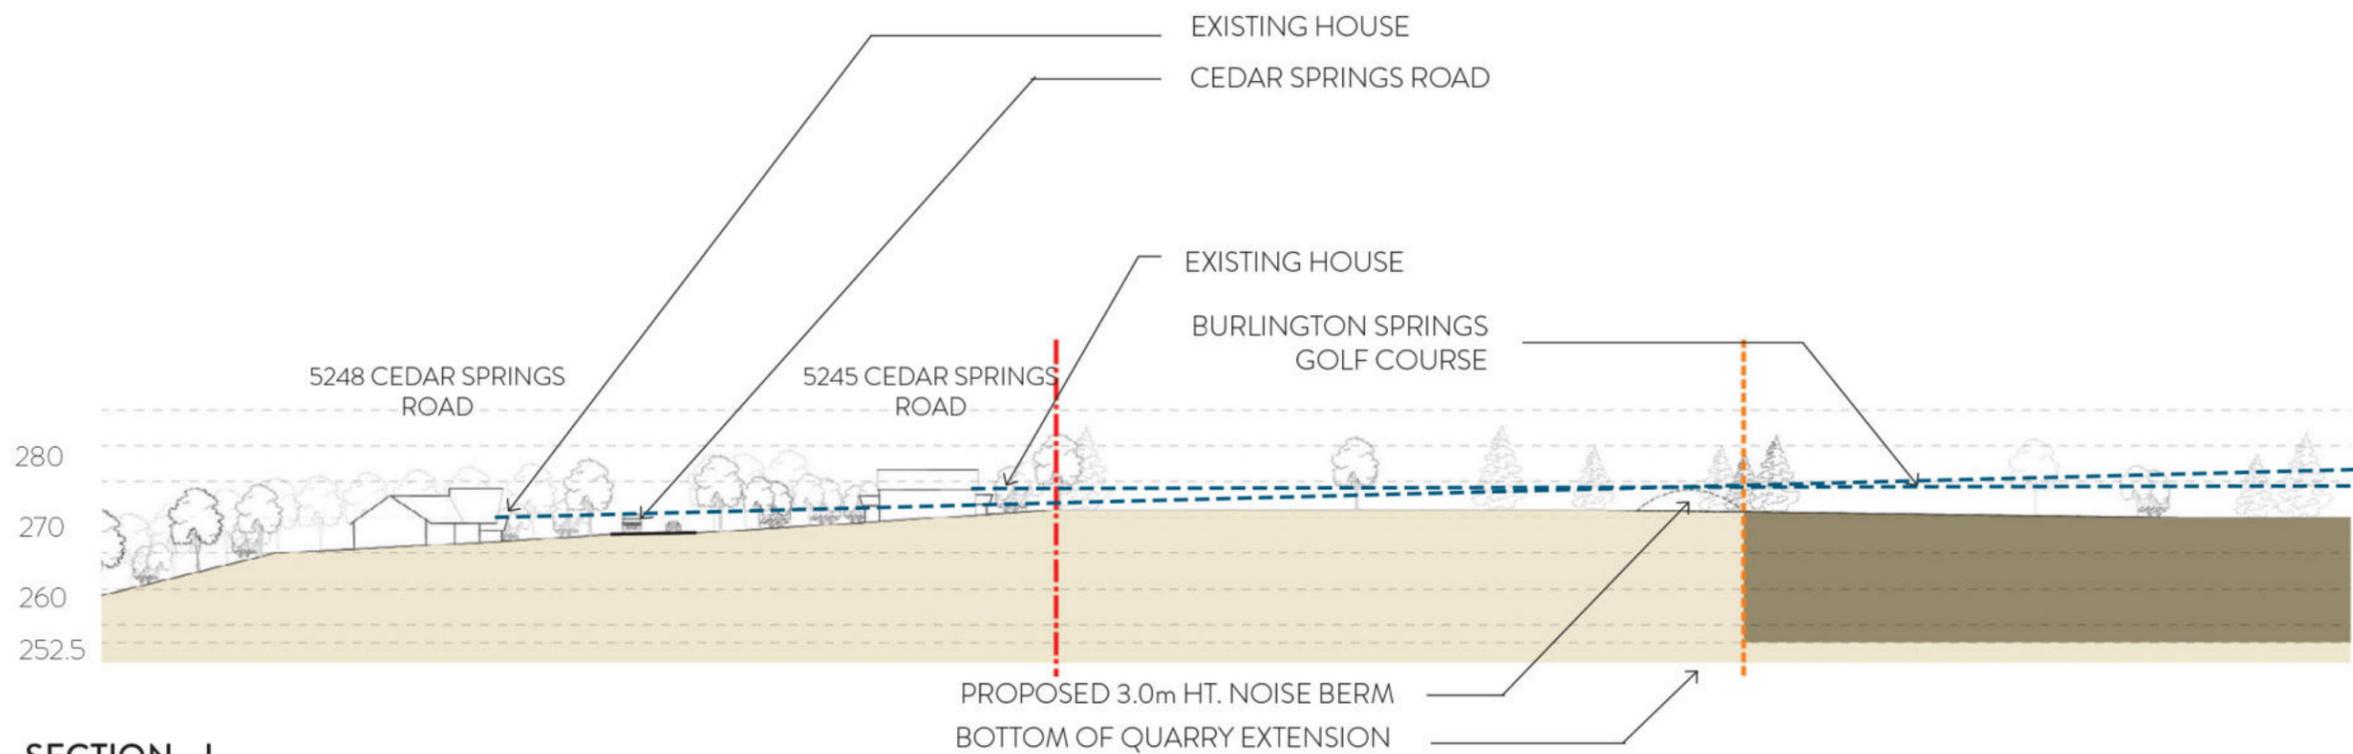
Figure 6 H, I

SECTION - H
 SOUTHWEST - NORTHEAST

SECTION - I
 SOUTHWEST - NORTHEAST

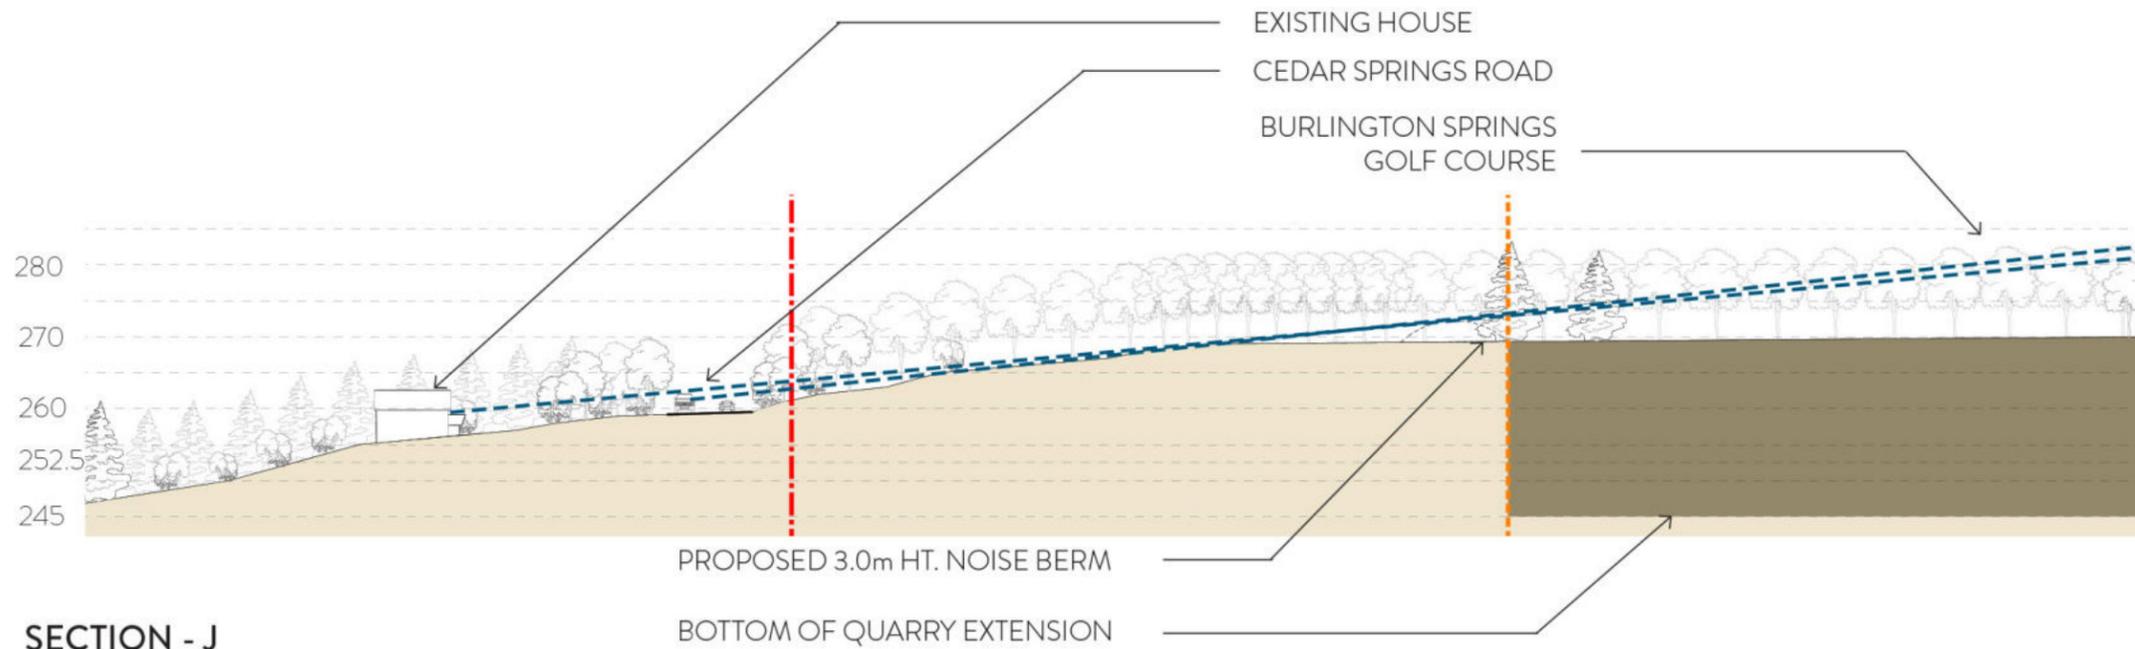
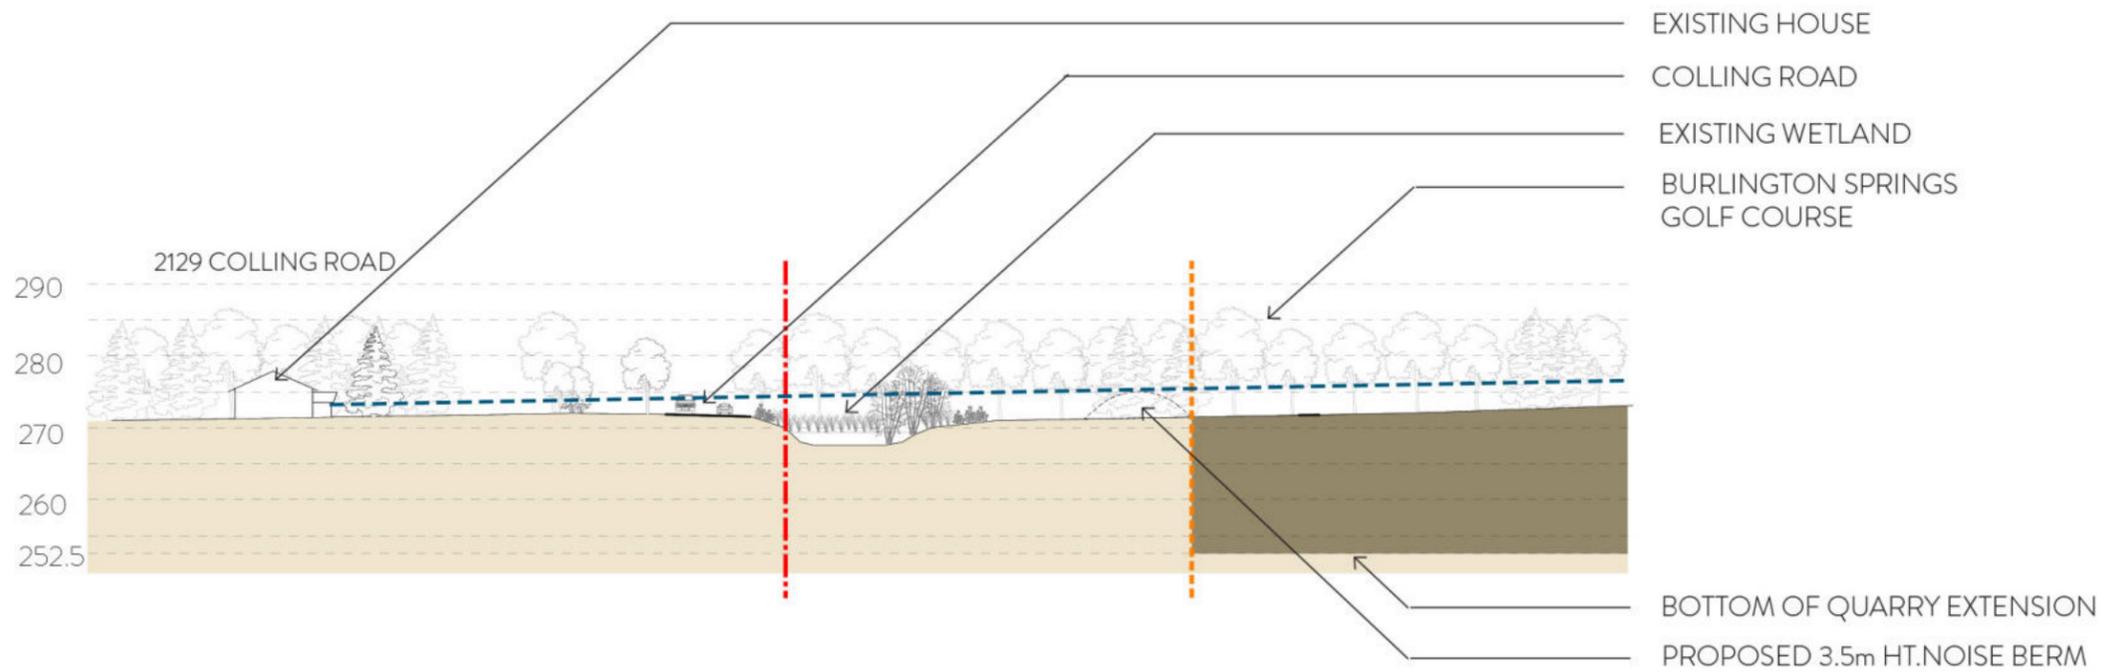
Figure 6 J, K

- Limit of Extraction
- - - Licence Boundary
- Existing Vegetation
- - - Line of Sight
- Area to be Excavated

SECTION - J
SOUTHWEST - NORTHEAST

SECTION - K
NORTHWEST - SOUTHEAST
