RE: Burlington Quarry Extension – Nelson Response to JART’s Comments on the Visual Impact Assessment
OUR FILE 9135D

**Proposed Burlington Quarry Expansion
JART COMMENT SUMMARY TABLE – Visual Impact Assessment**

VISUAL IMPACT ASSESSMENT

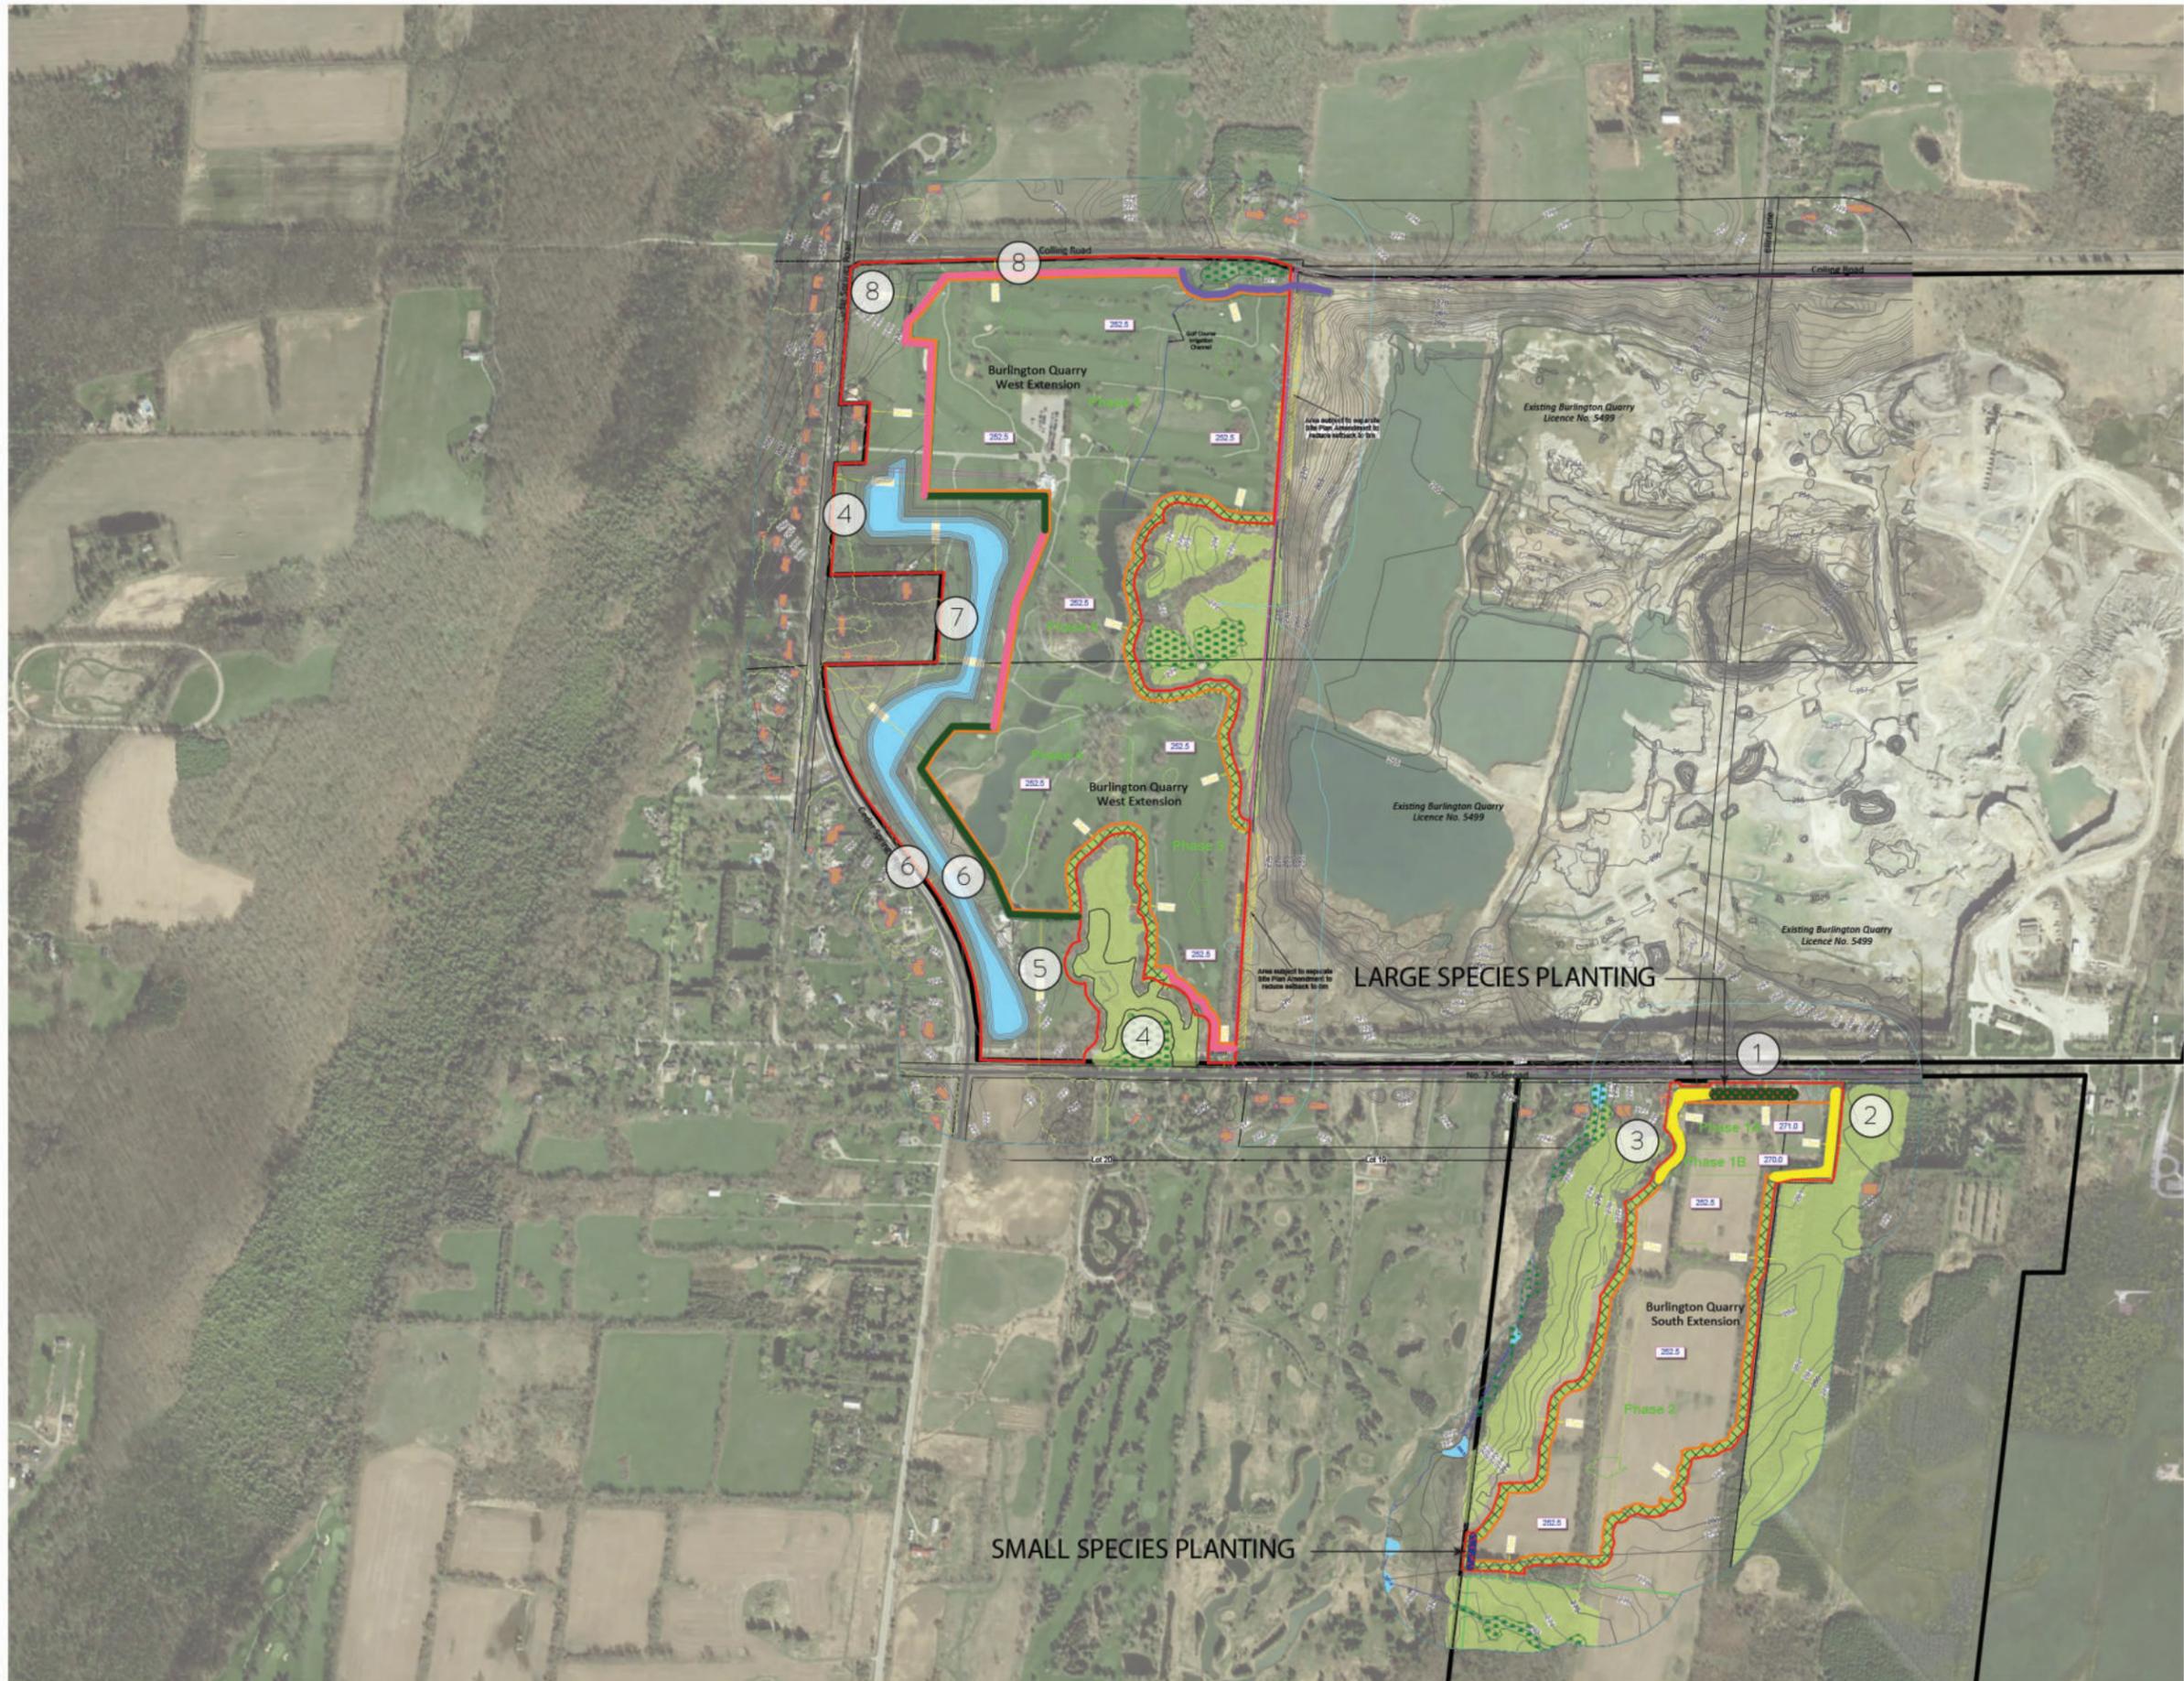
Figure 5

Mitigation Plan

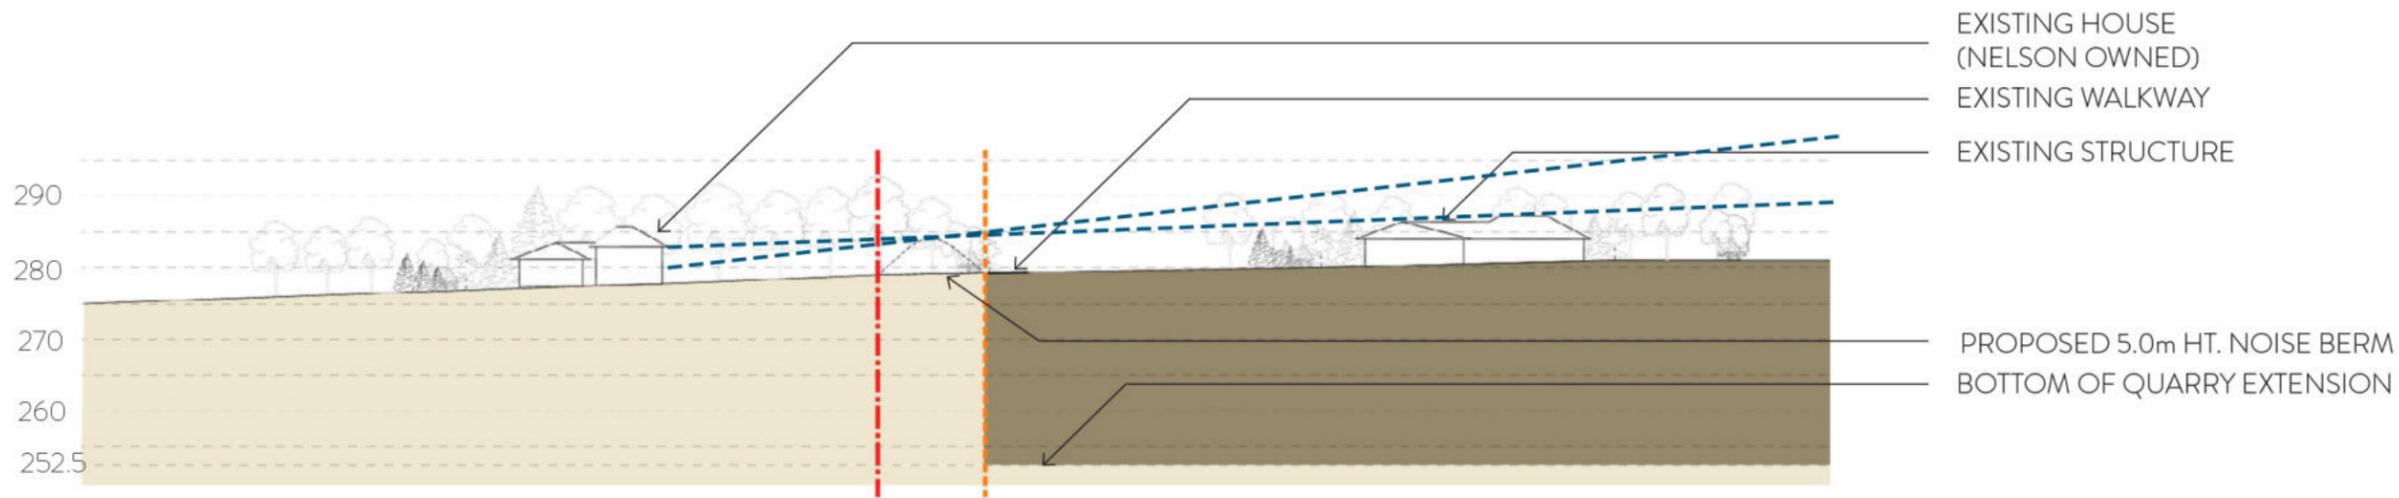
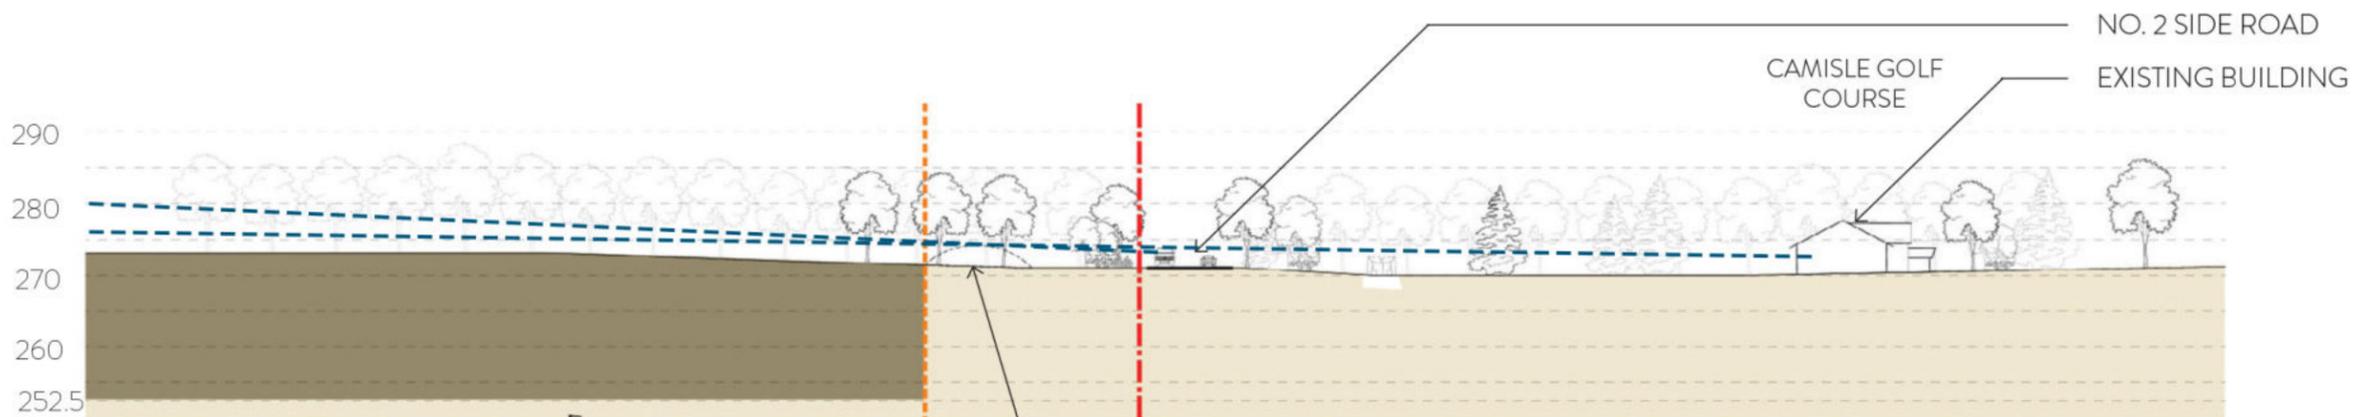
Figure 6 A, B, C

SECTION - A
 SOUTHWEST - NORTHEAST

SECTION - B
 SOUTHWEST - NORTHEAST

SECTION - C
 NORTHWEST - SOUTHEAST

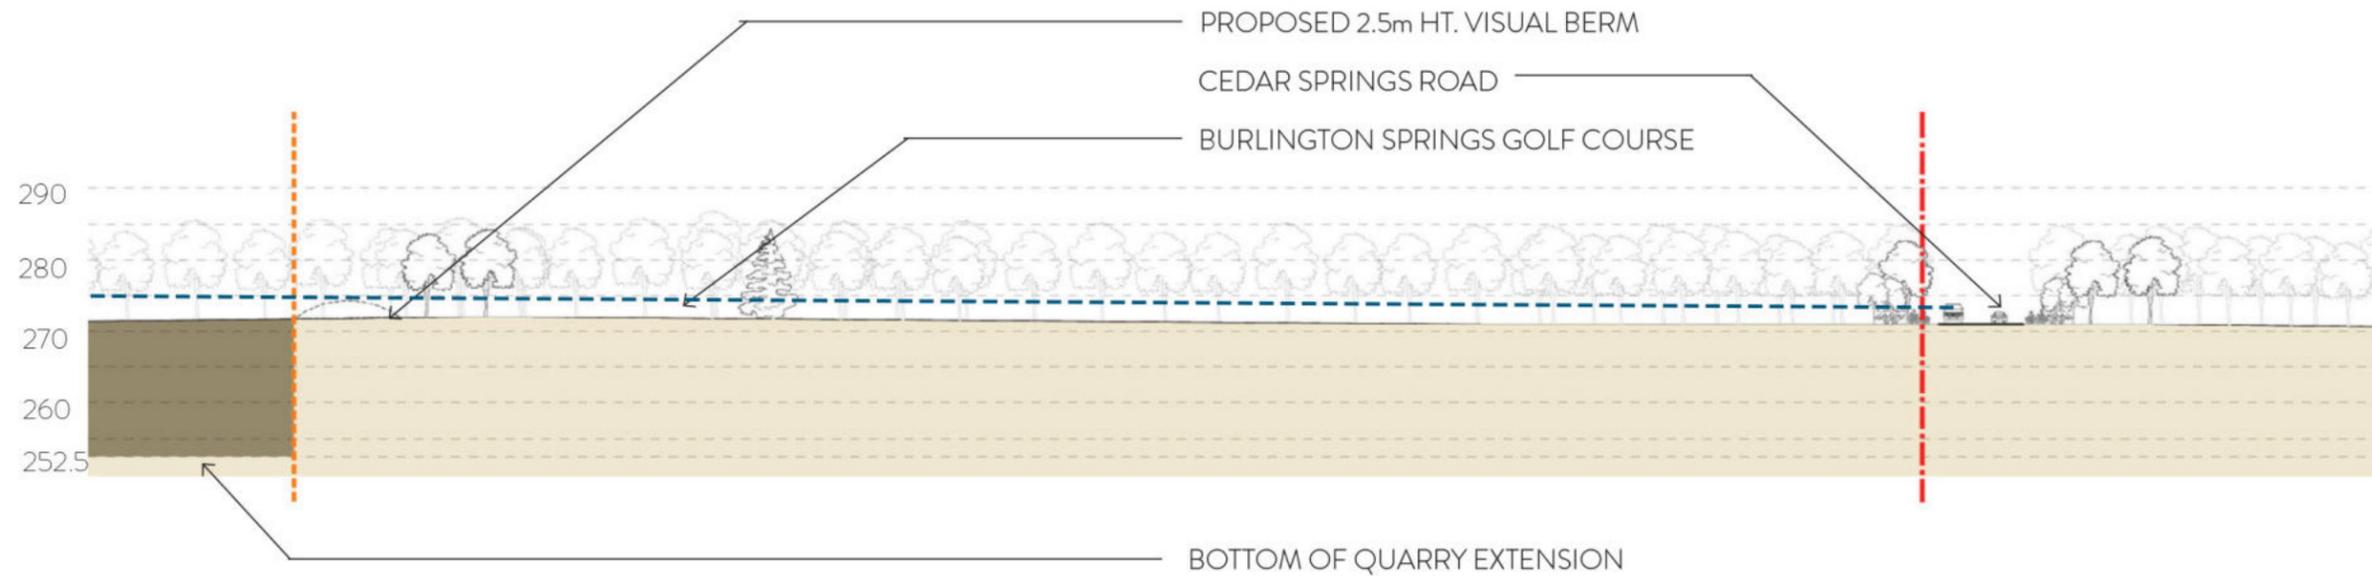
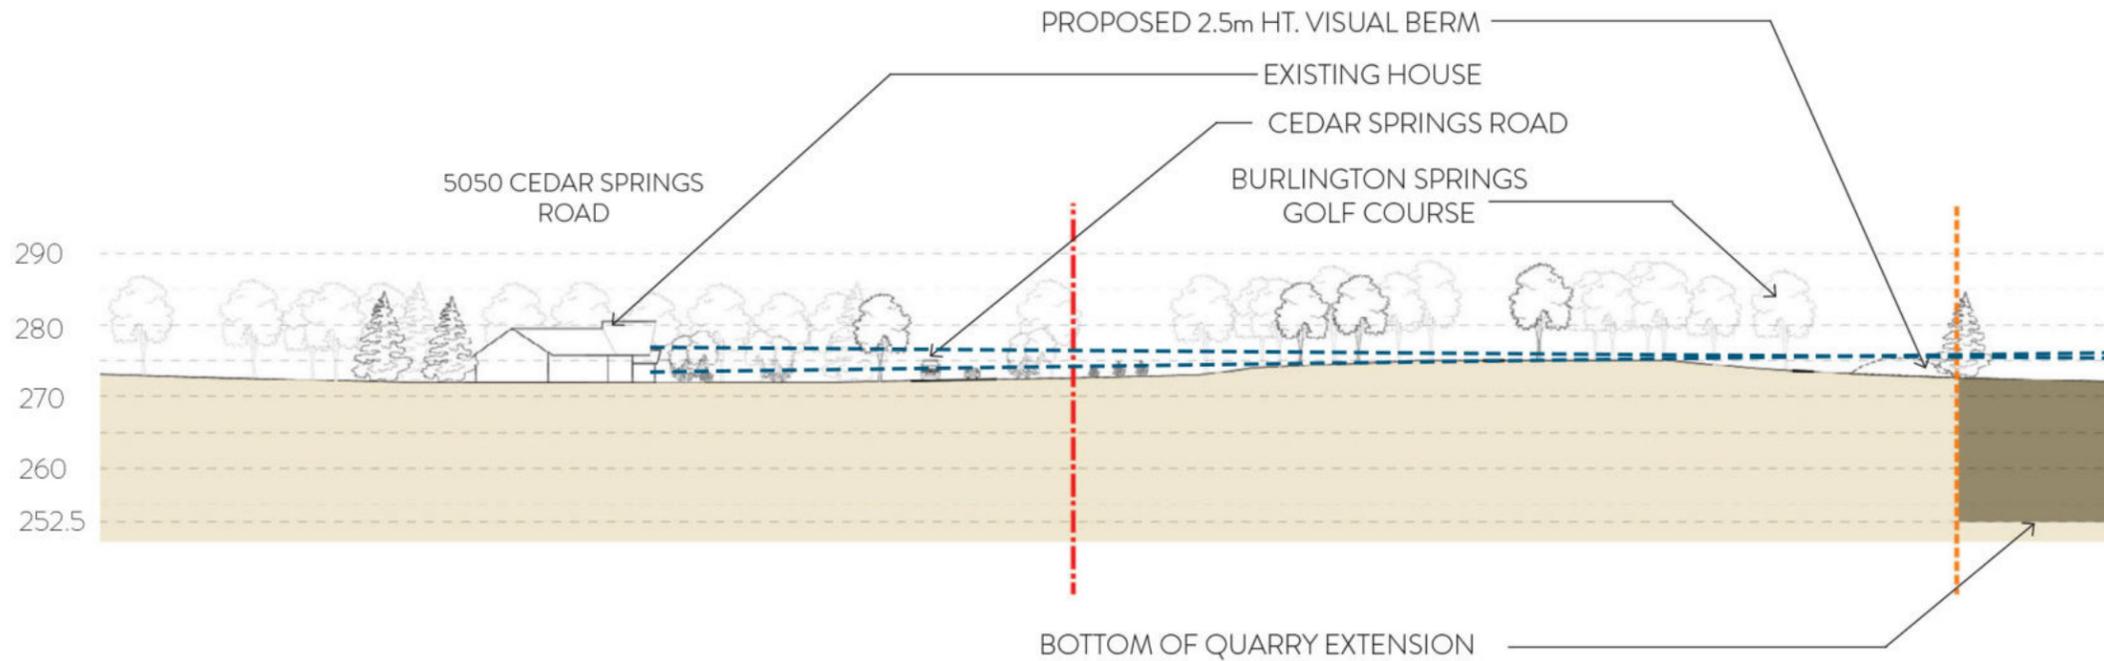
SECTION - D
NORTHWEST - SOUTHEAST

SECTION - E
SOUTH - NORTH

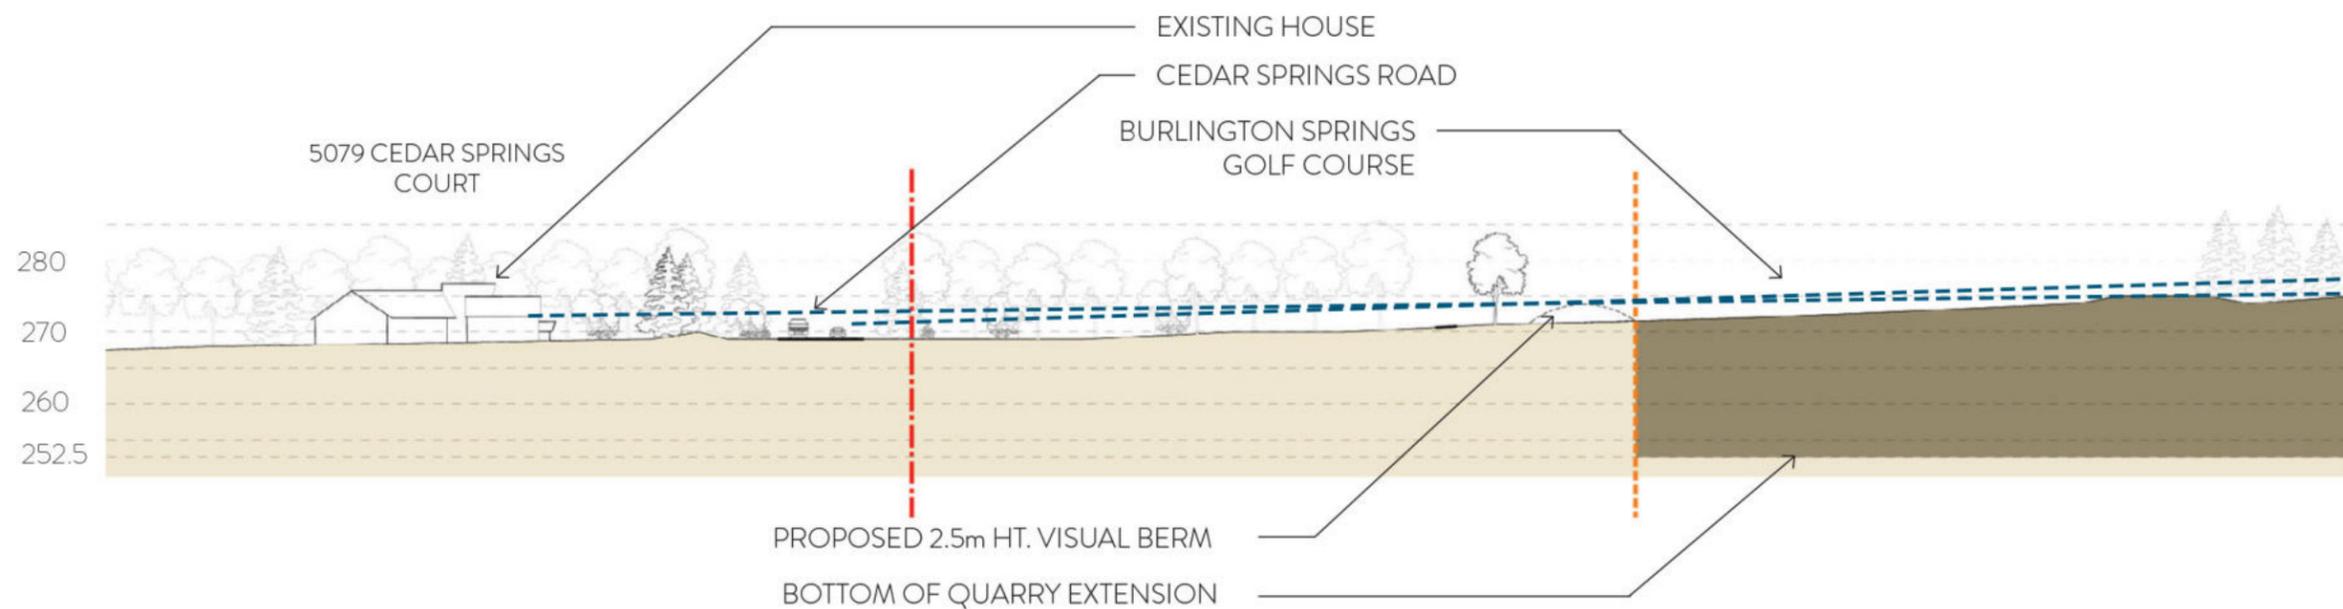
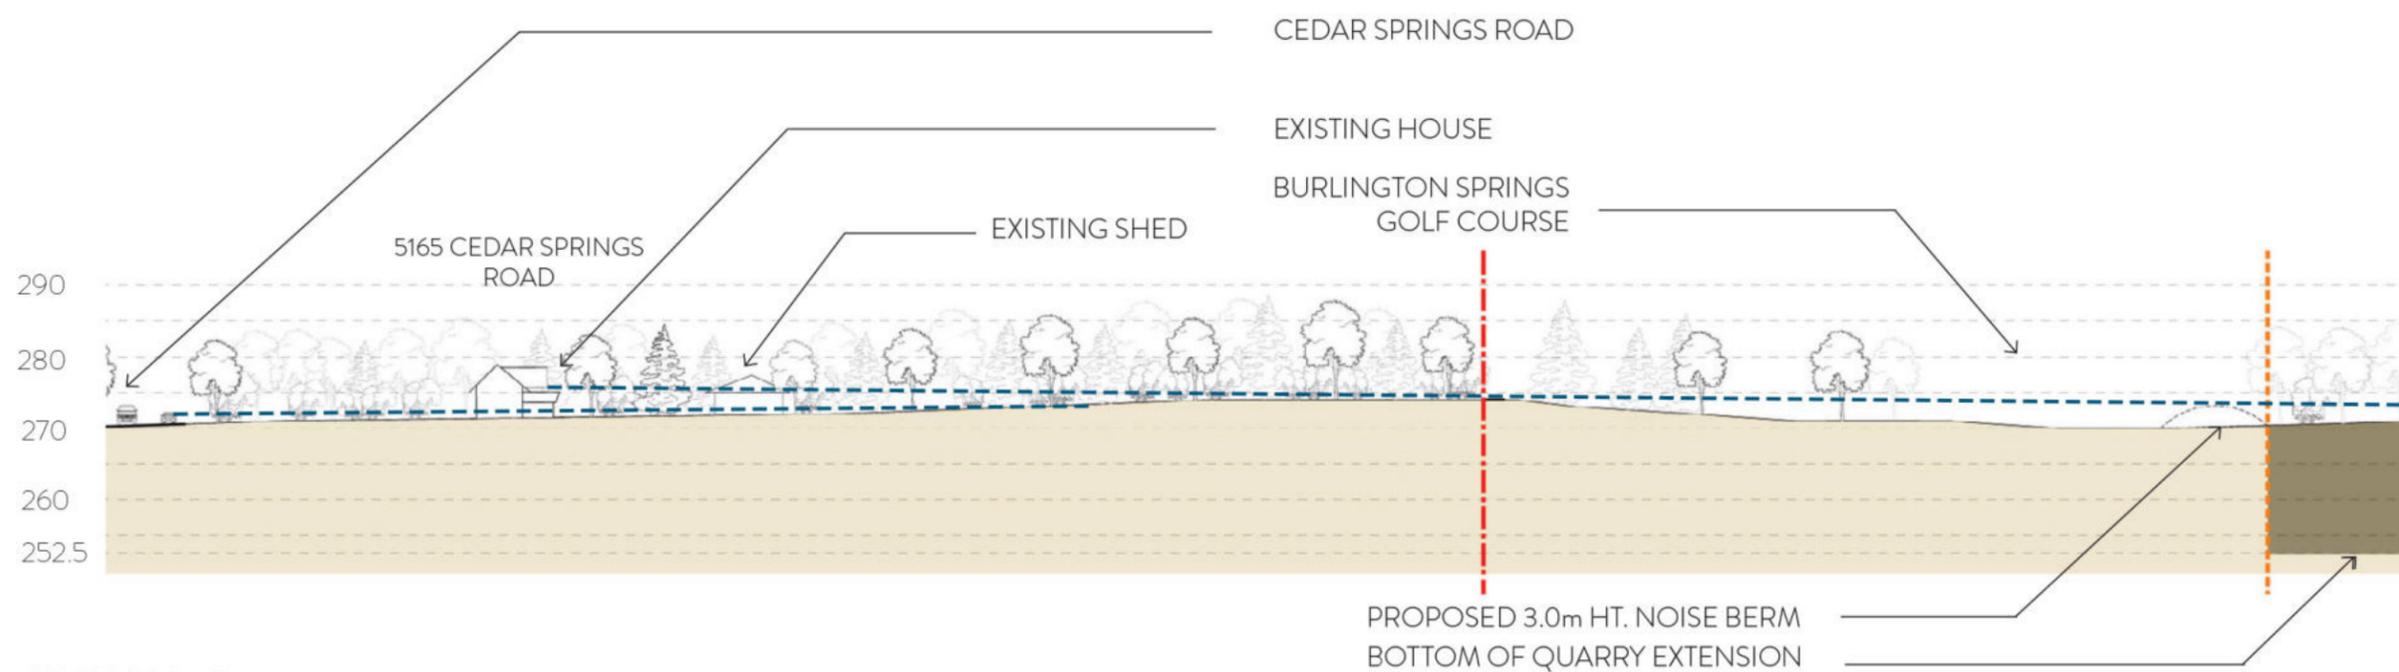
SECTION - F
SOUTH - NORTH

SECTION - G
SOUTHWEST - NORTHEAST

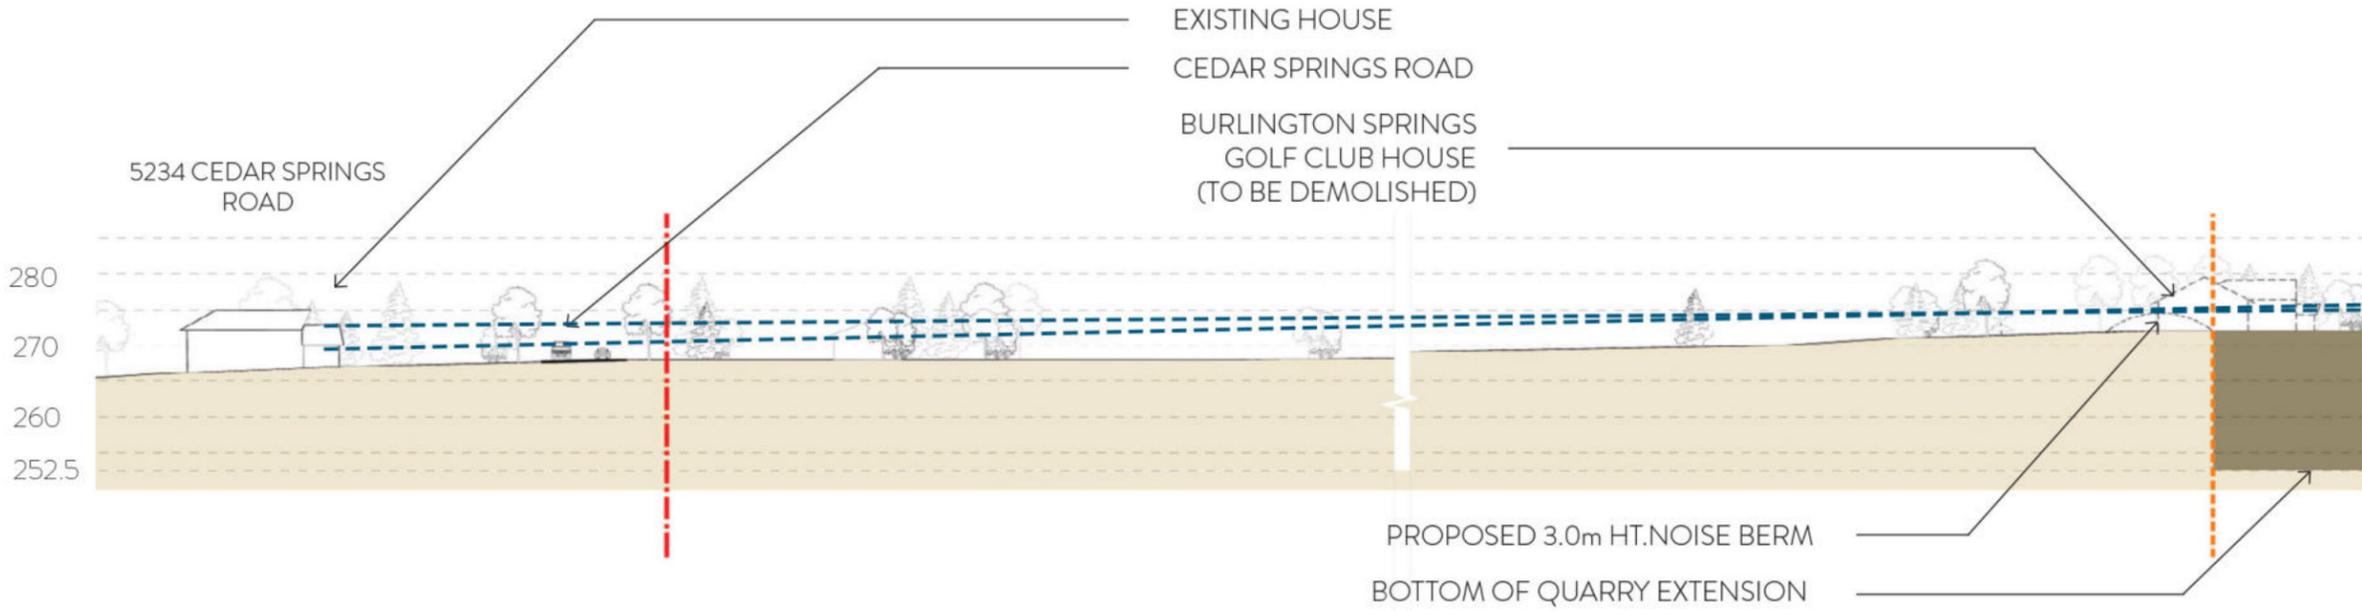
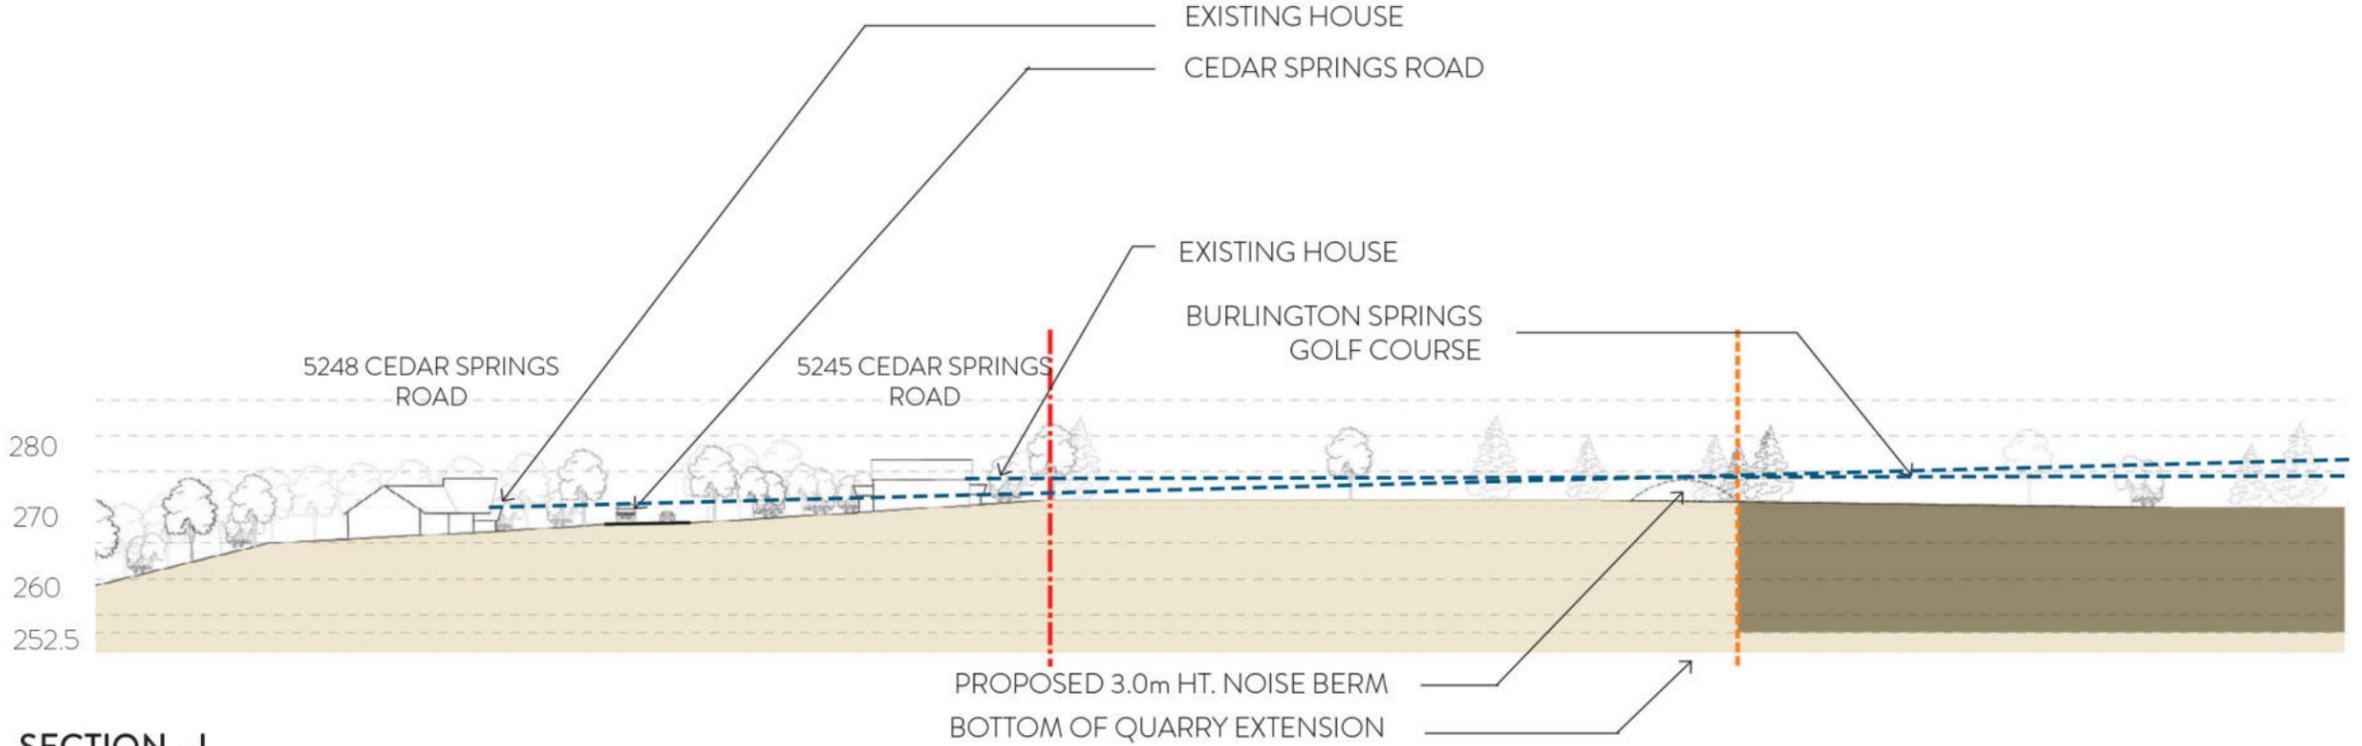
SECTION - H
SOUTHWEST - NORTHEAST

SECTION - I
SOUTHWEST - NORTHEAST

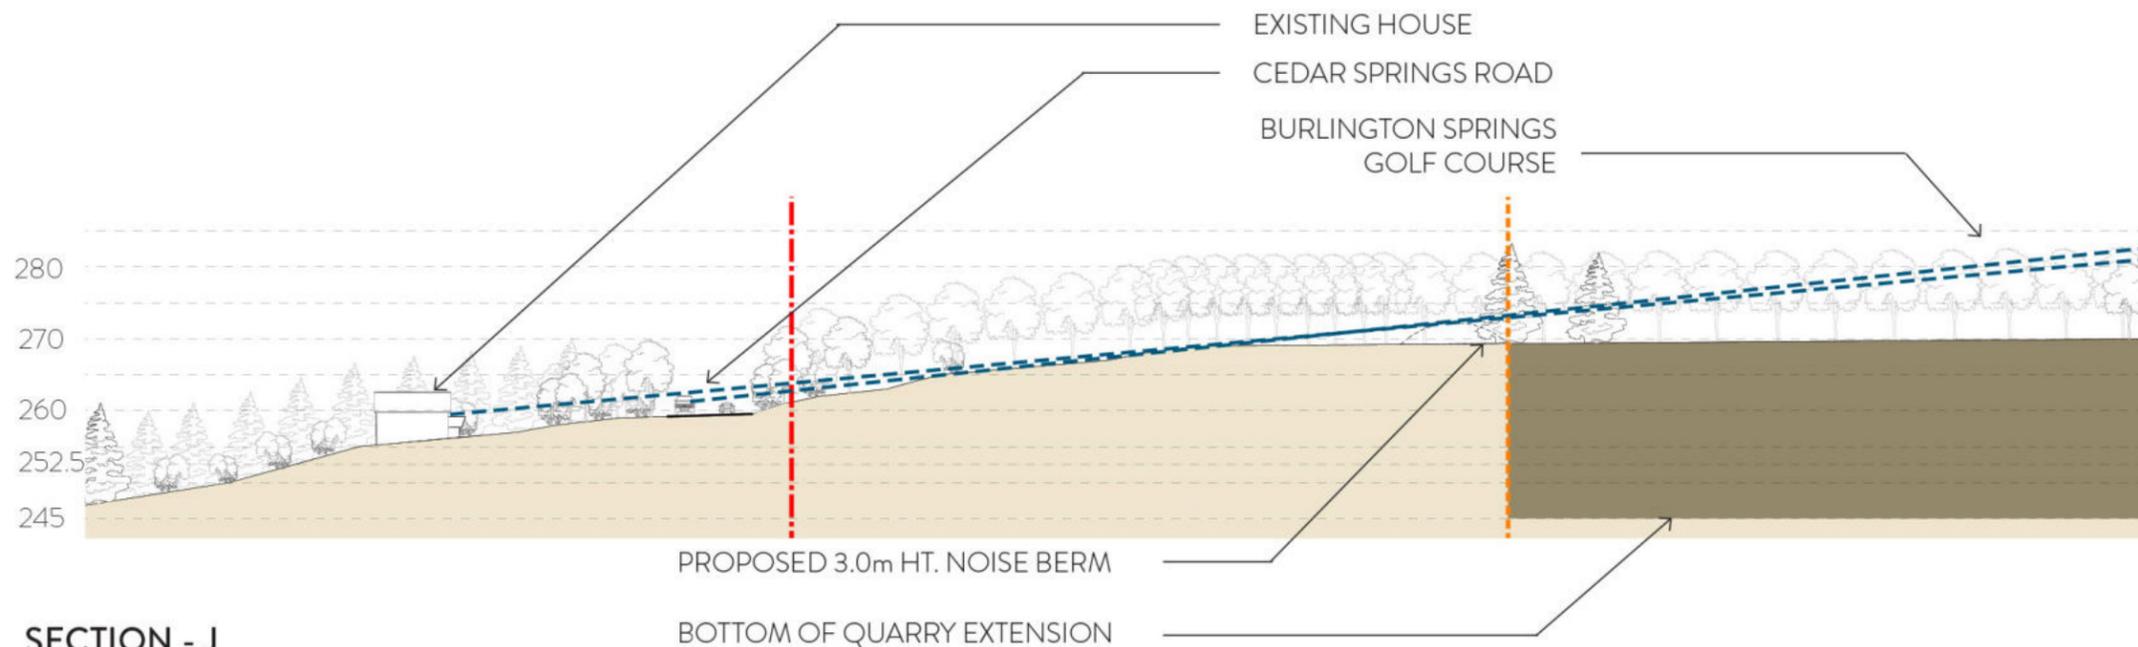
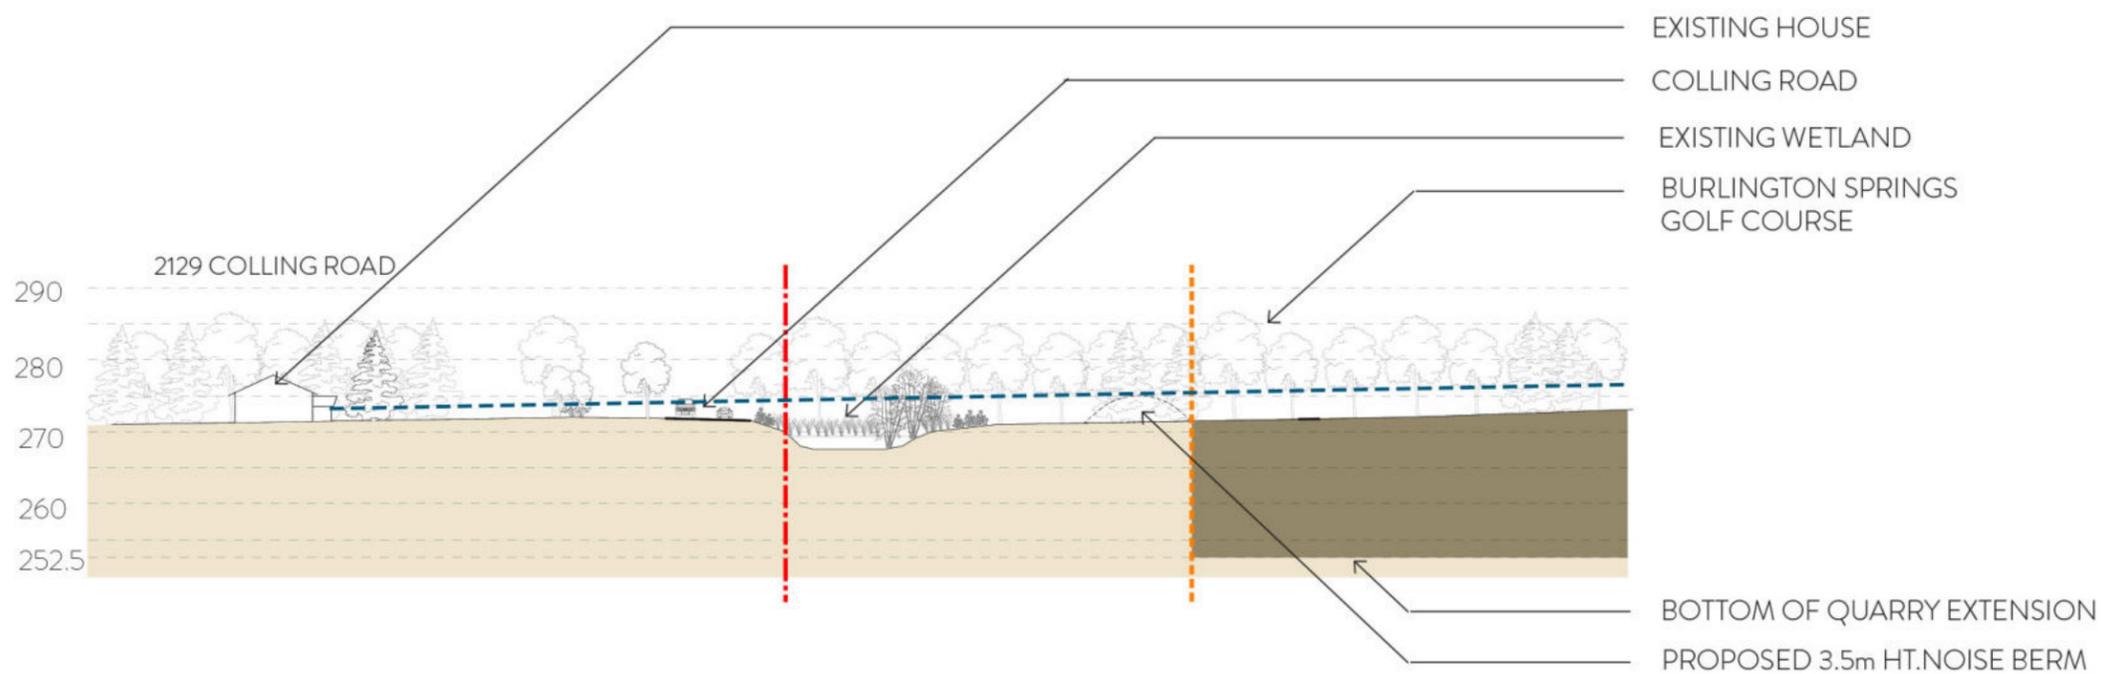
Figure 6 J, K

SECTION - J
 SOUTHWEST - NORTHEAST

SECTION - K
 NORTHWEST - SOUTHEAST
