To	Sheri Harmsworth	Page 1
Subject	Preliminary Evaluation of Integrating Trafalgar Road SWM with Pond 29 and Pond 30 (North Oakville Main-East Morrison Creek EIR/FSS)	
Prepared By	Janelle Wepler, B.Sc. (Env.), P.Eng., Water Resources Engineer	
Reviewed By	Glenn Farmer, Senior Environmental Technologist	
Date	November 4, 2013	Project Number 60119993

**Summary Action Report**  
**Structure 03-1182320 CU01 (MTO Site No. )**  
**Trafalgar Road**

Structure Number: **03-1182530 CU02**

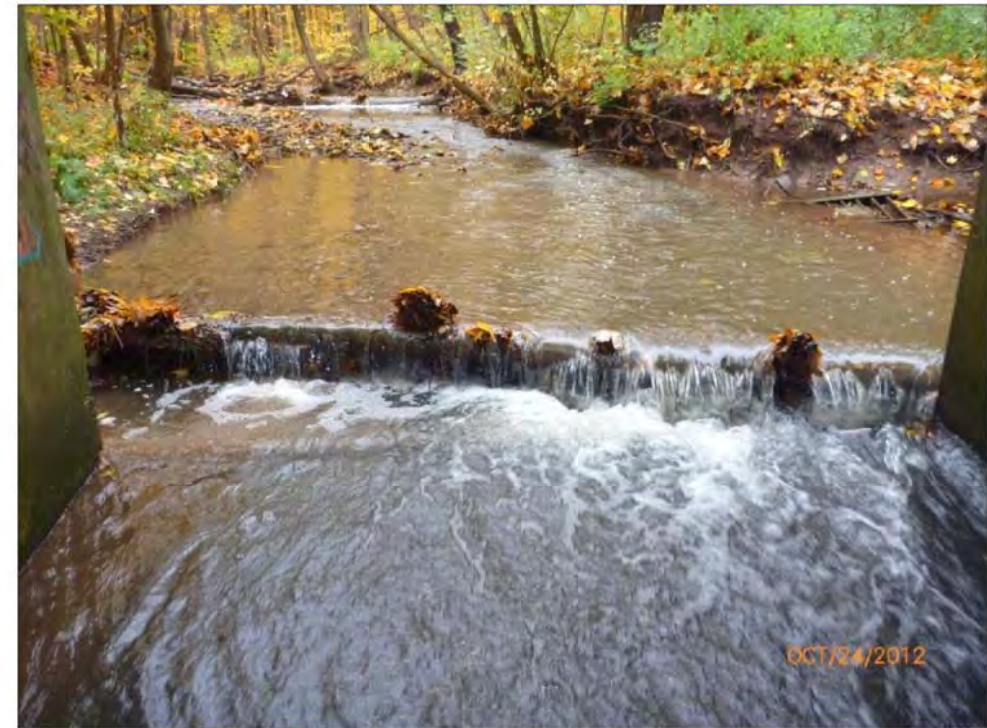
Tree at Barrel Inlet

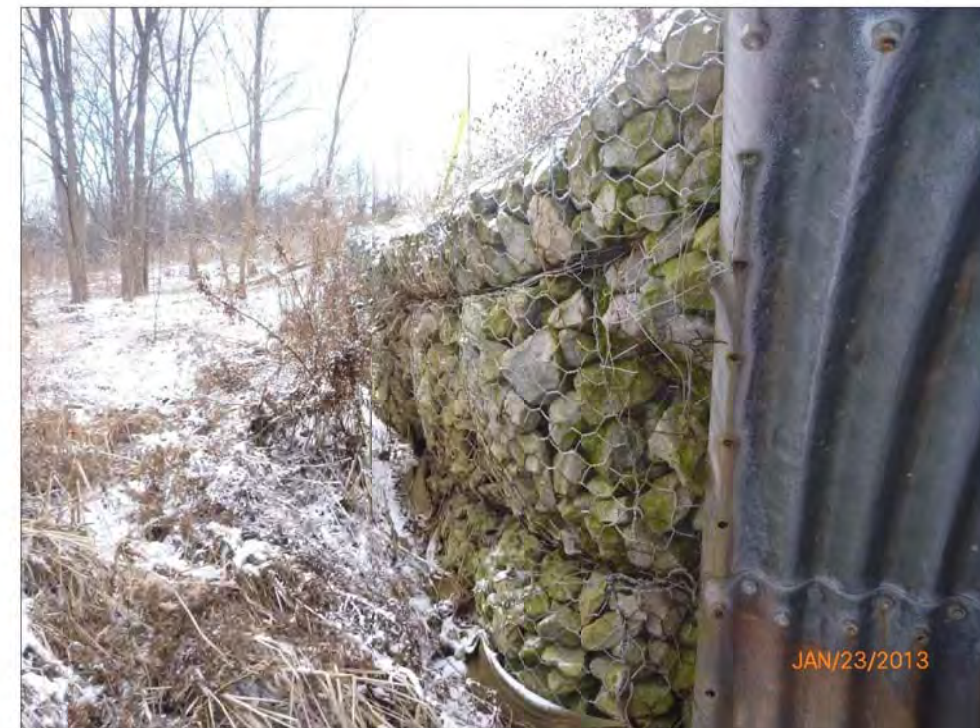
Minor Outward Rotation of Inlet Component
